MASH Test Nos. 3-11 and 3-10 on a Non-Proprietary Cable Median Barrier

*Midwest States Pooled Fund Research Program
Fiscal Years 2014 (Years 24)
Research Project Number TPF-5(193) Supplement #64
NDOR Sponsoring Agency Code RFPF-14-CABLE-1*

MASH TEST NOS. 3-11 AND 3-10 ON A NON-PROPRIETARY CABLE MEDIAN BARRIER

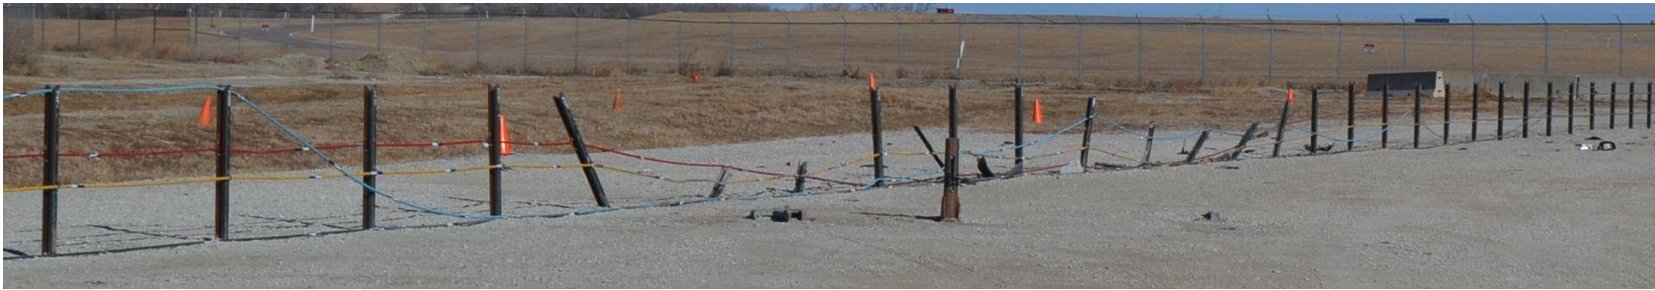
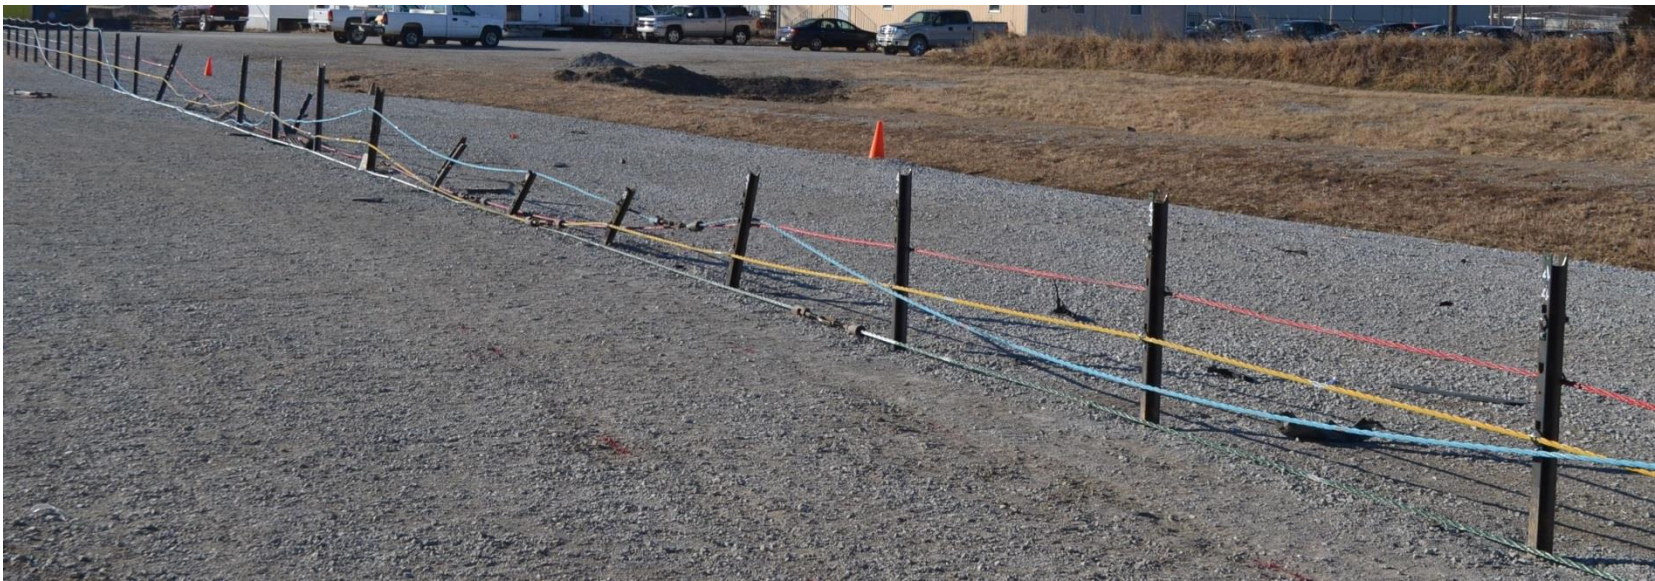
Figure 96. System Damage, Test No. MWP-6

Damage to the barrier was moderate, as shown in Figures 96 through 104. Barrier damage consisted of bent posts, disengaged cables, and bent and fractured brackets. At its final resting position, the vehicle was no longer in contact with the system.

Cable no. 4 disengaged from post nos. 29 through 52 due to fracturing of the brass keeper rods. Cable no. 3 disengaged from post nos. 24 through 49. Cable no. 2 disengaged from post nos. 32 through 40. Cable no. 1 disengaged from post nos. 32, 33, as well as from post nos. 35 through 39. Two of the brackets that released cable no. 2 fractured at the neck of the bracket. All of the other brackets released cable nos. 1 through 3 through rotation of the bracket tab through the key, allowing cables to release vertically. Displacement of the cable within the splices was documented. The maximum cable displacement within a splice was ½ in. (13 mm), found on the load cell splice located upstream from impact on cable no. 2.

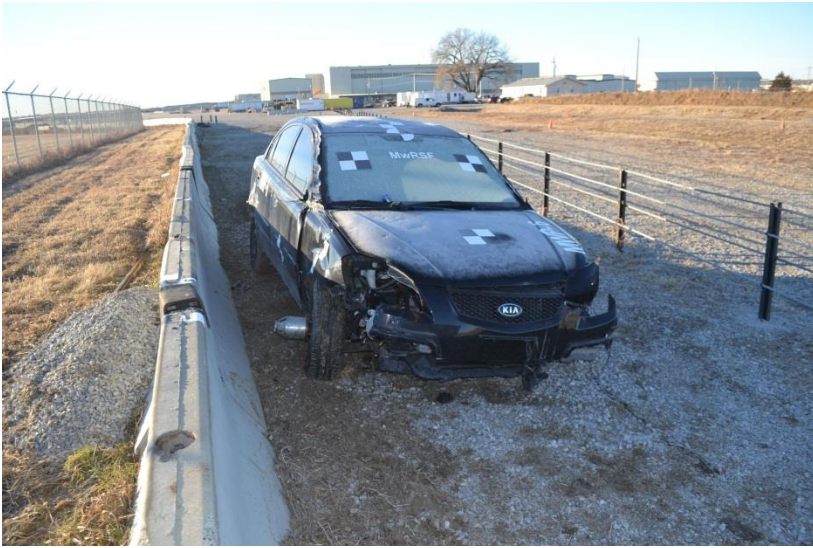
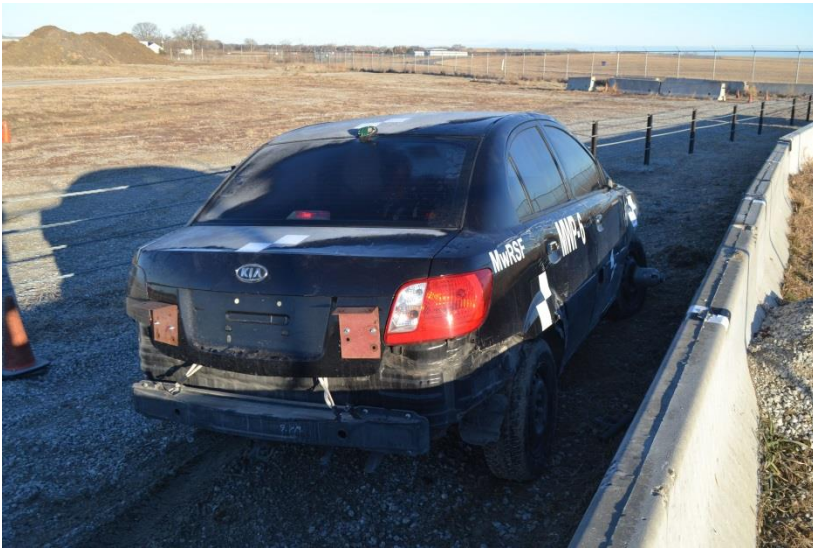
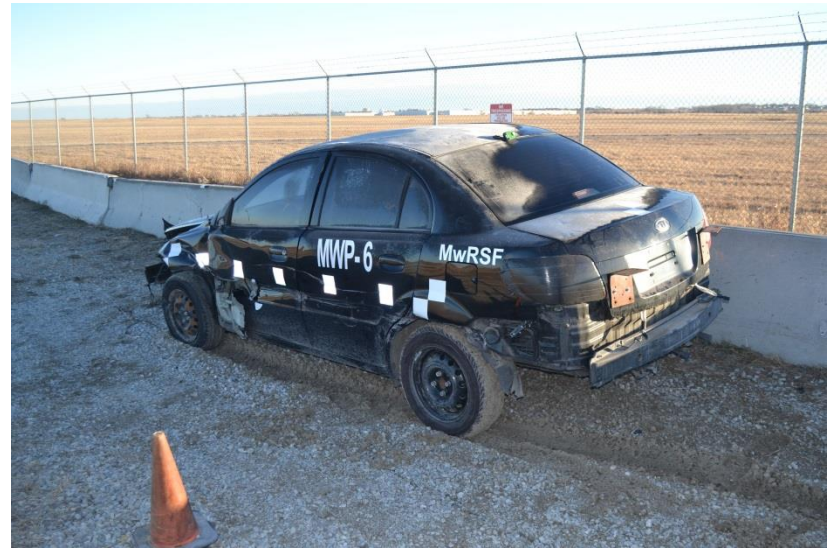
Figure 105. Vehicle Damage, Test No. MWP-6

The majority of the vehicle damage was concentrated on the left-front corner and left side of the vehicle where impact occurred, although other notable damage was found on the right-front corner. The vehicle's left and right headlights were both disengaged. The lower front bumper, the plastic portion of the rear bumper, both side mirrors, and the right-rear door handle were also disengaged. There was a 2½-in. (64 -mm) gap between the hood and the bumper, and a 4-in. (102-mm) gap between the fender and hood on the left side. The left fender was bent backward 9 in. (229 mm), folding into the vehicle on the bottom, resulting in a 14-in. (356-mm) buckle beginning above the left-front tire. There was also a 9x6-in. (229x152-mm) dent on the right-front door and fender. Three quarters of the left-front wheel well was removed from the vehicle. There was a 1½-in. (38-mm) long tear in the deflated left-front tire. The lower 16 in.

Contact marks from cables covered a majority of the vehicle – specifically on the front bumper, left side of the hood and left fender, left-front wheel rim, bottom of the left-rear door, on the right-rear door, along both A-pillars and on the entire roof. The majority of these contact marks were accompanied by gouges. The worst gouging occurred along the A-pillars, where the gouging on the left A-pillar caused the windshield to crack. Spider-web cracking occurred adjacent to the left-front A-pillar and propagated outward, extending as far as the center of the windshield.

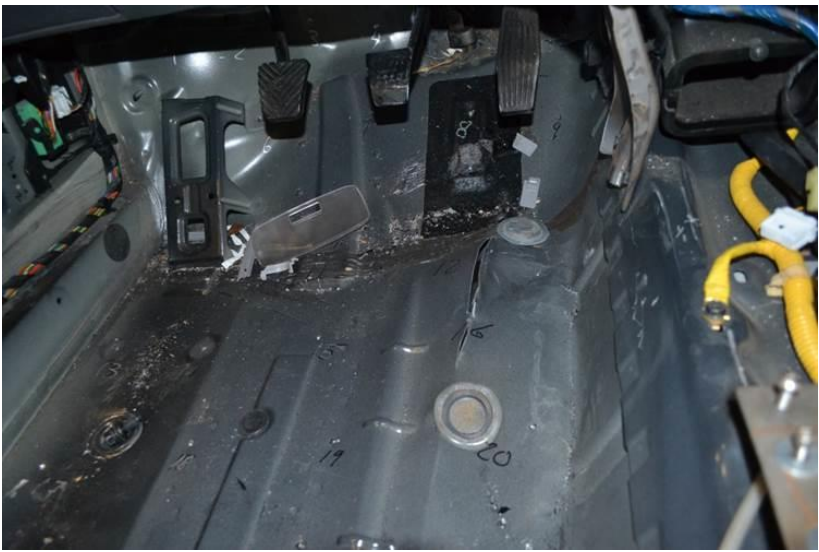
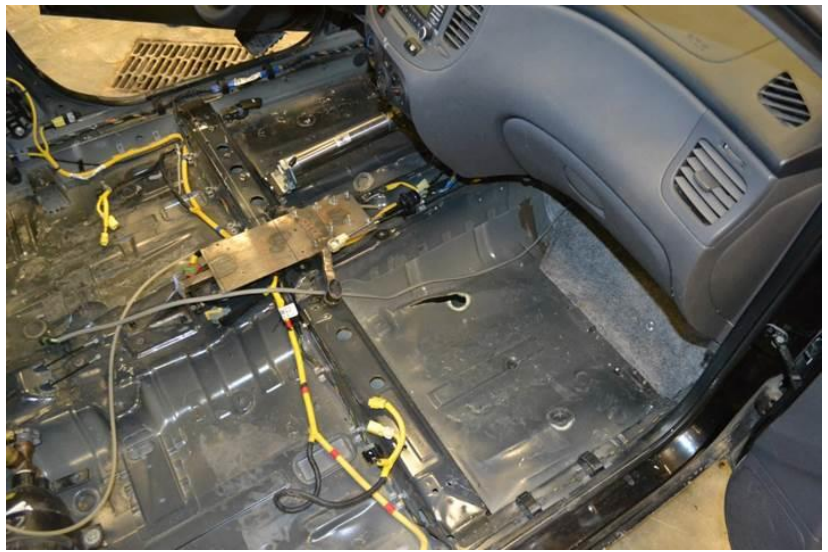
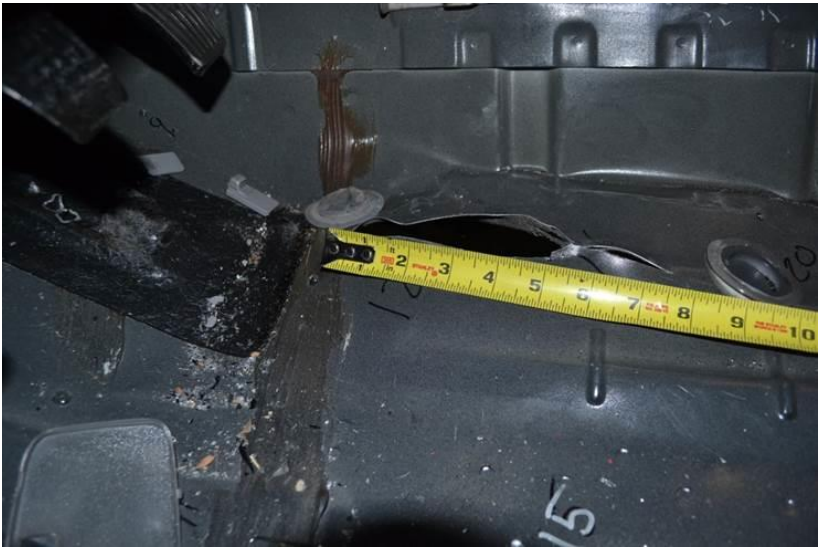
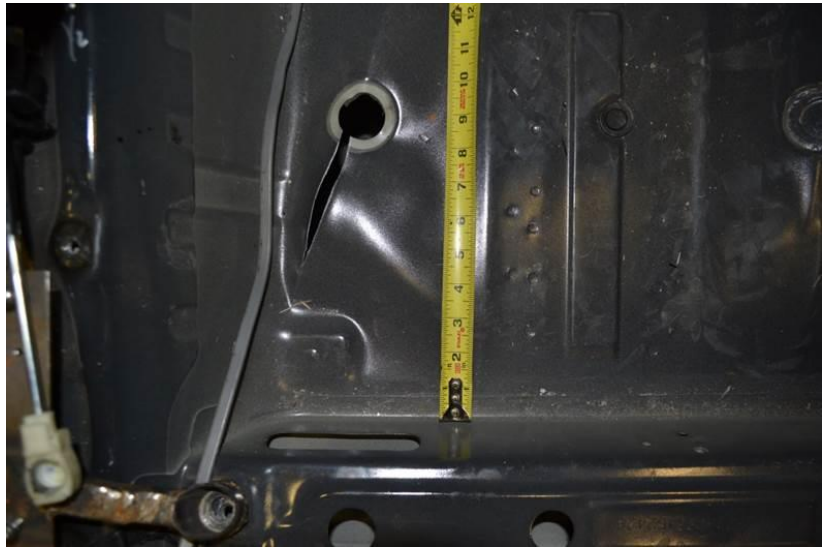
Figure 107. Occupant Compartment Damage, Test No. MWP-6

The damage to the vehicle was moderate, as shown in Figures 105 through 110. The maximum occupant compartment deformations are listed in Table 11 along with the deformation limits established in MASH for various areas of the occupant compartment. Note that none of the MASH-established deformation limits were violated. Complete occupant compartment and vehicle deformations as well as the corresponding locations are provided in Appendix D.

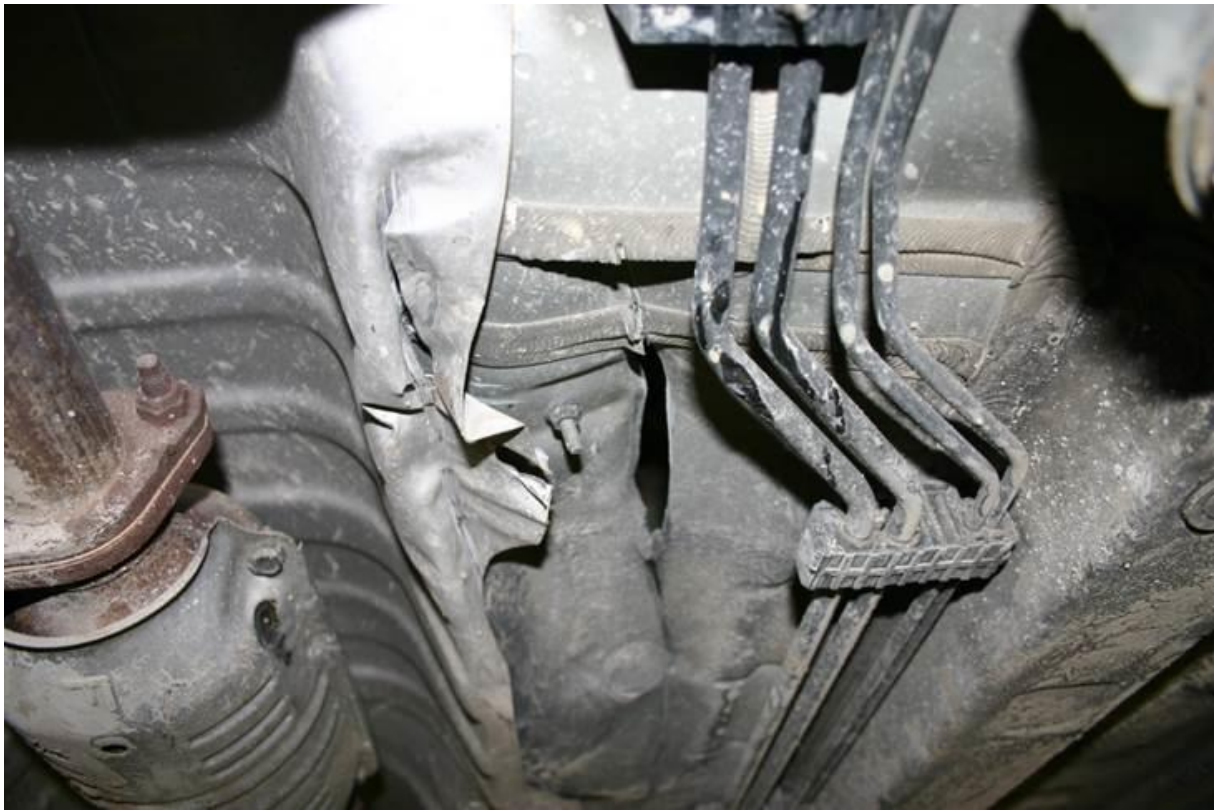
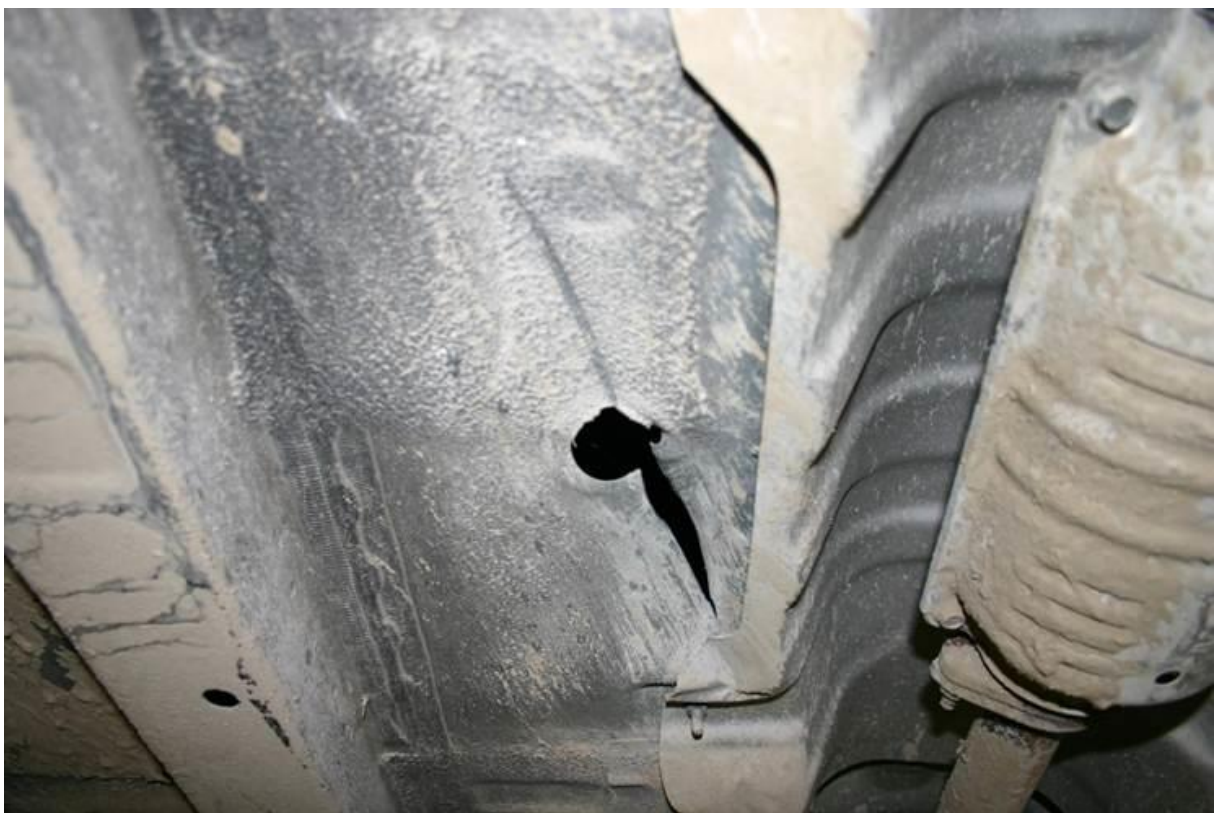
Figure 108. Occupant Compartment Penetration, Test No. MWP-6

occupant compartment, this trunk damage still raises concern. Additional scrapes and gouges were found on the floorpan and vehicle undercarriage, as shown in Figure 110.

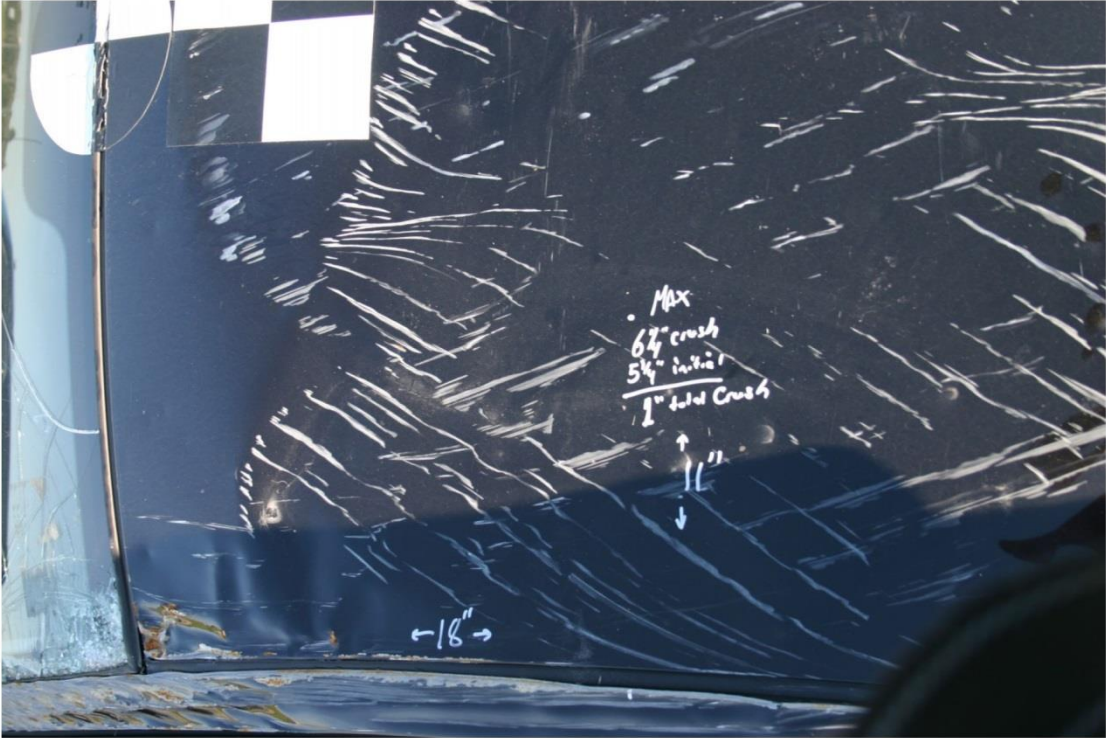
Figure D-11. Roof Deformation Documentation, Test No. MWP-6

MWP-6 at max point of crush	6.25"
Undamaged vehicle	5.25"
Total crush	<u>1"</u>
