Analysis of bearing steel exposed to rolling contact fatigue

I O P Conference Series: Materials Science and Engineering

2017

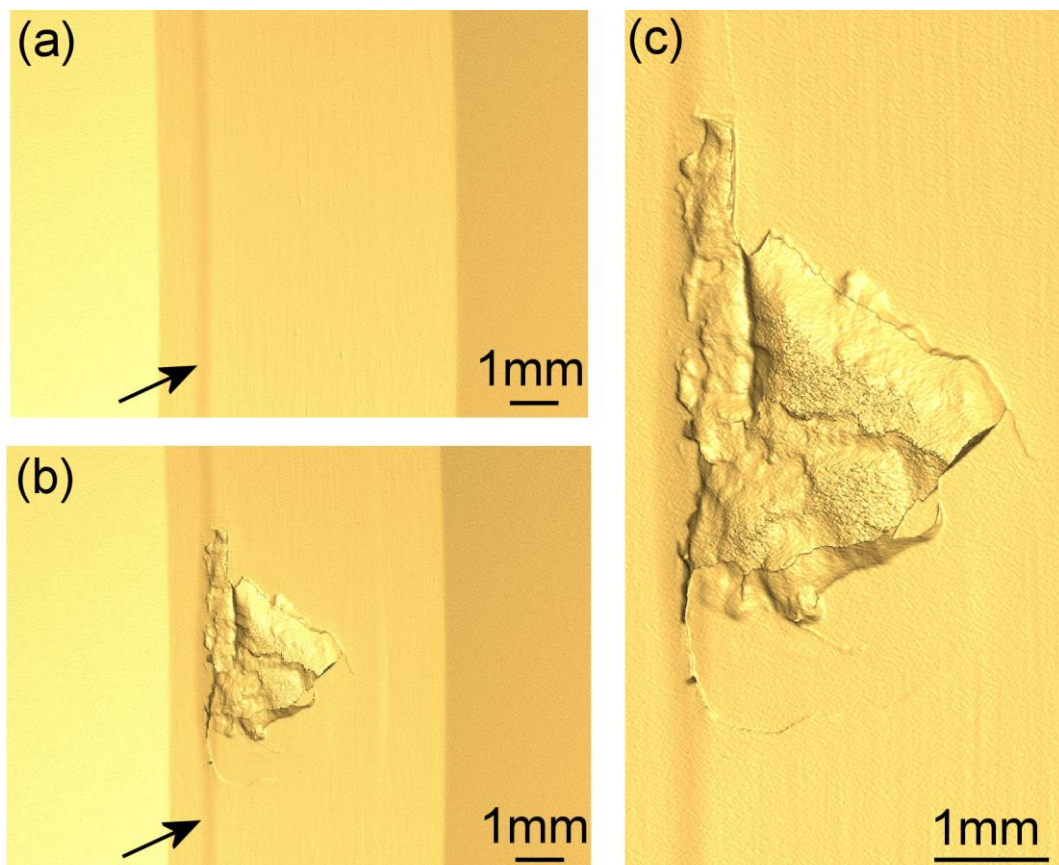
X-ray tomography images from the outer surface of the 5-mm ring are shown in figure 6. A circumferential groove with a depth of 35 μm is observed (marked by arrows) near one edge of the contact surface both in the pit-free sample (figure 6(a)) and in the sample with the coarse pit (figure 6(b)). Apparently, this groove extends over the entire ring circumference. The groove originates from the contact between the edge of the 3-mm ring and the 5-mm ring, and results from an angular misalignment between the two ring surfaces caused during the grinding process, which leads to conical contact between the two rings mainly along this groove. This was confirmed by inspecting another pair of rings, where it was found that the centre axis of the grinding stone was not properly aligned with the centre axis of the test piece. This resulted in a conical shape of the contacting surface with an inclination angle of 0.88° . Some degree of variation between the slopes is common since each ring is ground separately, but this variation is small compared to the magnitude of the misalignment. The conical shape greatly changes the contact situation, which ideally should have been a 3-mm wide line contact. The contact pressure was thus much higher at one end of the line contact than originally planned. As a result of the high contact pressure, it is likely that plastic yielding occurred in both rings, widening the contact area during the test.

Figure 6. X-ray tomography images from two samples machined from opposite sides of the tested 5-mm ring: (a) pit-free sample; (b,c) sample with a coarse pit, which is shown at low (b) and higher (c) magnifications. The groove corresponding to the high pressure region extending over the entire ring circumference is marked by arrows in (a,b).

The size of the pit shown in figure 6(b) is ~ 3 mm, and the depth is 420 μm . Since the pit is widest in the vicinity of the circumferential groove, it is suggested that the pit starts propagating from this groove. A SEM image in figure 7(a) shows the central portion of the coarse pit, where multiple cracks are seen both near the pit and on the pit surface. Cracks are also observed at some distance from the pit, but still close to the edge of the contact surface (see figure 7(b)). The defects observed on the contact surface appear to be examples of damage associated with classical pitting failure.

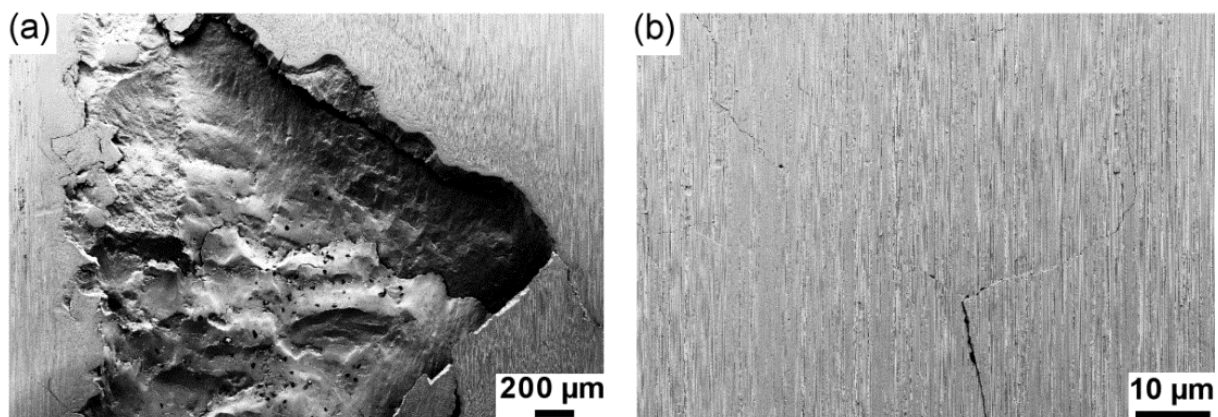
The RCF test was stopped when the vibration level increased significantly, due to the development of the coarse pit shown in figure 6(b,c) and figure 7(a). The cracks along the contact zone show, however, that more pits had started to develop before the RCF test was stopped. It is suggested that the cracks started below the surface, where the shear stress had its maximum value. Furthermore, SEM inspection reveals cracks on the contact surface even in the pit-free sample. Figure 8 shows an X-shape crack with arms extending over at least 0.5 mm, observed near the circumferential groove marked in figure 6(a). This crack is apparently very shallow and thus not observable in the X-ray tomography image in figure 6(a). Such cracks are considered to be precursors of pits.

Figure 7. SEM images from the sample containing the coarse pit: (a) central part of the pit; (b) cracks far away from the pit, but still near the groove.

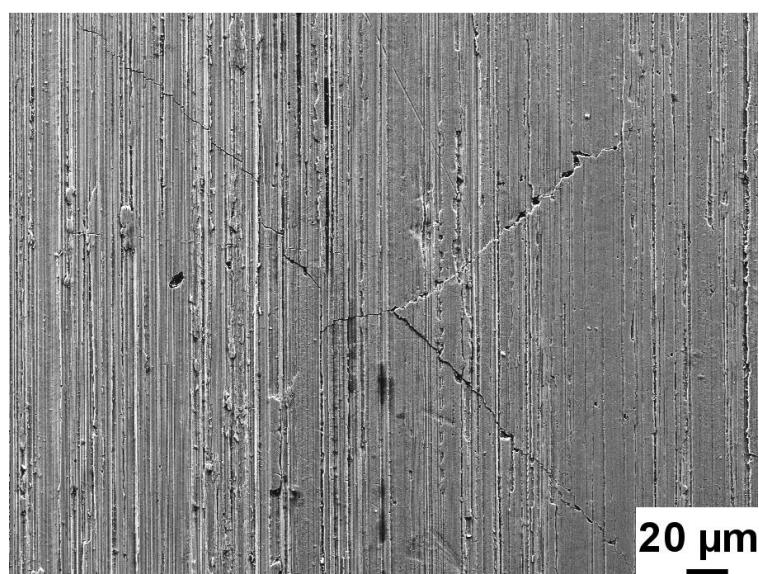
Figure 8. SEM image showing an X-shape crack near the groove in the pit-free sample.
