ASIA TURBOMACHINERY & PUMP SYMPOSIUM
SINGAPORE | 22 - 25 FEBRUARY 2016
M A R I N A B A Y S A N D S

Repair of Severely Damaged Rotor as an Emergency Spare

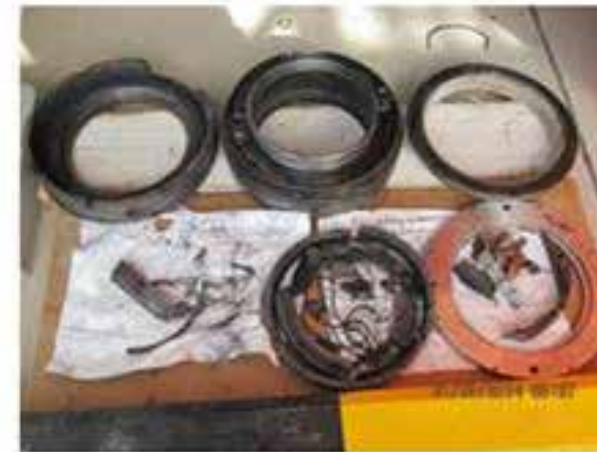
Remains of NDE DGS

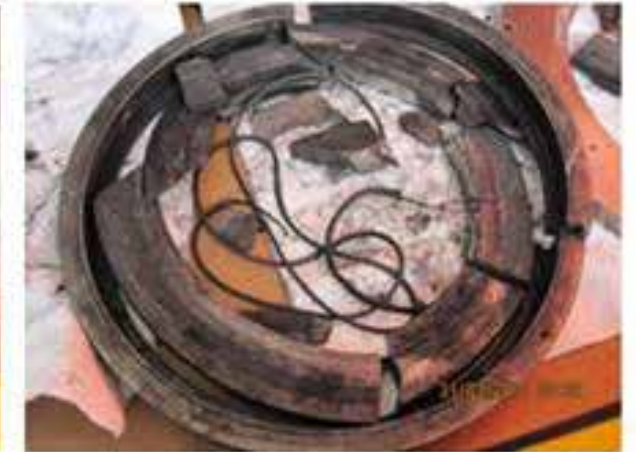
1 Secondary rotating ring

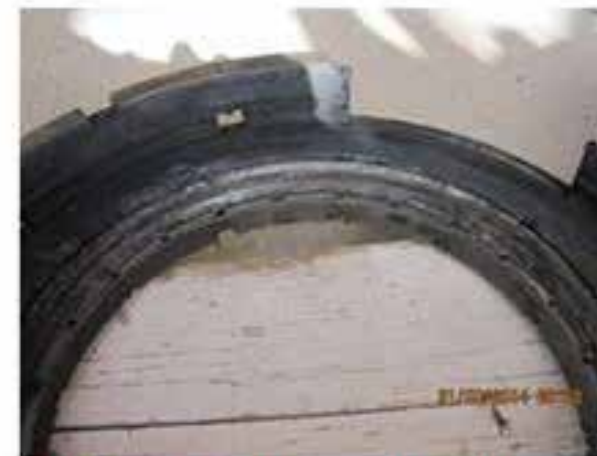
2 Secondary mating ring

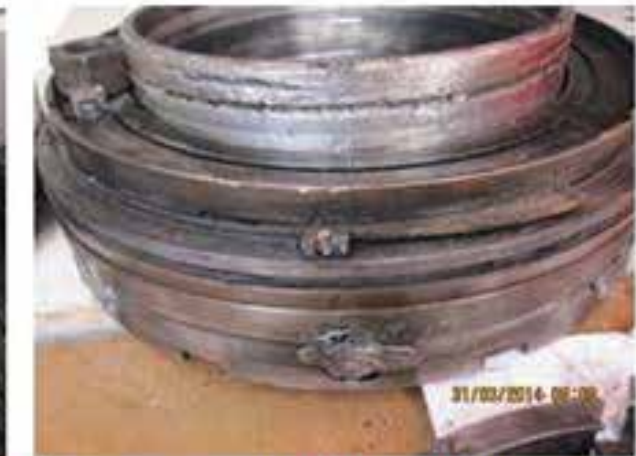
3 Primary seal with plug vent & supply ports with melted part

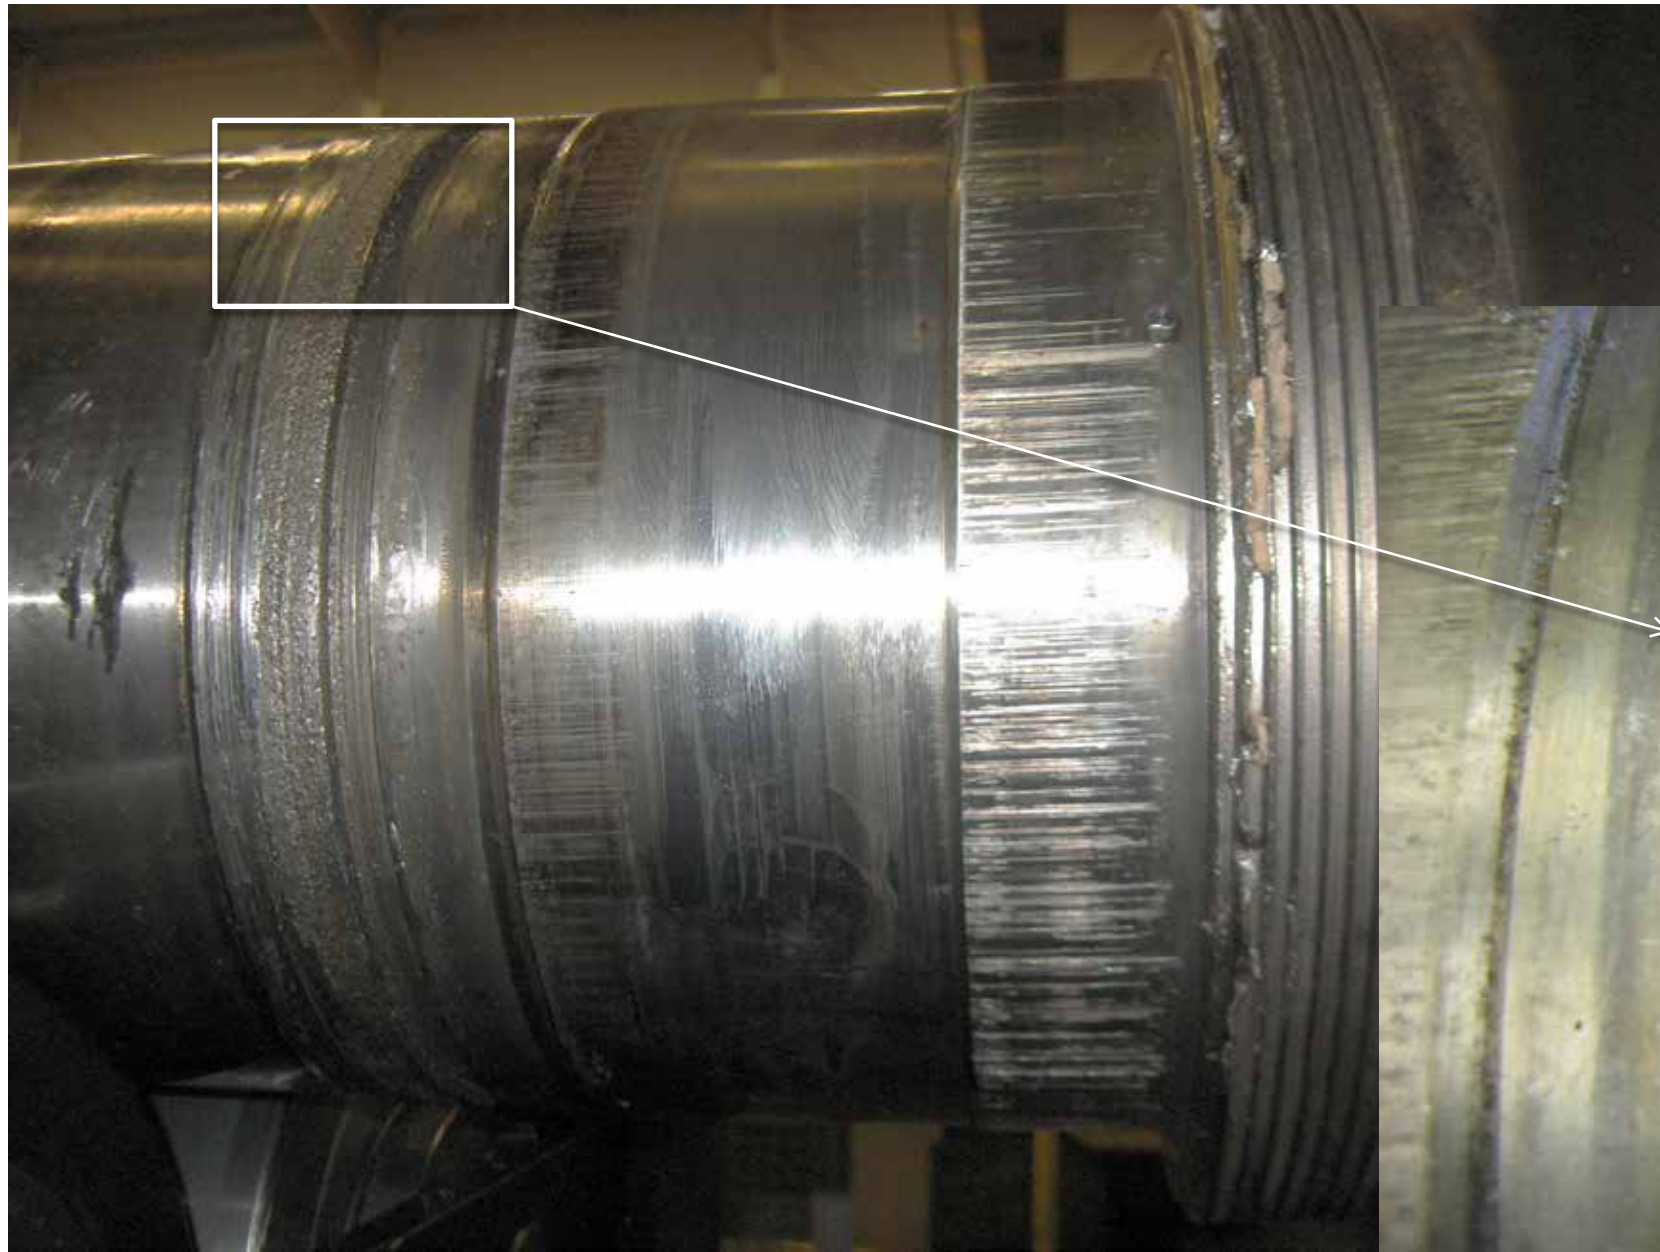
- Shaft had severe damage under the DGS

Shaft has severe wear and scoring damage

- Weld repair of the shaft is typical repair for the type of damage, but would likely negatively affect the schedule
- Estimates of the depth of grinding required to clean up the shaft to an adequate state was acceptable with respect to design allowances
- Dry gas seal vendor was contacted to determine if custom hardware could be designed to accommodate the new shaft dimensions with existing stationary dimensions

Shaft end was machined until it was mostly cleaned up.

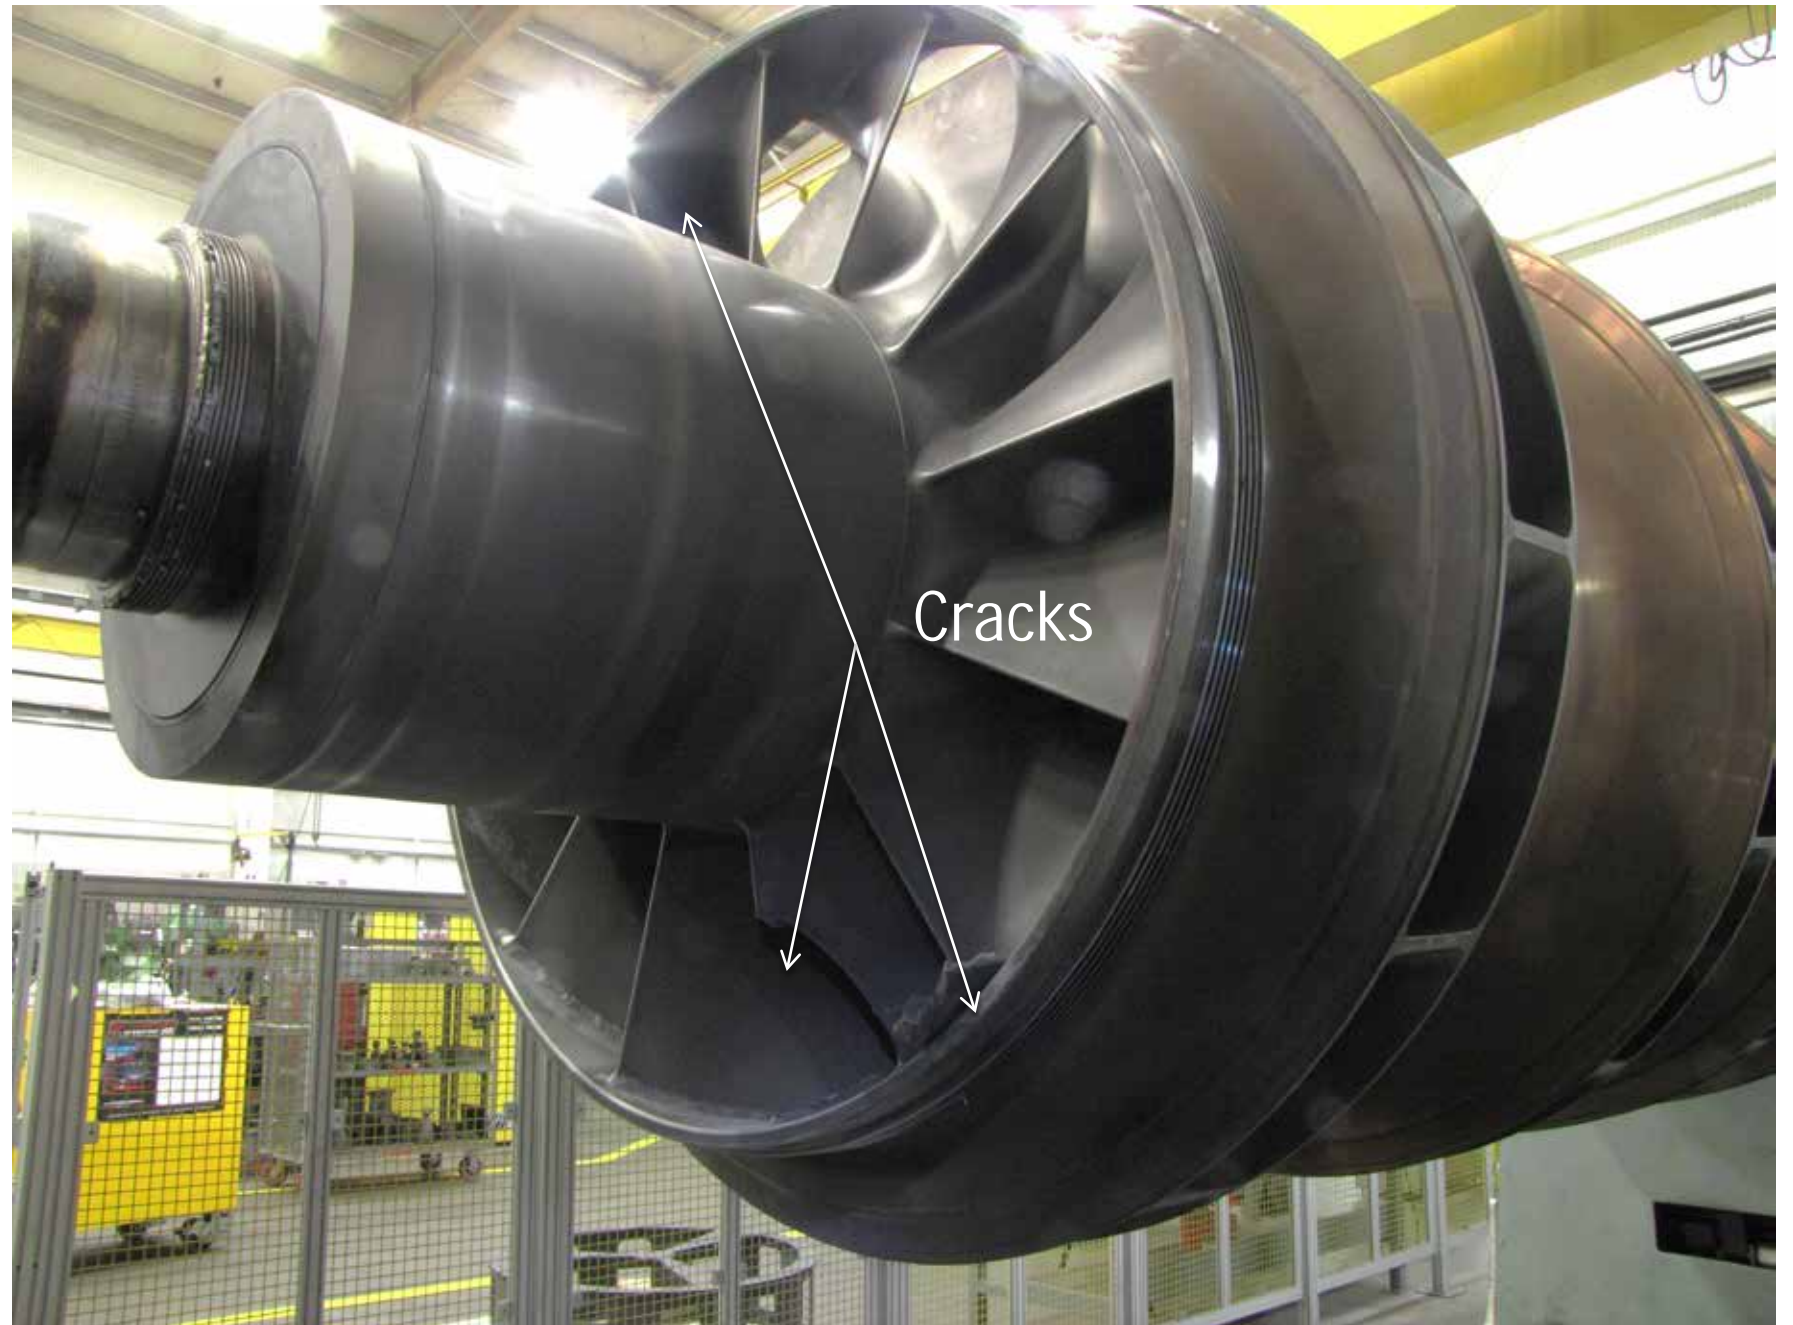
- It was noticed that the first stage impeller had cracks in three blades
 - A large piece was missing from one of the cracks
 - There was a step change in the vibration early in the run, but no obvious indication that there was a problem
-
- As a result, the spare rotor was installed and the compressor restarted

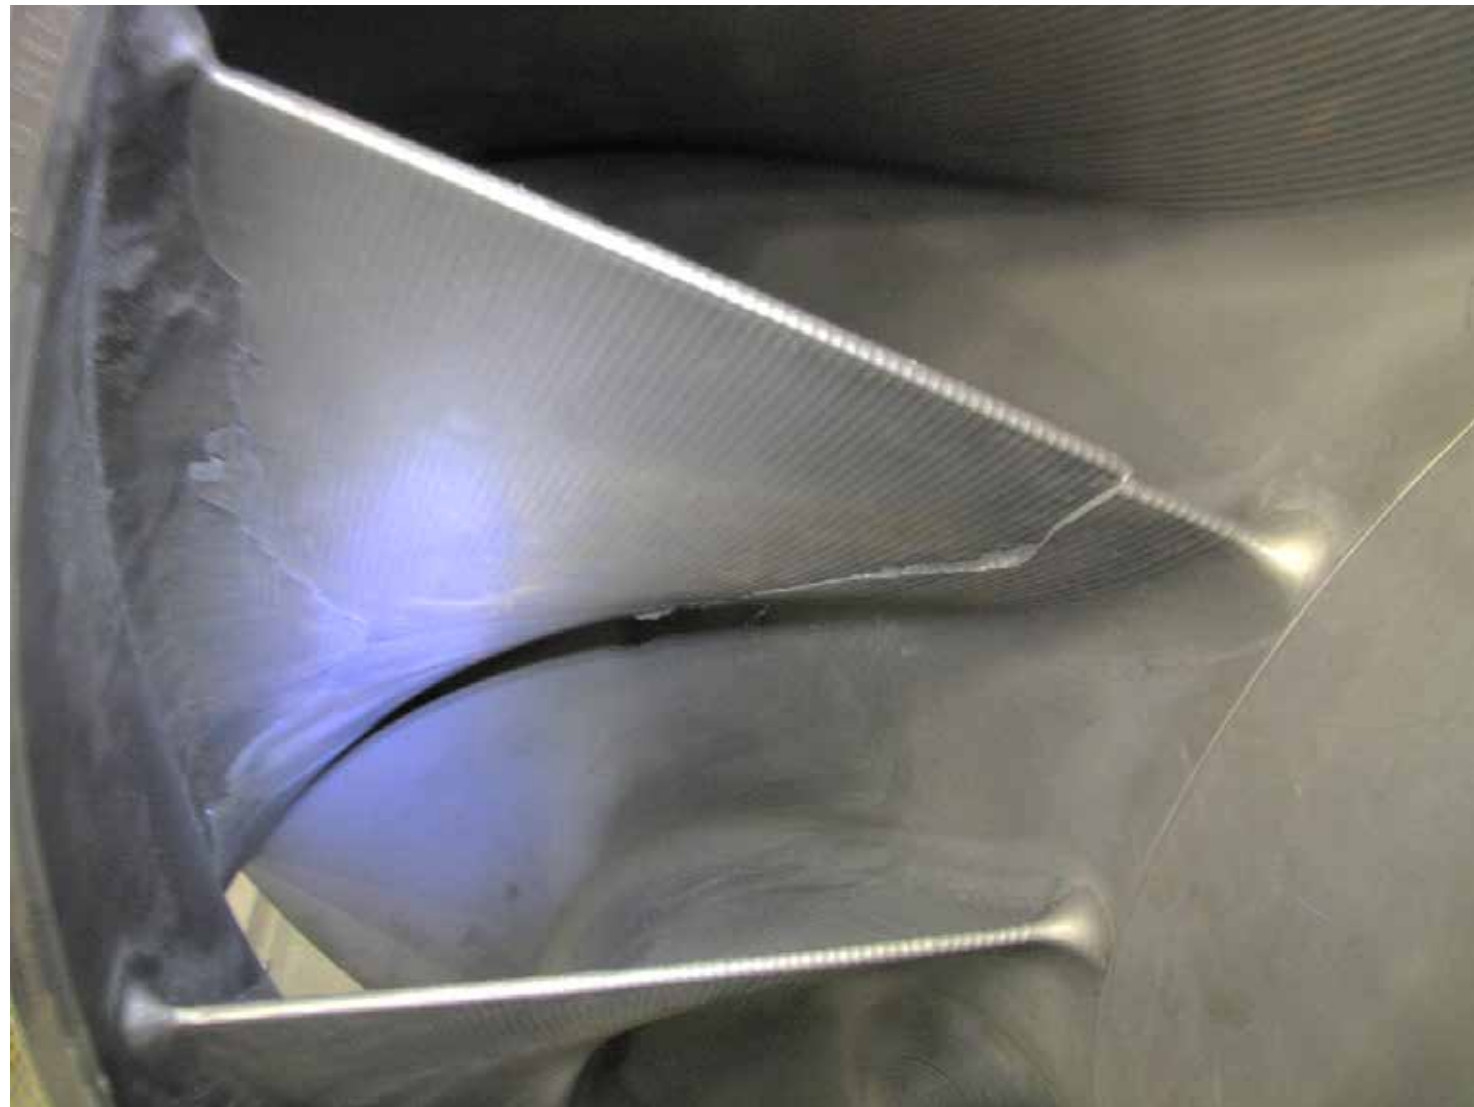
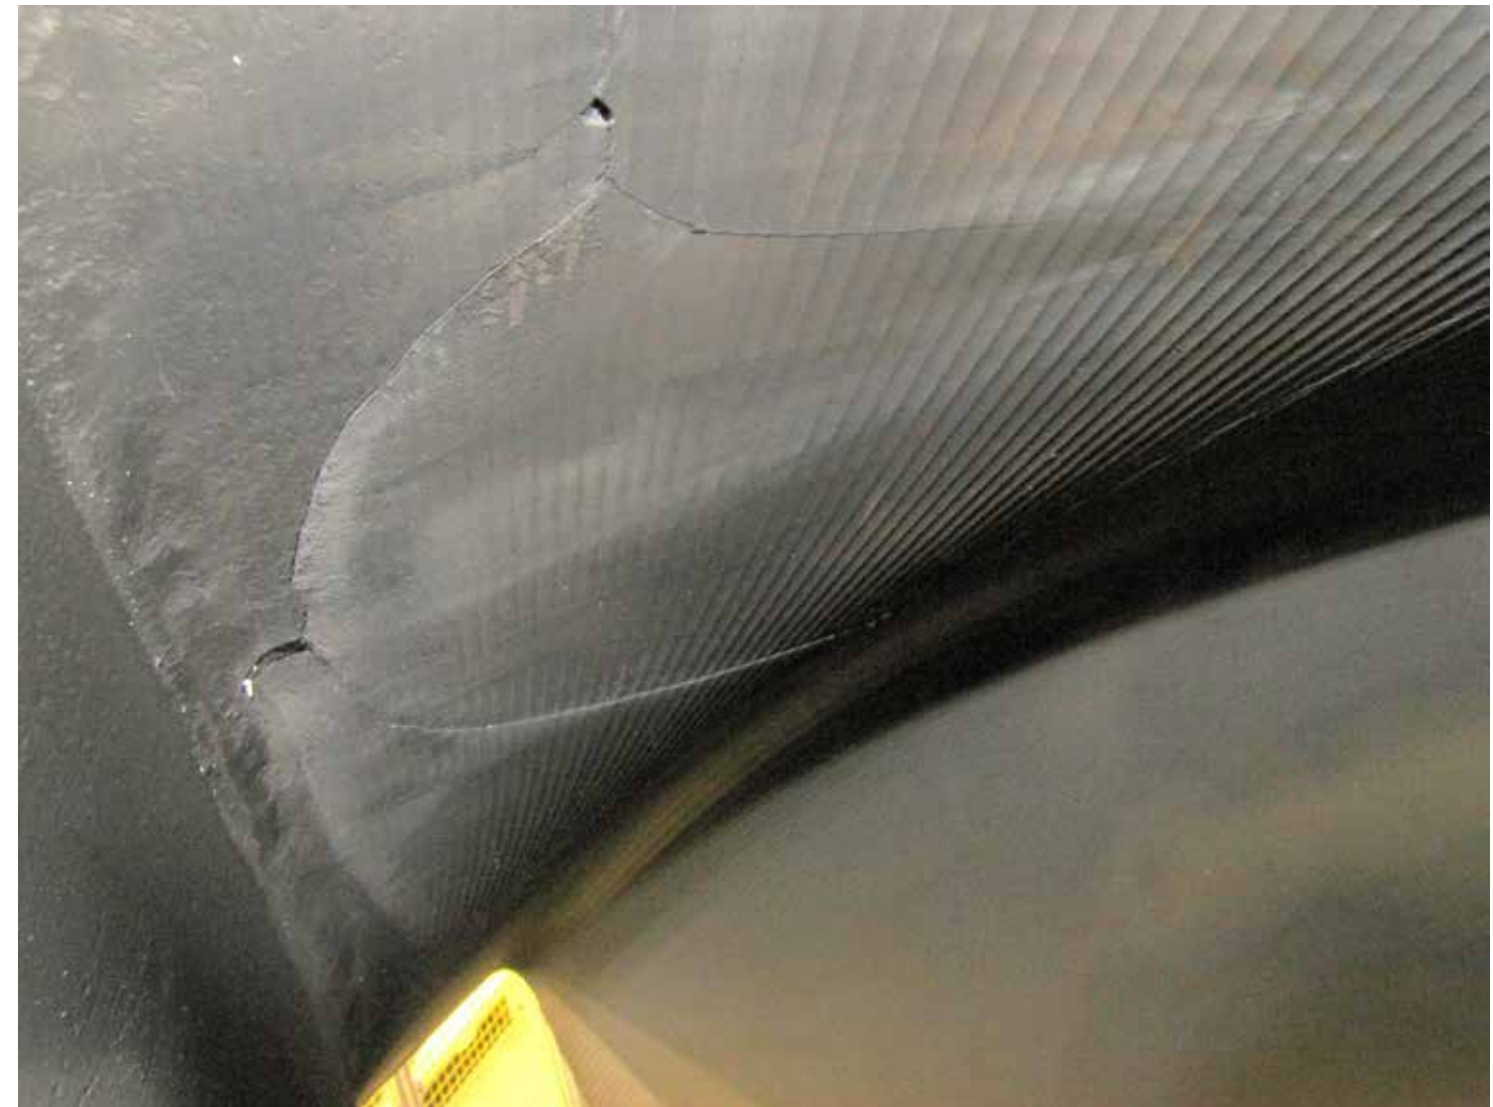
- Cracks in this blade extend from the eye nearly to the tip

First impeller is severely cracked and missing a piece

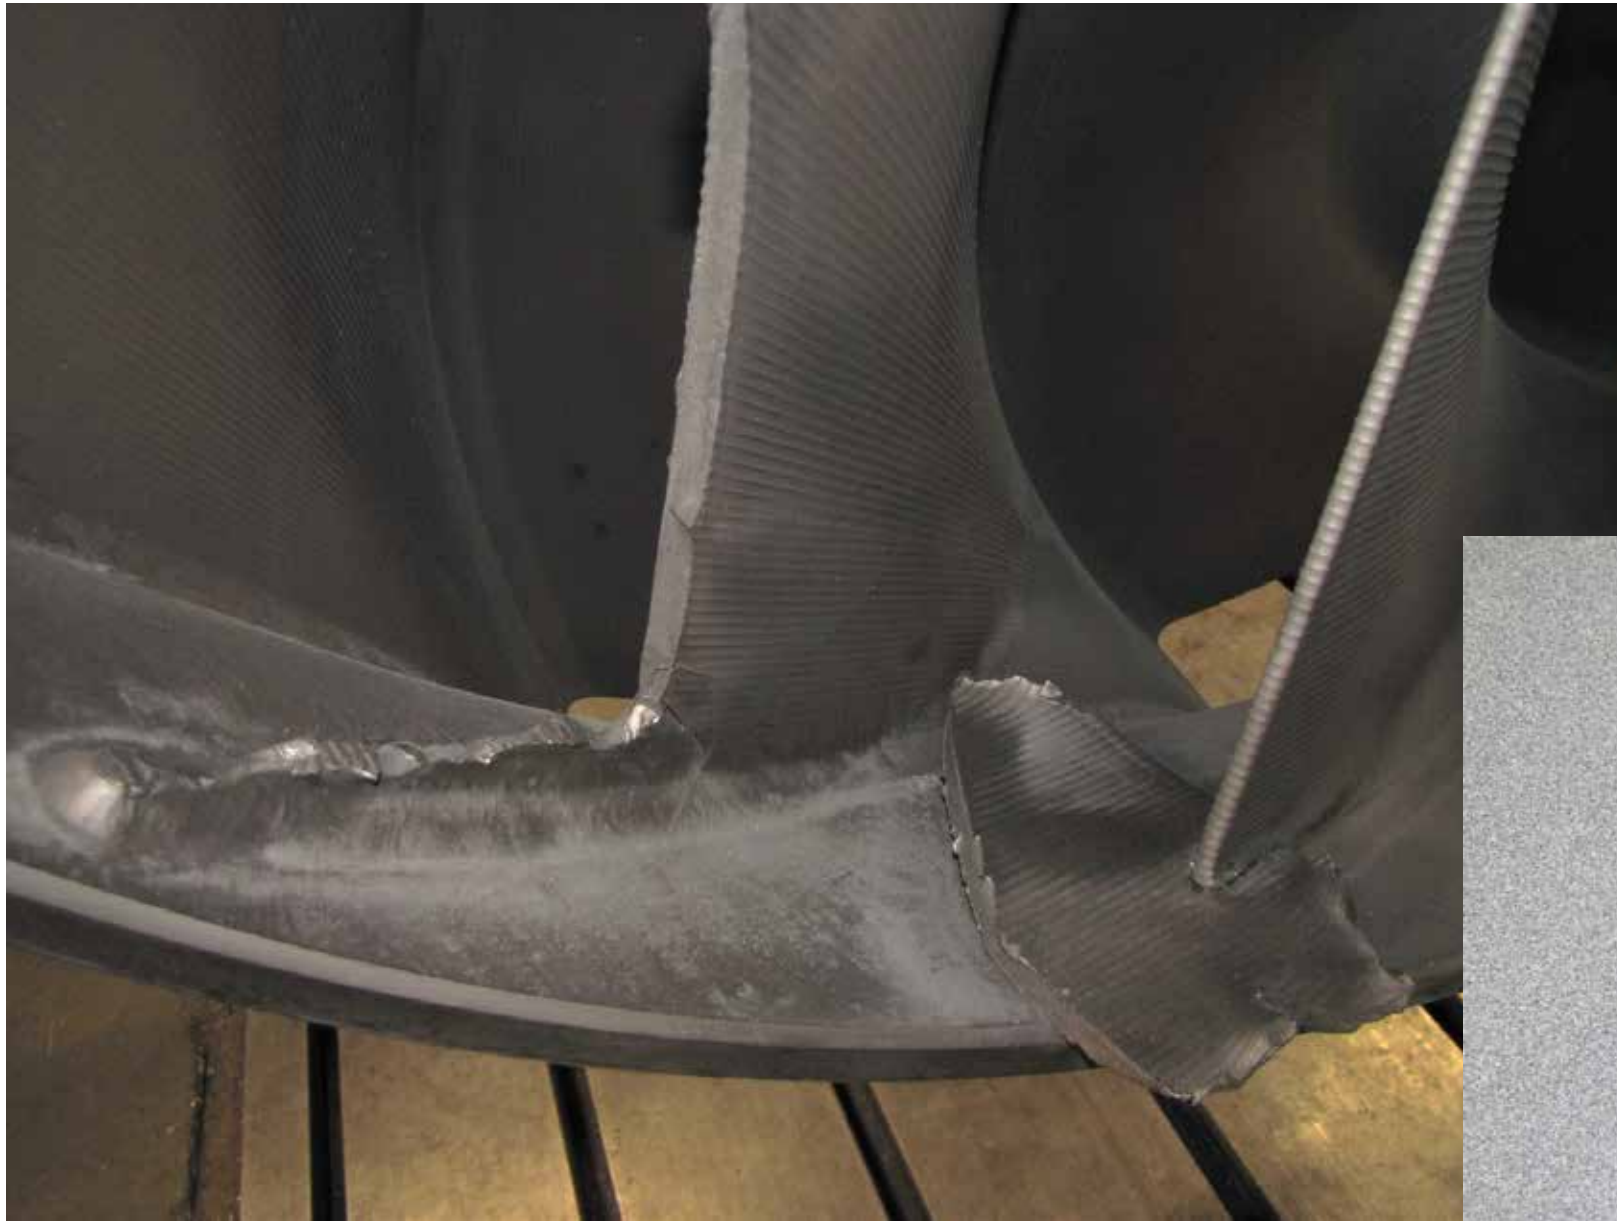
- A liberated piece struck the adjacent blade, initiating a crack
- There was much more of the piece missing than found

- Piece of adjacent blade removed for RCFA
- Crack ground out, NDT, remove any remaining cracks
- Weld and blend

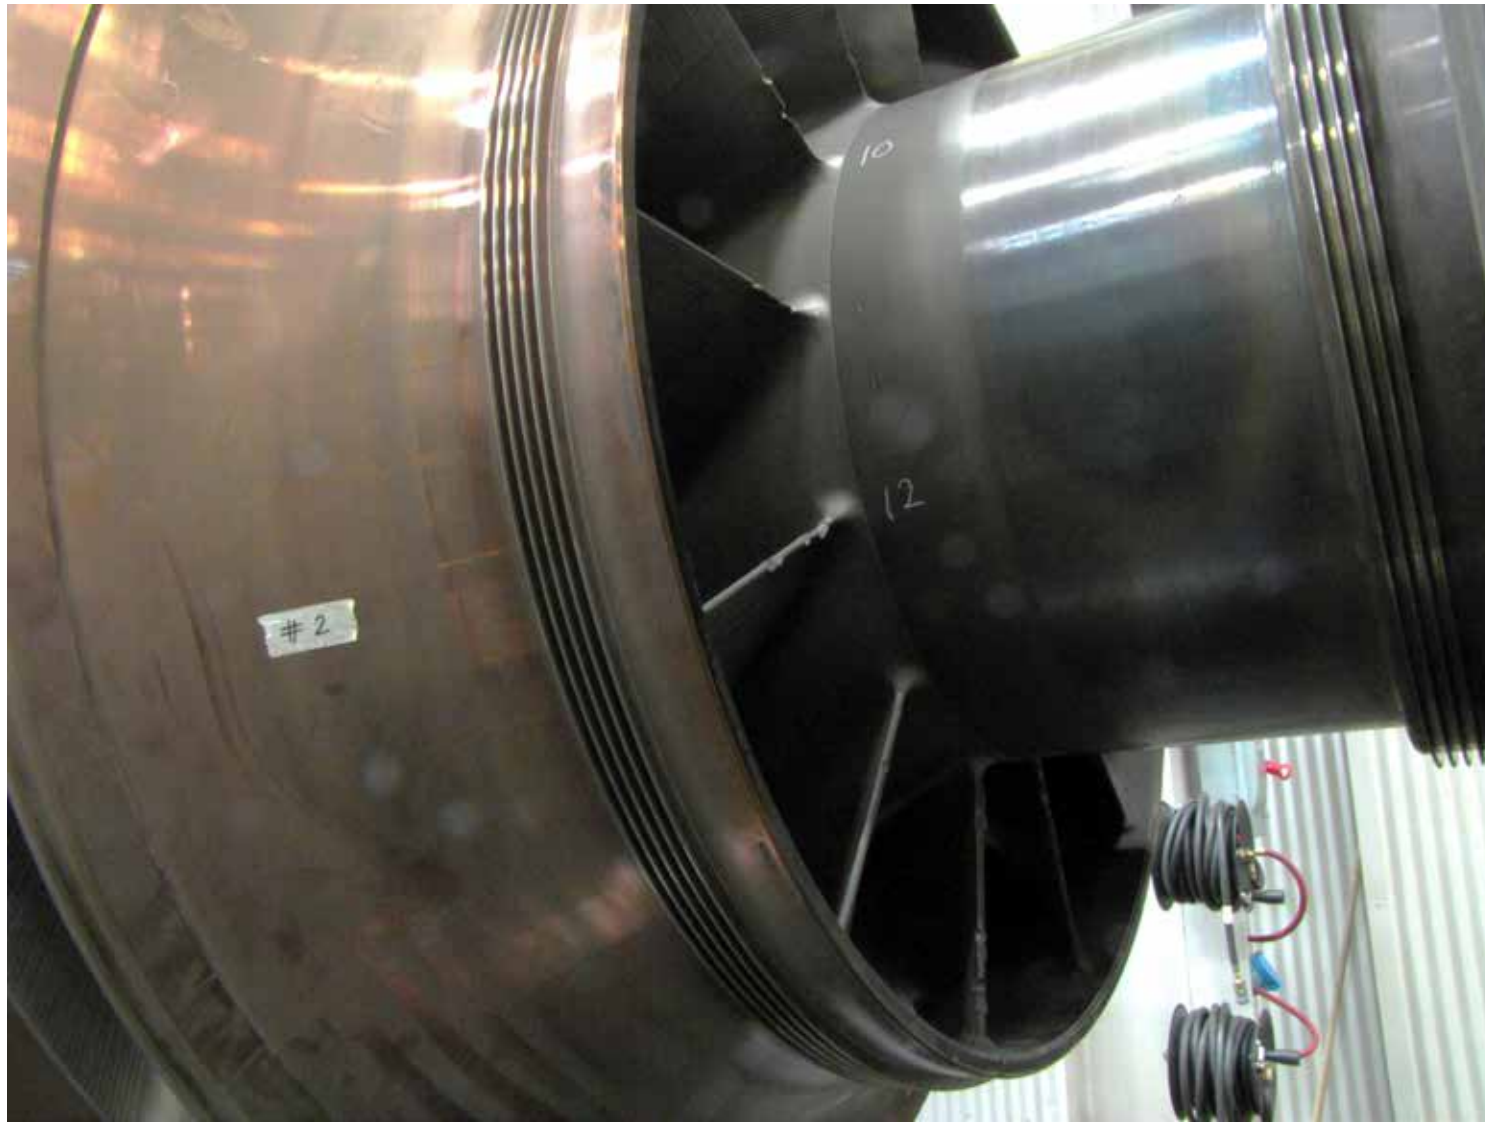
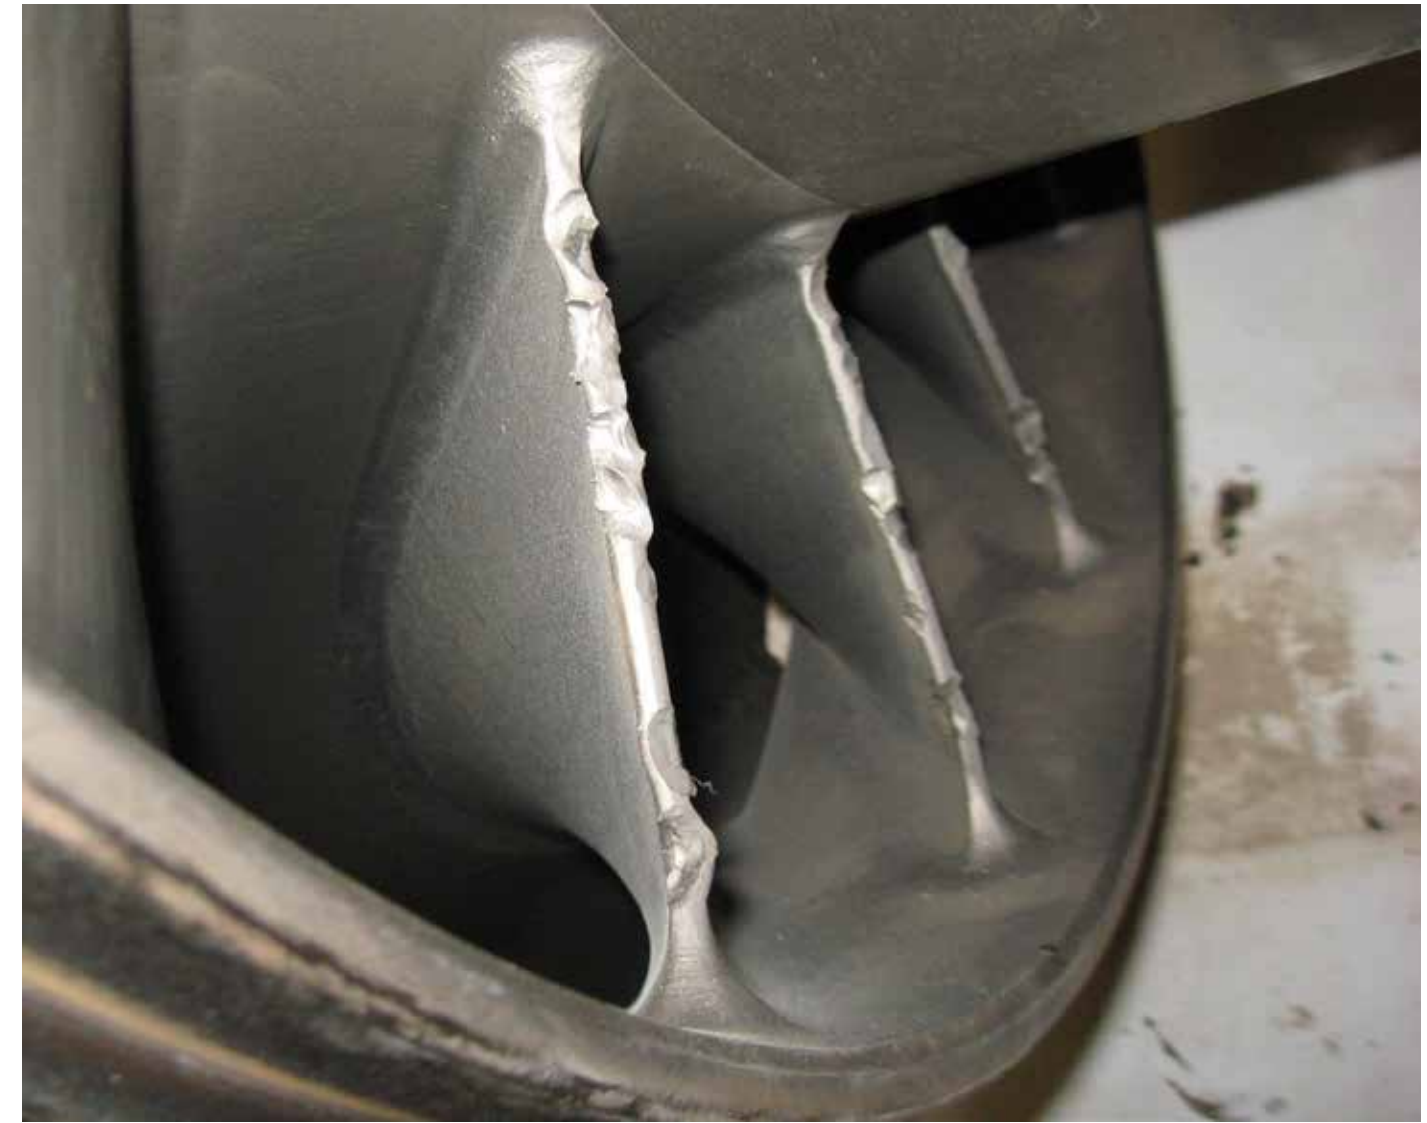
2nd Stage

- Virtually every blade in stages 2-4 have FOD at the leading edge

Remaining impellers have major FOD

- Decided that the fastest, easiest, and most effective method to remove the damage is to machine back the leading edge of every blade by 6.35mm (0.25") and hand radiusing the new leading edge
- Structural and Aero impacts are minimal
