GURU GOBIND SINGH REFINERY  
HPCL-MITTAL ENERGY LTD

Case Study:

High vibration problem resolution  
in centrifugal pump through  
design change

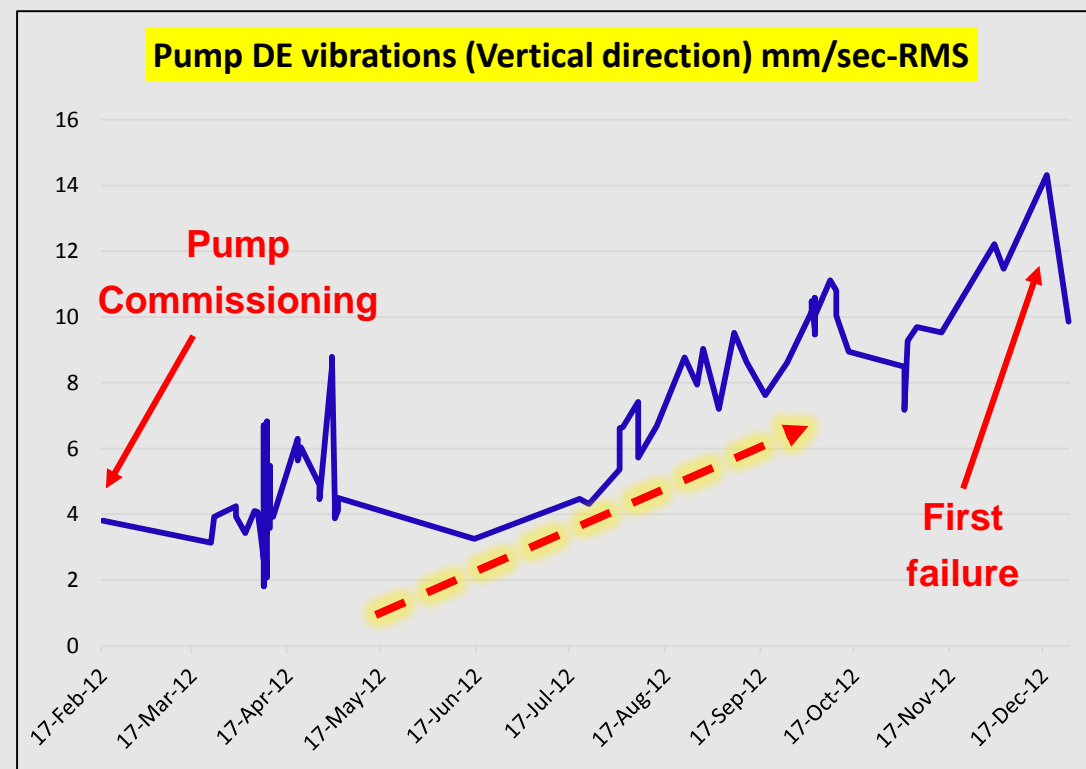
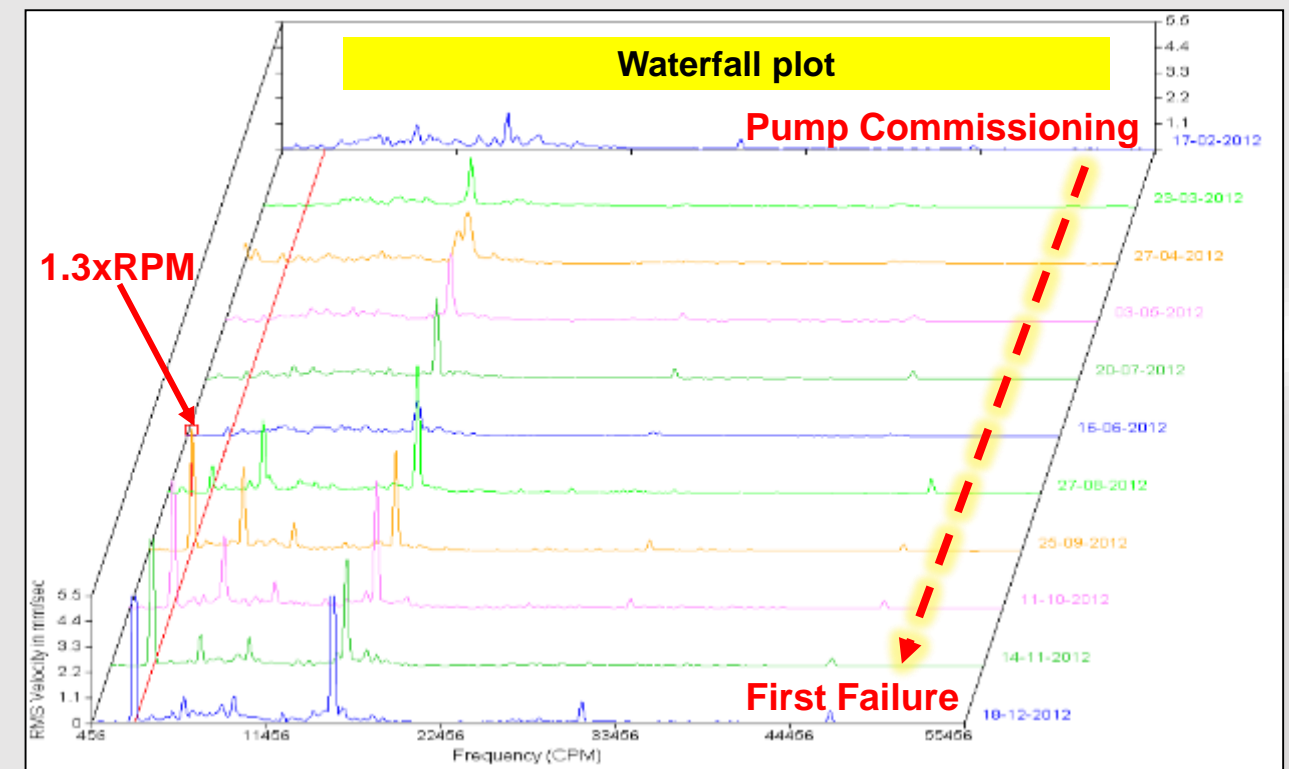
Vibration trend –  
Pump DE (vertical)  
(From  
commissioning to  
first failure)

- Pump commissioned on 17<sup>th</sup> February 2012. Vibrations measured during commissioning were in the range of 4 mm/sec-rms.
- Abnormal symptoms in the pump were observed first time within 2 months of commissioning when vibrations in the range of 8mm/sec-rms were recorded at pump drive end vertical direction - which subsequently got reduced to normal values. Vibrations are measured weekly using offline analyzer.
- October 2012 - vibrations at DE were recorded continuously higher and increasing. Vibrations spectrum indicated 1.3xRPM frequency as dominating frequency with fluctuating nature.

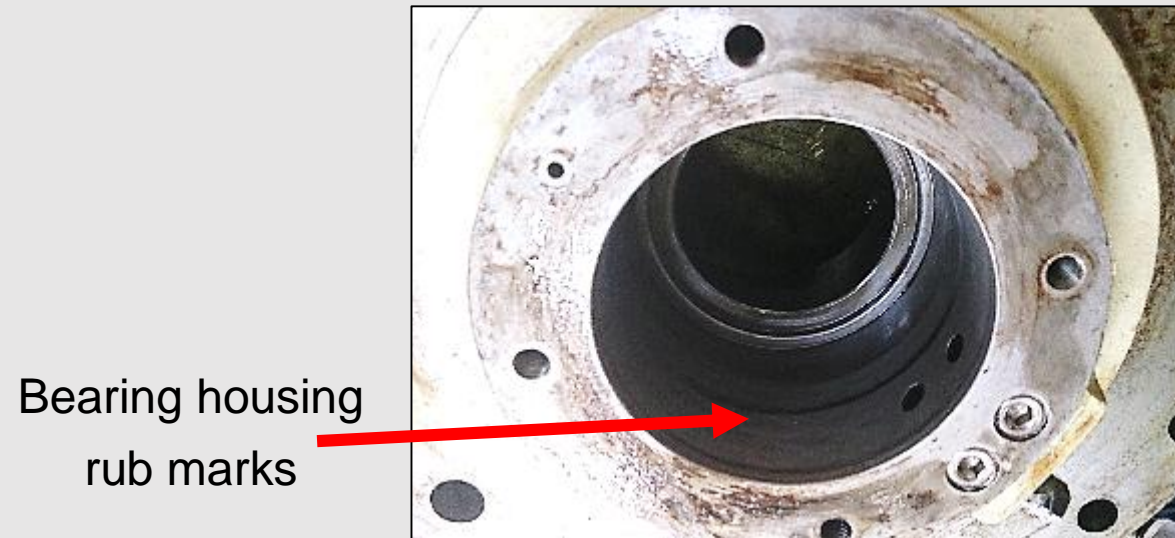
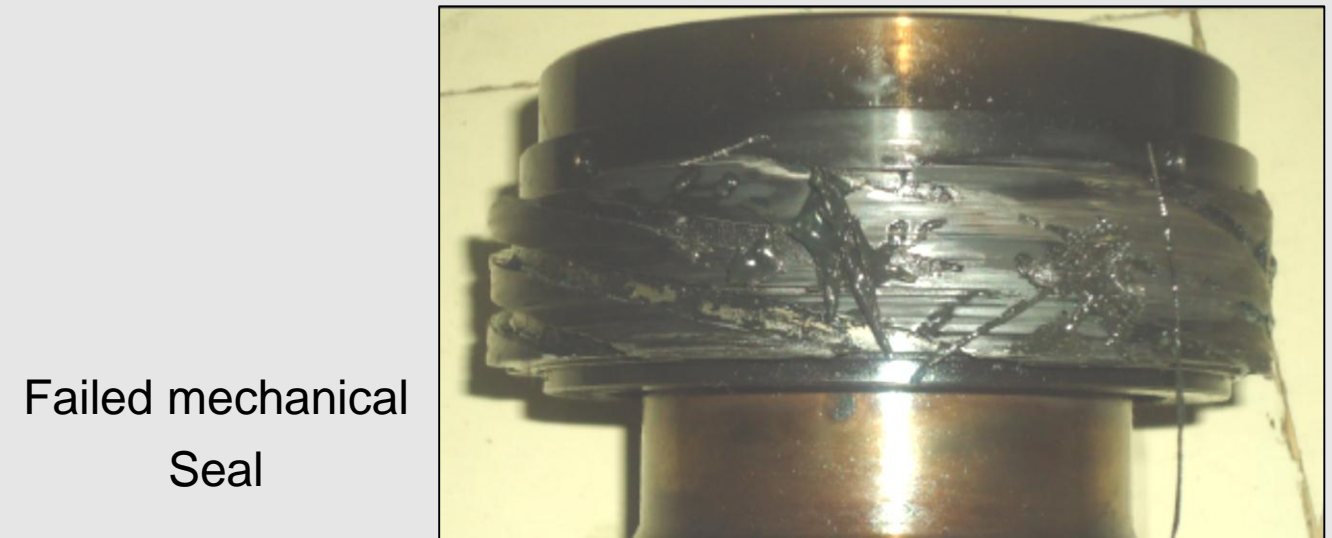
1. DE bearing failed and got seized, mechanical seal failed
2. Rubbing in bearing housing, throat bush
3. High run-out in Shaft bearing and coupling area
4. Suction and discharge piping were observed misalignment w.r.t. pump nozzles

Improvement actions implemented (during year 2013 and 2014):

1. Relocating pump warm-up line from pump top to bottom and defining a slow warm-up rate for uniform expansion.
2. Ensuring minimum flow through pump by fixed minimum opening of recirculation valve
3. Pump concentricity and assembly checks along with mechanical run test at alternate vendor shop-floor.

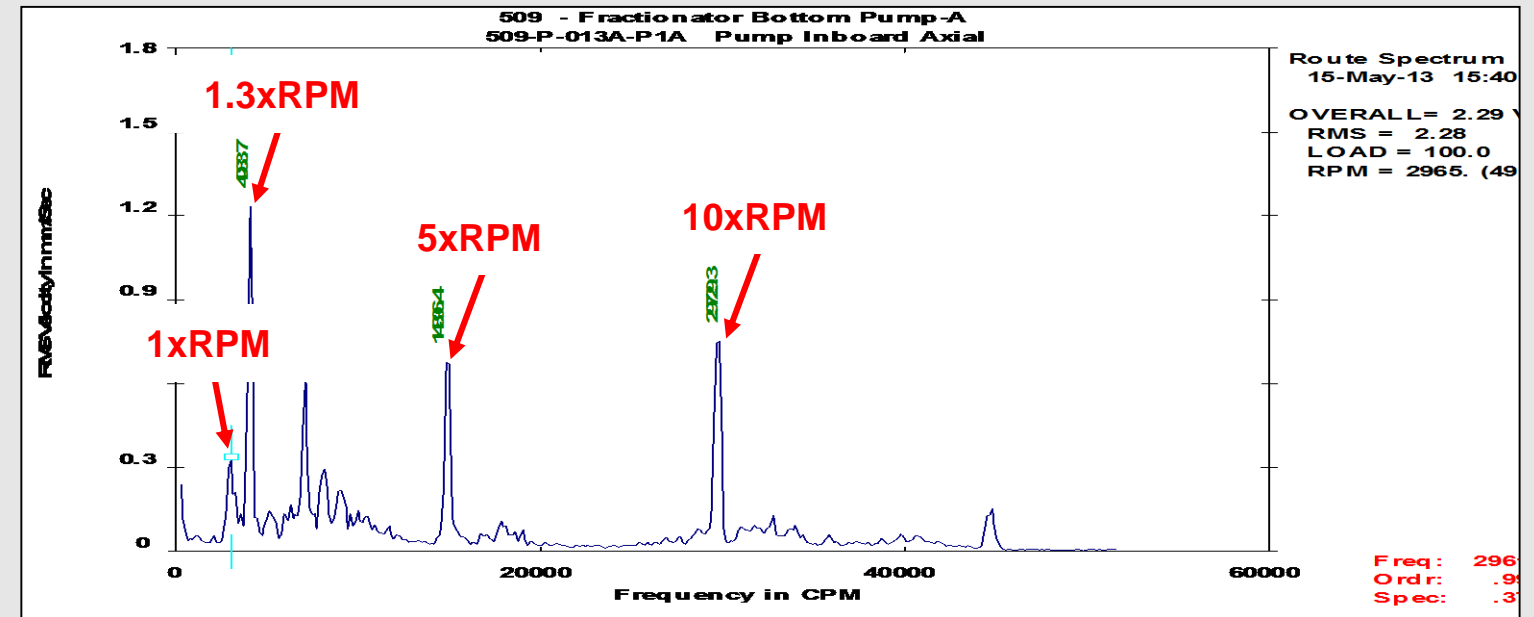
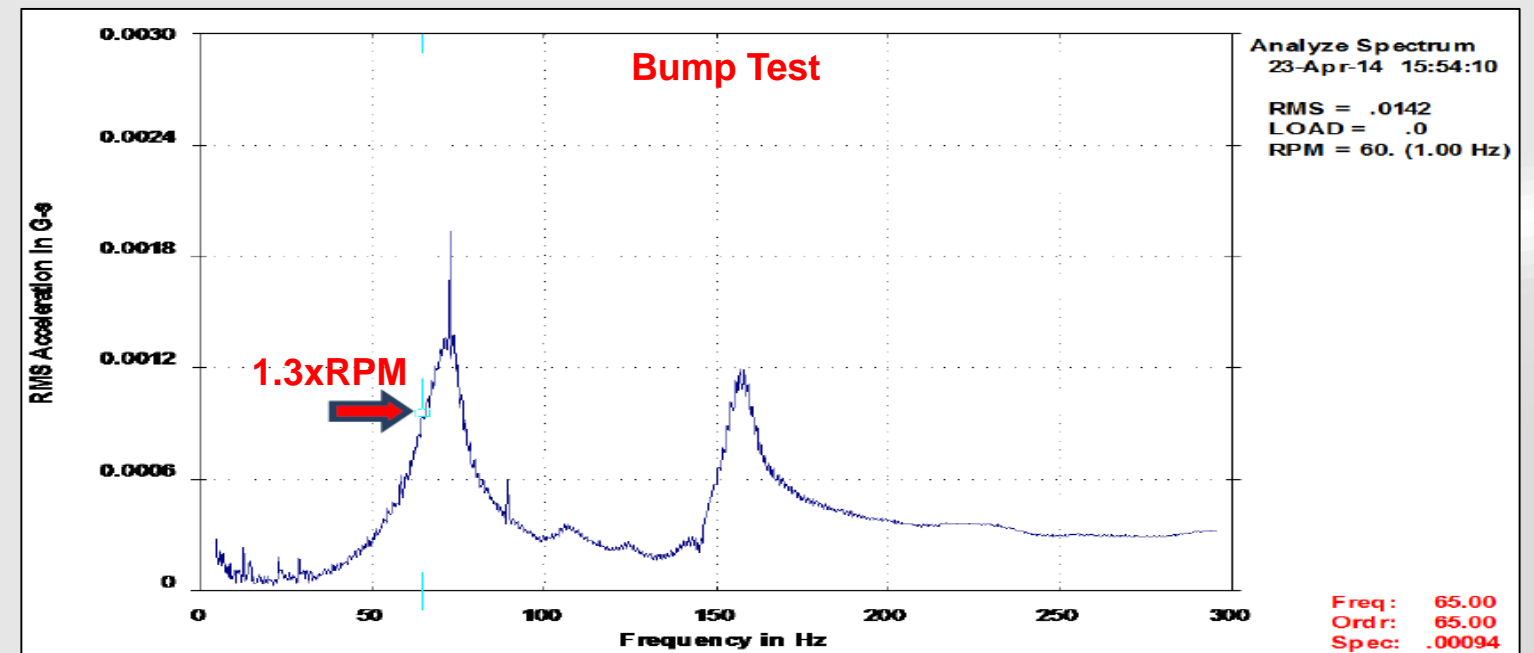
- Visual inspection of the failed components showed rubbing at shaft throat bush area and also at wear rings.

- Fault frequencies indicated dominating 1.3xRPM frequency, which was observed to be fluctuating in nature.

- Bump test carried out on pump shaft/impeller assembly indicated natural frequency in the range of 1.3xRPM to 1.4xRPM (~70Hz).
- Rubbing of pump shaft, while in operation, excites this natural frequency, hence 1.3xRPM vibrations are observed.

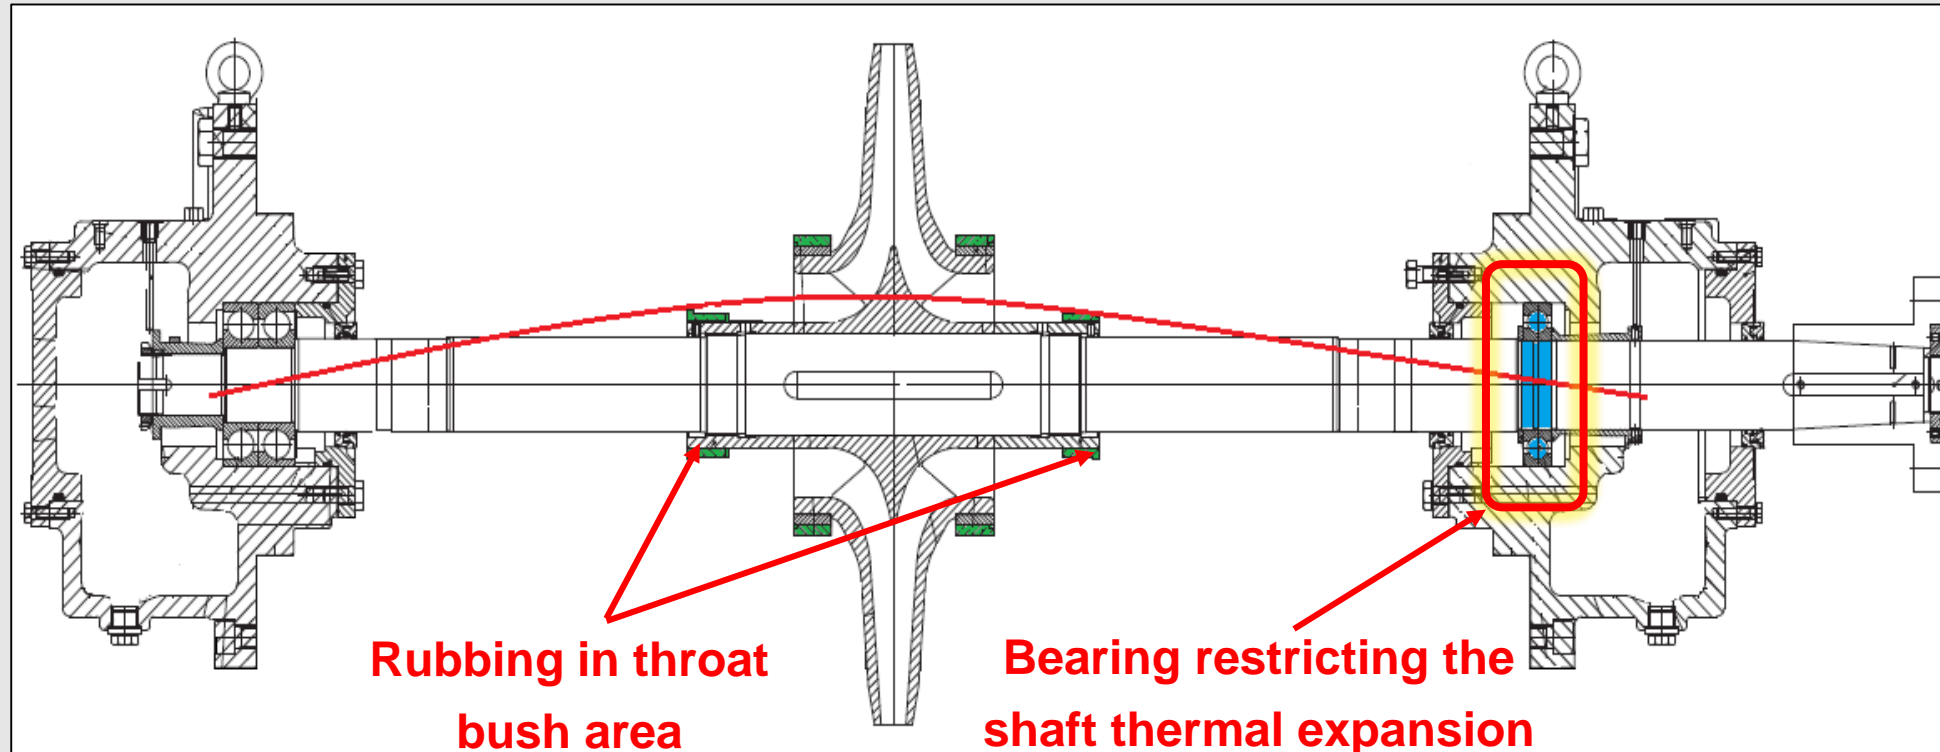
Wear marks of DE bearing housing (free bearing) indicated restriction in bearing axial movement, hence restriction in pump shaft expansion. *During warm-up, linear expansion measured in shaft is approx 1.0 mm.*

This results in deflecting the shaft, creating rub between shaft and throat bush as well as in wear rings. The phenomenon reflected in vibration spectrum as 1.3xRPM order vibrations.

*With fluid being pumped at very high temperature (355 °C), the fits of the bearing on the shaft and inside housing becomes highly important. The fits become even more important with deep groove ball bearing (6213) at the floating end.*

To improve free end bearing design so as to eliminate restriction to shaft expansion during pump warm up.

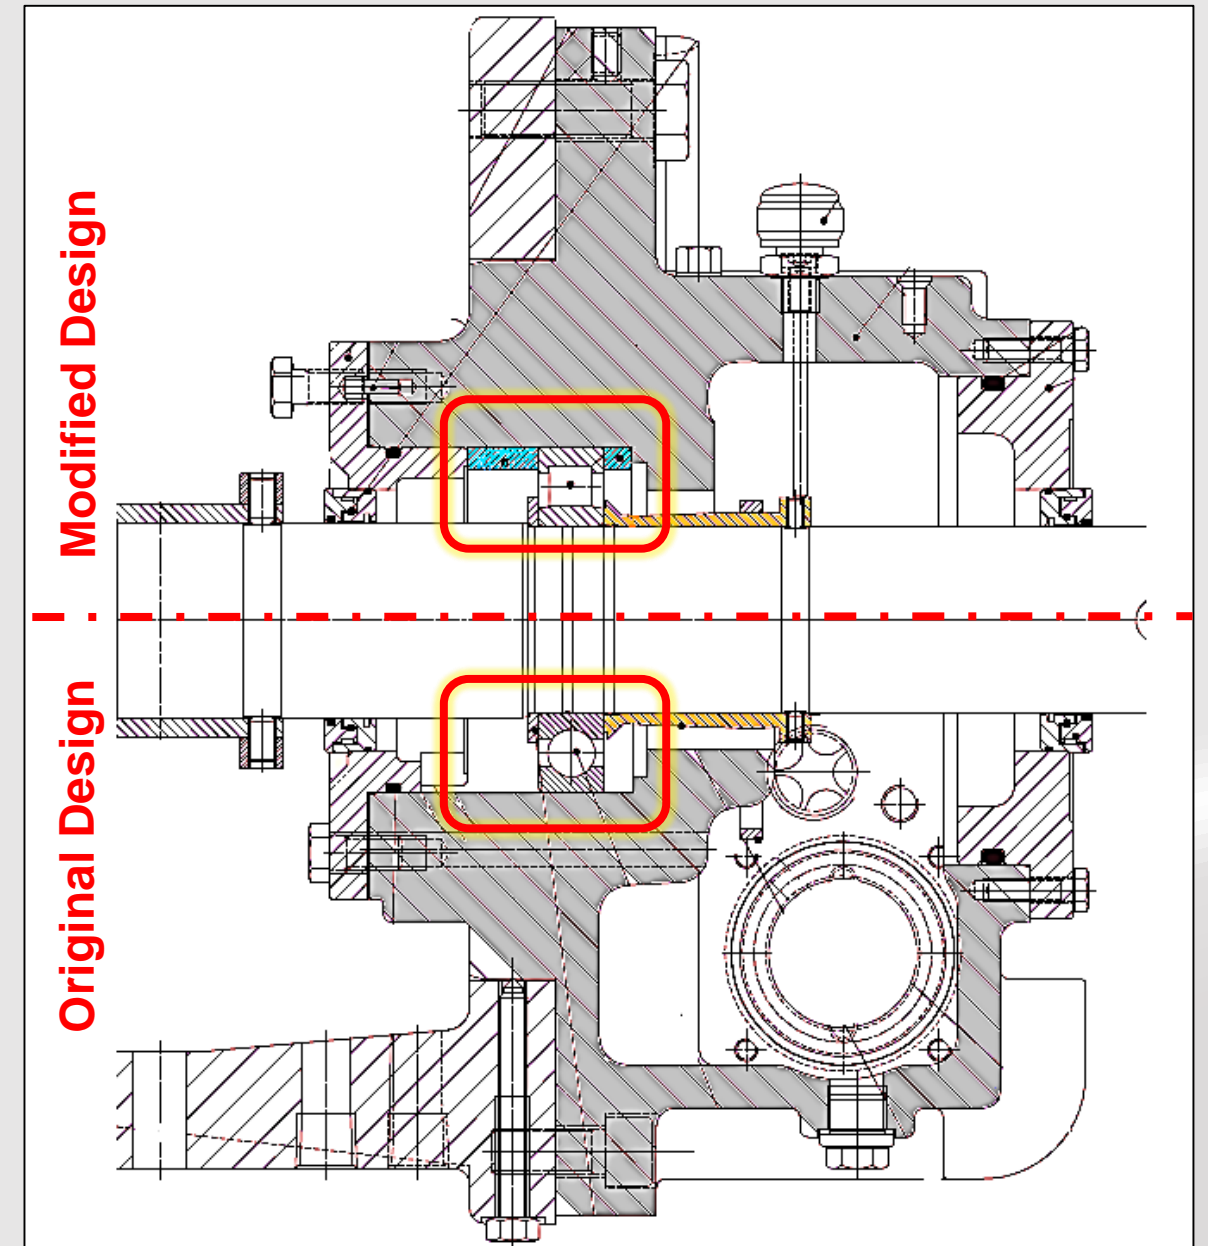
- Minimum load – Meets minimum load requirement (confirmed by pump OEM)
- Axial Displacement – Can withstand upto 1.4 mm displacement whereas actual displacement is 1.0 mm
- Fits and location – Can accommodate within same bearing housing by installing spacer rings

Drive End side 6213J (deep groove ball) bearing replaced with NU213 ECJ/C3 (cylindrical roller) bearing after due consideration of minimum load, axial displacement requirements and concurrence of pump manufacturer

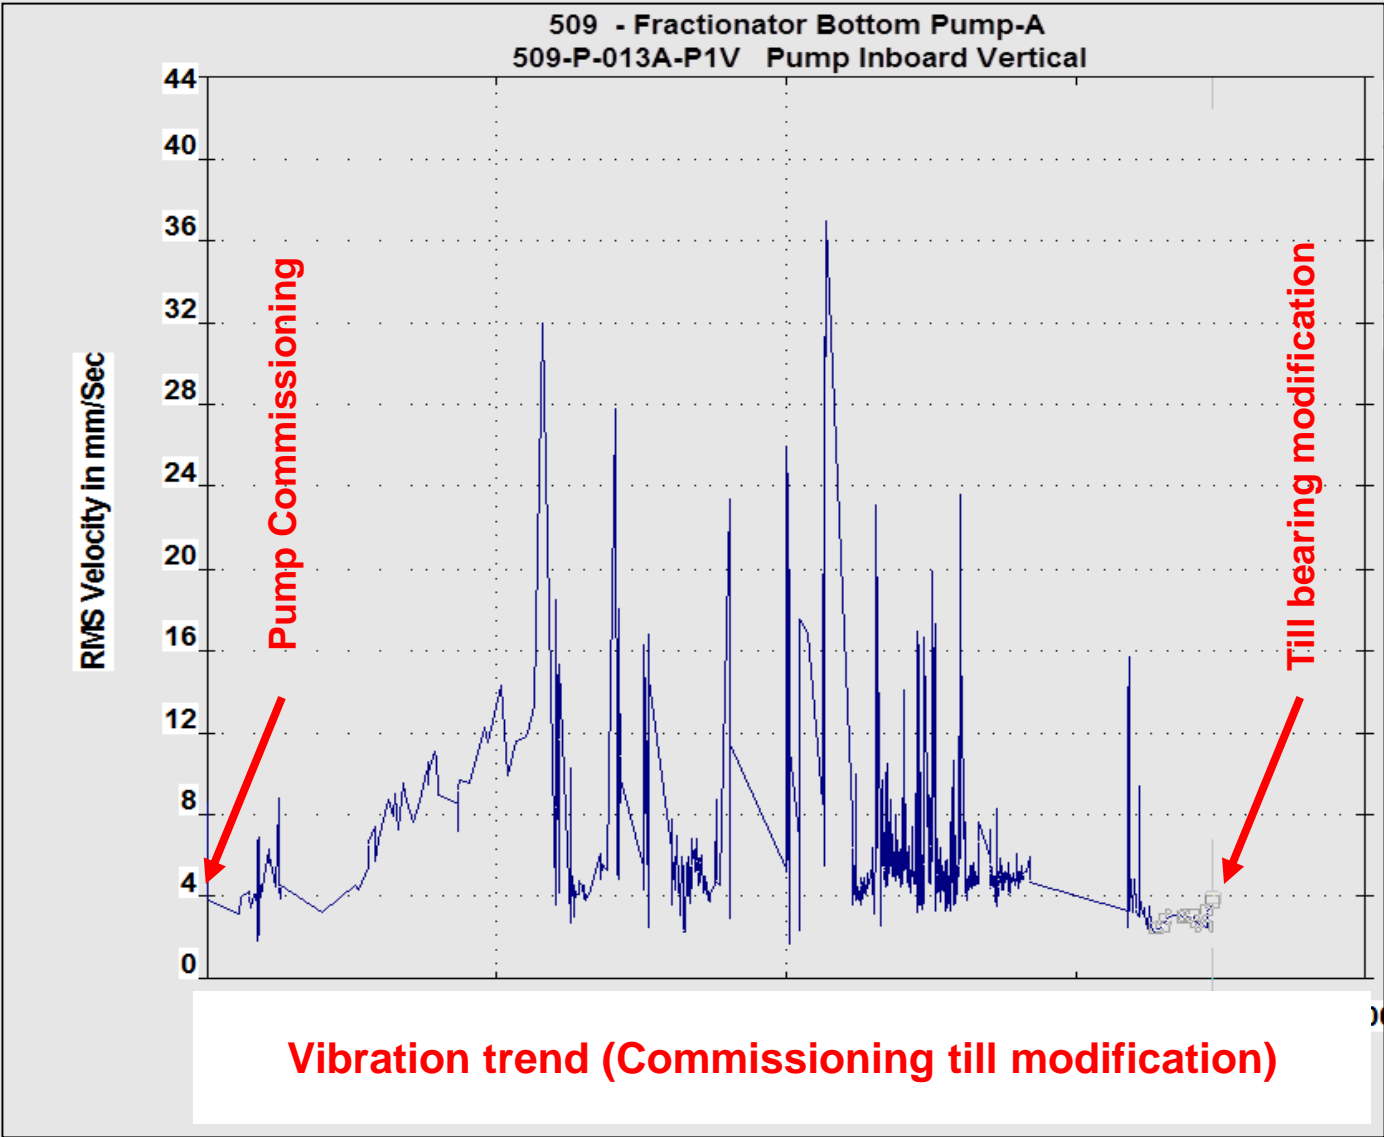
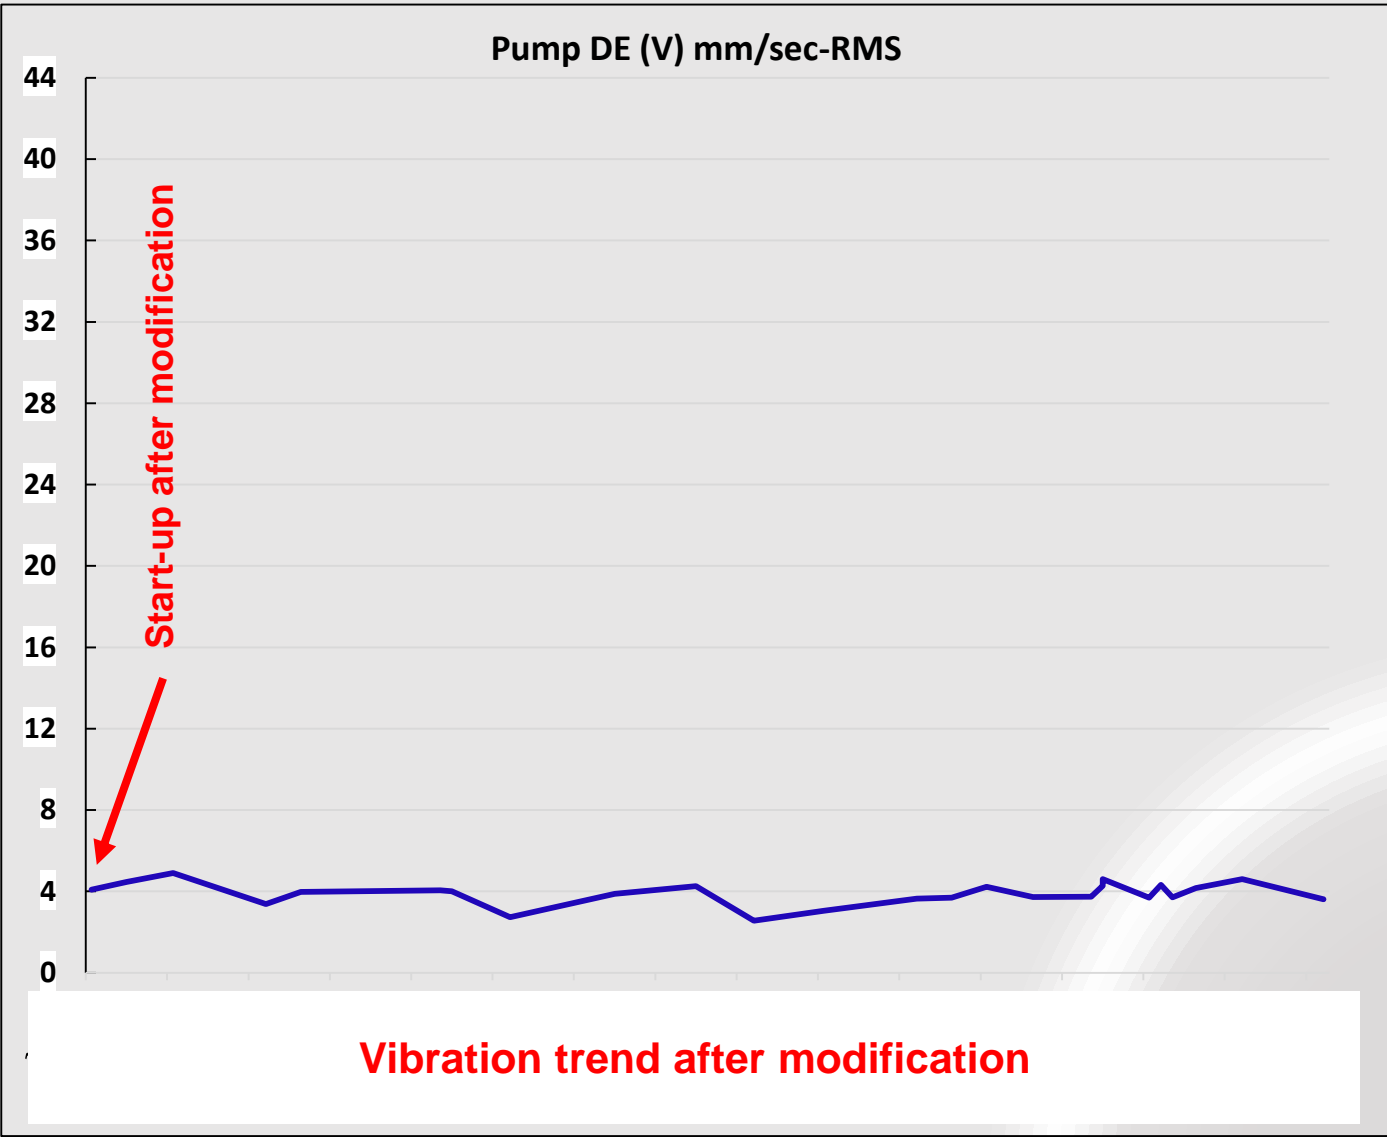
After change in bearing type, pump is running satisfactorily with vibrations well within limits in the range of 3 - 5 mm/sec-rms. No fluctuating peaks are observed even after considerable number of pump start-stop events
