# Emergency Damage Restoration Experience of 25MW Heavy-Duty Gas Turbine: Bearing Retrofit Design and Test Run

An Sung Lee, Byung Ok Kim, and Kyung Ho Sun  
Korea Institute of Machinery and Materials (KIMM)  
Daejeon, South Korea

Byeong Kyu Park, and Young-Soon Bae  
LG Chem, Ltd., Yeosu, South Korea

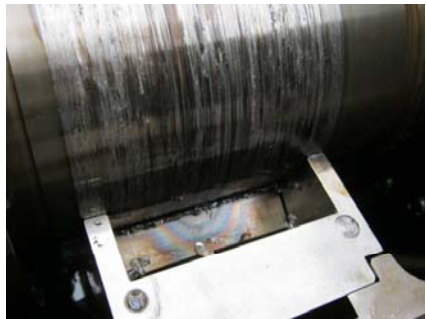
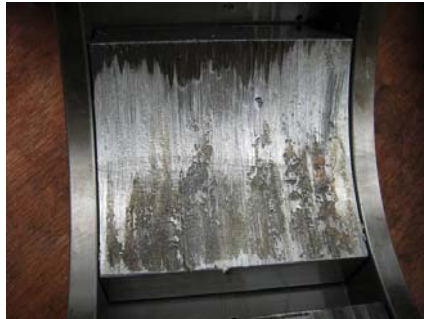
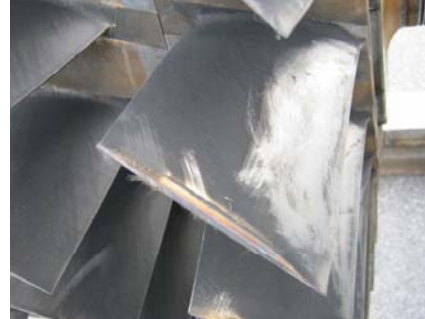
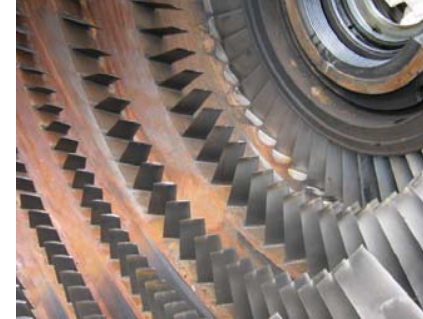
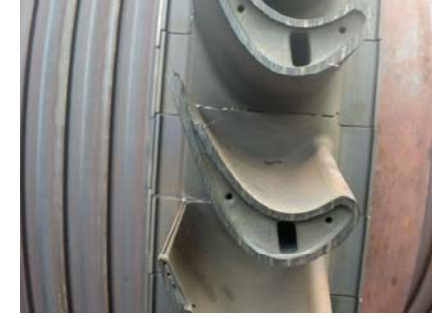
- Due to the loss of lubrication oil supply, the GT suffered extensive damages, particularly, at its bearings and journals.

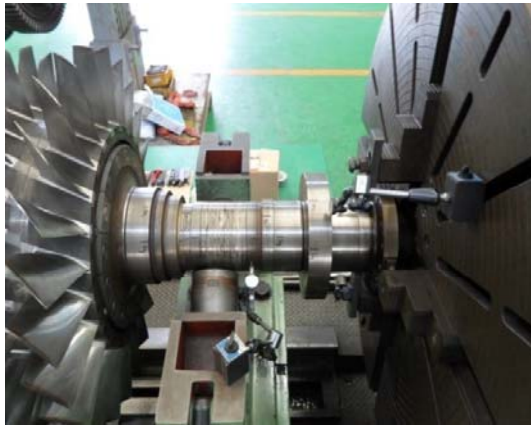
Machining-out damaged journal

- Because of repair machining-out, journal diameters decreased about 2%.
- But OEM gives a design assurance on any machining modification **only up to 1% of the shaft journal diameter.**
- **Need to secure a reliability on journal repair and bearing design retrofit by design analysis & review.**
- **Need to secure a vibrational/operational reliability of the whole rotor with rubbing damages of blades by test run, utilizing KIMM's high-speed balancing facility.**

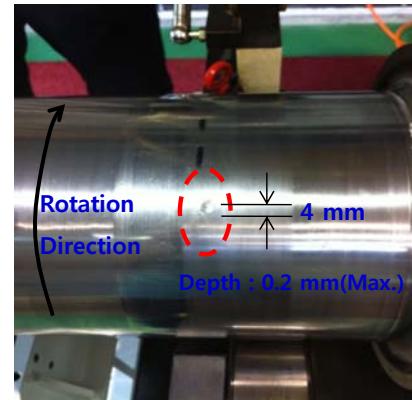
Remaining tear-drop in TBN side journal

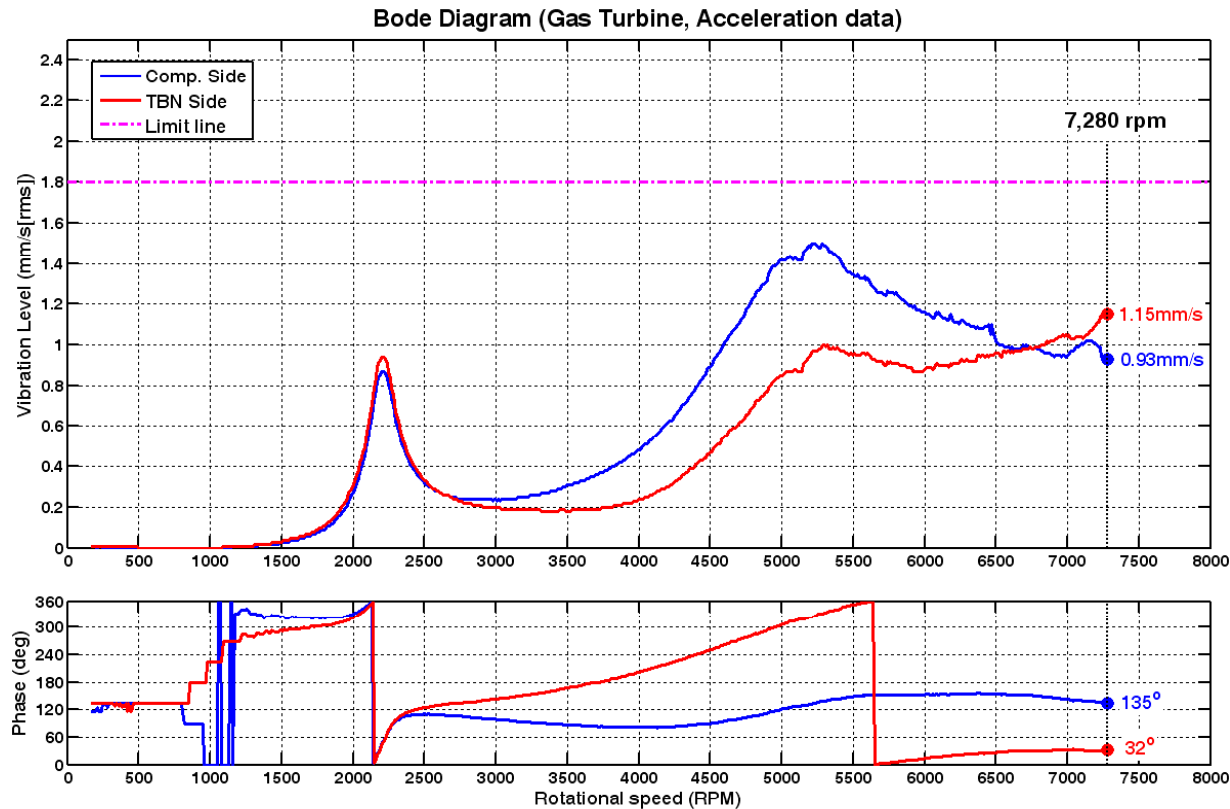
<b>7,280 RPM</b>	
<b>Comp. Side</b>	<b>0.93 mm/s <math>\angle</math> 135°</b>
<b>TBN Side</b>	<b>1.15 mm/s <math>\angle</math> 32°</b>

- After several run-ups, the sag effect was eliminated.
- After sag removal, the vibration responses were stable at the 2nd critical (about 5,300 rpm) and rated speeds.
- The vibrations at the rated were even and favorable as the max. 1.15 mm/s. (Therefore, a ship-out was determined without any high-speed balancing effort.)

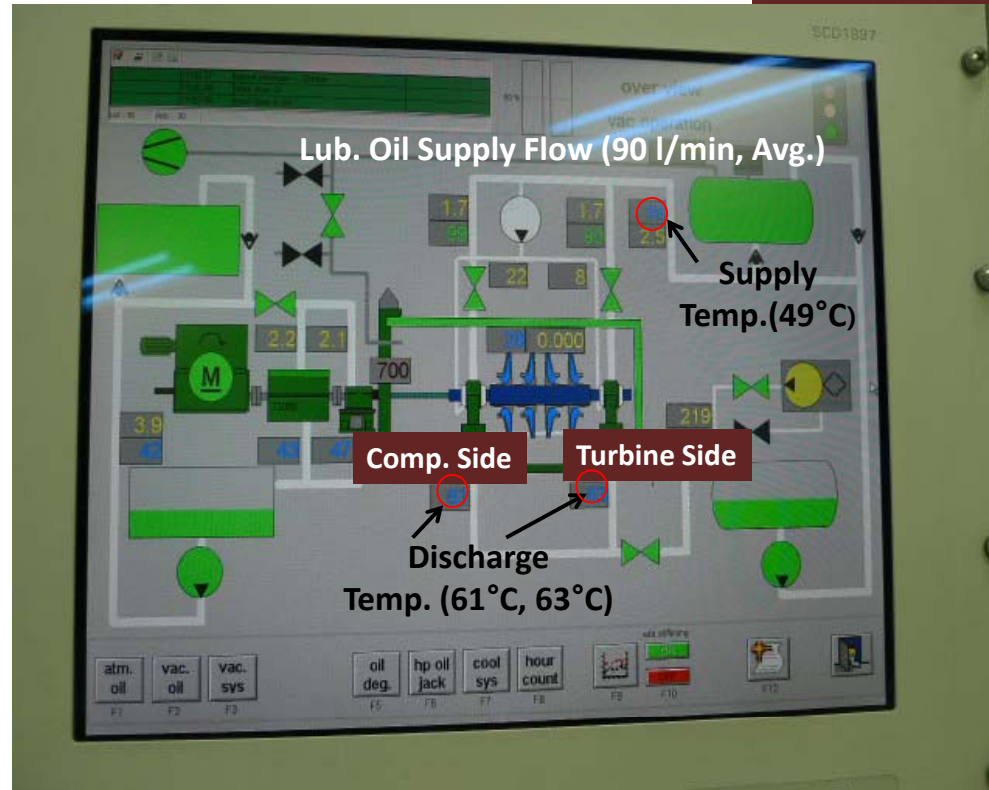
At rated speed with supply oil temp. of 49C, discharge oil temps. were measured as the comp.-side bearing: 61°C and turbine-side bearing: 63.5°C.
