BVL Power Systems

Abrupt Stoppage of Turbine Rotor, running on Barring after Major Overhauling

This case study is about a typical experience where a steam turbine, which was running at 100 RPM on barring (turning) after overhaul, stopped abruptly and the rotor was found to be seized.

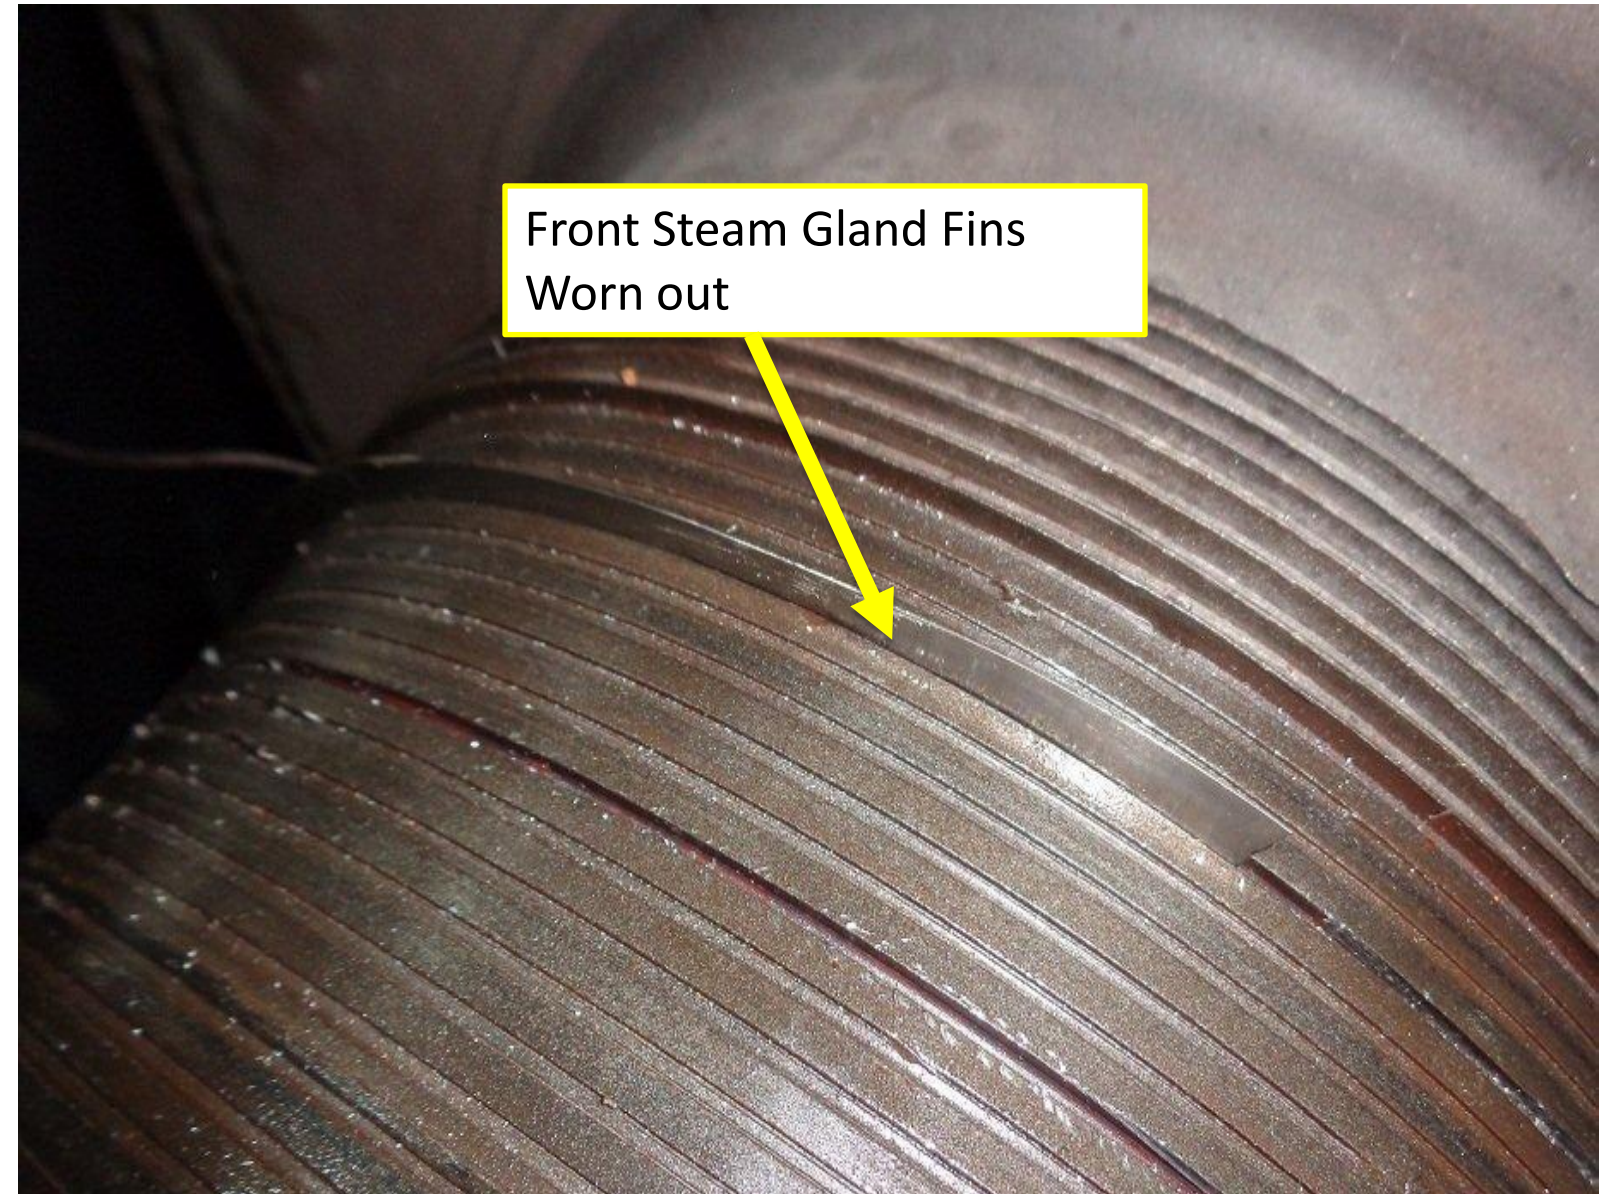
- Turbine Rotor running on barring gear stops abruptly
- Turbine Rotor did not rotate with Hand Barring System.
- Rotor rotates freely again on hand barring after 30Hrs of stoppage.

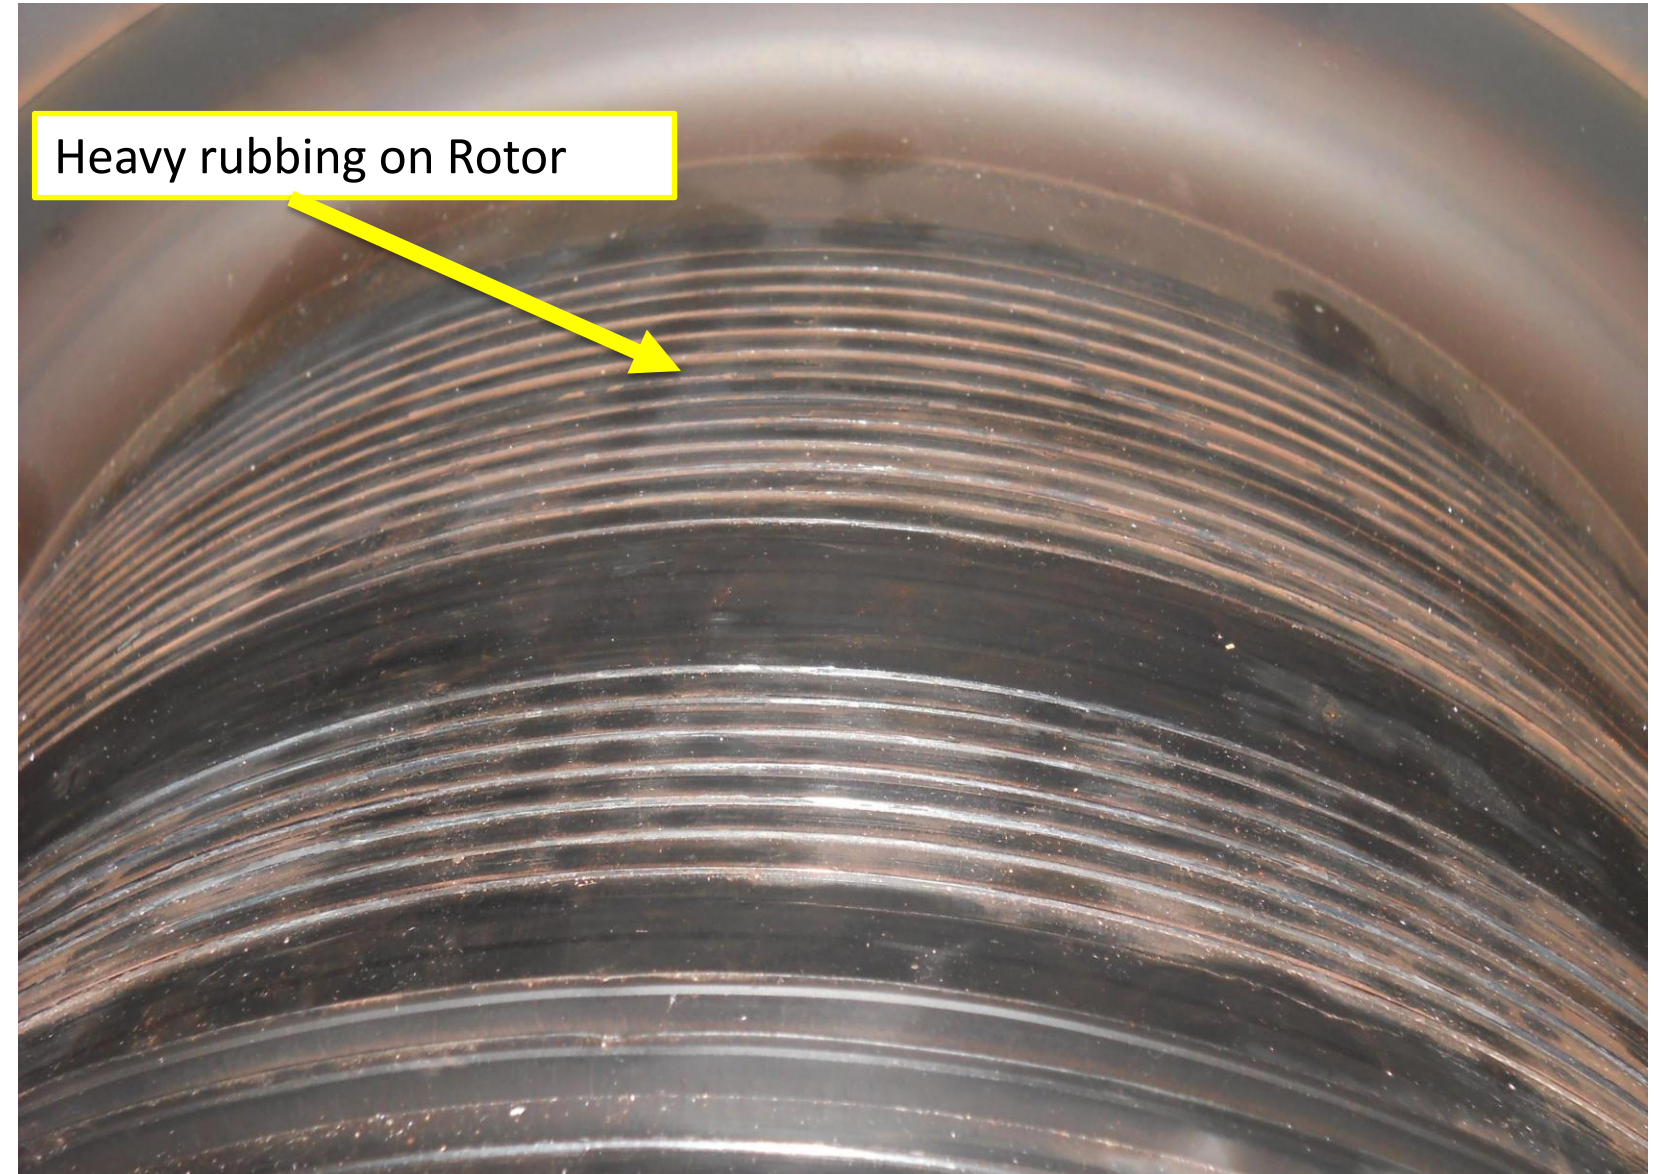
On opening the casing, heavy rubbing noticed on Front Steam Gland and rotor found to be touching the Steam Glands.

Therefore, due to uneven thermal expansion of the top casing and the bottom casing, the rotor rubbed against the static casing internals (mainly the steam glands), and led to the seizure of the rotor.

- Turbine rotor and stator parts repaired
- Insulation installed per the specification
- Turbine restarted without further issues

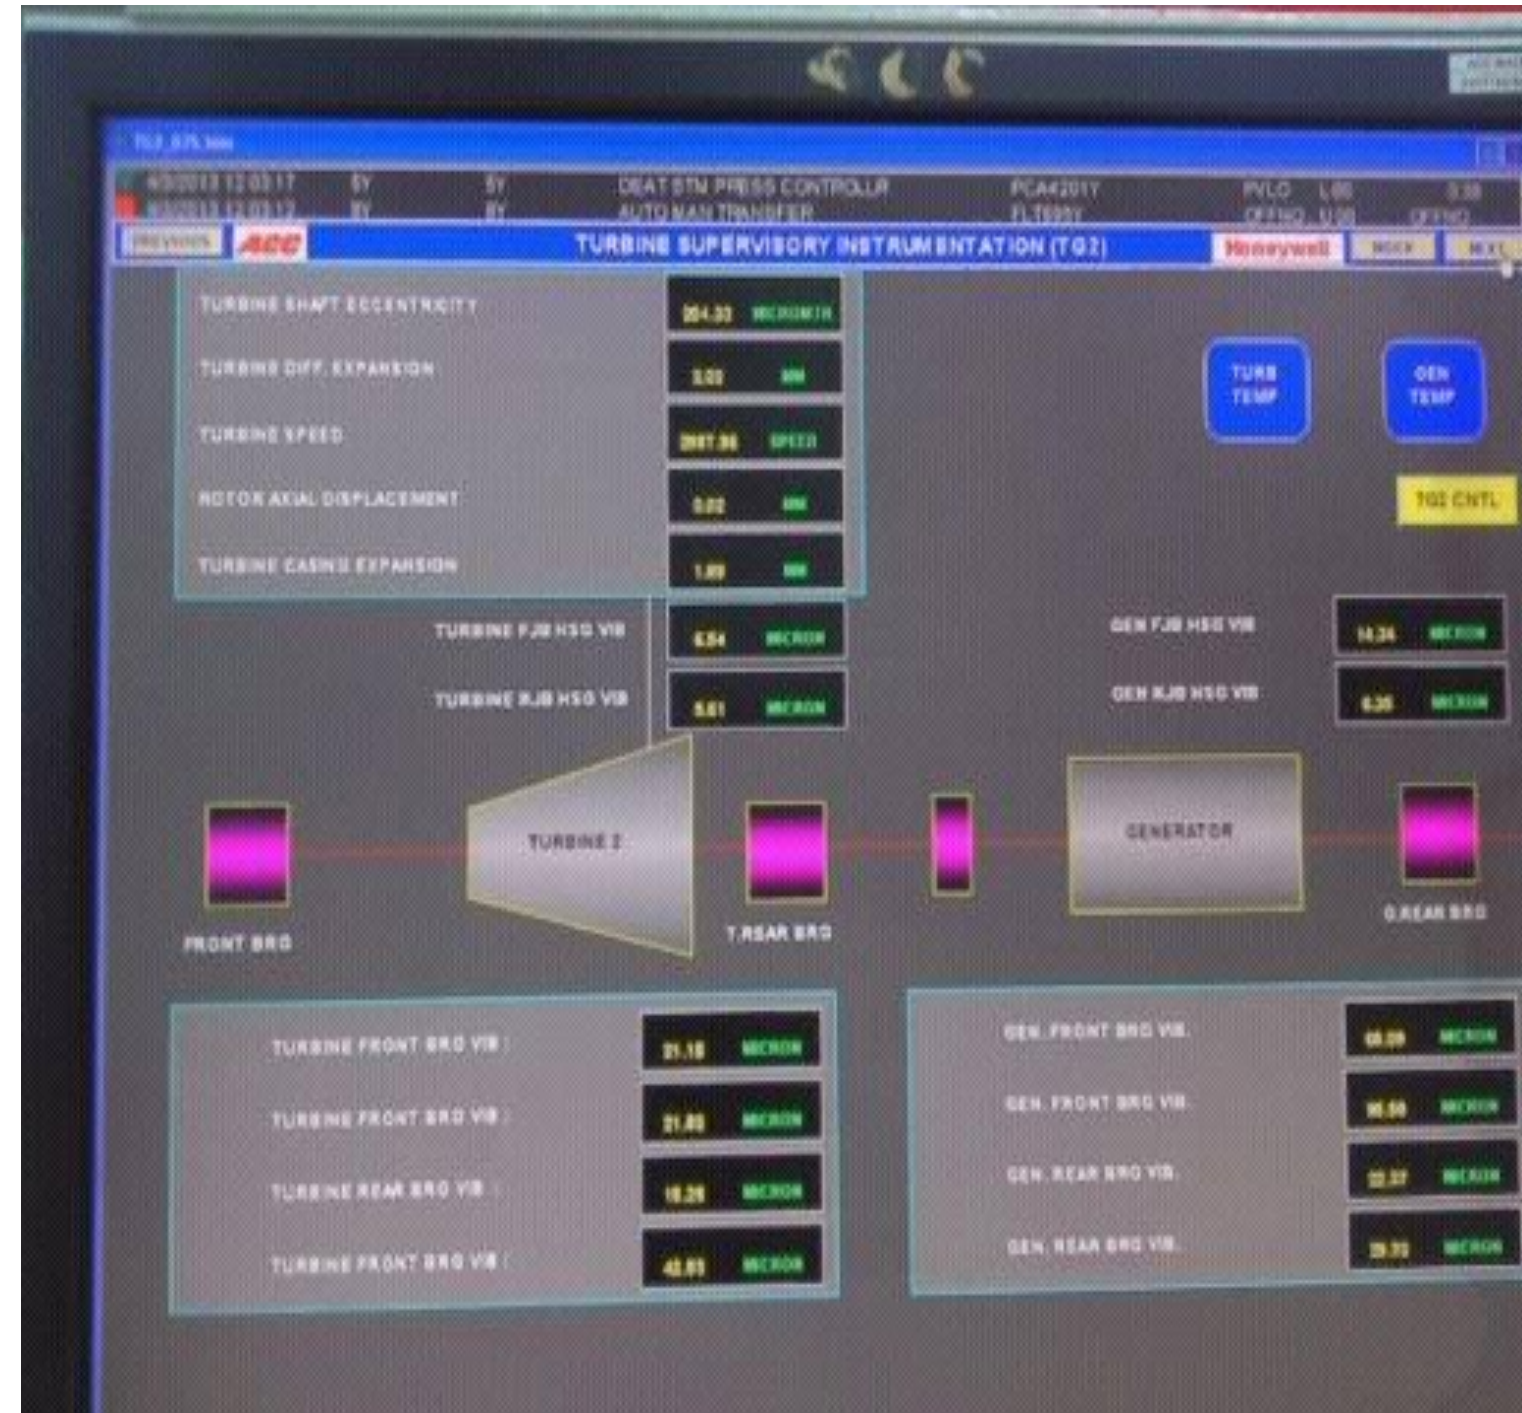
▪ Log Sheet Parameters checked and found that the Turbine tripped on High Front Journal Bearing Vibrations.

▪ Turbine Rotor Centering checked and found to be OK

▪ Turbine Rotor Setting dimensions were checked and found to be as per design values.

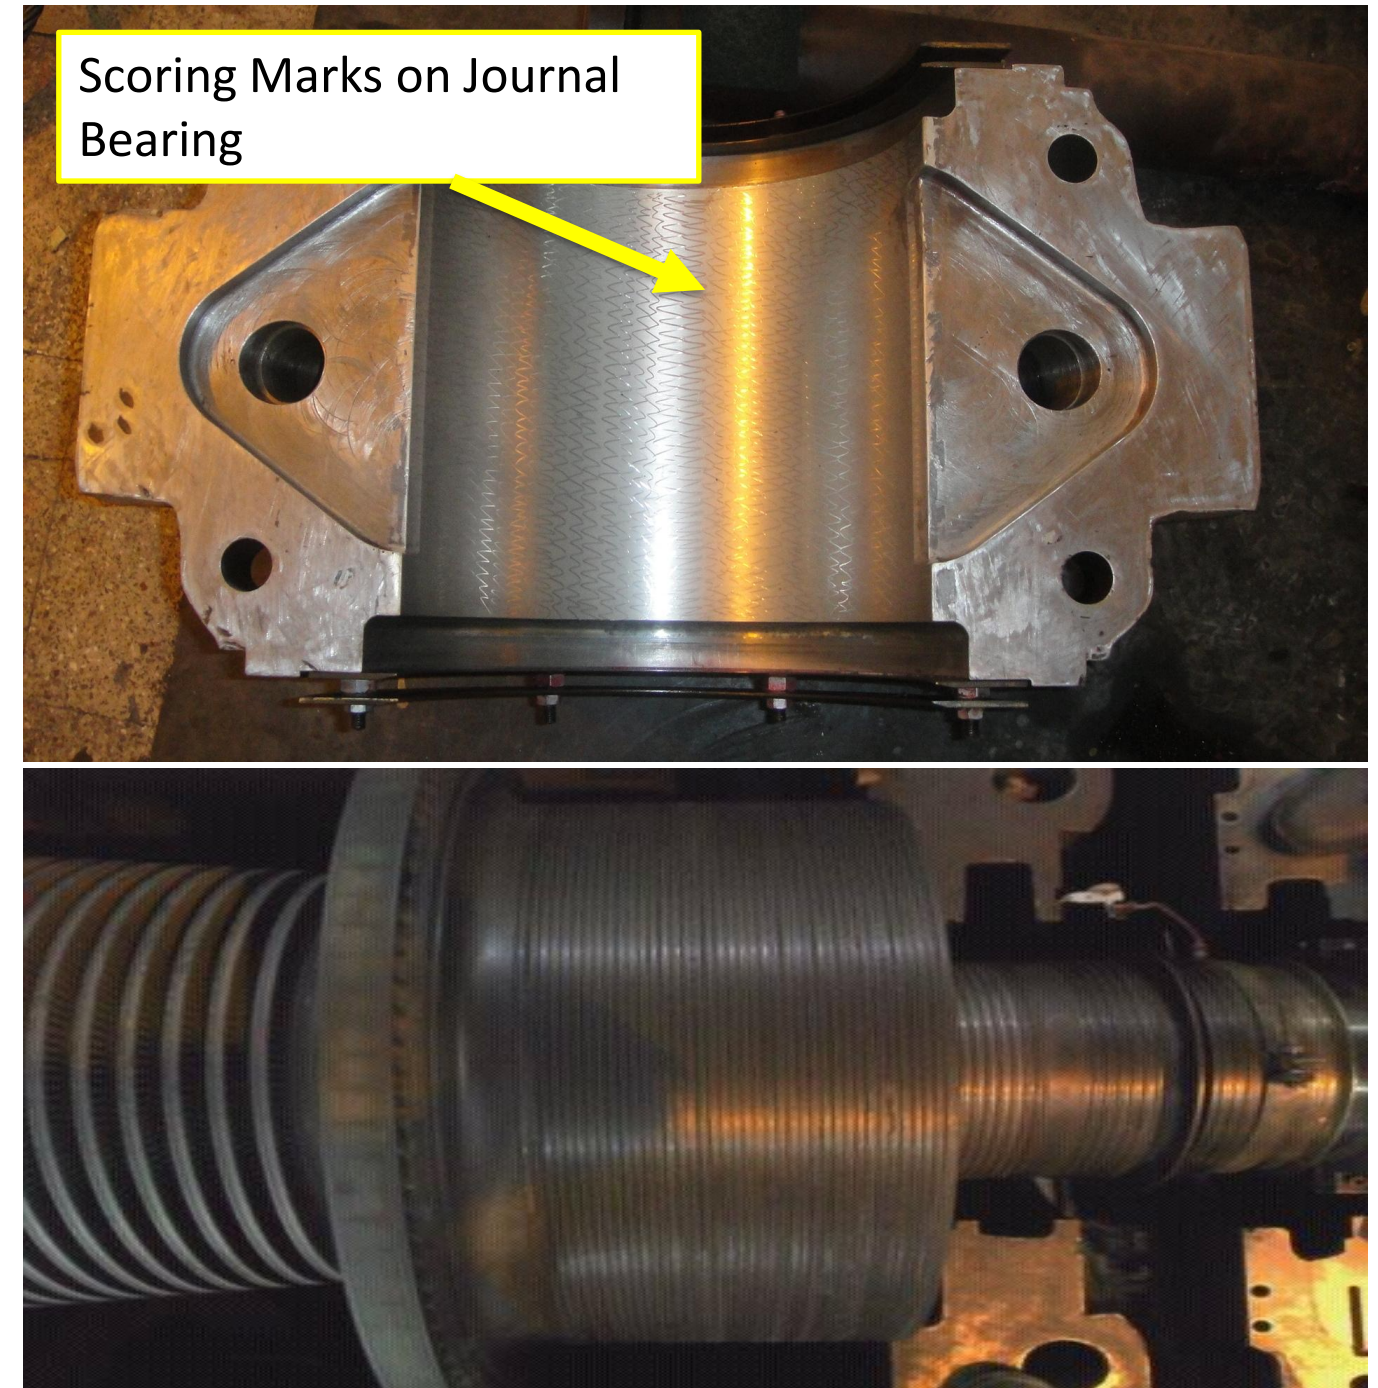
- Bearings were checked and found slight scoring marks.
- Axial clearances between Barring Gear Wheel and Nozzle block was checked and found to be OK.
- Oil flows to all bearings and Barring gear inlet nozzles were checked.

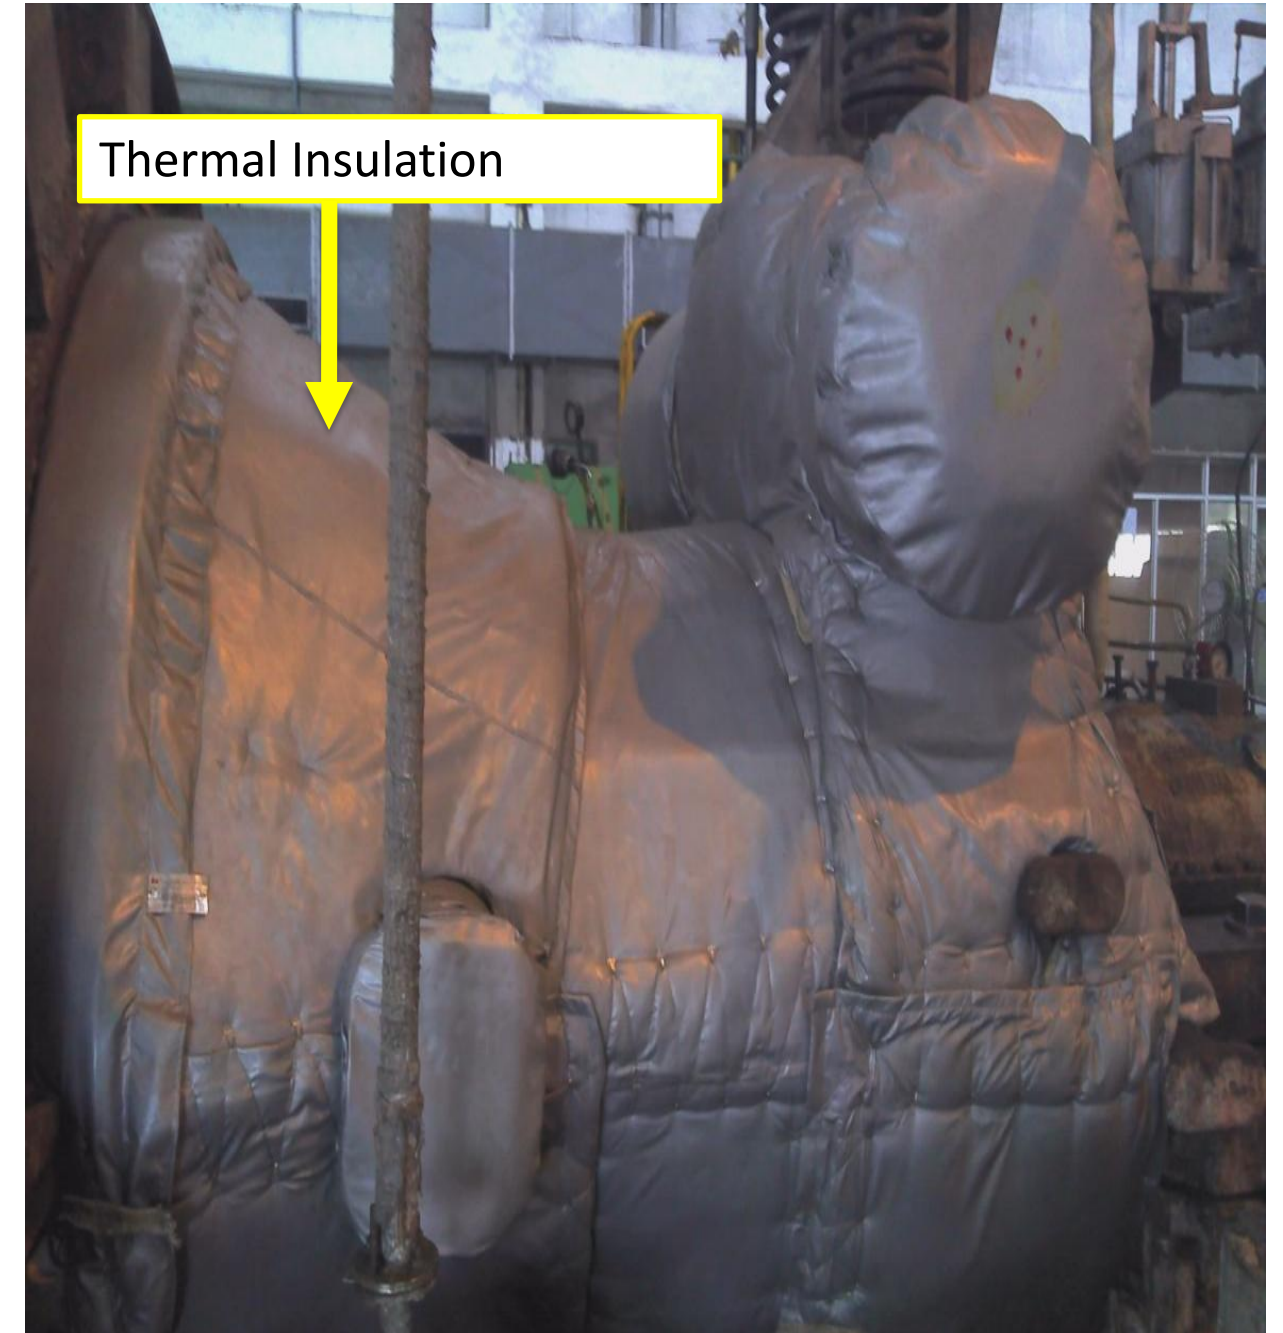
- Turbine Casing Temperatures were measured. Found that the temperature of the bottom casing was 317°C and the temperature of the Top casing was 237°C.
- Turbine Casing Insulation skin temperature on the top side was 135°C and on the bottom side was 55°C.

The root cause was very typical. After the turbine major overhaul its thermal insulation was not replaced as per the OEM design and recommendations. The thermal insulation was installed properly, as per recommendation, on bottom casing but the top casing's thermal insulation was not installed to the correct thickness, i.e. less than recommended.

As per design the thermal insulation thickness on the casing (top and bottom) should have been 10-12" whereas only 5-6" was reinstated at the top. This resulted in a temperature differential between the top and bottom casings of 80°C, whereas the allowable limit is 25°C.

- Turbine Casing thermal insulation thickness should be 10"-12" on the entire casing surface.
- Proper Insulation material to be used.
- Plaster of Paris to be done on Turbine casing thermal insulation
