# Case Studies in Construction Materials

# A study on the cement-based decorative materials in the San Fedele Church in Milan

Cement-based materials have been used since the 19th century for different decorative purposes, and a high levels of expertise has often reached in reproducing or restoring even quite elaborated stoneworks. An important example is the application of cement-based decorative materials on the façades of the San Fedele church in Milan. The church, built in the 16th century and characterized by the presence of pinkish-yellowish Angera stone on the façades, was subjected, especially in the 20th century, to several restoration works. Damaged decorative elements of the façades as well as portions of its structural elements were replaced or covered in the last century by “stone imitating render”, made with cementitious materials which imitate the original Angera stone. In this study, several samples of cement-based decorative materials, collected from different elements of the external façades of the Church, were characterized by several analytic techniques (thermogravimetric analysis, X-ray diffraction, scanning electron microscopy and IR analysis), in order to in

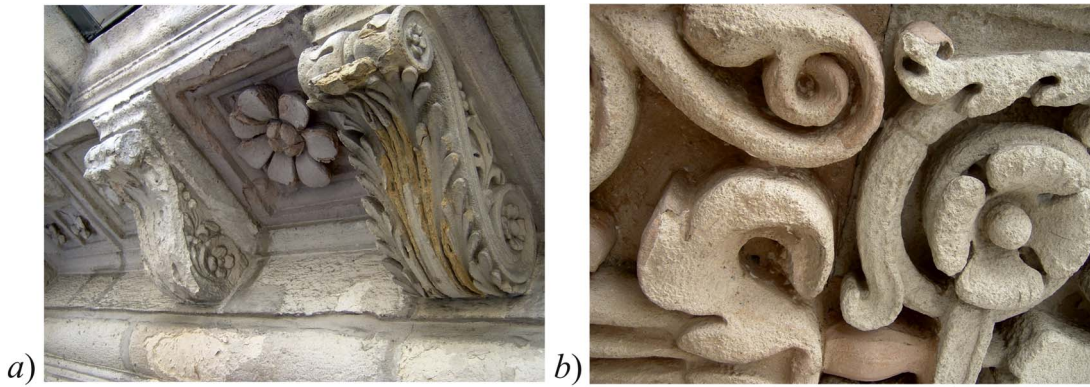
Fig. 3. Damaged decorations in Angera stone on the left side (a) and well preserved decorations made in cementitious materials on the main façade (b).

The façades of the San Fedele Church are characterized by the presence of renders and decorations in cement-based materials, which imitate in texture and colour the Angera stone. Renders are present on the elements of the church as the columns and the *sfondati*. The inspection revealed that the decorations, predominantly present in the main façade, under the gable are similar in the shape, but not in the materials, to those present in the left façade. In fact, those present in the left façade are made in Angera stone and showed, at the time of inspection, a high level of degradation, with exfoliation, granular disintegration and scaling (Fig. 3a), whilst those in the main façade are made with cement-based decorative materials and showed a better state of conservation (Fig. 3b).

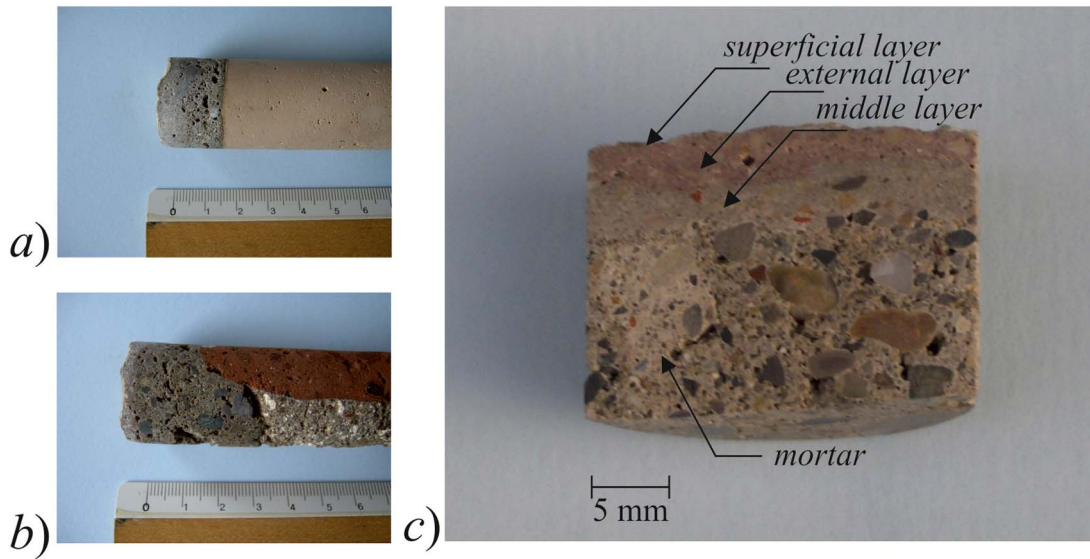
Table 1 lists all the analysed specimens, indicating their location, the stratigraphy, the thickness of each layer and the main results of visual observations. Cores allowed to verify that, in some cases, the column was made with the Angera stone and a layer of cement-based repair render was applied directly on the damaged stone (Fig. 4a). In other cases, the render was applied above burnt-clay bricks as for the columns of the second order (Fig. 4b) or the *sfondati*. Furthermore the macroscopic analysis showed a multilayer

The visual observations showed high cohesion between the various layers of render and substrate and did not show any type of

Fig. 4. Example of sample (C1) cored from a stone column (a) and (C4) from a brick column (b) and example of stratigraphy of the sample (C5) from a brick column (c).

damage, suggesting a good state of conservation of the cement-based decorative materials.

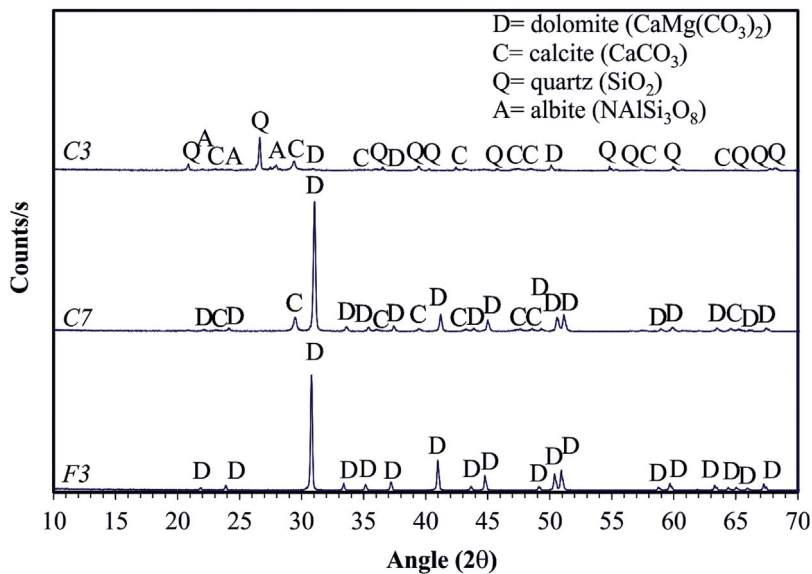
Although the study was focused on the cementitious materials, also a sample of Angera Stone (F3), which visually appeared yellow and porous, was analyzed. From X-ray diffraction (XRD) analyses the presence of the calcium magnesium carbonate (CaMg(CO<sub>3</sub>)<sub>2</sub>), in the crystalline form of dolomite was assessed (Fig. 5). Fig. 6 shows the thermogravimetric analysis of this sample: a unique relevant mass loss can be observed in the TG curve, at temperature between 550 and 750 °C, which is associated to the decomposition of calcium magnesium carbonate. The mass loss of 47.7% showed that the stone was entirely constituted by dolomite.

Analyses were then carried out on samples of cement-based decorative materials. As far as the composition of the external layer is concerned, in all the samples, the presence of calcium carbonate (CaCO<sub>3</sub>) with the crystalline structure of the calcite (C) and of quartz (Q) was detected through XRD analyses and their peaks were always those of greater amplitude (Table 1). Sample C7 was an exception, since quartz was not observed (Fig. 5).

For those samples with a pink or yellow colouration, the XRD analyses showed also the presence of dolomite (D). In particular, it was observed that the samples of the first order of the left side, especially those taken from the stone columns (C7 and F6), had a higher content of dolomite in comparison to those taken from the second order. Comparing the XRD diffractogram of a sample taken from the first order, as sample C7, with one taken from the second order, as sample C3, it can be observed that in both samples

Fig. 5. XRD analyses of samples F3 (Angera stone), C7 and C3.

dolomite was present, however in the sample taken from the second order the dolomite peaks intensity was more pronounced (Fig. 5). In some cases, XRD peaks of other crystalline compounds were detected, which can be attributed to the presence of residual fragments of aggregates in the powders analysed, as, for instance, albite ( $\text{NaAlSi}_3\text{O}_8$ ).

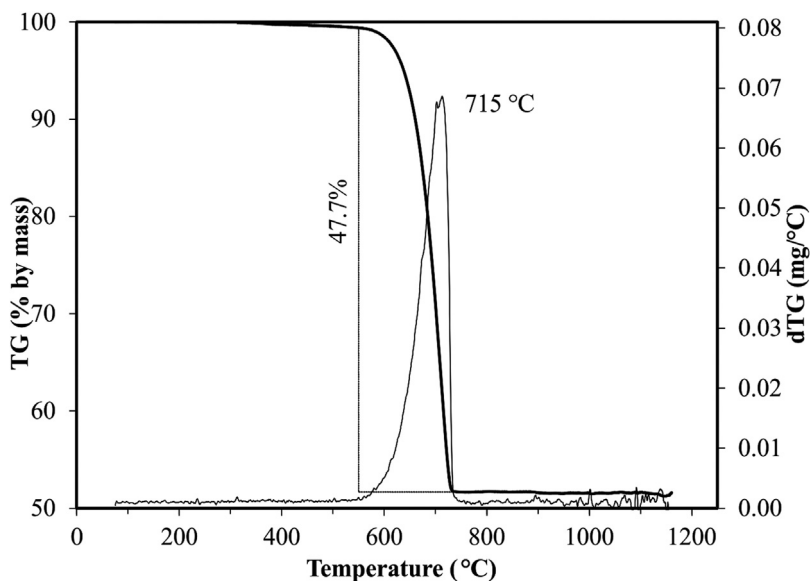
Fig. 6. Thermogravimetric analysis of sample F3: loss of mass of the sample as a function of temperature (TG) and its derivative (dTG).

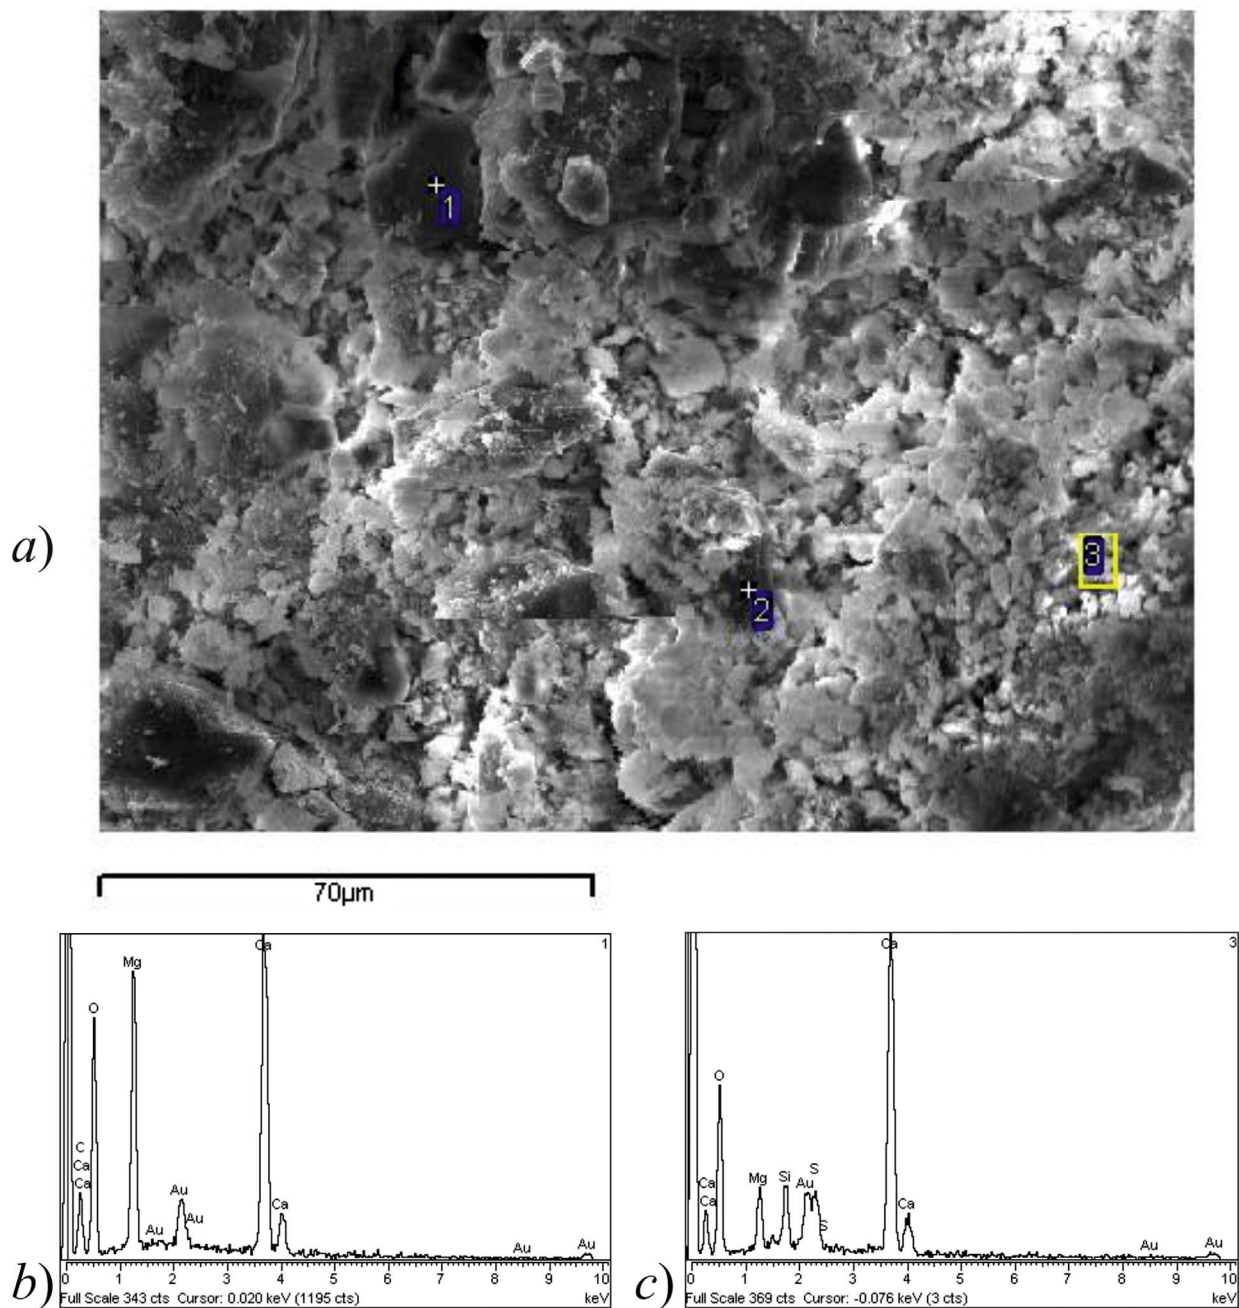
The observations with the scanning electron microscope and elemental EDS microanalysis showed that the matrix of the *external layer* was prevalently formed by calcium carbonated, as evidenced, for instance, by the presence of calcium, oxygen and carbon in the EDS microanalysis of Fig. 7c, as also detected by XRD and TGA analyses. This did not mean that, originally the binder was a lime mortar; as a matter of fact the calcium carbonate might be attributed to the carbonation of a hydraulic binder. An interesting aspect that emerged from EDS analysis of the areas in which there were particles of calcareous binder, was the presence of silicon (Si) and aluminium (Al). Since the analyses were made on spots and, therefore, directly on the particles that constitute the binder, it should be assumed that these elements had been incorporated in the reaction products. It can therefore be assumed the presence of silico-aluminates and, therefore, of compounds able to confer certain hydraulic properties to the binder [6,7]. These compounds typically are non-crystalline and, therefore, cannot be detected with X-ray diffraction analyses. This observation further supports the hypothesis of the employment of a hydraulic binder that could have contributed to the formation of a denser and more compact microstructure within the hardened paste, hardly compatible with the use of a non-hydraulic binder.

The observations with the scanning electron microscope and elemental EDS microanalysis confirmed the presence of dolomite within the cement matrix in the *external layer* of specific samples. Fig. 7a shows that, for instance, dispersed in the cement matrix, particles of dimension up to 10  $\mu\text{m}$  were present, probably of dolomite, since they were constituted predominantly of calcium, oxygen and magnesium (Fig. 7b). In the samples with higher amount of dolomite, also aggregates of Angera stone, with dimensions of 1 mm, were spread in the matrix. Based on these analyses it is clear that the colour of the *external layer* was obtained by blending the binder with the Angera stone finely ground and, furthermore, using the stone also as aggregate. The analyses showed that in the cement-based materials used for covering the stone columns a considerable quantity of finely ground particles of dolomite was present, whilst those applied on substrate of bricks the dolomite content was less or in some case absent.

Fig. 7. SEM image of the binder of the external layer of sample C7 (a) and EDS analyses in spots 1 (b) and 3 (c).

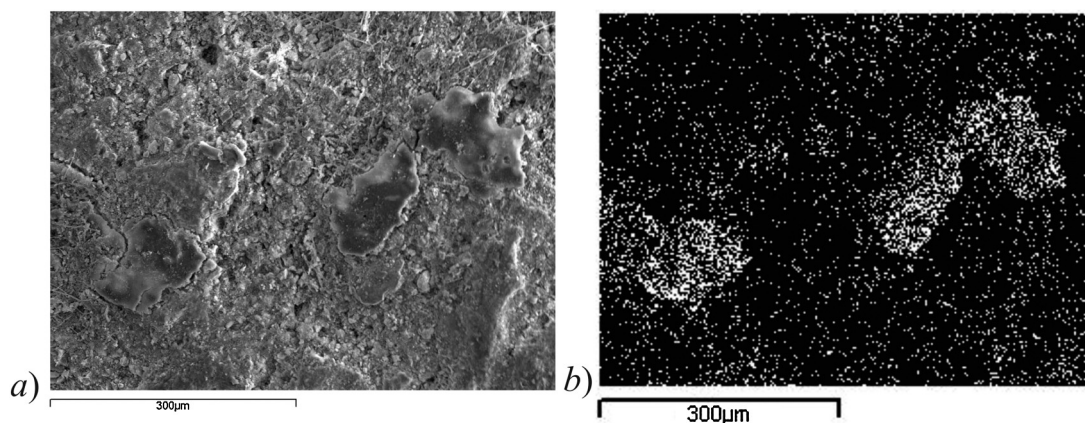
The observations with the scanning electron microscope, carried out on the *superficial layer*, revealed that both on the samples taken from the first and the second order, residuals of organic coating were present, in both façades. From the historic documents it emerged that in the second half of the 20th century several consolidating works were made on the façades of the church. The observations showed that the surface was characterized by the presence of darker and compact areas, probably due to the residues of the coating, and by lighter areas of the underlying cement paste (Fig. 8a). EDS microprobe maps of carbon (C), made on a portion of the *surface layer* of sample C5 (column, Left side – II order), showed that the darkest areas were enriched of this element, confirming the organic nature of the coating (Fig. 8b).

Fig. 8. SEM image of the *superficial layer* of sample C5 (a) and EDS map of carbon (b).

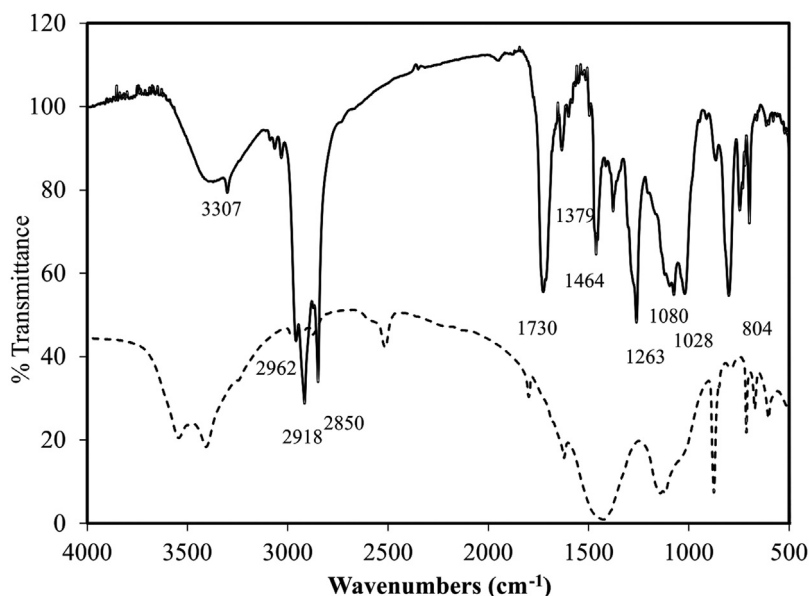
Functional groups of this polymer coating were analysed by FT-IR analyses, carried out on a powder sample taken nearby to core C5, Fig. 9. It can be observed that in an un-treated sample the absorption bands of calcium carbonate from the cement-based substrate (with wavenumbers of 804, 1080 and 1464  $\text{cm}^{-1}$ ) interfered with the determination of peaks of organic compounds. Only

after the extraction with toluene (full line in Fig. 9), absorption bands that can be correlated with acrylates (2962, 2918, 2850, 1730 and  $1379\text{ cm}^{-1}$ ), became visible, although a full determination of the organic nature of the coating was not possible [13]. SEM observation clearly showed that only traces of this treatment were present, so that the polymer coating did not affect the performance of the underlying layer.

Fig. 9. IR analyses on the *superficial layer* of sample C5 (full line: after toluene extraction; dashed line: without toluene extraction).

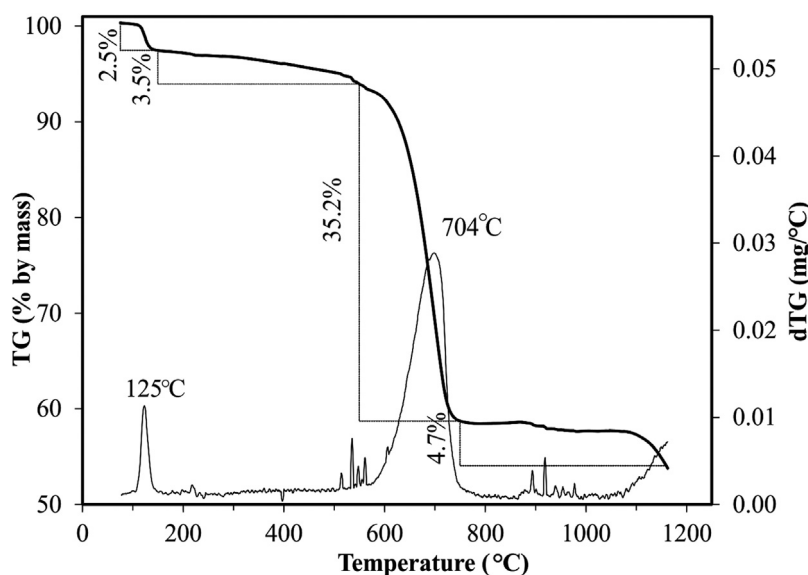
EDS analysis (Table 1). Hence, it might have been intentionally applied with the organic coating (since it was found in correspondence of this) [3]. By means of the thermogravimetric analysis (Fig. 10) the percentage of gypsum present in the samples was evaluated. In the TG analysis the first and last mass losses can be associated with gypsum. The first interval (at temperature lower of 150 °C) corresponds to the loss of water for the formation of hemihydrate and subsequently anhydrite (collectively:  $\text{CaSO}_4 \cdot 2\text{H}_2\text{O} \rightarrow \text{CaSO}_4 + 2\text{H}_2\text{O}$ ) while the second, at temperature above 750 °C, is associated to the decomposition of anhydrite ( $\text{CaSO}_4 \rightarrow \text{CaO} + \text{SO}_3$ ). Hence, through the loss of mass in these two intervals the percentage of gypsum was calculated. For example, in the *superficial layer* of sample C7 (Fig. 10) from the loss of 2.5% by mass observed around 125 °C a content of about 12% of gypsum can be calculated, while from the loss higher of 4.7% at temperatures above 750 °C a content of gypsum higher of 10% can be estimated. Therefore, in this sample, a content of gypsum about 10–12% can be estimated. Where present, the gypsum content ranged between 3% and 17% by mass (Table 1).

Gypsum may also be the result of alteration of calcium compounds due to the effect of sulphur-based pollutants (definitely present, at least since the 20th century, in the urban centre of Milan): in this case the attack was moderate and cannot be considered pathological, since it did not significantly affect the cohesion of the *superficial layer*.

Fig. 10. Thermogravimetric analysis of the superficial layer of sample C7.
