The impact of tool wear on the functionality of replicated polymer surface with micro structures

D. Li¹, Y. Zhang¹, F. Regi¹, G. Tosello¹, J. B. Nielsen²

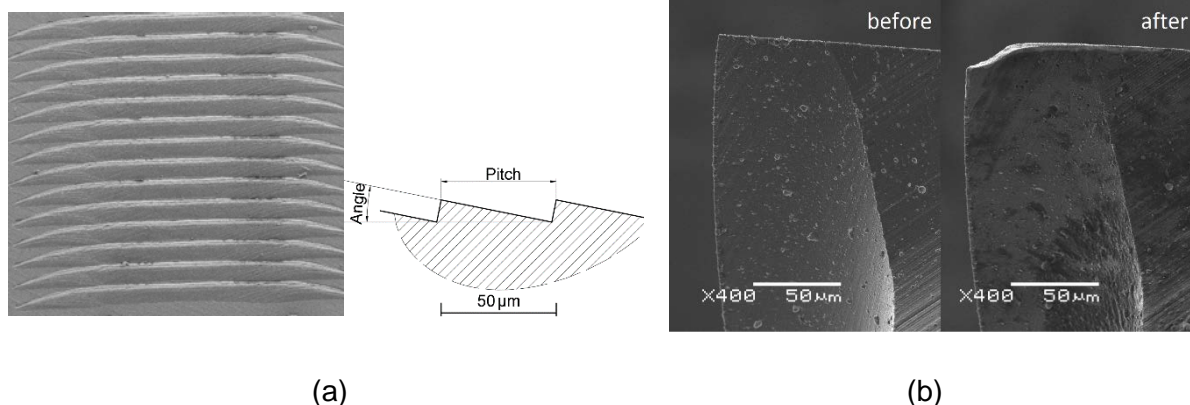
The mill tool was inspected by scanning electron microscope (SEM) before and after the machining. Noticeable wear was observed. The weight of the studied tool was measured before and after machining for comparison. The obtained surface features on the insert and the LSR replica were measured using a confocal 3D laser scanner. The reflectance of the surfaces on the LSR replica was evaluated using a gonioreflectometer[1]. The gonioreflectometer captured the images of every 100th pixel from all the viewing angles by rotating the sample holder and tilting the objective lens. The reflectance for each configuration were obtained via image processing tools.

Results in this study include: 1. Tool wear was visualized by SEM images, which is shown in figure 1 (b). 2. However, the weight decrease could not be detected due to lack of precision in the measurement. 3. The number of defects on the obtained surface structures increased significantly along with the process. 4. The reflectance of these pixels on the LSR replica decreased from the first machined one to the last one.

As a conclusion, the tool (Φ 0.5mm, ARNO[®]) used in this study worn after machining for approximately 100 pixels, considering the function loss of replica surface. Future work will be dedicated to the methods that can prolong the tool life.

Figure 1: (a). Structures on the surface; (b). Wear on the tip of the tool was observed after machining
