44TH TURBOMACHINERY & 31ST PUMP SYMPOSIA
HOUSTON, TEXAS | SEPTEMBER 14 – 17 2015
GEORGE R. BROWN CONVENTION CENTER

Analysis and On-Stream Countermeasures of High Thrust Bearing Temperature of Centrifugal Compressor

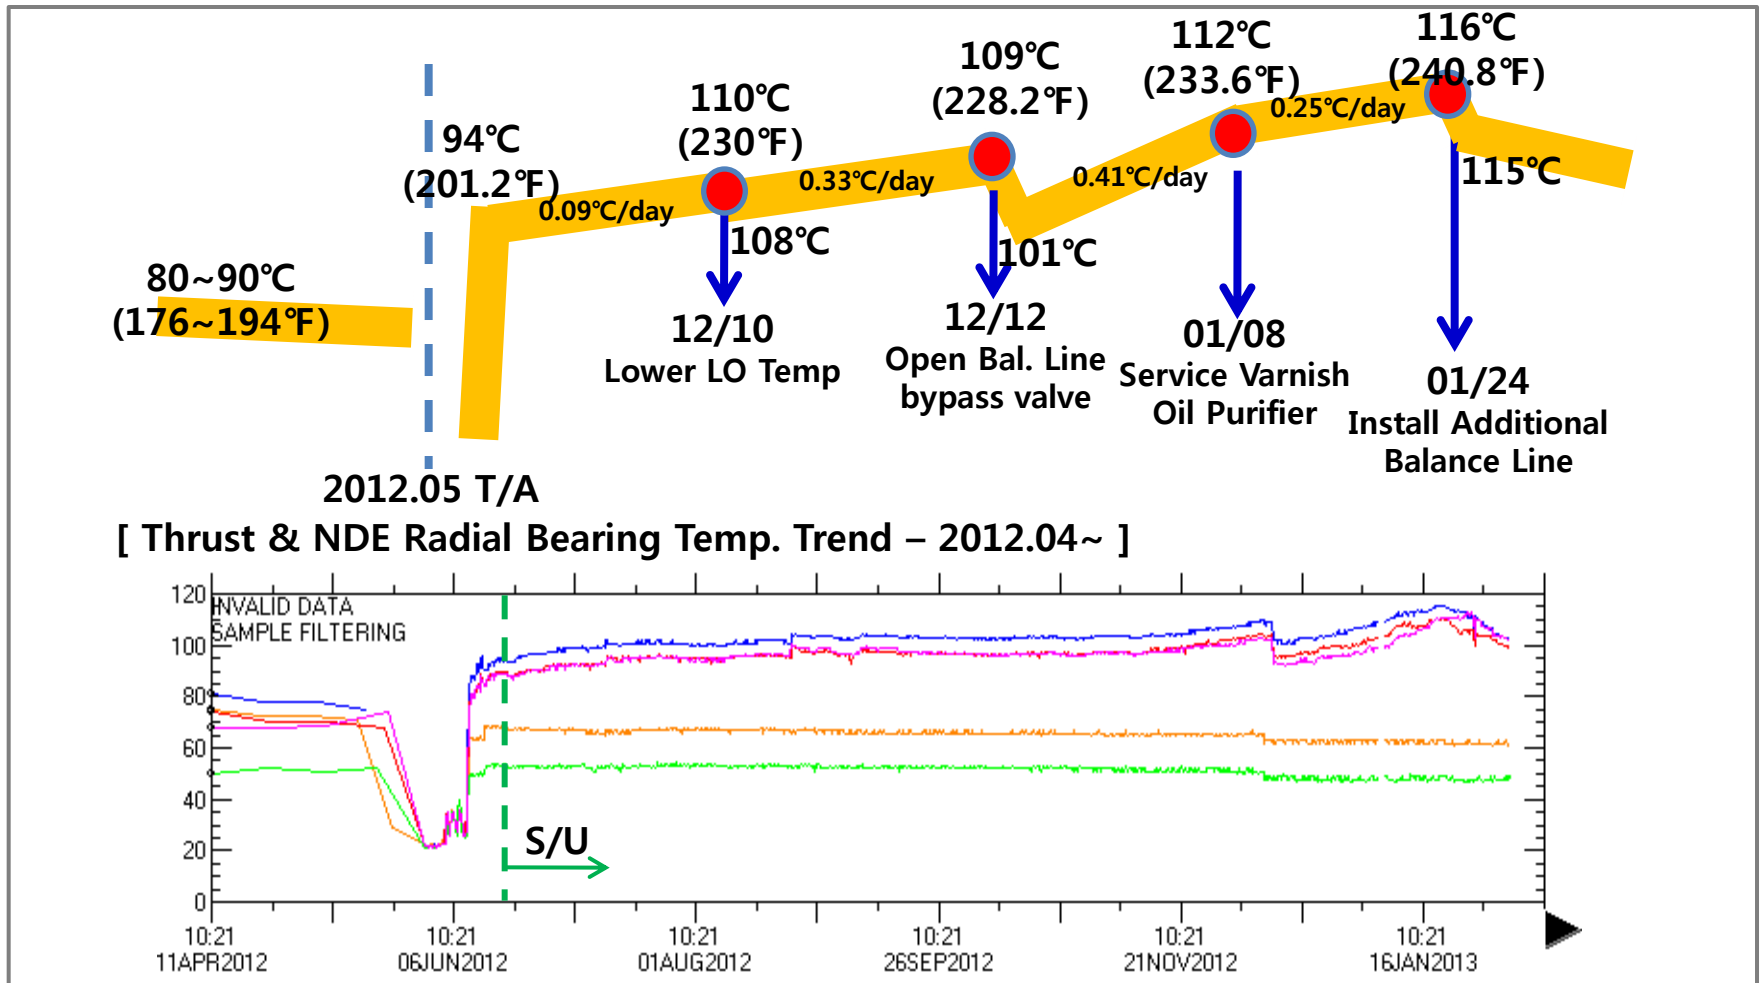
Active side thrust bearing temperature was higher than previous run since Jun. 2012's T/A. It had reached 116°C(240.8°F) at the peak.

- Overall Trend and Counteractions (Alarm/Trip : 120/125°C (248/257°F))

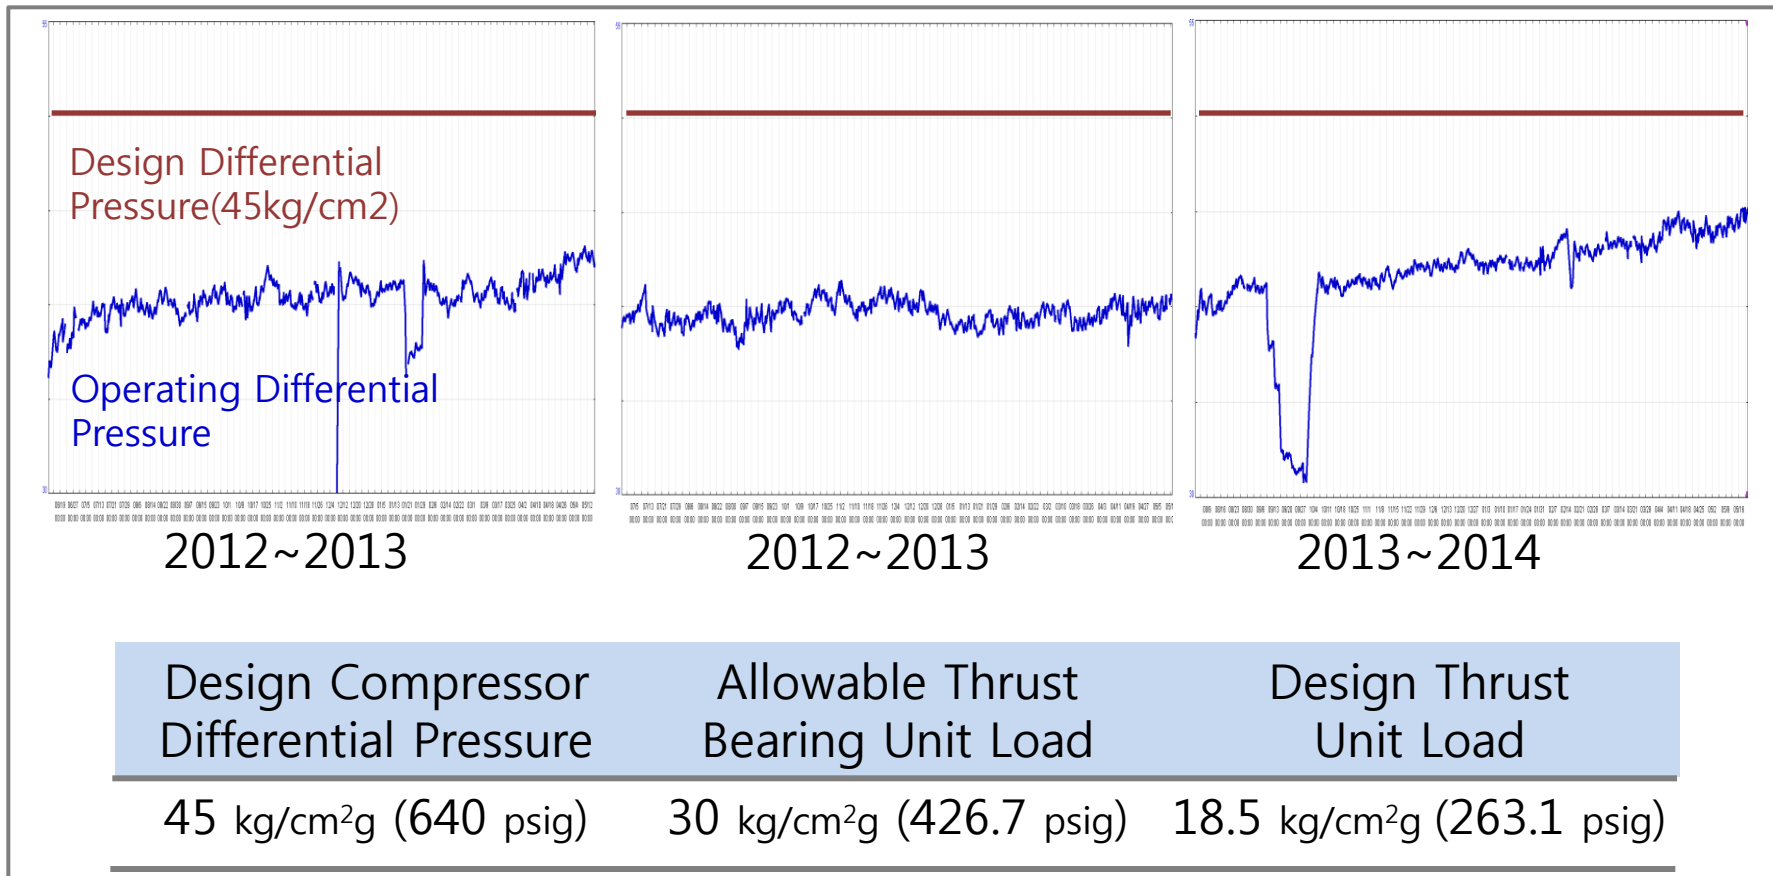
① Excessive Differential Pressure

The actual operating differential pressure of compressor was maintained under design differential pressure and design thrust load at design differential pressure is much lower than allowable thrust load on bearing.

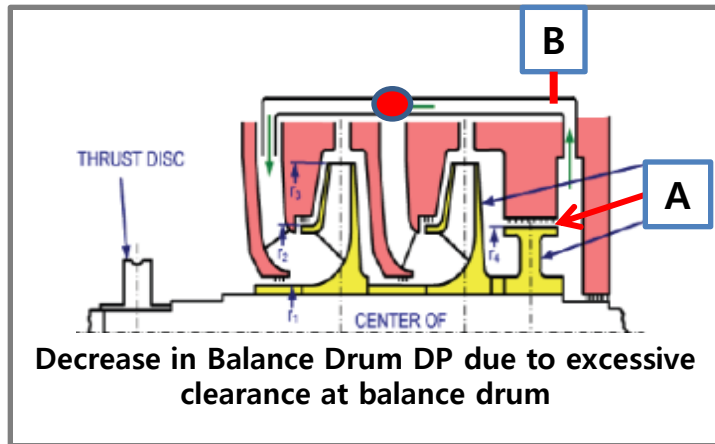
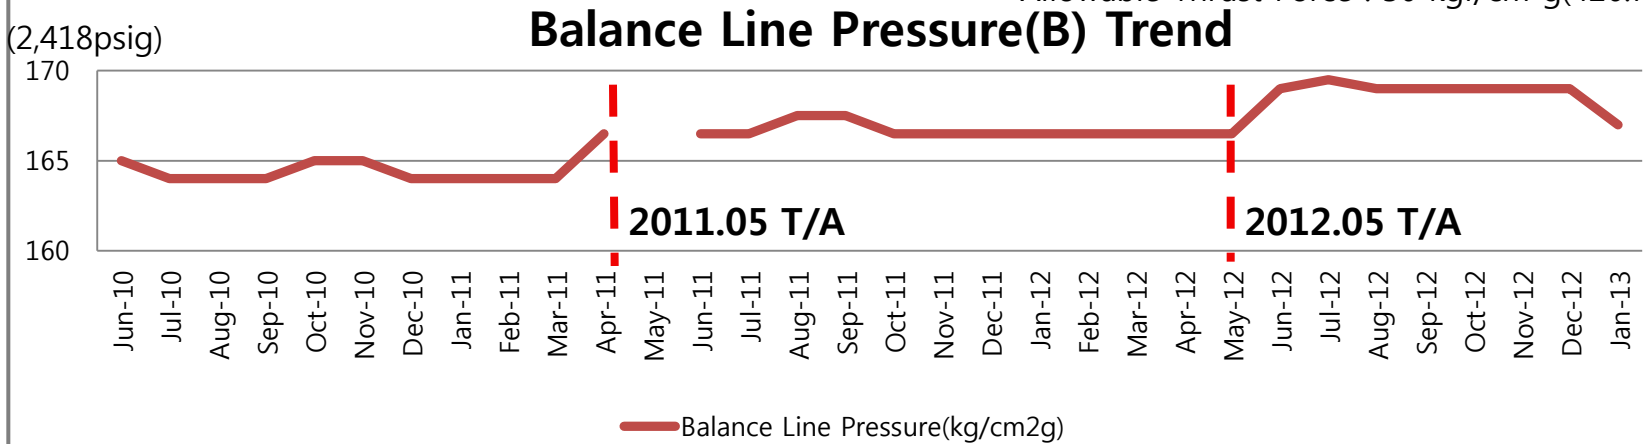
② Insufficient Balance Force

The balance drum labyrinth clearance had been increased above design clearance. Excessive clearance could cause higher balance chamber pressure which in turn negatively affected the balance force.

Balance Drum Labyrinth Clearance(mm(in)) "A"	*Thrust Force (kgf/cm ² g(psig))
Design	0.5 (0.0197)	3 (42.67)
2004	0.43 (0.0178)	-4 (-56.9)
2007	0.53 (0.0209)	5 (71.1)
2011	0.8 (0.0315)	14 (199.1)

* Allowable Thrust Force : 30 kgf/cm²g(426.7psig)

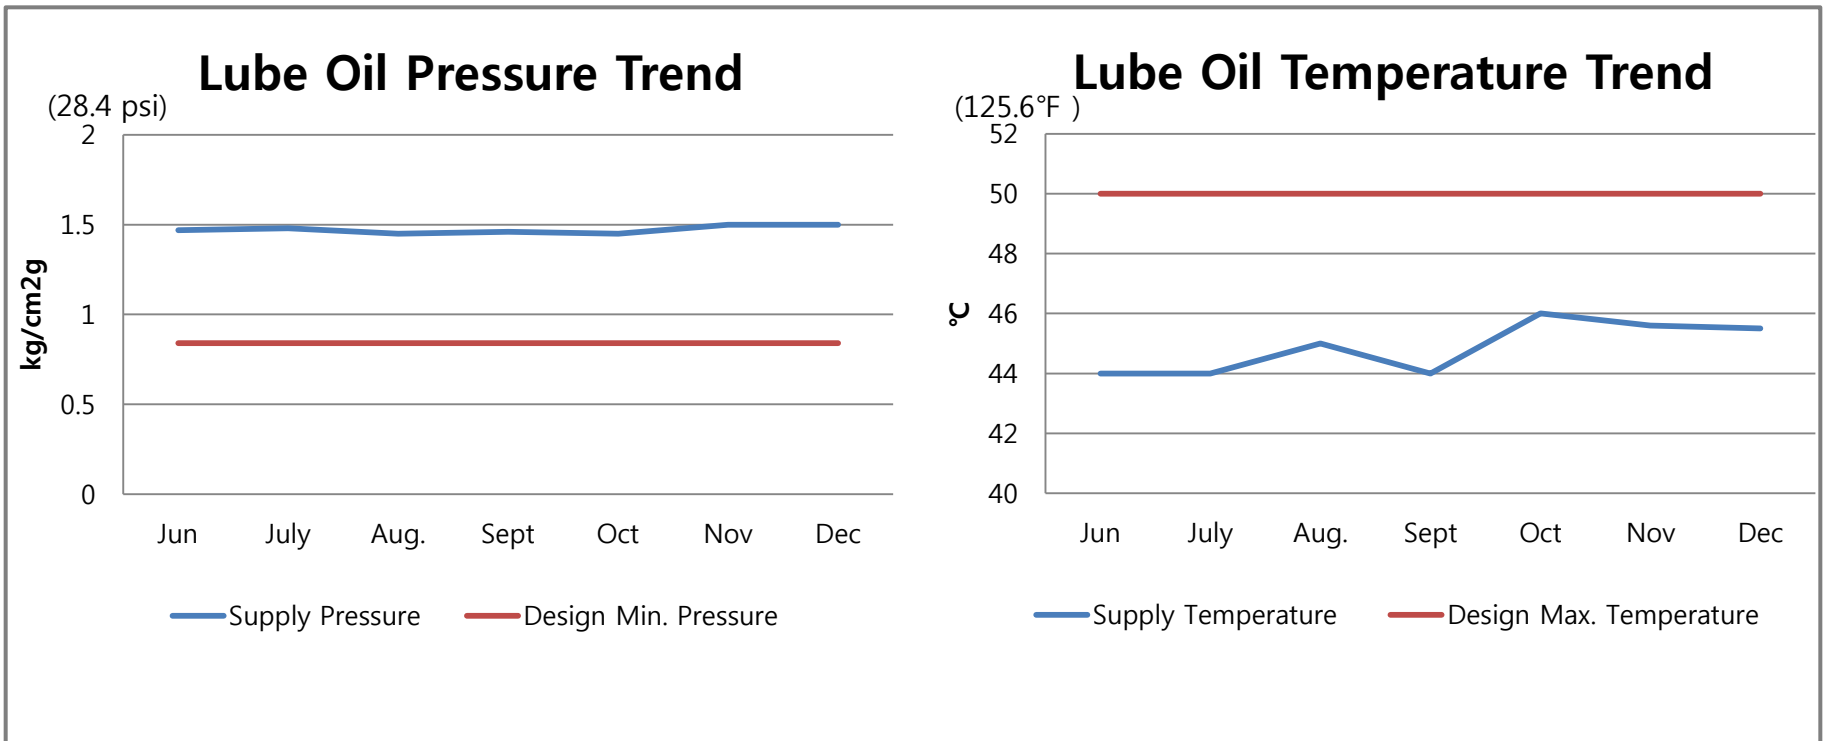
③ Low Oil Pressure(Flow)

④ High Oil Supply Temperature

The lube oil pressure was maintained higher than design min. pressure which result in enough flow being supplied. Lube oil supply temperature was maintained lower than design max. temperature which mean lube oil temperature **didn't affect high bearing temperature directly.**

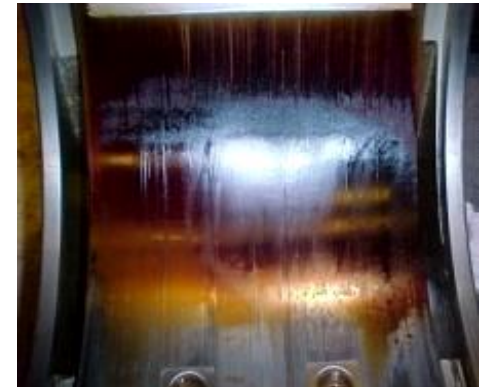
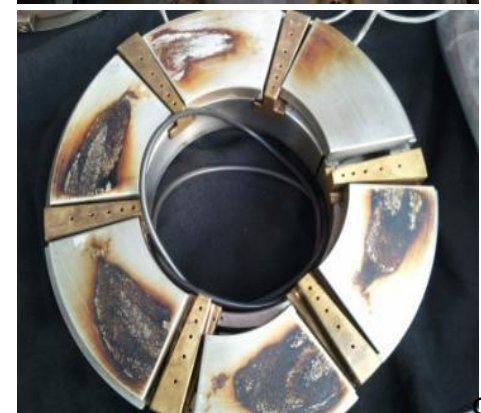
⑤ Varnish on bearing Pad

MPC Test Result (21.37) was a little bit higher than normal value(15). Varnish could be one of possible causes for bearing temperature increase due to lower cooling effect.

Varnish is a general term for **by-product of oil degradation**.

High temperature, contact with oxygen and entrained foreign material accelerate oil degradation

- Disturb formation of uniform oil film
- Low heat conductivity
- Increase Friction
- Form additional varnish

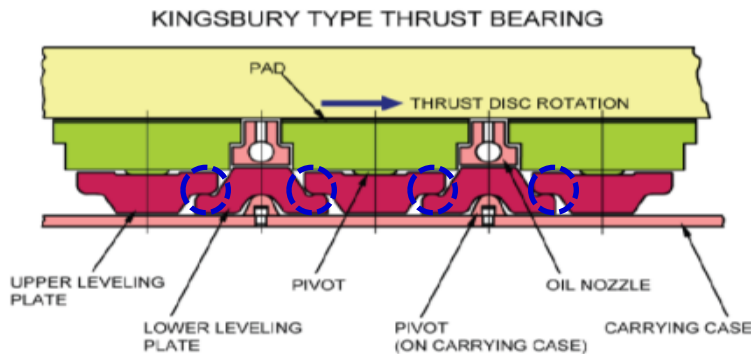
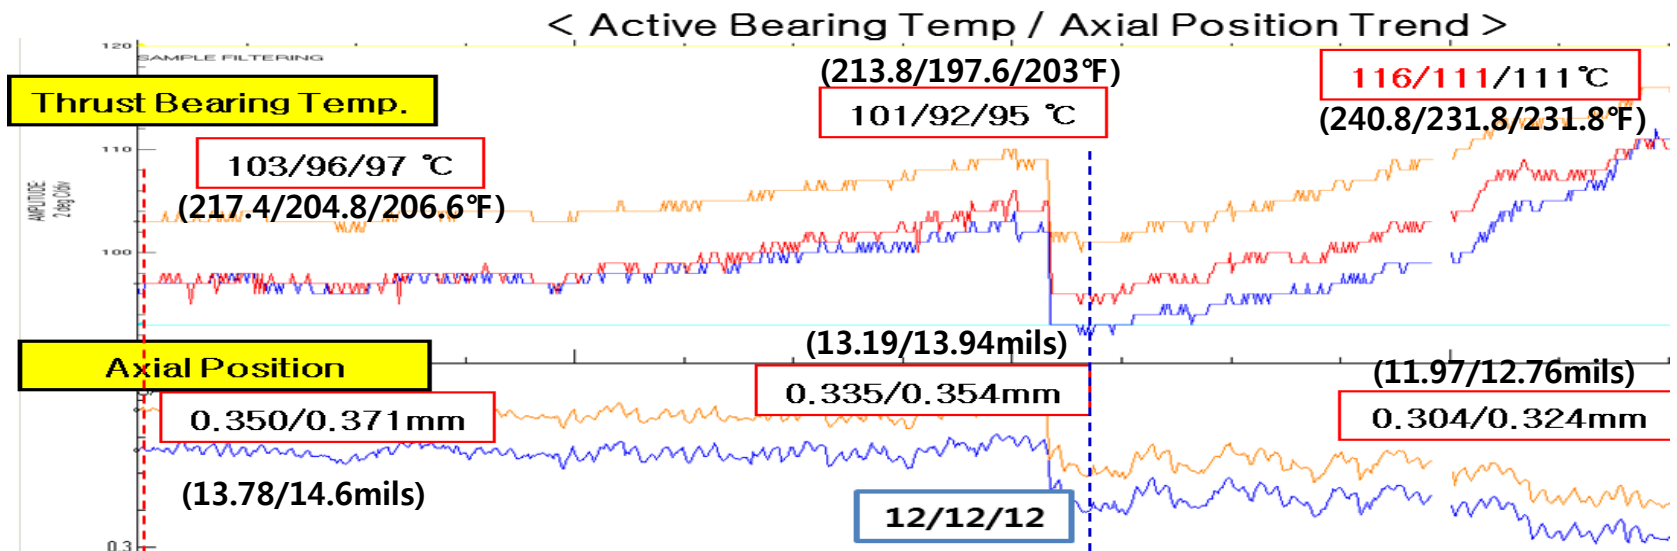
⑥ Thrust bearing leveling plate malfunction

Sticking of leveling plate could cause uneven load distribution to all bearing pads. The temperature of bearing pads which the load is concentrated on could increase abnormally.

Deviation btw temp sensors was High
110/99°C(230/210.2°F) → 102/100°C (215.6/212°F)
ΔT 11°C(19.8°F) → 2°C (3.6°F)

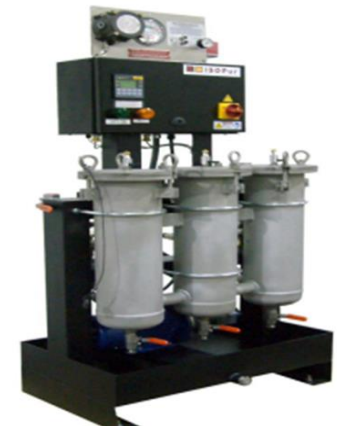
(2) Install varnish purifier to improve the oil quality and remove varnish

MPC had been gradually improved after varnish purifier was installed. The increase rate of bearing temperature was mitigated and finally went down

Sampling date	Install Varnish Purifier						
	01/08	01/11	01/14	01/16	01/18	01/21	01/23
MPC	21.37	18.6	15.79	13.6	13.3	12.43	10.51

- Remove tiny varnish particles(<4 micron),
- Remove varnish attached in piping, reservoir and bearings

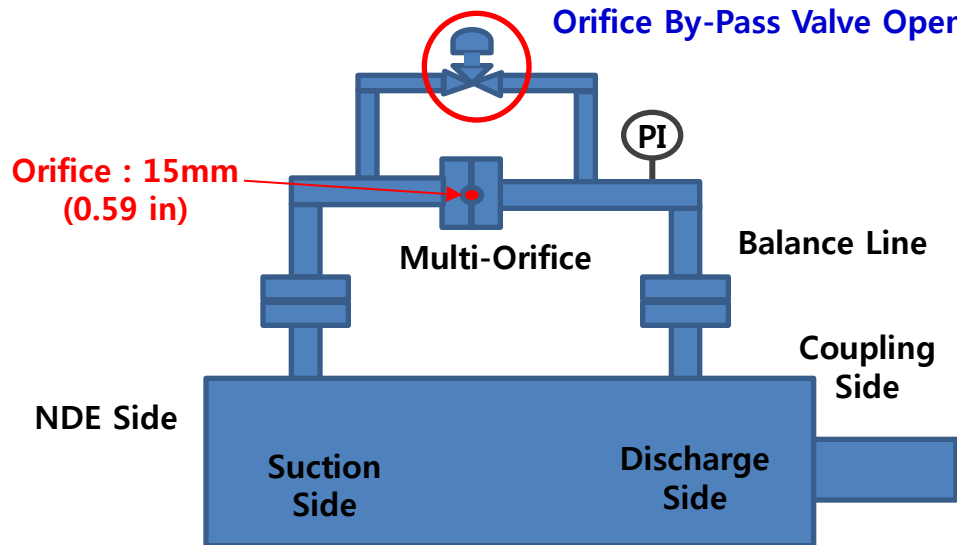
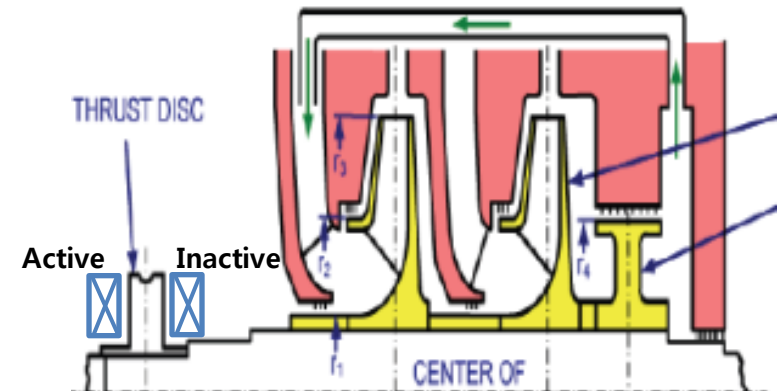
1st Adjustment

<i>Balance Line Pressure (kg/cm²g (psig))</i>	<i>Thrust Position (mm (mils))</i>	<i>Active Thrust Bearing (°C (°F))</i>
<i>Before Valve Open</i>	169 (2,403.8)	0.367/0.347 (14.45/13.66)	109/104 (228.2/219.2)
<i>After Valve Open</i>	167 (2,375.3)	0.348/0.329 (13.70/12.95)	101/96 (213.8/204.8)

Balance Line Bypass Valve Opened to reduce balance chamber pressure

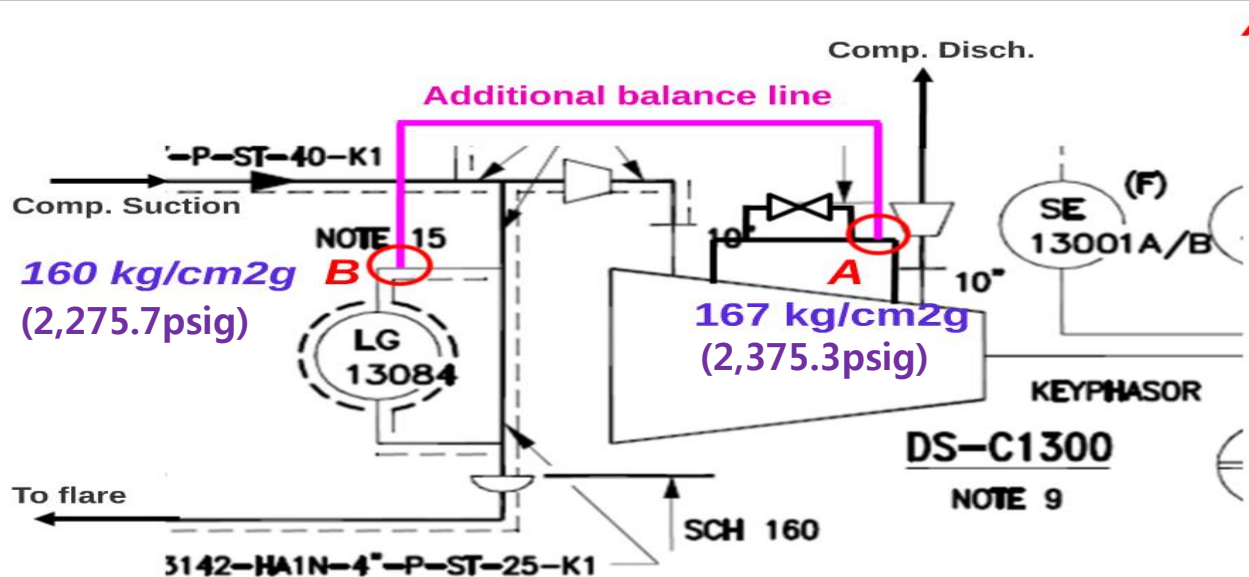
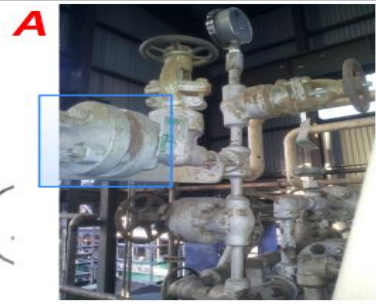
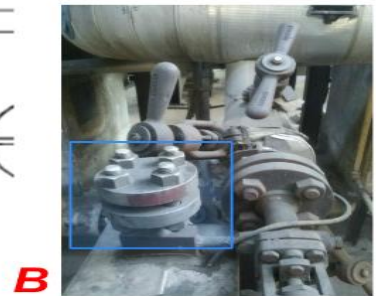
2nd Adjustment

<i>Balance Line Pressure (kg/cm²g (psig))</i>	<i>Thrust Position (mm (mils))</i>	<i>Active Thrust Bearing (°C (°F))</i>
<i>Before Service</i>	167 (2,375.3)	0.295/0.314 (11.61/12.36)	116/106 (240.8/222.8)
<i>After Service</i>	165.5 (2,354.0)	0.293/0.312 (11.54/12.28)	115/105 (239/221)

Connect balance line to suction line to reduce the pressure of balance chamber

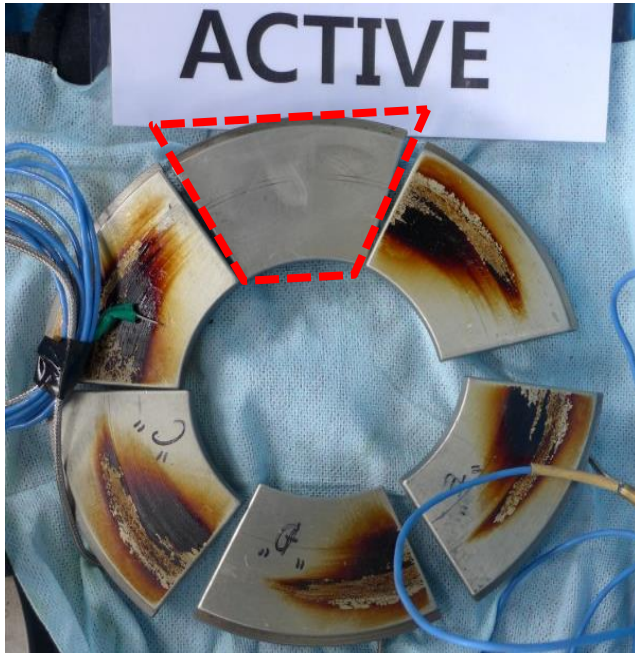
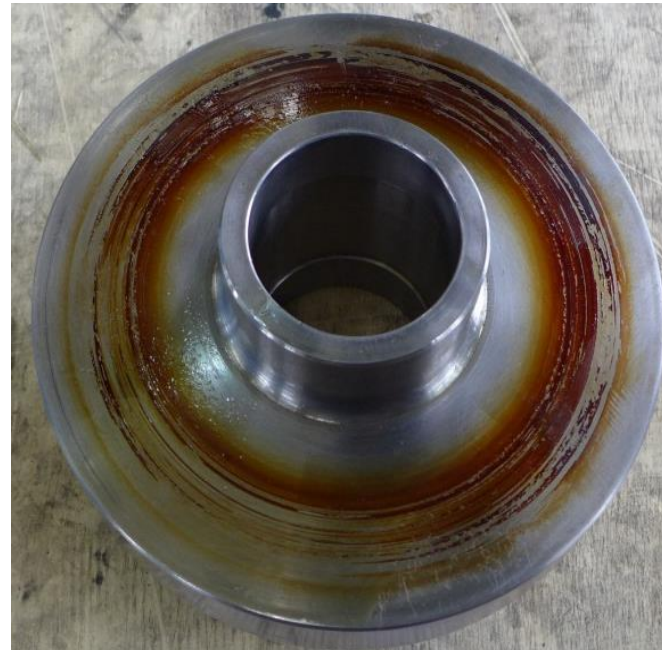
※ `2013 T/A Overhaul Results

- Ⓐ Varnish Formation on Bearing pads and thrust collar
- Ⓑ Uneven Load Distribution on each pad

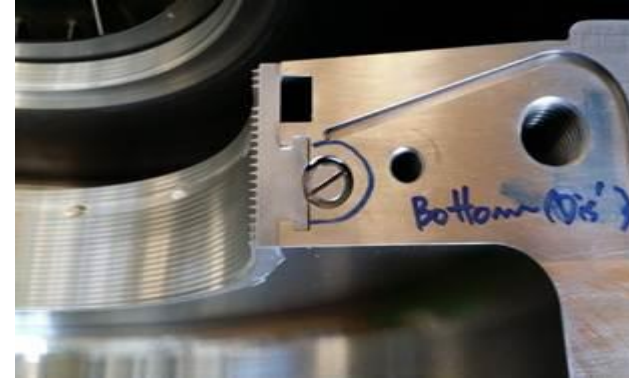
(4) Replace Balance Drum Labyrinth)

- Ⓒ Balance drum labyrinth clearance was enlarged

2012 T/A (mm(in))	2013 T/A(mm(in))
Left	0.37 (0.01457)	0.42 (0.01654)
Right	0.43 (0.01693)	0.48 (0.01890)
Total	0.80 (0.03150)	0.90 (0.03544)

Before (mm(in))	After(mm(in))
Left	0.42 (0.01654)	0.20 (0.00787)
Right	0.48 (0.01890)	0.27 (0.01063)
Total	0.90 (0.03544)	0.47 (0.0185)
