**43<sup>rd</sup> Turbomachinery & 30<sup>th</sup> Pump Users Symposia (Pump & Turbo 2014)**  
**September 23-25, 2014 | Houston, TX | [pumpturbo.tamu.edu](http://pumpturbo.tamu.edu)**

**REPETITIVE SHAFT CRACK FAILURE ANALYSIS  
 ON A MULTISTAGE CENTRIFUGAL PUMP IN REACTOR CHARGE SERVICE  
 IN A NUCLEAR POWER PLANT - BASED ON ODS AND FEA**

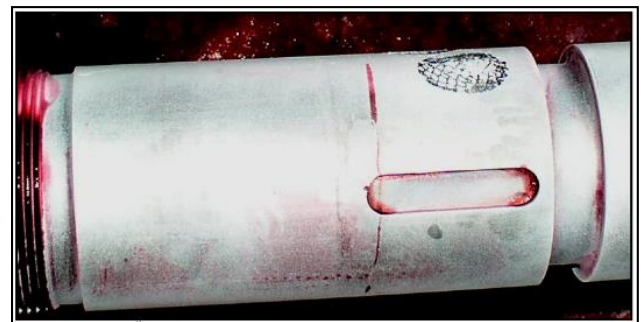
Figure 4. Detail of 11<sup>th</sup> Impeller Area with Circumferential Crack by Color-Contrast LPT. Redmond, 2008, Duke Power "Evaluation of CNS 1B NV Pump Shaft and Related Components – Metallurgy File #3917".

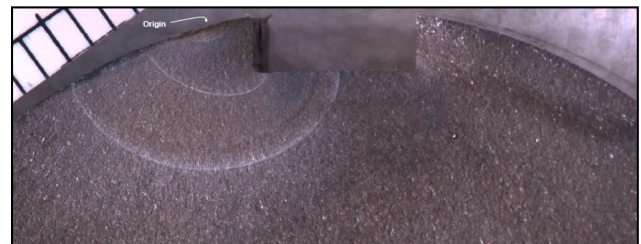
Figure 5. Fracture Overview Showing the Origin and the Crack Propagation. Redmond, 2008, Duke Power "Evaluation of CNS 1B NV Pump Shaft and Related Components – Metallurgy File #3917".

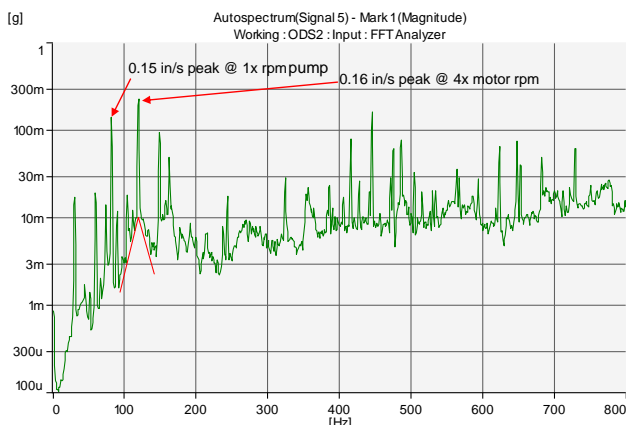
During normal operation of the 1B NV pump at 145 gpm (32.9 m<sup>3</sup>/h) or (85 gpm [19.3 m<sup>3</sup>/h] + 60 gpm [13.6 m<sup>3</sup>/h] of min-flow) the pump indicated a relatively low vibration level of 0.15 in/s pk (3.8 mm/s pk) at the running speed of the pump or 81 Hz measured at the OBB housing in the vertical direction as can be seen in the vibration spectrum in Figure 15. Notice the broadband peak indicating a structural natural frequency of the OBB housing at approximately 120 Hz.

Figure 15. 1B NV Pump Vibration Spectrum at the OBB in the Vertical Direction (g's versus Frequency in Hz)

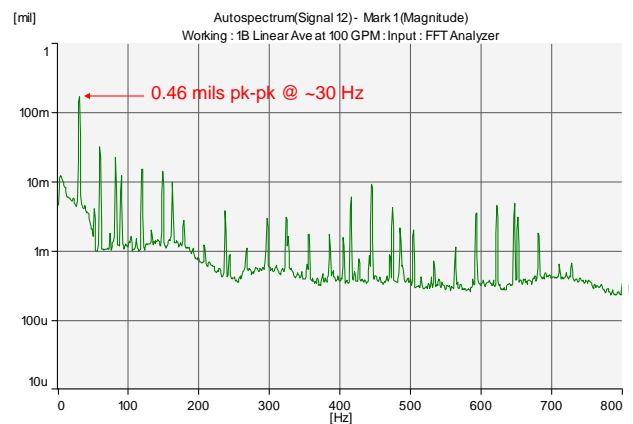
The axial proximity probe installed at the OBB of the 1B NV pump indicated an interesting narrow band peak at approximately 30 Hz, which represented the running speed of the motor. The amplitude of this spike was measured to be almost 0.5 mils pk-pk (12.7 microns pk-pk). Figures 17 and 18 show the FFT and the time waveform plots from the axial probe, respectively. CNP had reported that the axial motion of this pump had been detected as high as 1.7 mils (43.2 microns) pk-pk, while the other three charge pumps only showed mostly displacement at the running speed of the pump (81 Hz) likely due primarily to mechanical axial run-out of the target plate of the probe.

Figure 17. 1B NV Pump Axial Proximity Probe Vibration Spectrum (mils rms versus Frequency in Hz)

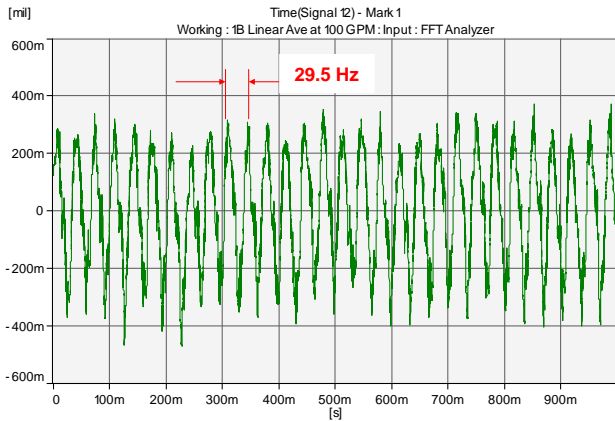
Figure 18. 1B NV Pump Axial Proximity Probe Vibration Waveform (mils versus Time in Seconds)

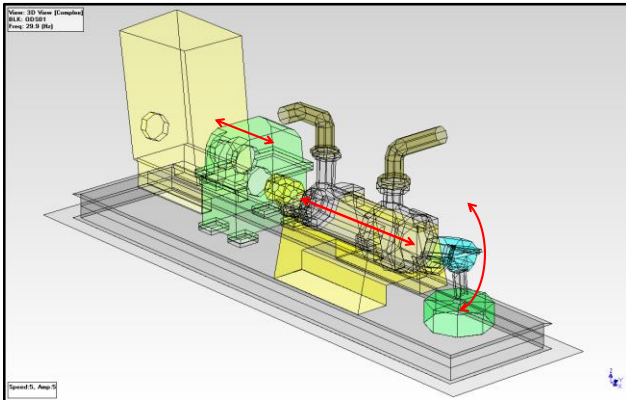
The ODS animation at 1x rpm of the motor (30 Hz), which is shown in Figure 23, indicated relatively high axial motion of the pump shaft driving the vertical rocking motion of the OBB (in-phase motion). The gearbox also shows axial rocking motion in phase with the pump shaft motion. At the running speed of the pump (81 Hz), the animation shown in Figure 24 indicated an orbiting motion of the OBB along with a typical radial motion of the pump shaft, while the rest of the unit remained stationary.

Figure 23. 1B NV Pump ODS at 1x rpm of the Motor (30 Hz)

- The gearbox on 1B NV pump was recommended to be refurbished by replacing the gear set. In addition, was suggested to verify the actual axial run-out of the output shaft by turning the input shaft. This action was accomplished in 2010 and it was found that the axial run-out of the output shaft was measured to be approximately 7 mils (178 microns).

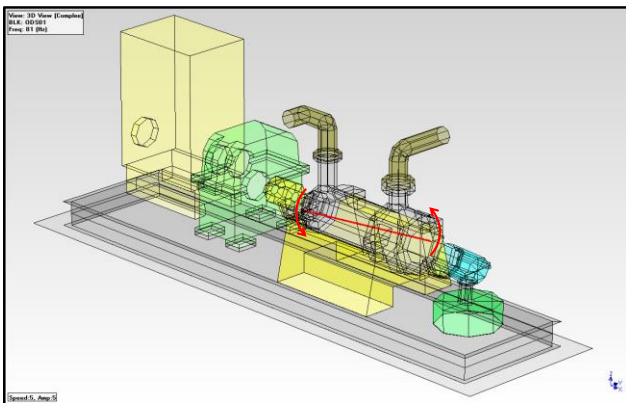
Figure 24. 1B NV Pump ODS at 1x rpm of the Pump (81 Hz)

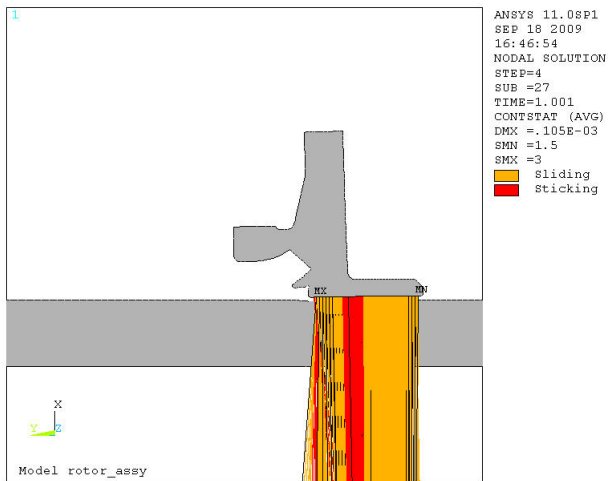
Based on the transient dynamic analysis it revealed that acoustic wave propagation in the shaft was able to result in micro-motion at the press fit interfaces. Therefore, the idealized axi-symmetric model of the pump shaft and the last stage impeller predicted that a momentary sliding condition exists between the impeller and the shaft. This sliding condition led to fretting damage and crack initiation. Figure 30 shows a contact status plot between the impeller hub and the shaft at load step 4. Red zones indicate sticking and orange areas means sliding status. Therefore, most of the contact area indicated sliding effect under 30 g's (294.2 m/s<sup>2</sup>) pseudo-static loading of "jerk" effect.

Figure 30 Contact Status Plot at Load Step 4

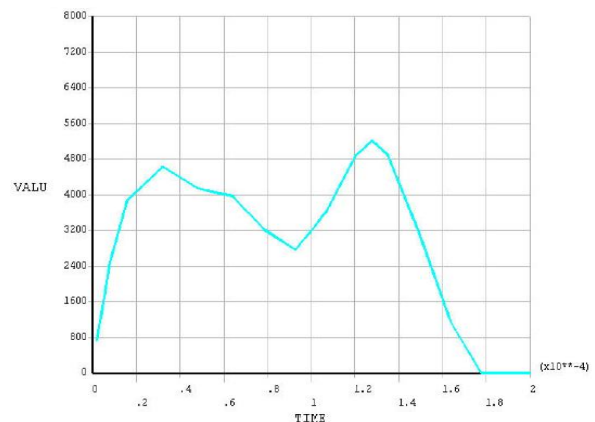
Figure 33 shows von Mises stress plot (psi) calculated by the FEA program at the root of the crack during the impact event (“jerk” effect). Note that the double peak observed is due to flexing of the impeller and later spring-back response. The stress distribution (von Mises) in the vicinity of the crack (psi) is shown in Figure 34.

Figure 33 von Mises Stress Plot (psi) at Root of Crack

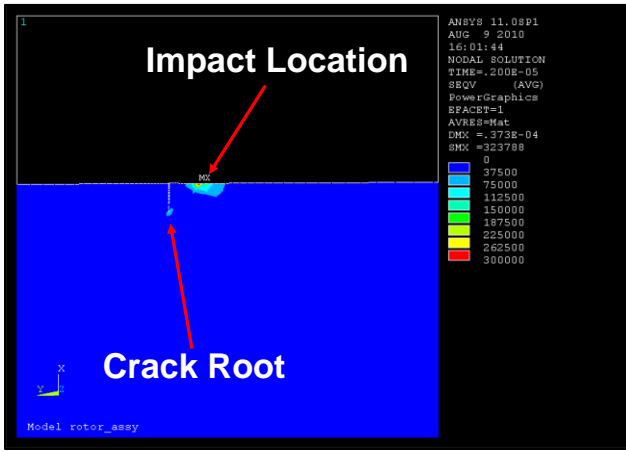
The stress-intensity factor ( $\Delta K_I$ ) was calculated to be 16.3 ksi $\sqrt{\text{in}}$  (17.9 MPa $\sqrt{\text{m}}$ ). Based on the experimental crack-growth rate graph of a similar material (Figure 35) in water at 2400 cpm, the calculated stress-intensity-factor intersected the curve beyond the threshold point. Therefore, crack propagation was expected to occur.

Figure 34 von Mises Stress Contour Plot (psi) in the Vicinity of the Crack
