**43rd Turbomachinery
30th Pump SYMPOSIA**

**DRIVE SHAFT FAILURE ANALYSIS ON A MULTISTAGE VERTICAL TURBINE
PUMP IN RIVER WATER SUPPLY SERVICE IN A NICKEL AND COBALT MINE IN
MADAGASCAR - BASED ON ODS AND FEA**

Juan Gamarra
Mechanical Solutions, Inc.

Paul Behnke
ITT Industries, Industrial Process

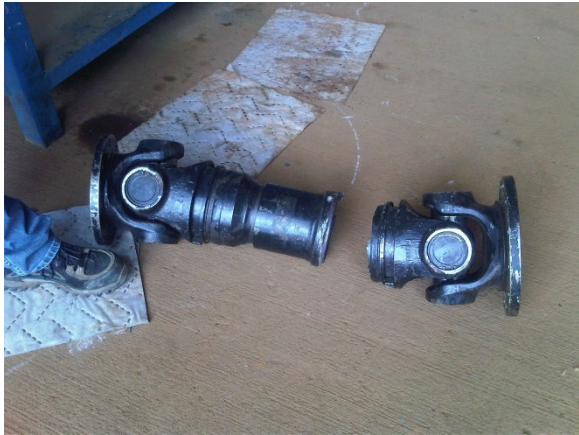
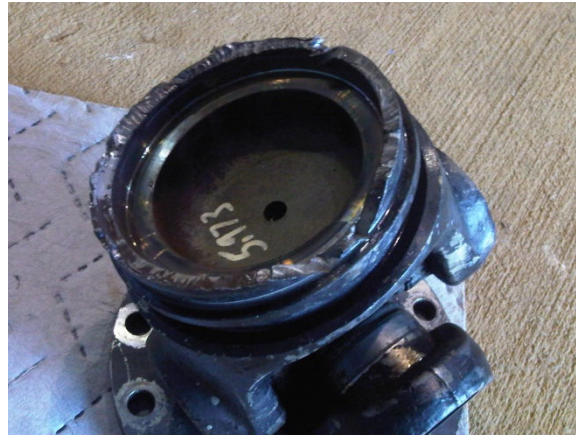
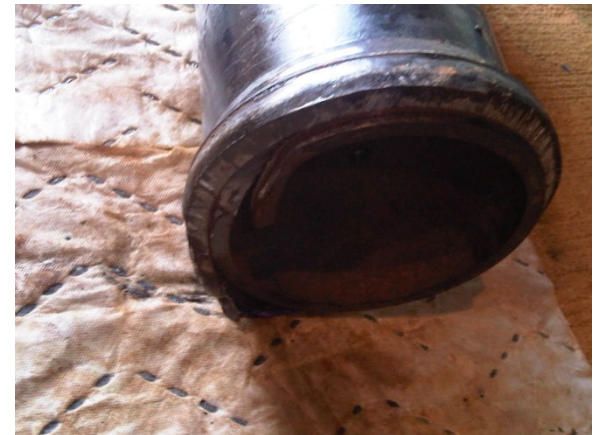
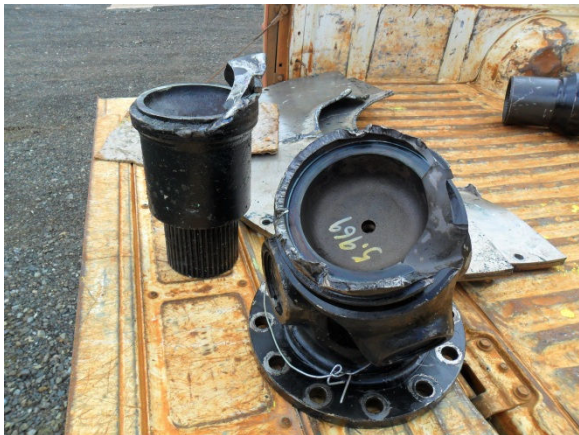
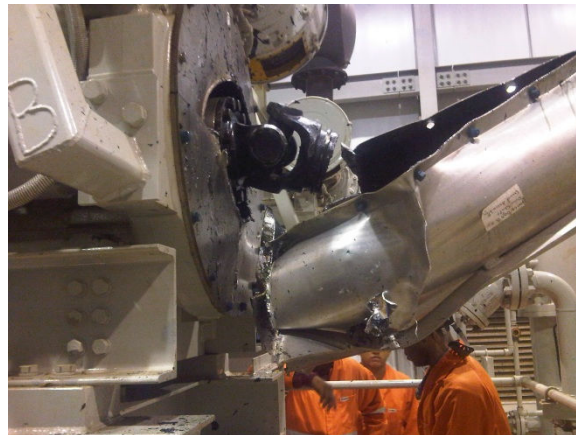
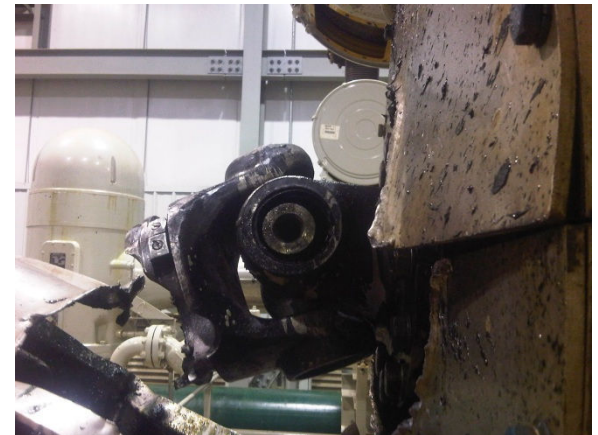
Photos Drive Shaft Failures

Failures located at the male end weld (same location each incident) at the engine-side of the assembly.

If the weld on the driveshaft did not penetrate to the inner diameter of the welded components in the region near the weld, this would create a geometry that is basically a crack around the circumference of the shaft. This creates a high stress concentration at the inner edge of the weld. Such a circumstance can be quantitatively evaluated with Linear Elastic Fracture Mechanics (LEFM).

1. The failure mechanism of the drive shaft was caused by the elevated axial and torsional oscillation loads in combination with the jammed driveshaft spline.
2. The situation became severe because an axial (horizontal parallel to the crankshaft) pump natural frequency and torsional shaft assembly natural frequency were simultaneously in resonance with an unexpectedly high 1.5x running speed harmonic, which appeared due to a poorly tuned engine (resulting in a 1/2x rpm fundamental and its harmonics).
3. The 2nd torsional natural frequency of the drive shaft was determined to be at 42.0 Hz (Pump C). The separation margin from 1.5x running speed is within 5% from both the pump and engine speed.
4. The torsional oscillation was observed to be as high as 94% zero-to-peak of the mean torque value.

5. The measured axial force oscillation imposed on the drive shaft peaked at 11,000 lbf pk-pk.
6. Since the weld on the driveshaft did not penetrate to the inner diameter of the material the region near the weld, this created effectively a crack around the circumference of the shaft. This resulted in a high stress concentration at the edge of the weld. The peak oscillating membrane plus bending stress amplitude located at the region near the “crack” was calculated from the FEA model to be 3118 psi due to the observed alternating torque and axial loading.
7. For carbon steels, exceeding a critical stress intensity factor of 8,000-10,000 indicates the effective initiated crack length “a” has the ability to propagate under alternating load. This analysis calculated a stress intensity factor value of 11,040 which explained the failure from fatigue loading on the weld bead.

1. The engine was re-tuned due to the observed mis-firing, since it was providing unusually strong torque impulses or "shocks" at the rate of $1/2x$ RPM, which caused strong frequency harmonics. This left no place to "park" the system natural frequencies to avoid resonance.
2. A torque shock absorbing coupling between the engine and the drive shaft was implemented. The entire drive shaft and coupling assembly was replaced including the u-joints at each end.
3. The highest vibration level dropped from 24 mm/s pk at the gearbox horizontal measurement location near the input shaft to 7.8 mm/s pk after change to a flexible coupling. Failures ceased.

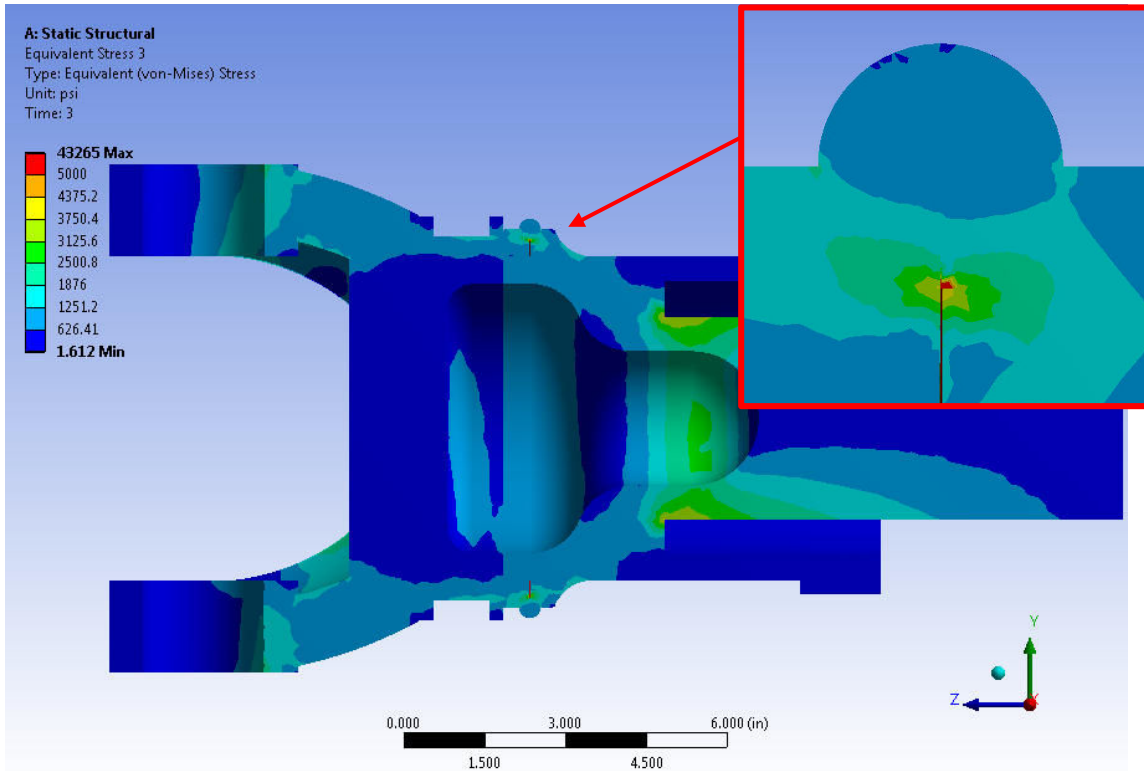
Finite Element Analysis

Stress Linearization Through Weld Bead

Results	
<input type="checkbox"/> Membrane	1407.2 psi
<input type="checkbox"/> Bending (Inside)	1739. psi
<input type="checkbox"/> Bending (Outside)	1739. psi
<input type="checkbox"/> Membrane+Bending (Inside)	3118.1 psi
<input type="checkbox"/> Membrane+Bending (Center)	1407.2 psi
<input type="checkbox"/> Membrane+Bending (Outside)	535. psi

The peak membrane plus bending stress located at the region near the “crack” was calculated from the FEA model to be 3118 psi due to the observed alternating torque and axial loading.

For carbon steels, exceeding a critical stress intensity factor of about $10,000 \text{ psi(in)}^{0.5}$ indicates that the crack or material flaw of radial length “a” has the ability to propagate under alternating load. This analysis calculated a possible k_I value of 11,040 which indicates significant but “borderline” probability of failure from fatigue loading of the weld bead.

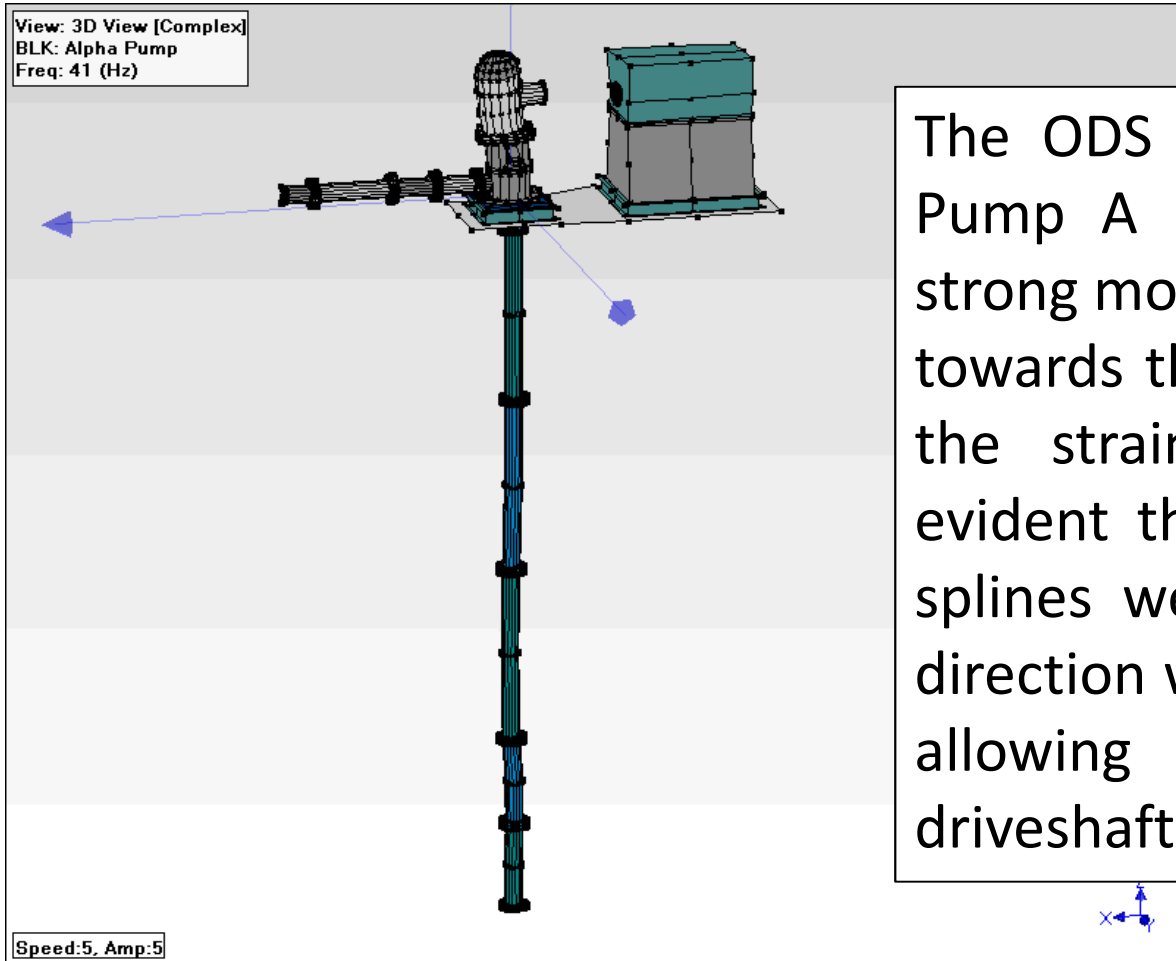
Computer Model Using ME'Scope Program Plotting ODS Test Results

The ODS animation at 41 Hz on Pump A (1.5x RPM) indicated a strong motion of the gearbox head towards the engine. According to the strain gauge data, it was evident that the drive shaft axial splines were binding in the axial direction when under torque load, allowing this mode to enable driveshaft failure.

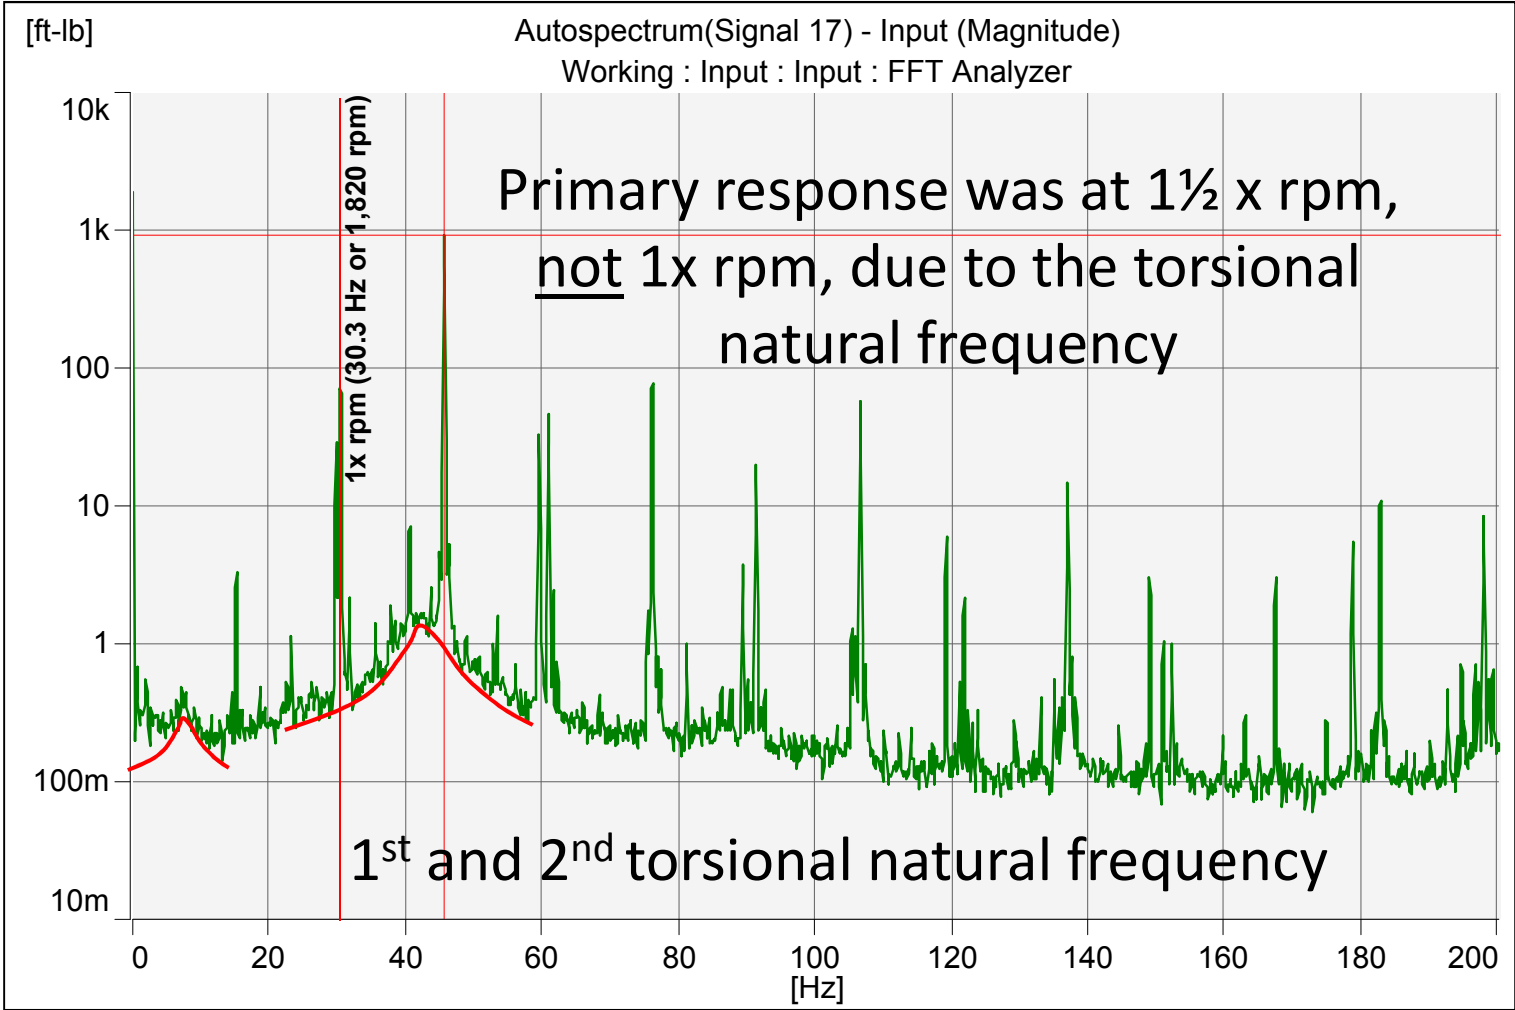
Strain Gage Test

Drive Shaft Torque Spectrum and Torsional Natural Frequencies
Natural frequencies at 7.25 Hz and 42 Hz.

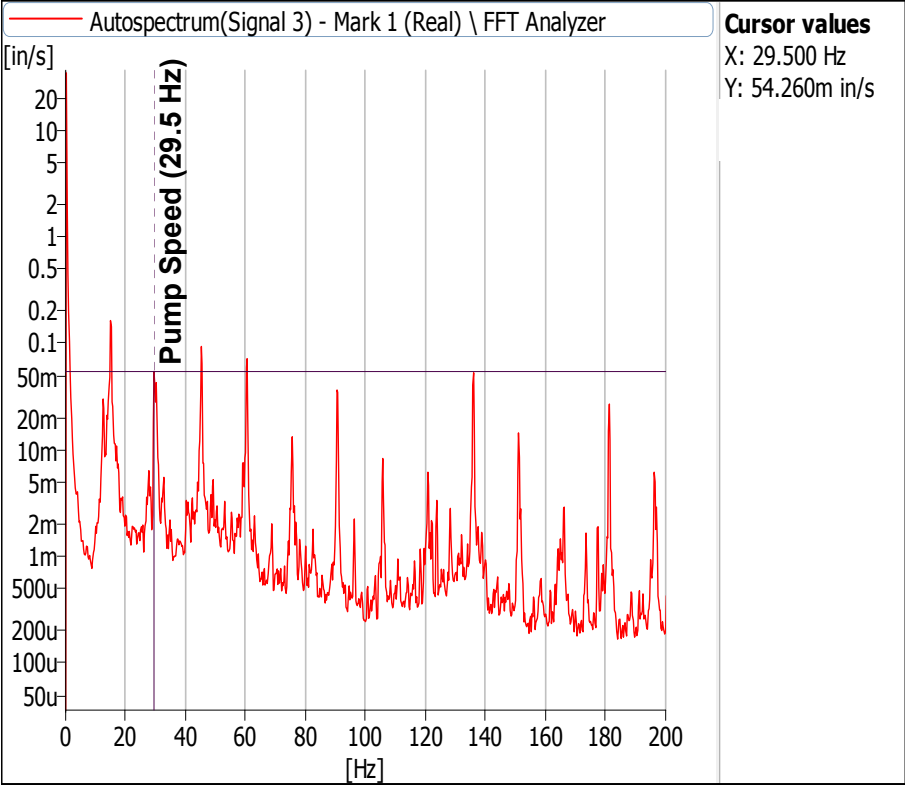
Gearbox Top,
Input Shaft End

Notice that the $\frac{1}{2} \times \text{rpm}$ harmonics appear in both the engine and gearbox.
