# The Effect of Foundation Piers on the Natural Frequencies of a Vertically Mounted Sewage Pump in Resonance with Vane Pass Excitations

27<sup>th</sup> International Pump Users Symposium

**Paul A. Boyadjis**

*Mechanical Solutions, Inc.*

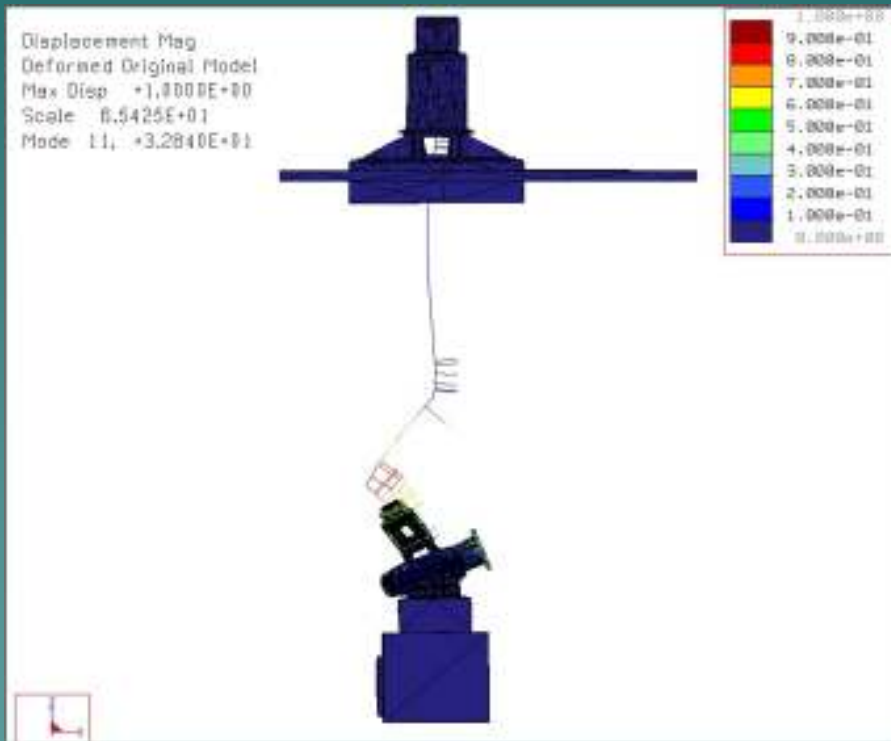
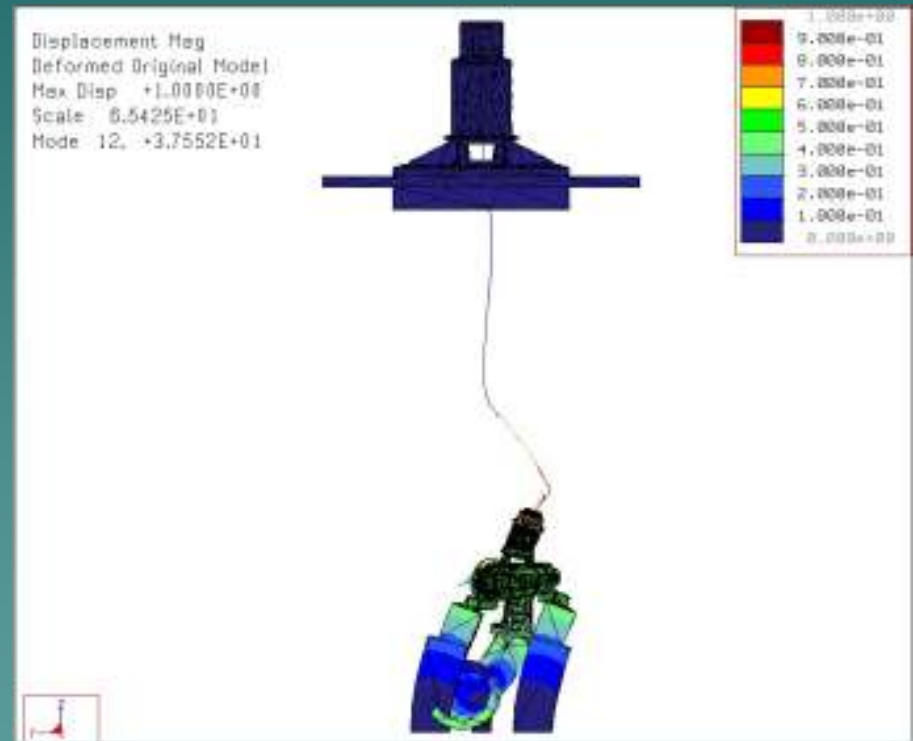
Figure 1

- ◆ Preliminary analysis found that the entire pump volute casing mounted on two 10 ft. high vertical concrete piers predicted rocking modes that fell within 4x running speed of the pump (36.8 Hz-39.7 Hz) and the  $\pm 20\%$  separation margin range of 29.4 Hz to 47.6 Hz

Casing Rocking Modes @ 32.8 Hz and 37.6 Hz

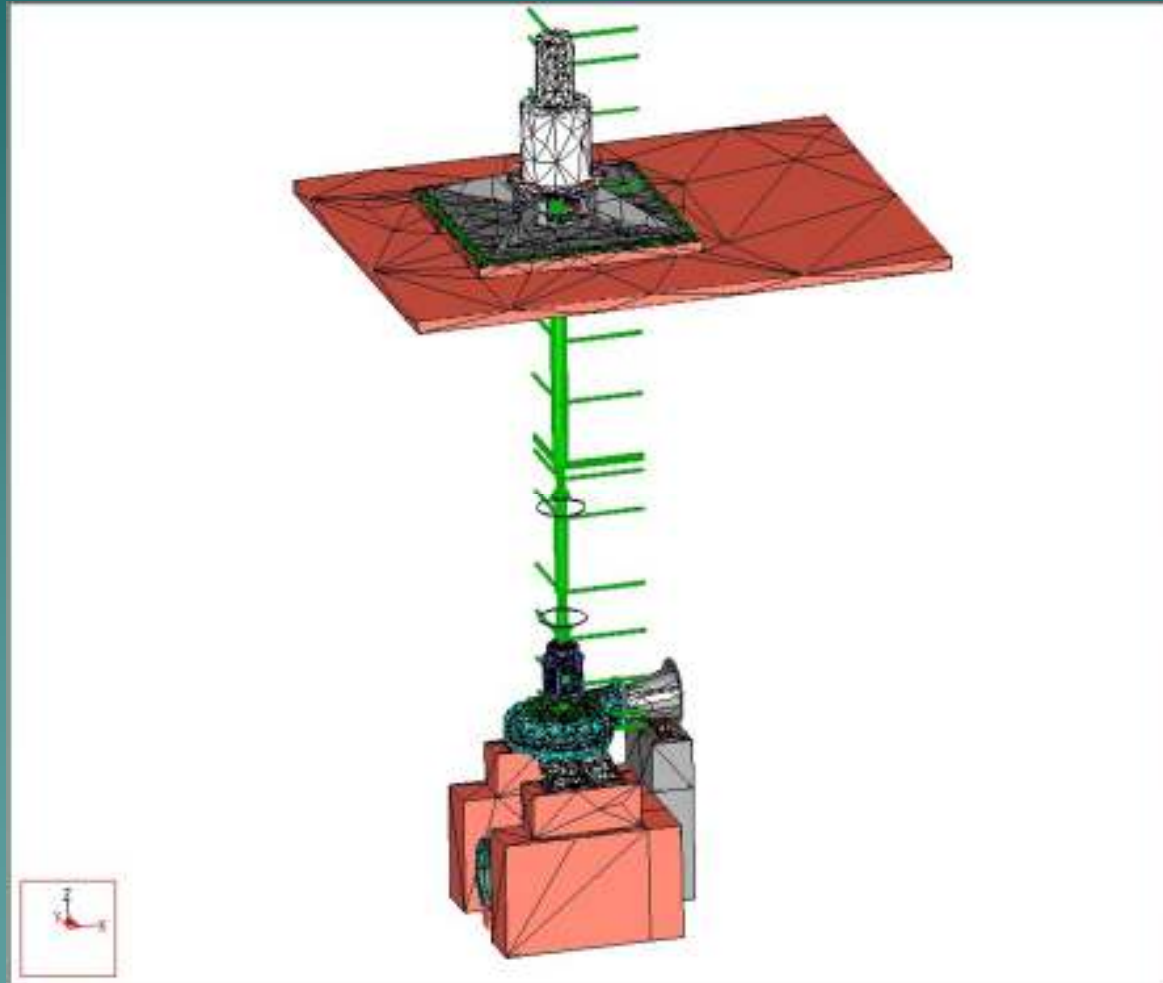
Figure 2

- ◆ Modifications to the model were made prior to the pump's installation which consisted of supports for the suction and discharge nozzles as well as joining the two vertical piers on the discharge side to form a horseshoe support. These modifications were predicted to raise the offending casing rocking mode natural frequencies to 20% above 4x running speed (vane pass) to  $\sim 48$  Hz.

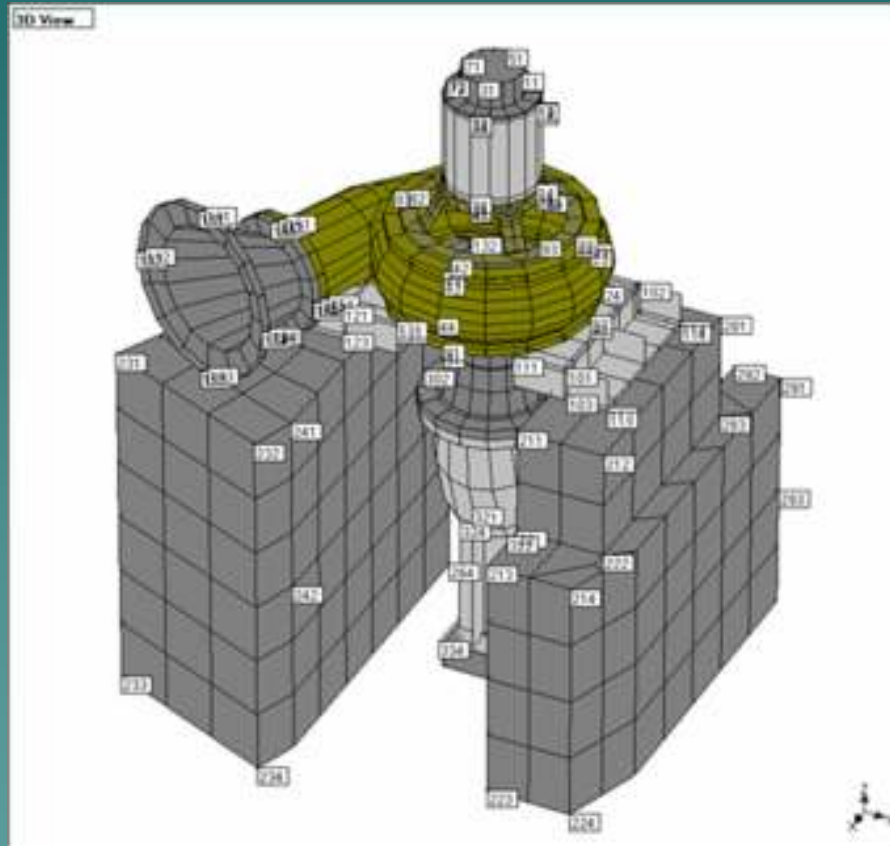
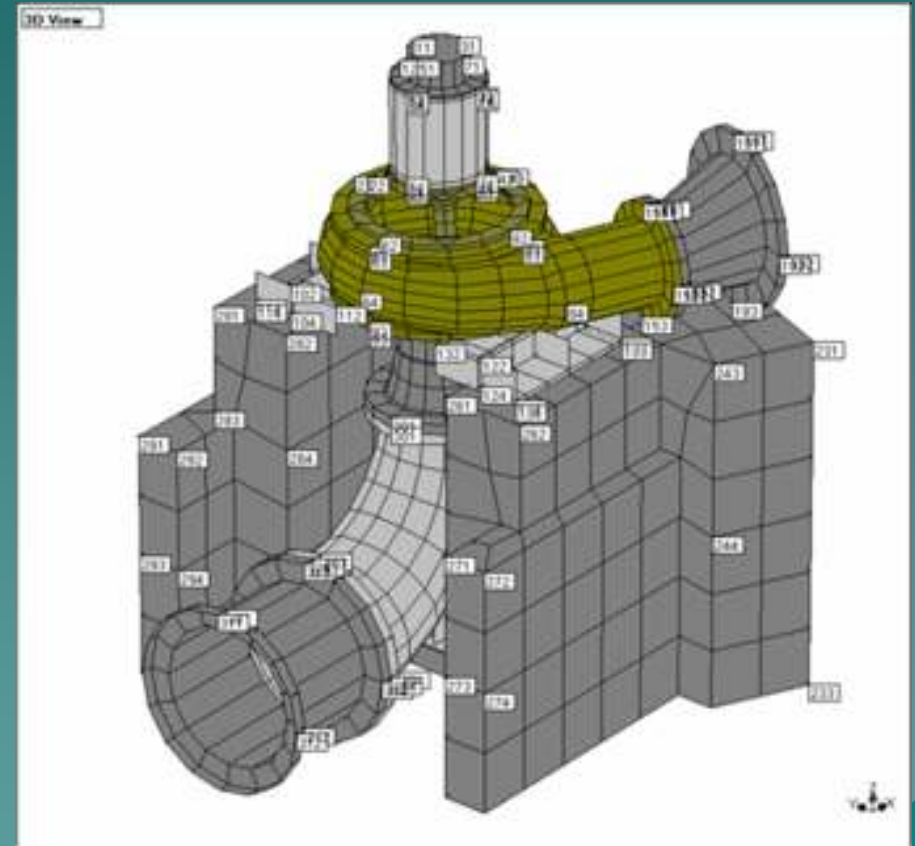
Figure 4

Over 500 vibration measurement/ direction using tri-axial accelerometers

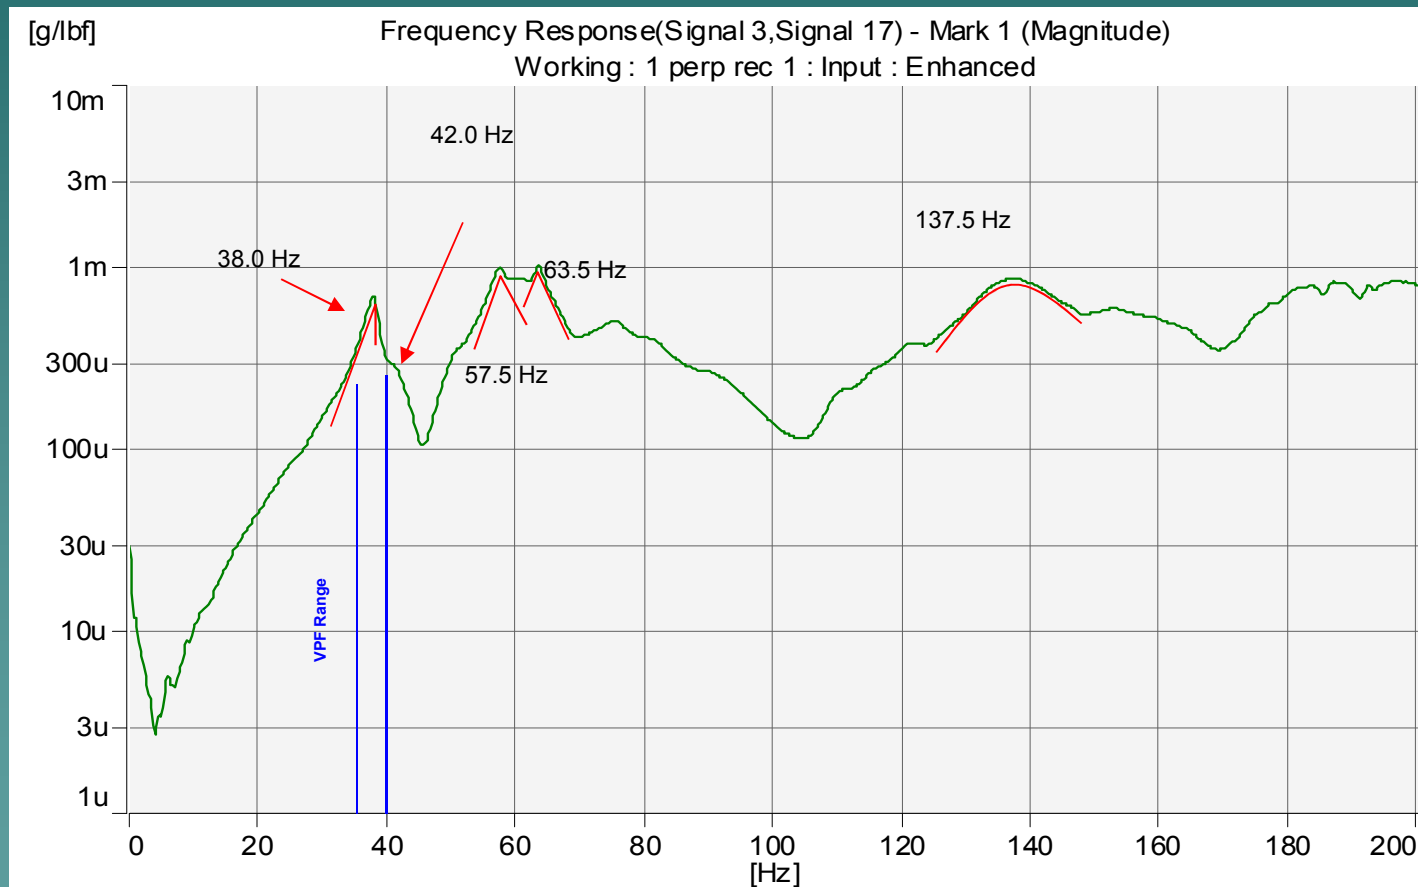
Figure 5

- ◆ When the pump was finally installed, high vibrations were being measured on the pump bearing tower of 0.6 in/s RMS at 4x running speed (vane pass). ***But Why? Hadn't the analysis provided guidance to avoid this???***
- ◆ The task now was to determine the source of the vibration via field trouble shooting methods and propose a suitable solution without costly trial and error field fixes using the existing FEA model.

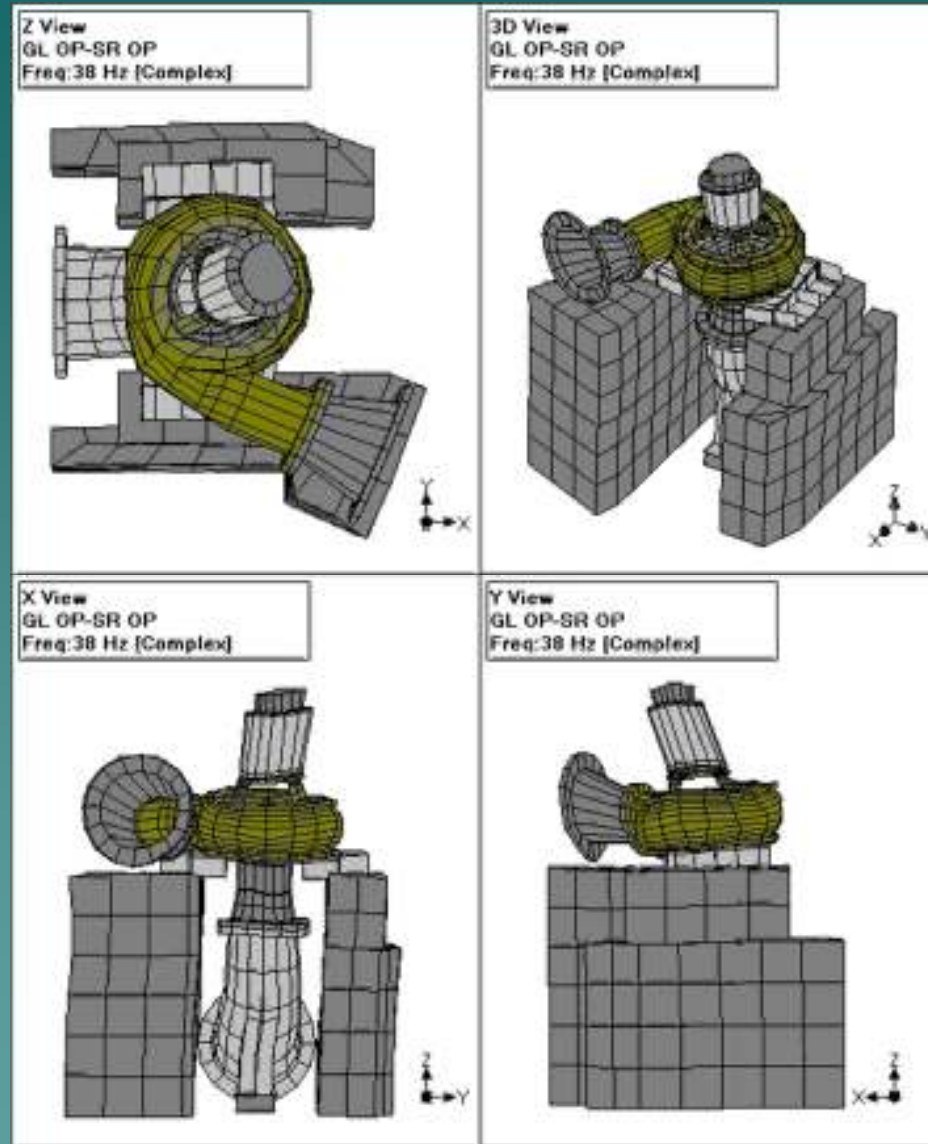
Figure 6

- ◆ Clearly the high vibration was due to the casing rocking natural frequency in the vane pass operating range at 38 Hz.
- ◆ Apparently due to access issues the two piers were never connected together, but this information was never communicated back for evaluation.
- ◆ Although the model had originally predicted modes interfering with vane pass, the discharge nozzle being supported should have raised the natural frequency to just outside of the operating range albeit not with sufficient separation margin.

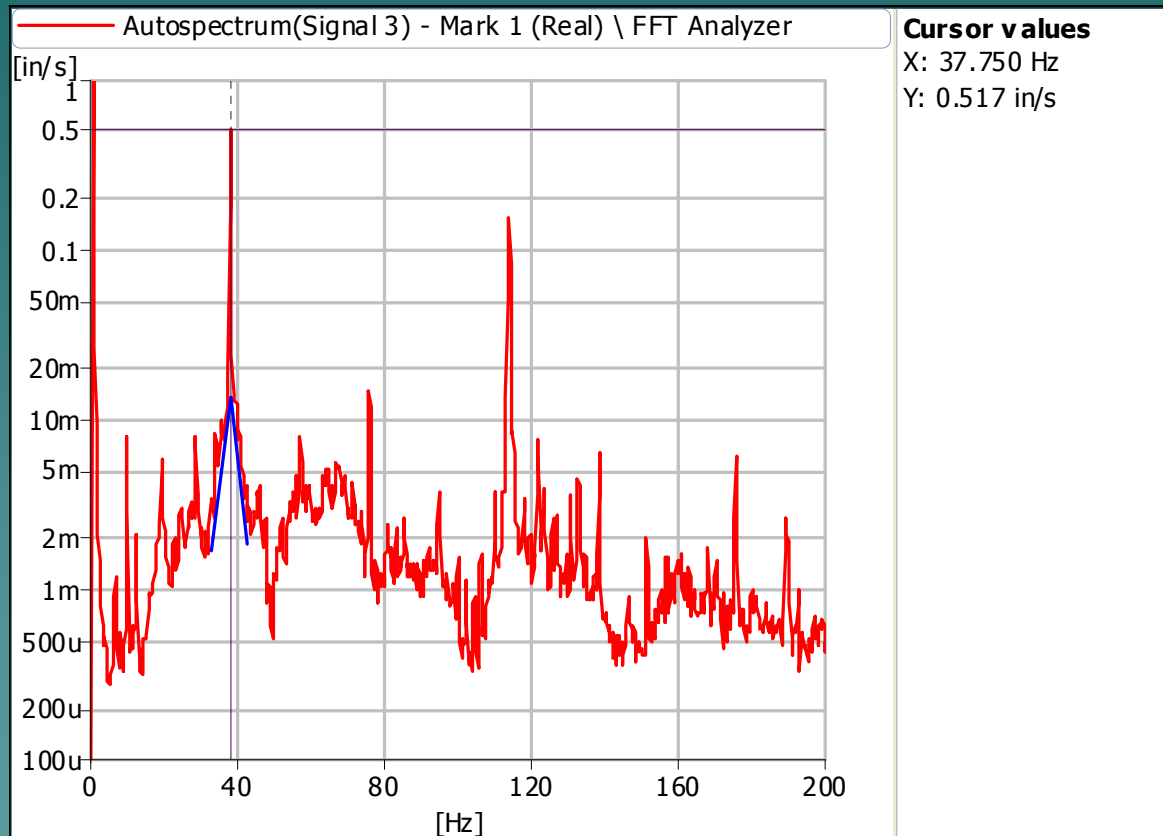
Figure 9

Spectrum measured at the top of the bearing tower in the parallel (top) direction to the discharge pipe while the pump was running at 570 rpm

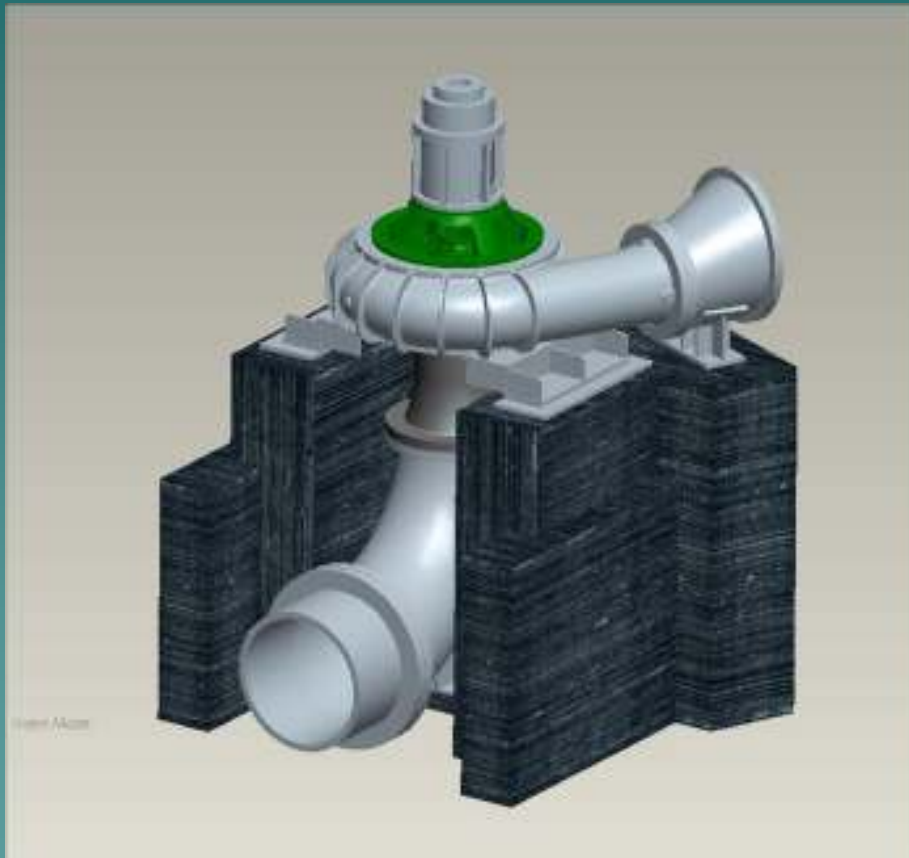
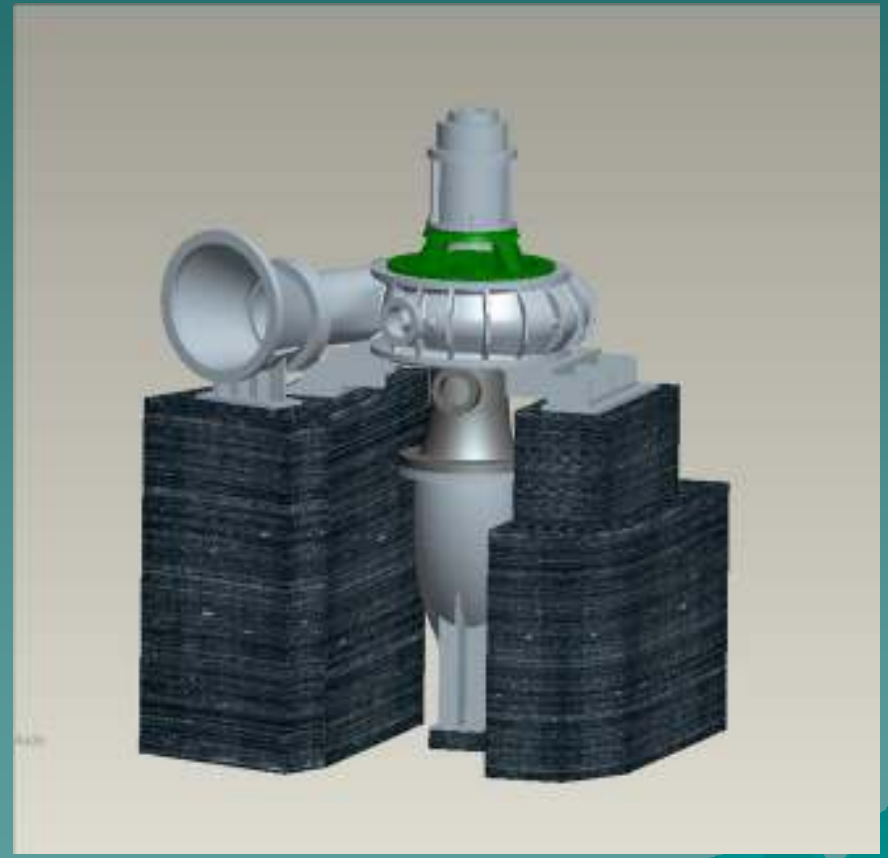
Figure 10

- ◆ The installed pump was mounted on two vertical piers that were not connected together as recommended.
- ◆ The suction inlet was not supported as recommended.
- ◆ The discharge was supported but its pier was mostly imbedded in one of the vertical piers.
- ◆ The pump discharge was rotated approximately 5 degrees.

- ◆ It was suspected that in addition to the obvious differences between what was analyzed and reality, there may have been soft foot conditions present.
- ◆ Thus, the previous finite element analysis needed to be updated to reflect the current pier configuration and casing orientation to establish a new baseline from which modifications could be evaluated.

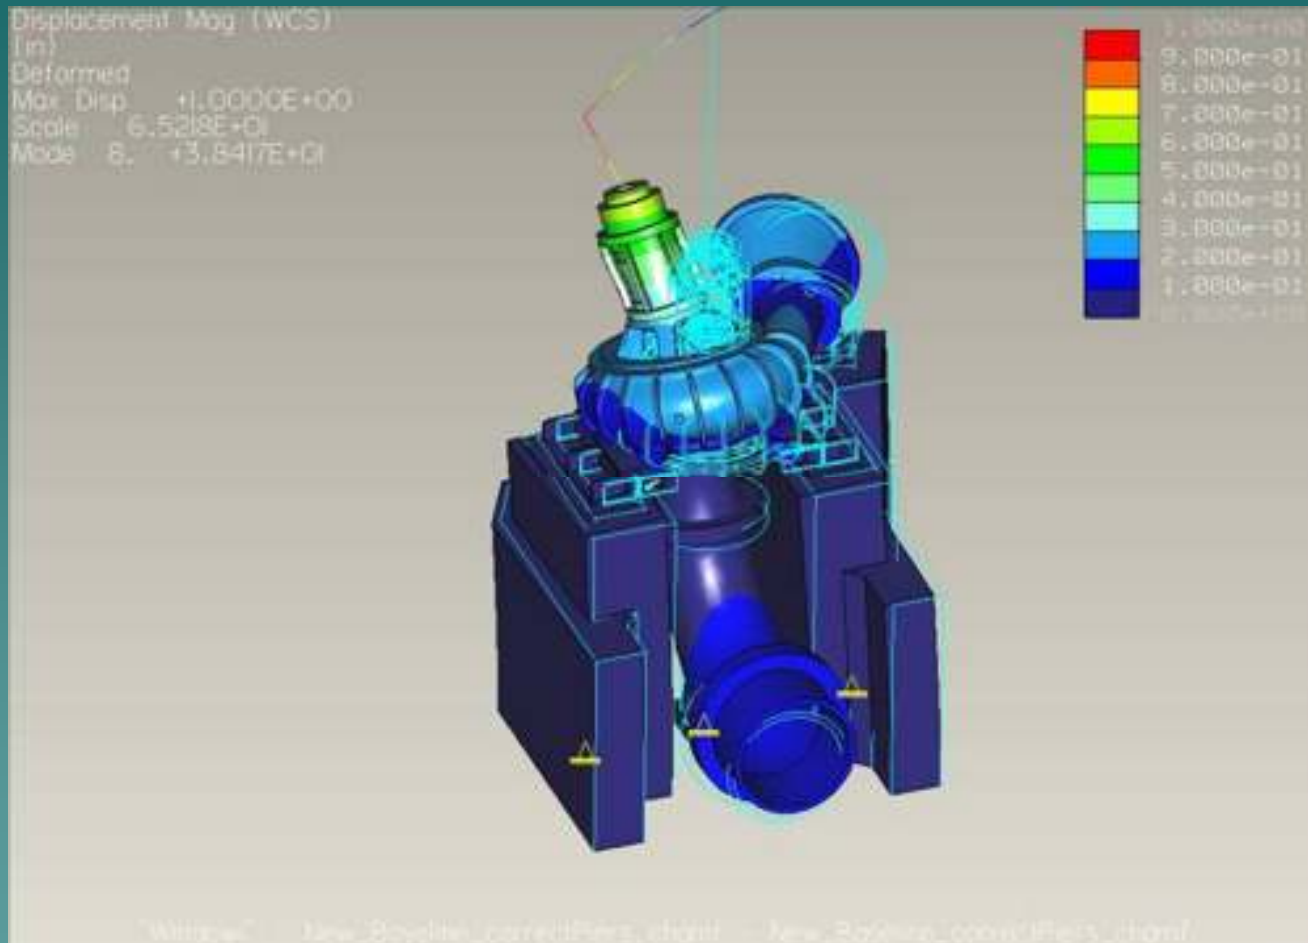
Figure 11

Baseline results with soft mounting at the pump support brackets – 38.4 Hz

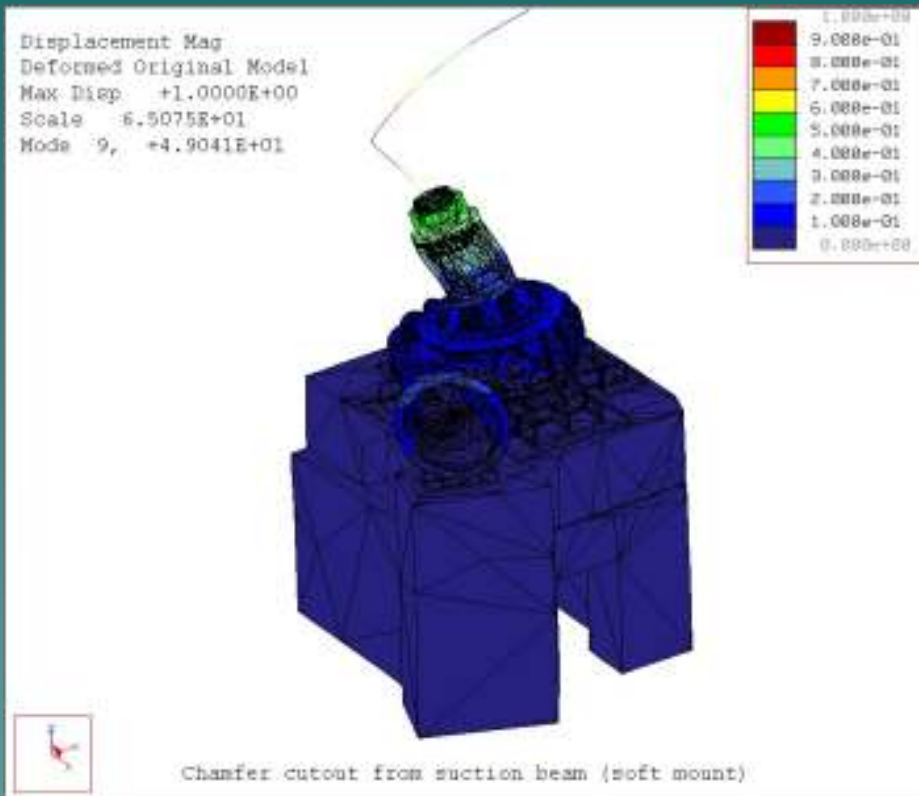
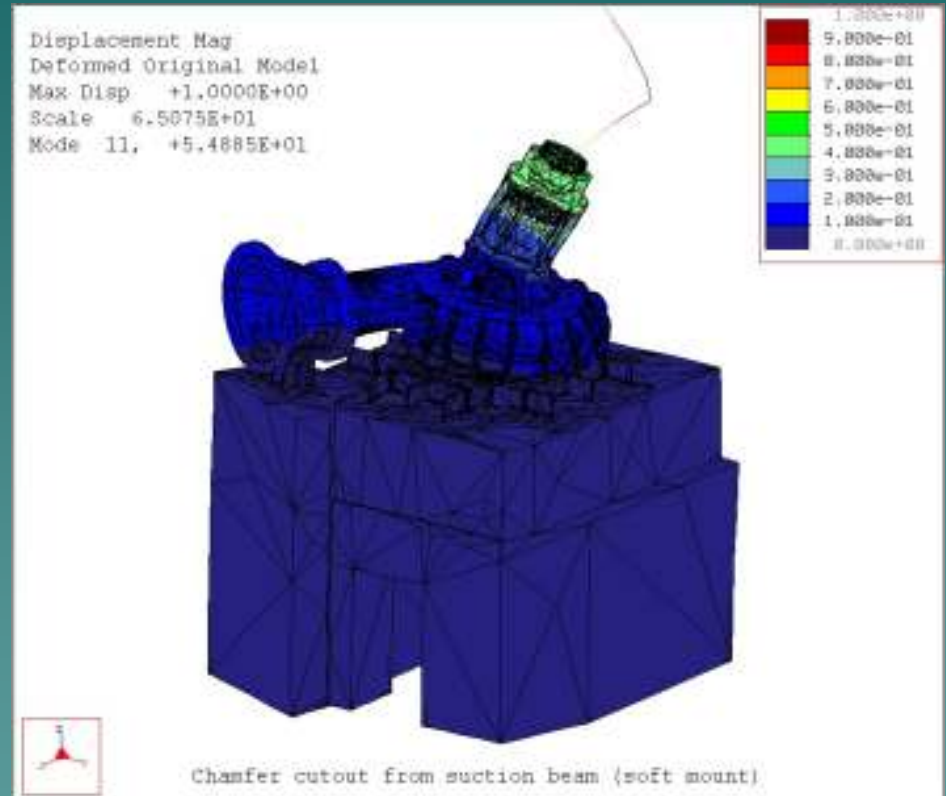
Figure 14

Mode 1 – 49.0 Hz

Mode 2 – 54.9 Hz

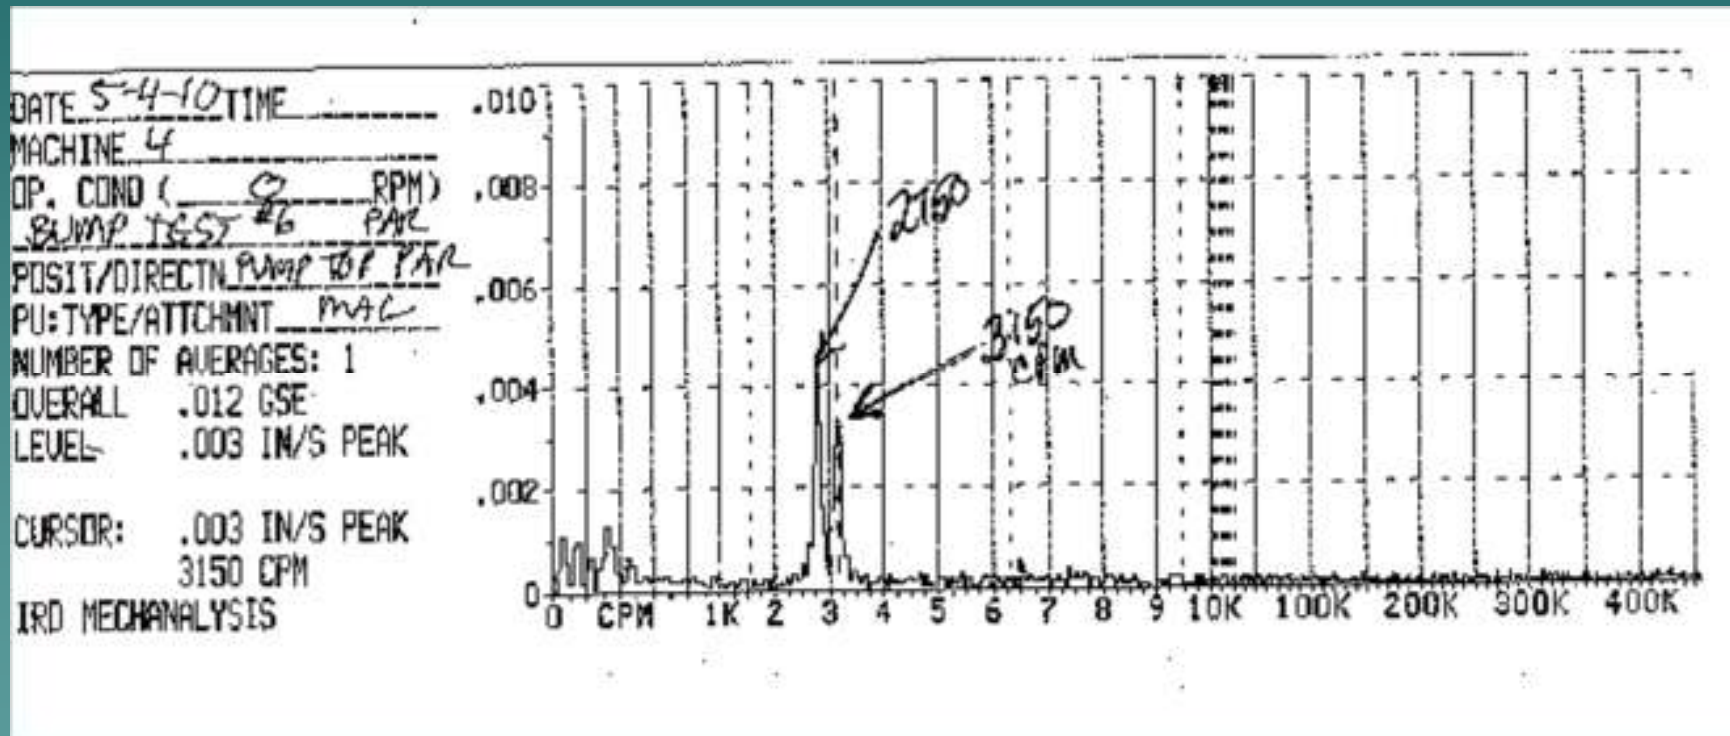
Figure 15

- ◆ After the recommended fixes were implemented, the vibration levels decreased from 0.6 in/s RMS to less than 0.2 in/s RMS at the bearing tower.
- ◆ Follow up field test by others showed that the frequencies that were at 38 Hz had shifted to 46Hz and 52.5Hz, close to analysis predictions.
