Diagnosing and Correcting a Damaging Below-Ground Column Natural Frequency in a Vertical Pump Using Field Testing and FEA

28th International Pump Users Symposium
September 24 - 27, 2012

Case Study

Paul A. Boyadjis & Maki M. Onari
Mechanical Solutions, Inc. – Whippany, NJ

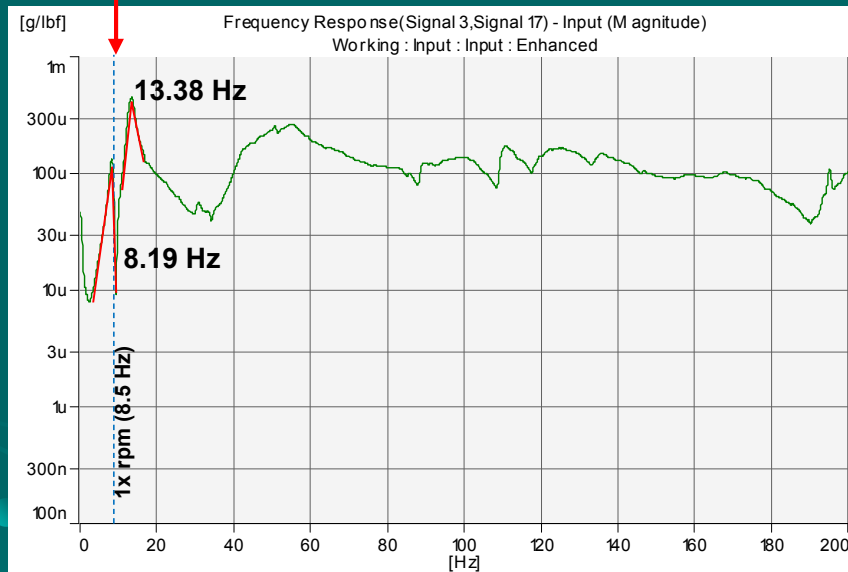
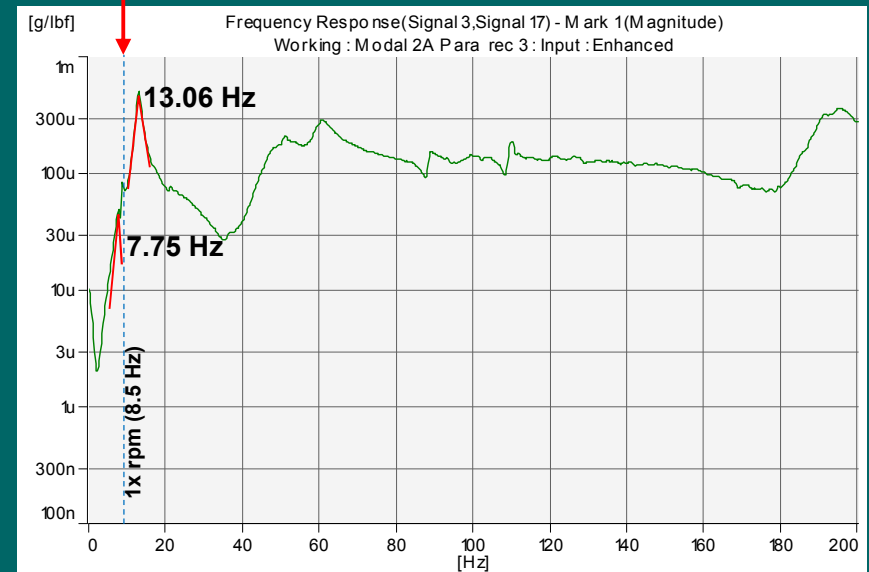
Pump A While Operating
(Loose Pump)

Running speed (8.50 Hz)

Motor Top Perpendicular

Motor Top Parallel

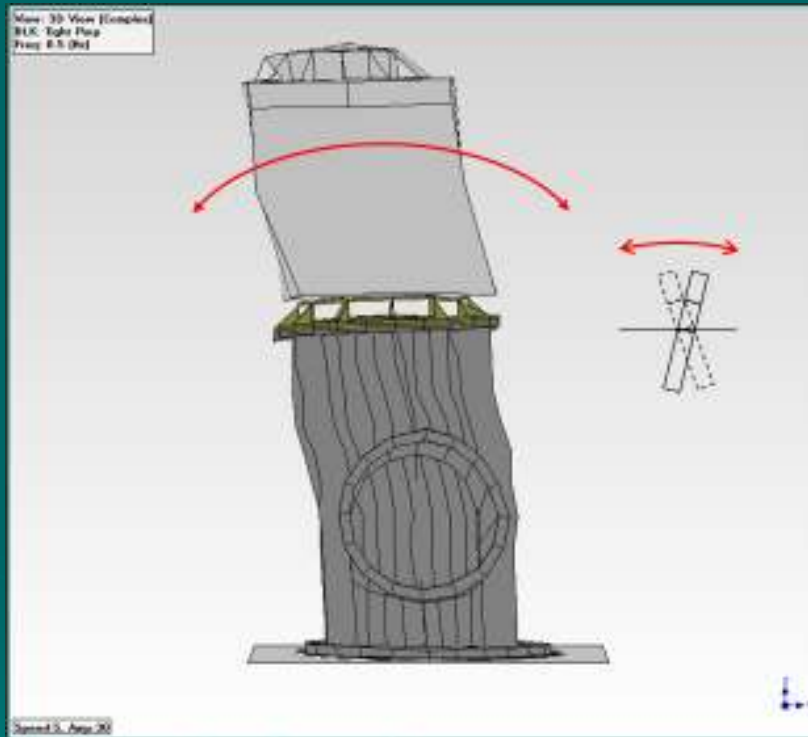
Trunion mode at 8.44 Hz in the perpendicular direction

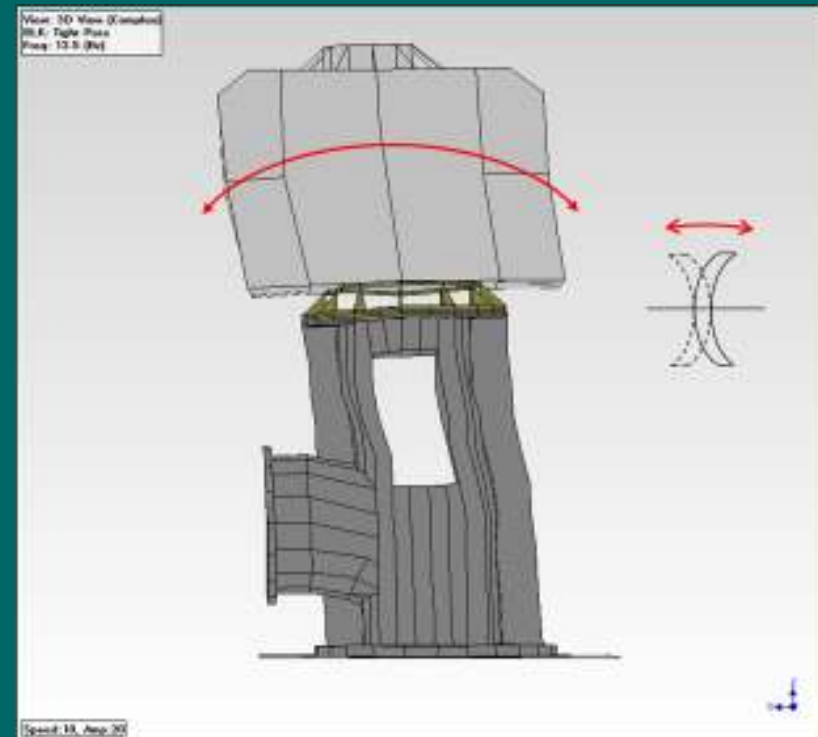
Global "C" shape mode at 13.50 Hz in the parallel direction
