PERFORMANCE LOSS INVESTIGATION USING THERMAL IMAGING

SCOTT MCPHERSON

LEAD FIELD ENGINEER – SULZER PUMPS (US) INC

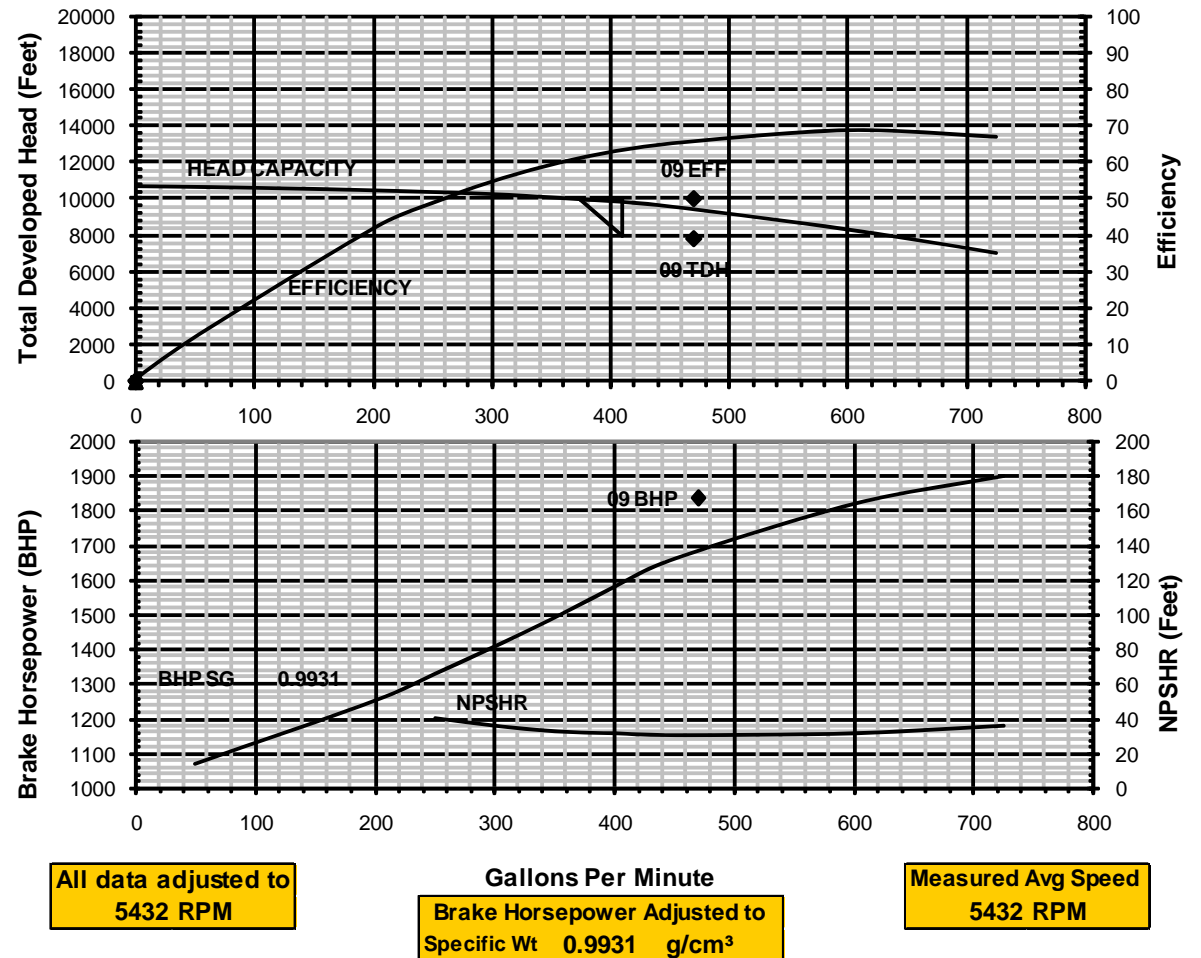
- Field testing suggested severe performance loss. Head low by approximately 20%!!!
- Efficiency down by approximately 30%!!!

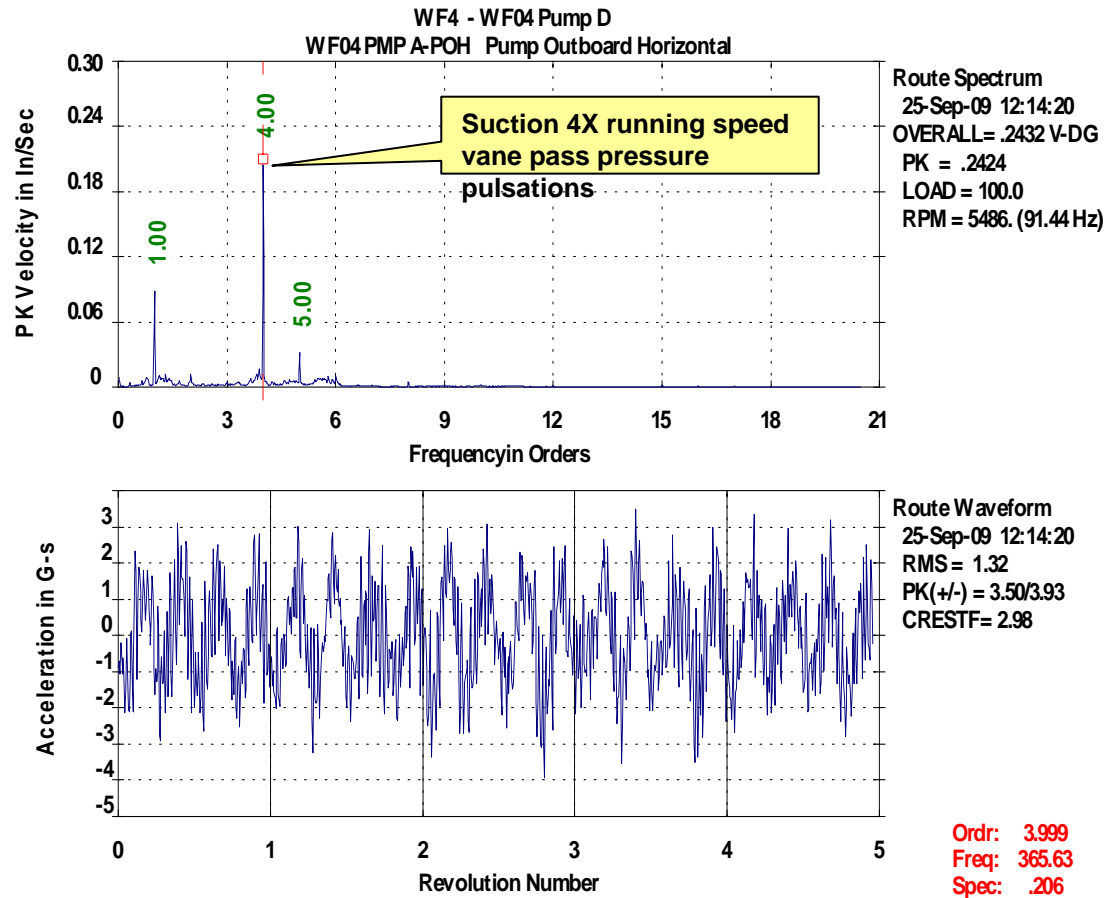
- Vibration spectrums showed no abnormalities that could explain performance loss.
- No readings more than 0.24 in/s overall
- All spectrum characteristics were explainable and typical of normal pump operation

Pump POH spectrum and time waveform indicating the dominance of the 4X suction impeller vane pass pulsations

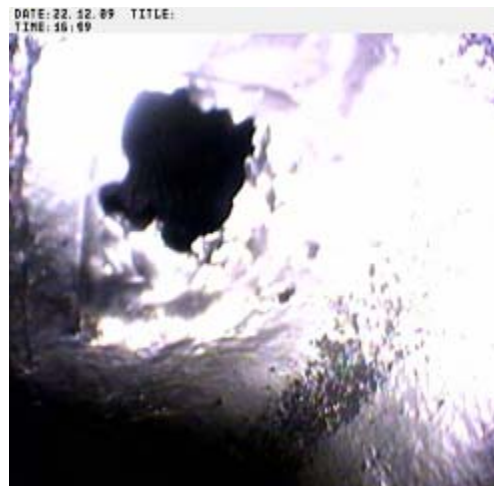
A BIG HOLE!

- Last 7 stages recirculating additional flow due to 1 inch hole from discharge to cross over
- 7 stages worth of differential pressure across 1 in hole = lots of flow
- Excessive temperature rise due to fluid recirculation passing through 7 stages x 2!!
