2X PINION VIBRATION PROBLEMS AND SOLUTIONS FOR MOTOR-GEAR-COMPRESSOR TRAINS DURING COMMISSIONING

CASE/STUDY 2014 TAMU TURBO SYMPOSIUM

2X Pinion Vibration Problems and Solutions for Motor-Gear-Compressor Trains During Commissioning

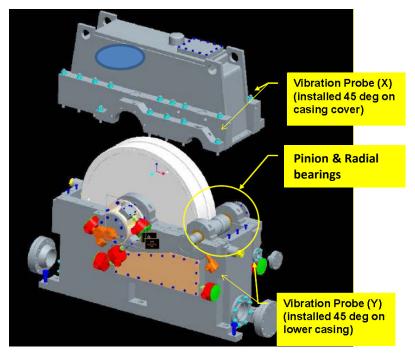
- Basic information:
 - Customer: *****
 - Gear Vendor: *****
 - Where: *****
 - When: 2013
 - RADIAL BEARING : PRESSURE DAM
 - THRUST BEARING : TILTING PAD
 - MINIMUM SPEED [rpm] : 1196 / 9796
 - RATED SPEED [rpm] : 1495 / 12245
 - MAX SPEED [rpm] : 1570 / 12857
 - GEAR RATIO, # OF TEETH : 8.1905 (21/172)
 - TRANSMISSION POWER (RATED/NOR) [kW] : 4500/3604
- What happened:
 - 4 identical equipment trains, 3 tested. All 3 have the same symptom: 2X vibration at coupling side of the pinion. Vibration from all other probes including the motor and the compressor is low.

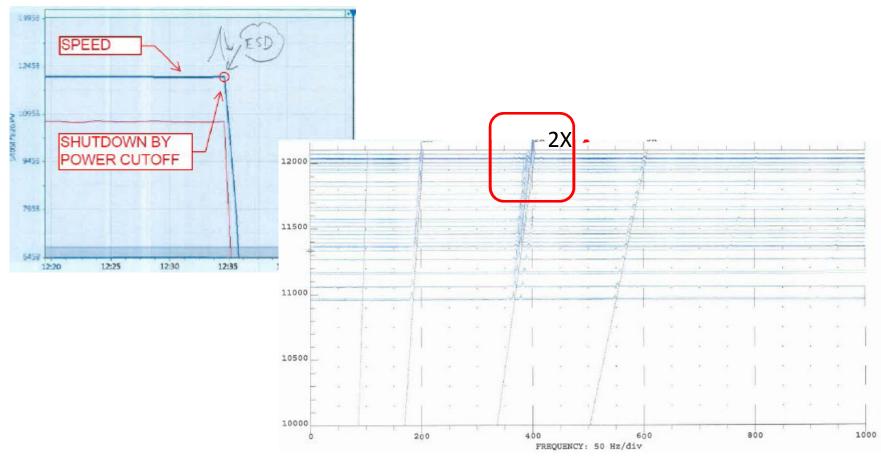
- Motor/VFD problem is ruled out by cutting off the power:
 - 2X shows up even with power cut-off

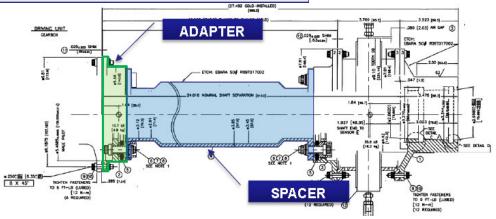
Note: Pinion model and bearing coefficients are provided by Gear Vendor

An relatively simple solution: change the coupling weight to shift the critical speed

NO.	DESCRIPTION	CRITICAL SPEED by Gear Vendor (CPM)	CRITICAL SPEED by ELLIOTT (CPM)	REMARKS (HALF WEIGHT ON PINION)
1	Original Coupling	23614 (11807 rpm)	23400-24000 (11700-12000 rpm)	4.9kg(10.7Lb)
2	Titanium Space Coupling	25545 (12773 rpm)	25000-25800 (12500 – 12900 rpm)	3.4kg(7.6Lb)
3	Heavy Adapter Coupling	19158 (9579 rpm)	19000-20000 (9500-10000 rpm)	9.5kg(21Lb)

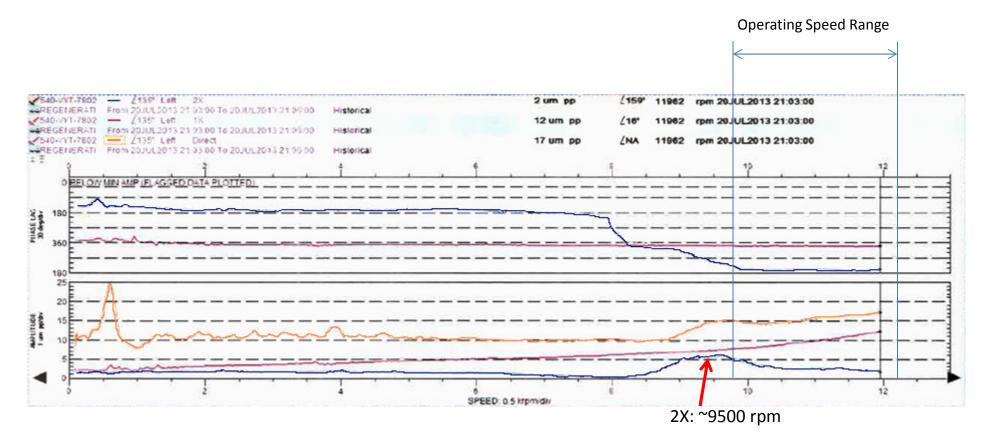
Heavy Adapter Coupling Test Result

The prediction is close, and the problem is solved!

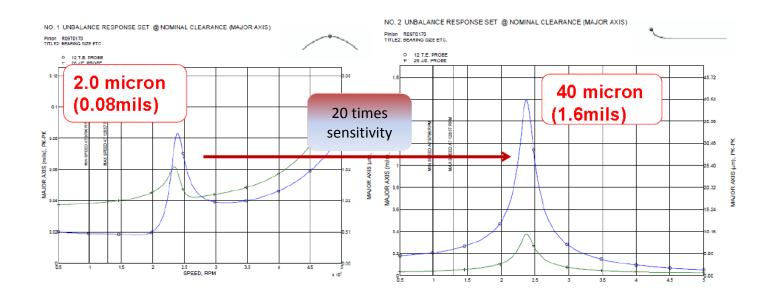
- There are many gears with VFD/Turbine drives may operating smoothly with 1st critical speed in the 2X range, why these gears have problems?
- What are different/special about these gears?
 - Bearing load: 440 psi (high in general, but common for gears)
 - Bearing design: with fins
 - Coupling: with power wheel (complex and heavy)
 - Pinion: very sensitive to coupling unbalance/excitation (see plots below)
 - Compressor second critical speed: 21400-22800 rpm (close to 2X)
