**43rd Turbomachinery
30th Pump SYMPOSIA**

COUPLING FAILURE DUE TO A MOTOR FAULT

Clay McClinton

Rotating Equipment Reliability Analyst, Chevron

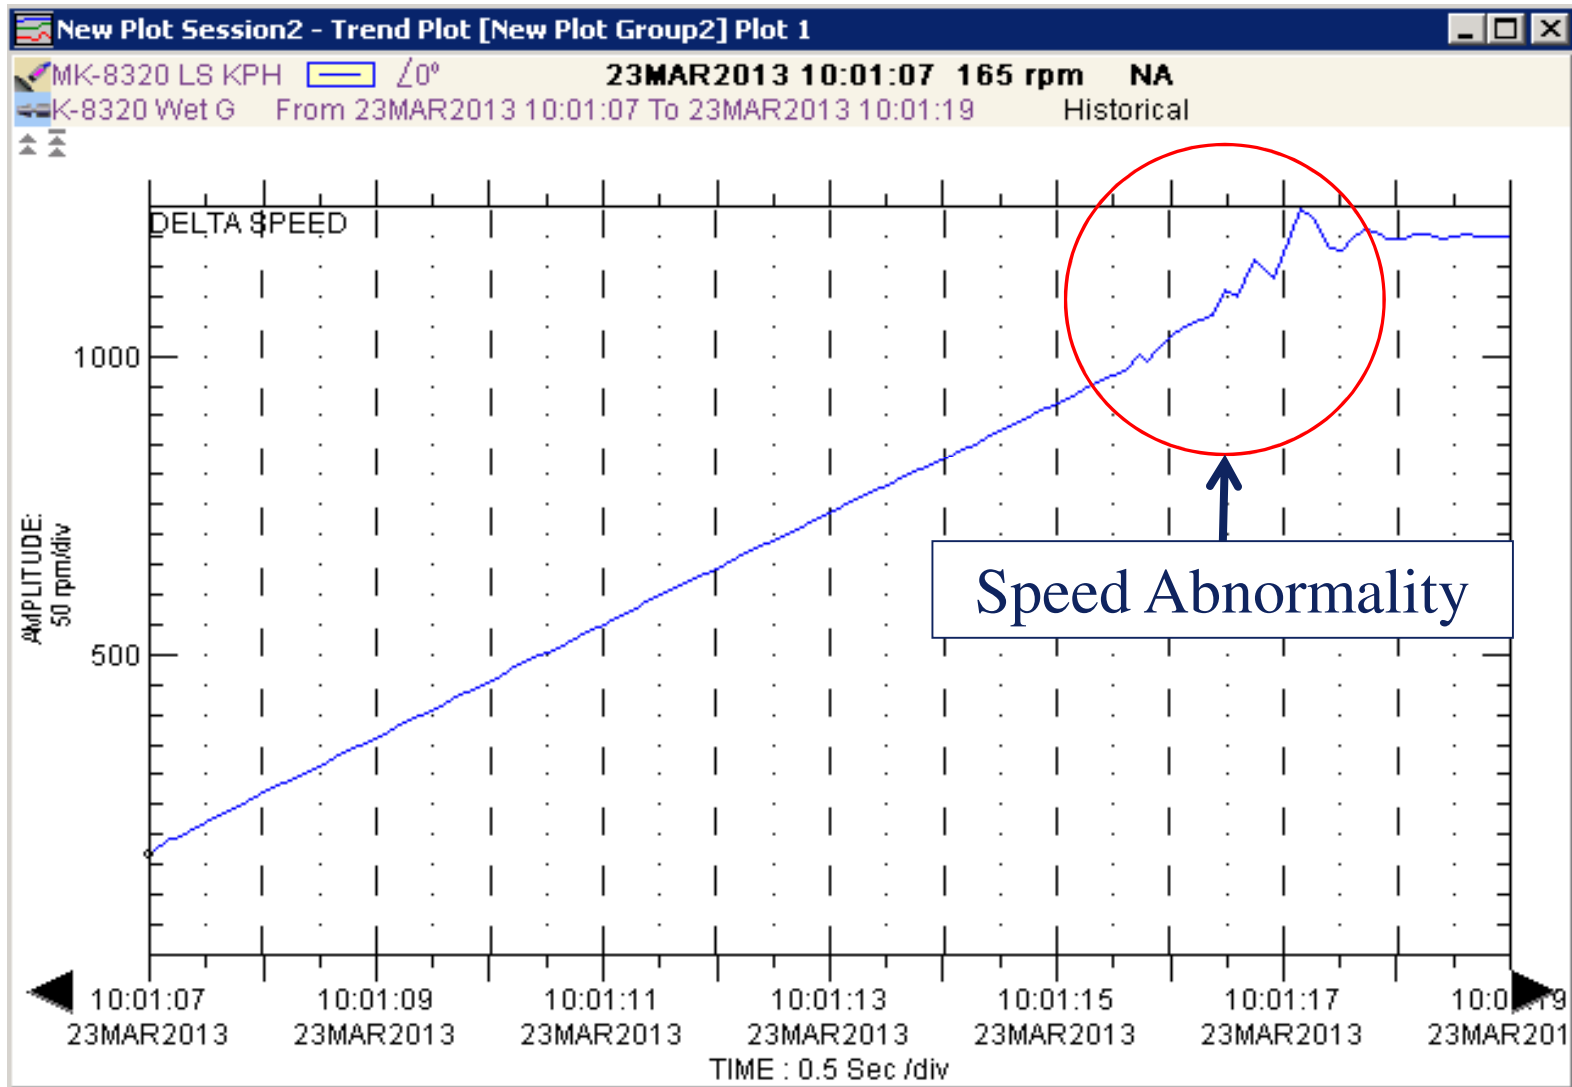
Motor Speed Data from LS Speed Pick-up

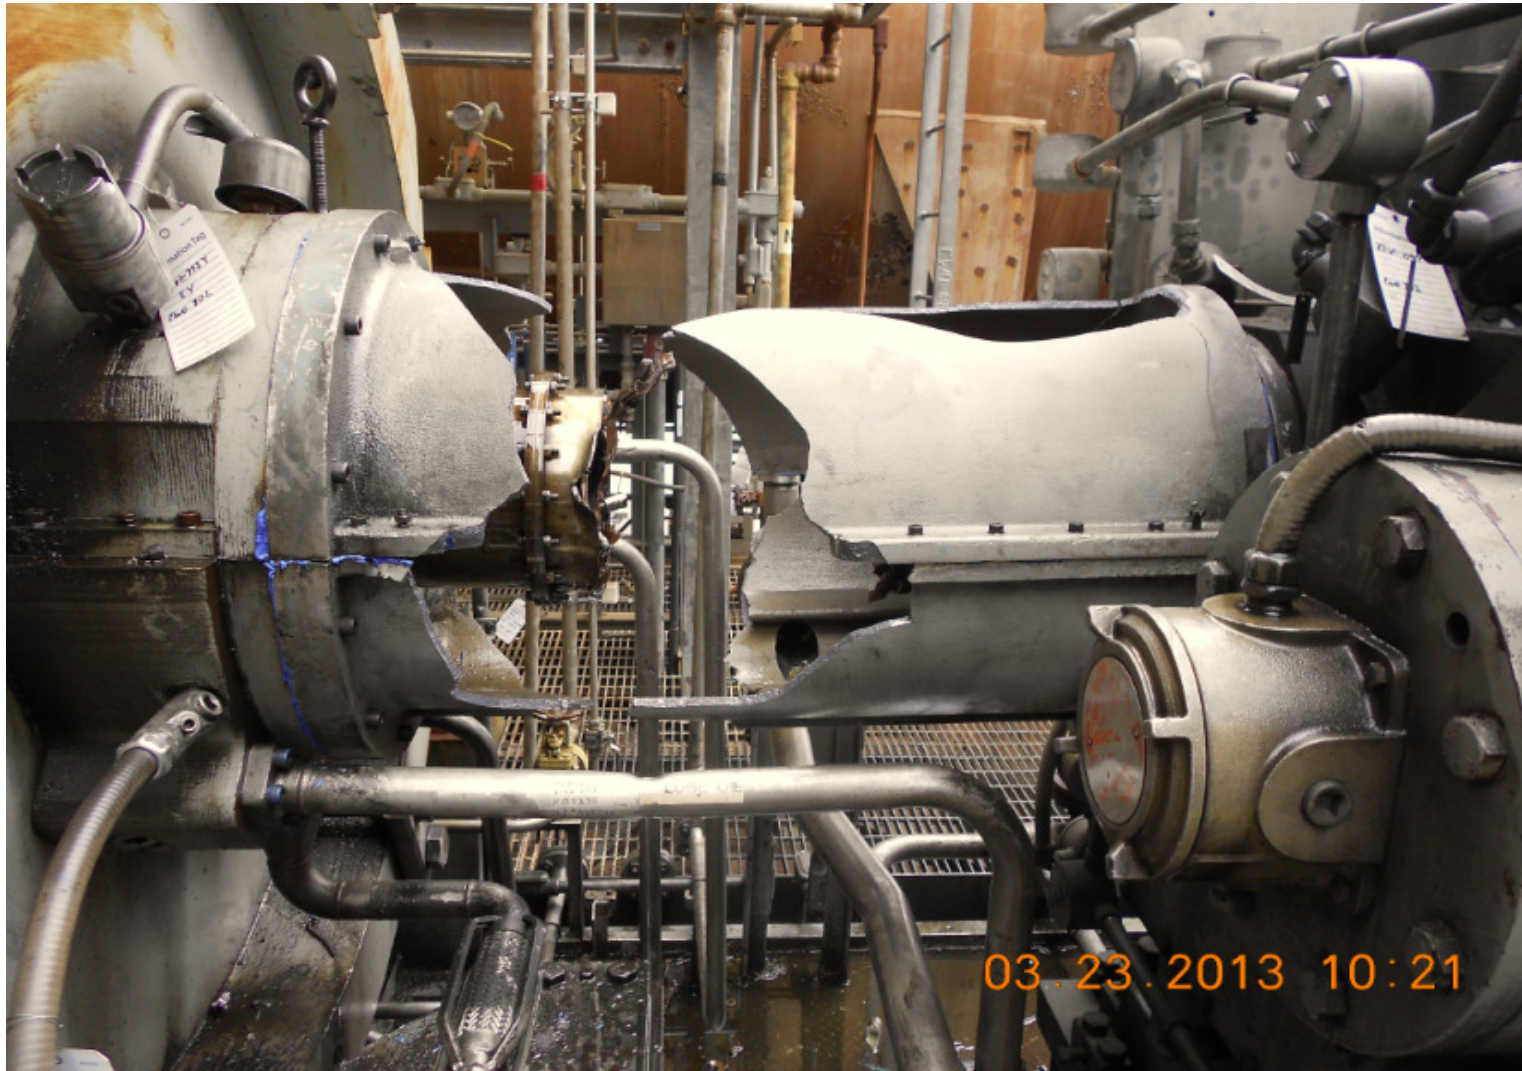
Broken Guard Due to Ejected High Speed Coupling Center Section

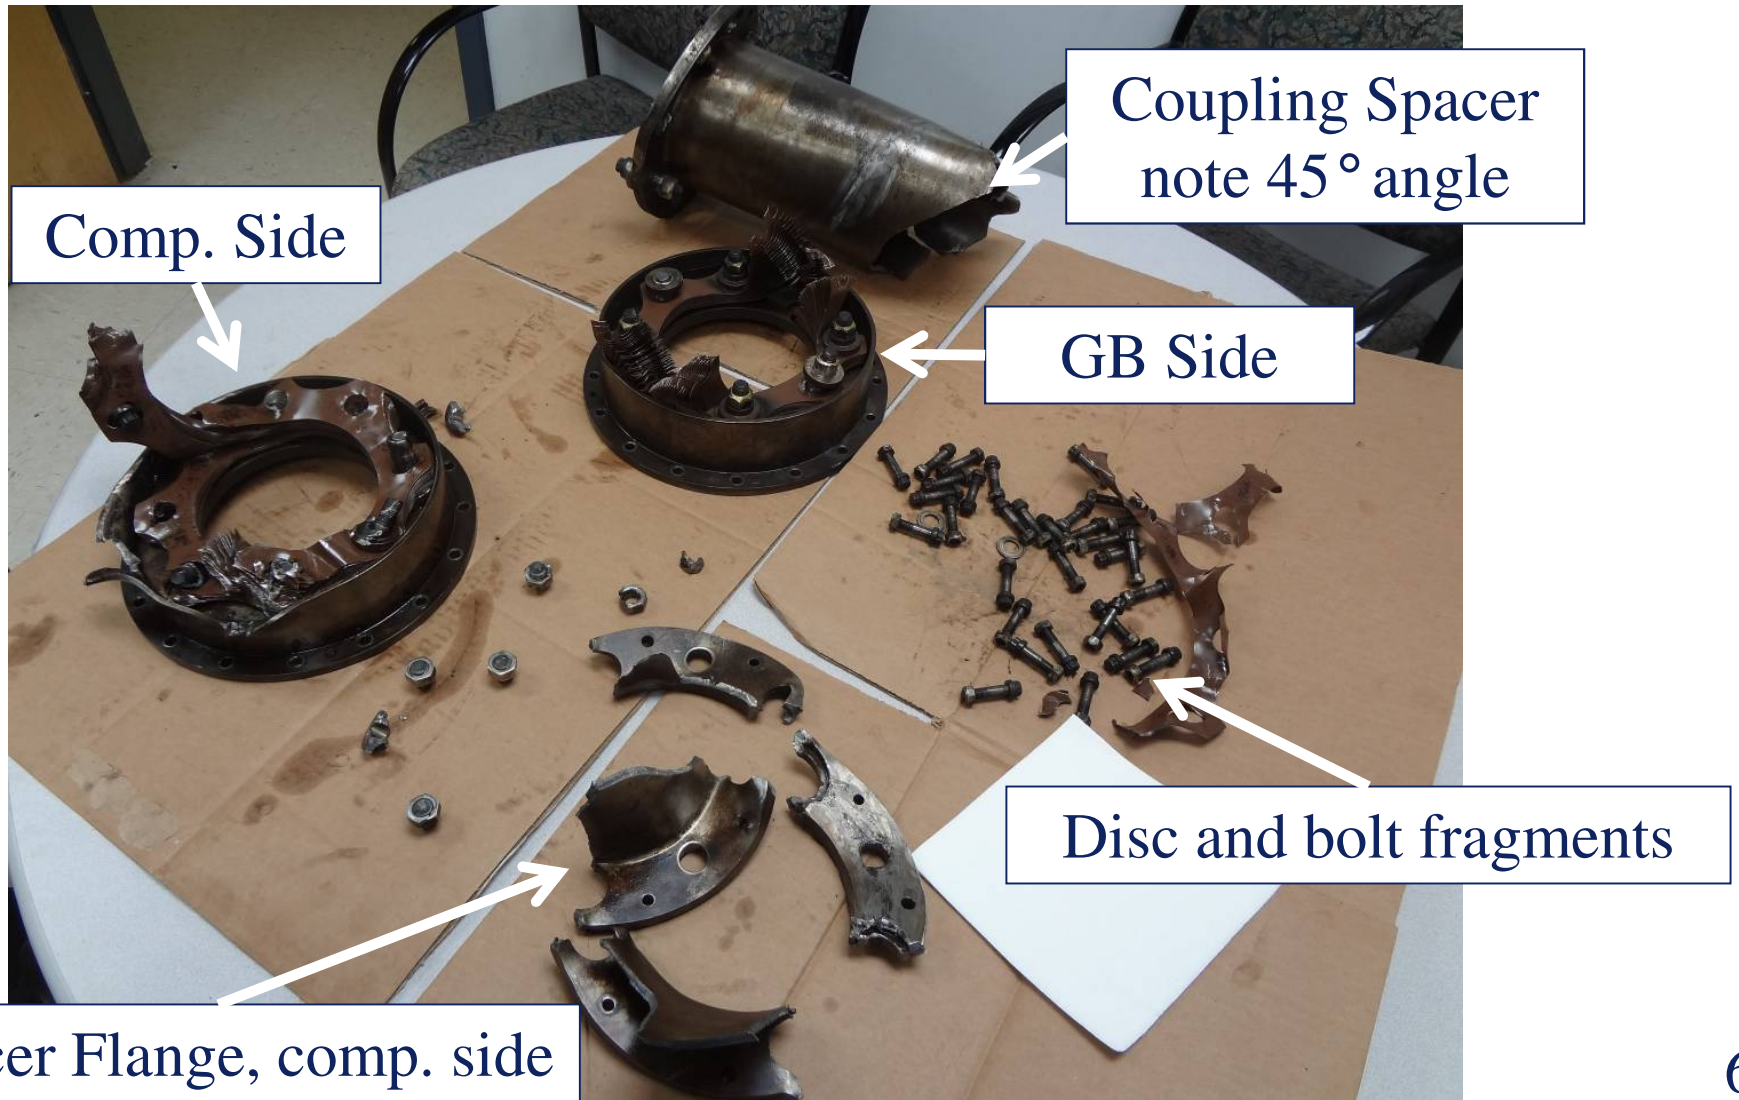
Failed Components Less Rigids

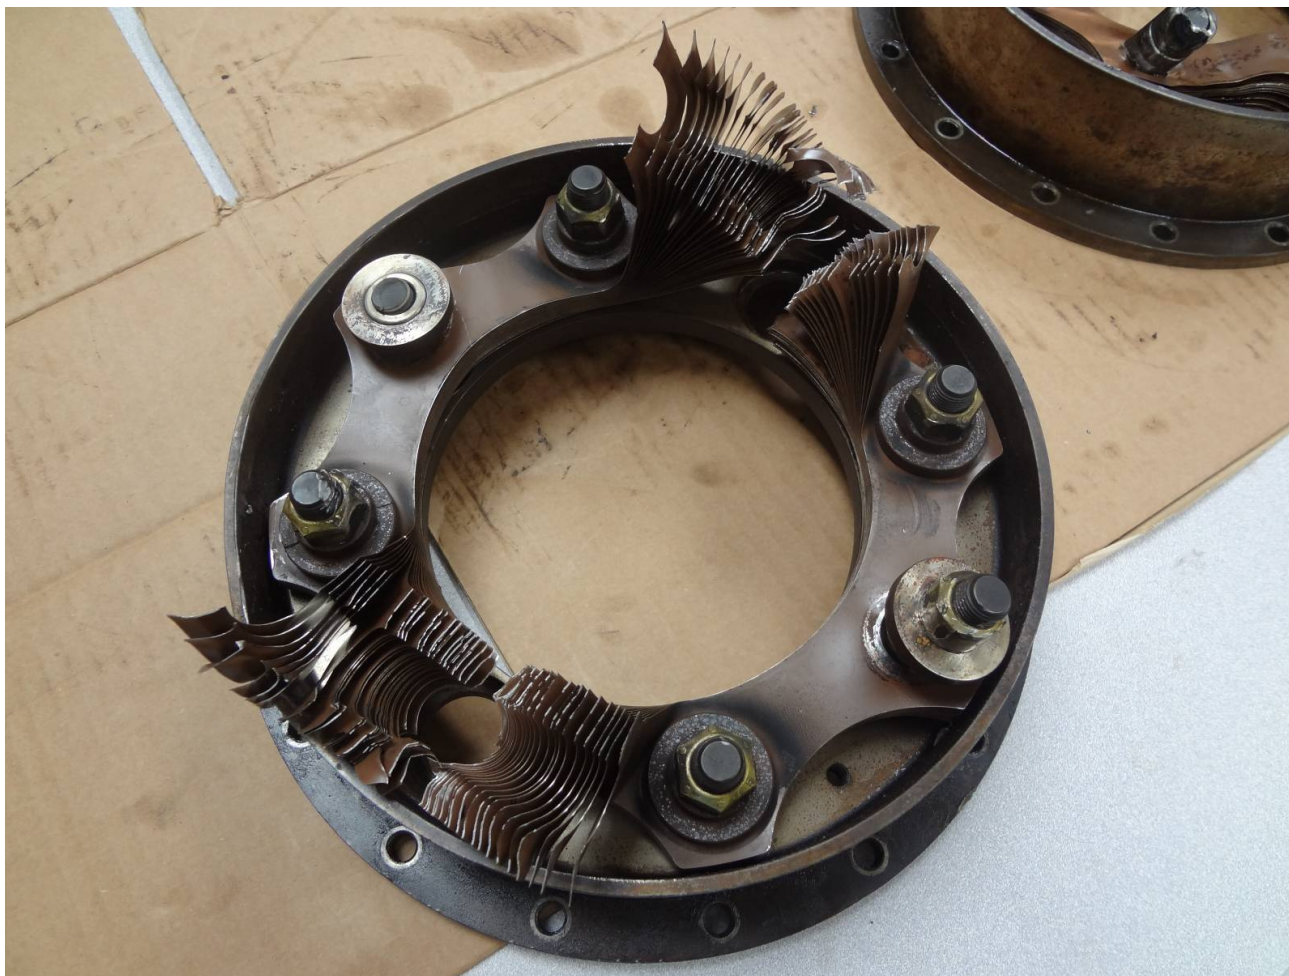
Spool Piece from Gearbox Side

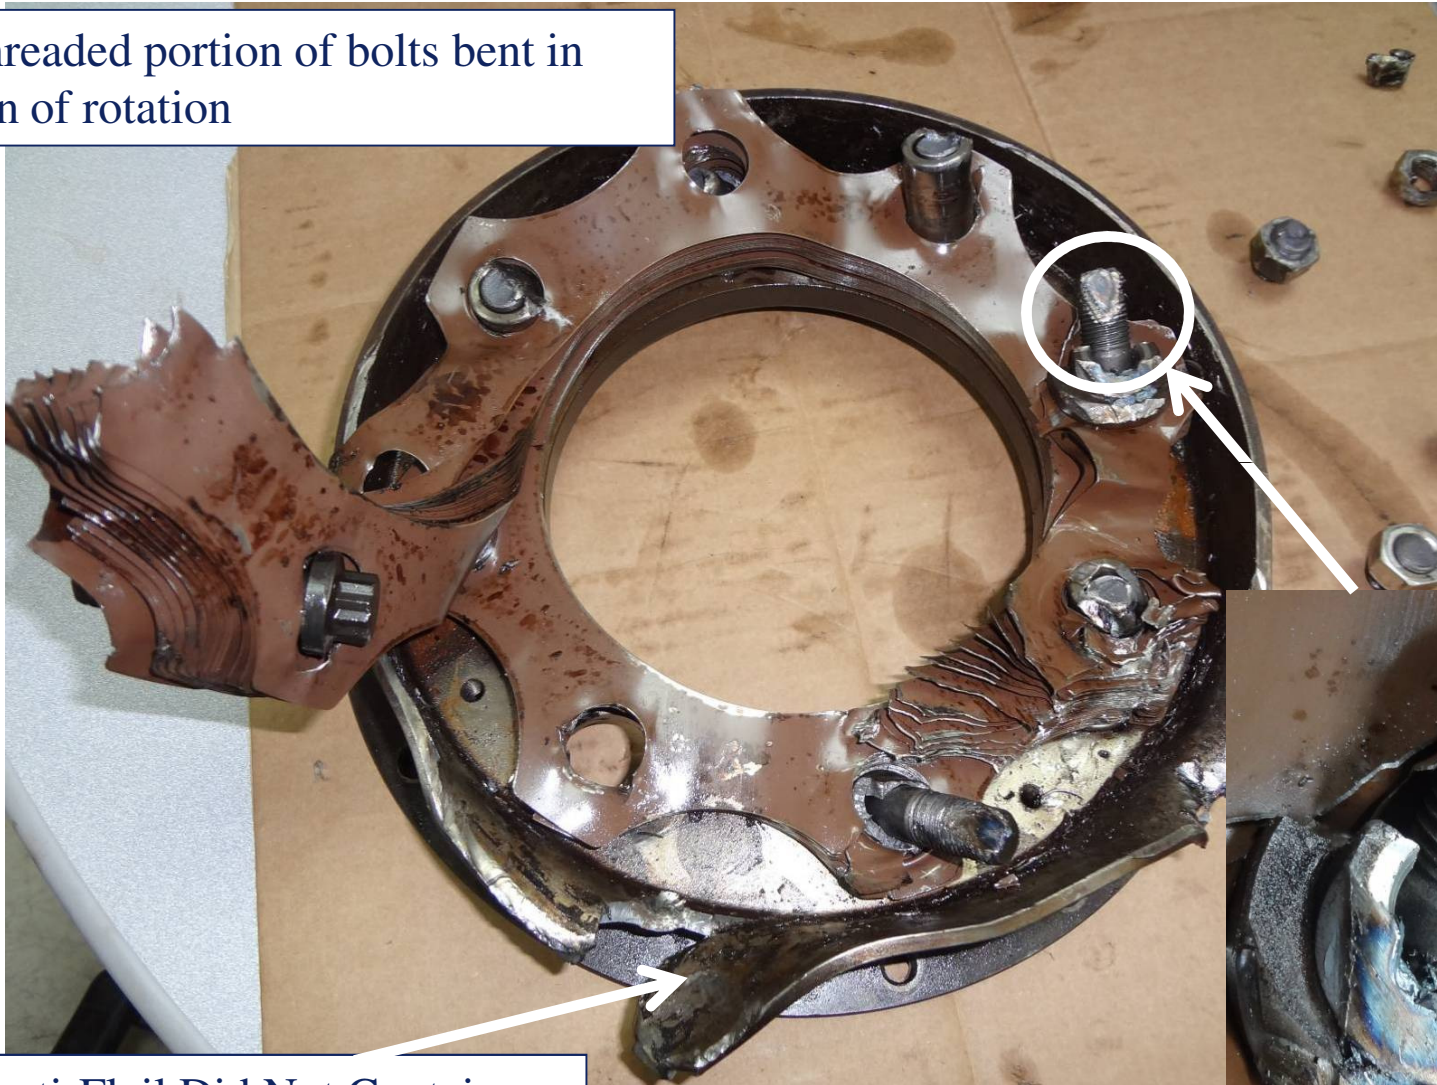
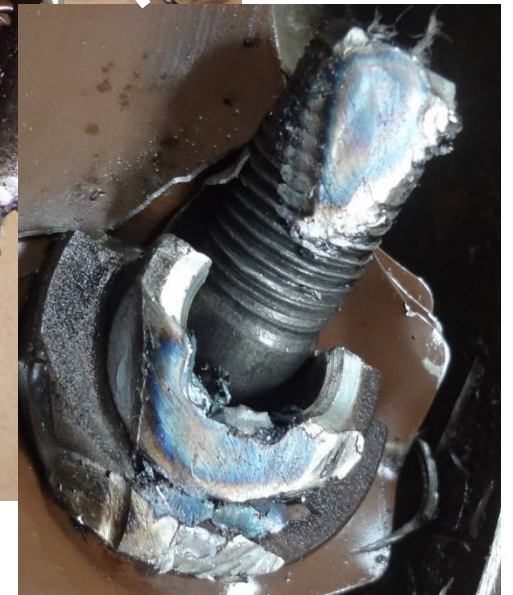
Spool Piece from Compressor Side

Note: threaded portion of bolts bent in direction of rotation

Note Anti-Flail Did Not Contain

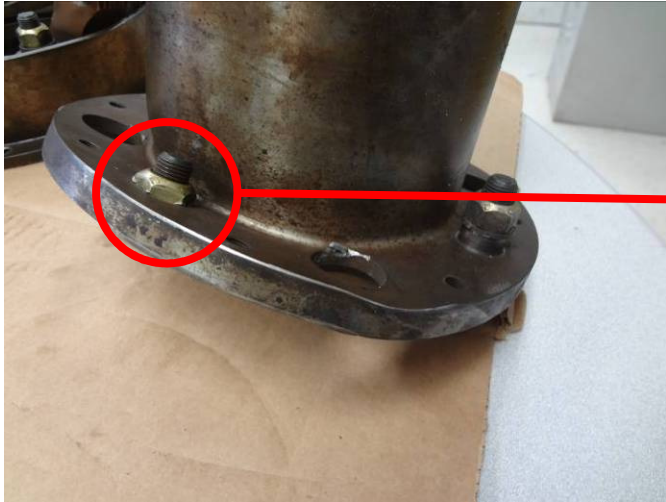
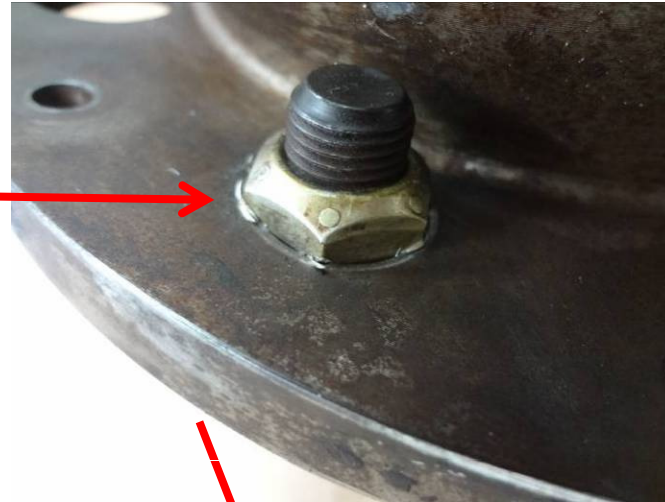
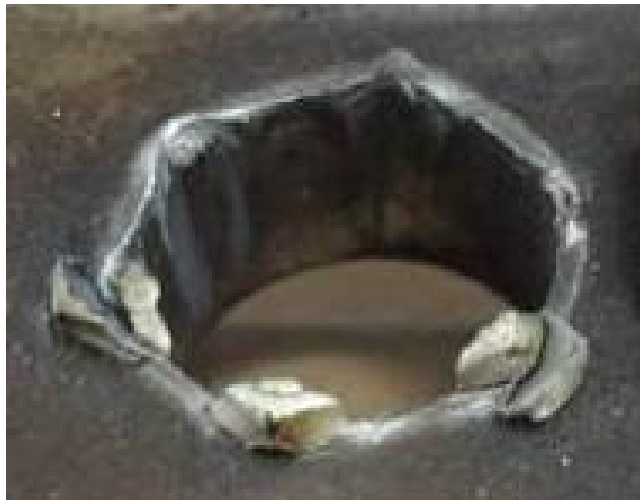
Driving End of Spacer with “Nut Broaching”

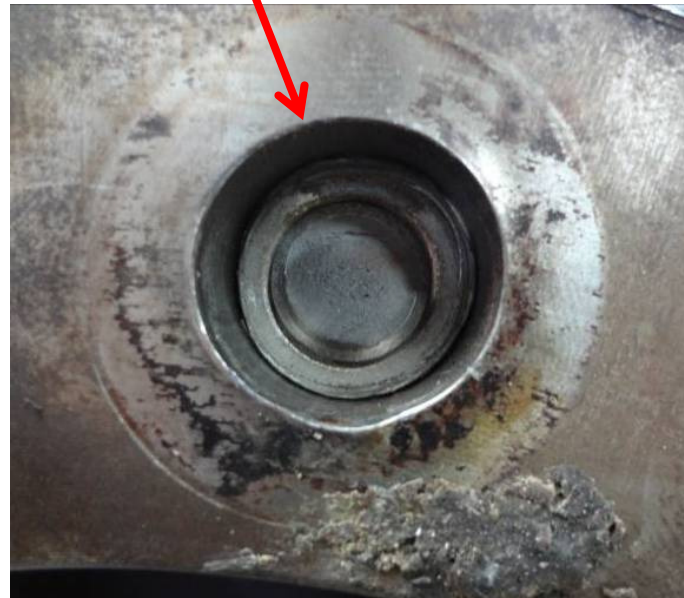
Nut/bolt pulled through flange

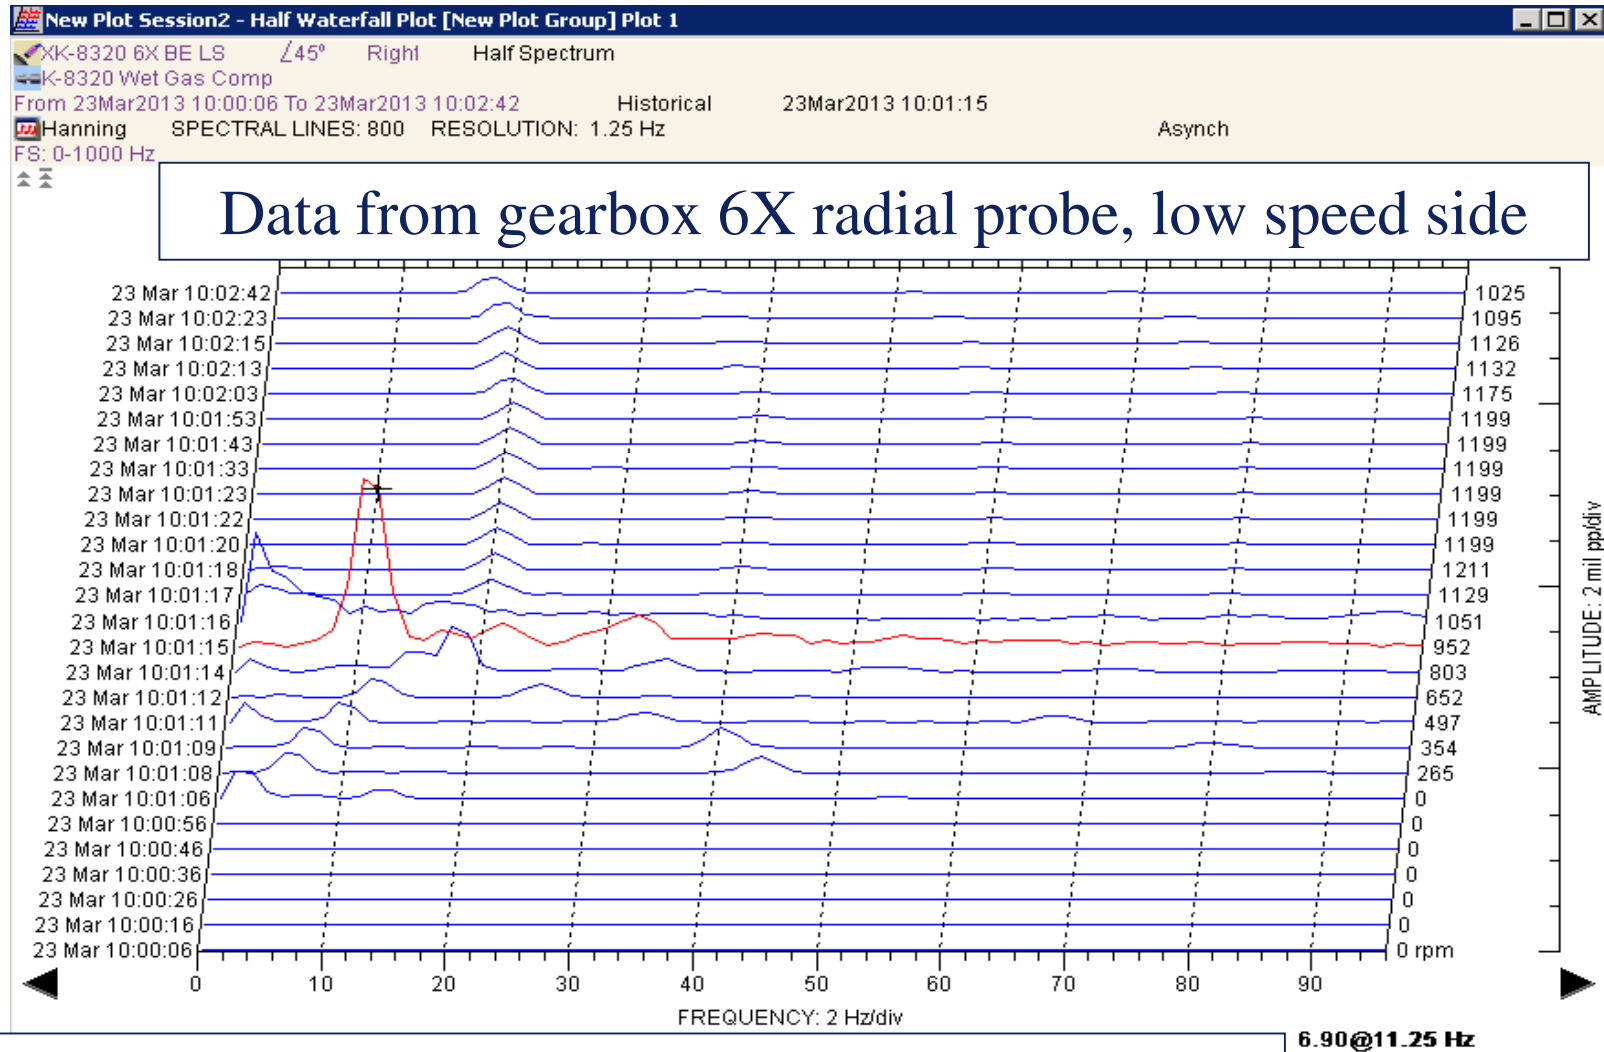
Waterfall Plot from Start Up Reveals 6.9 Mils @ 11.25 Hz

Prior to shutdown, radial vibration was $<0.5\text{mils}_{p-p}$

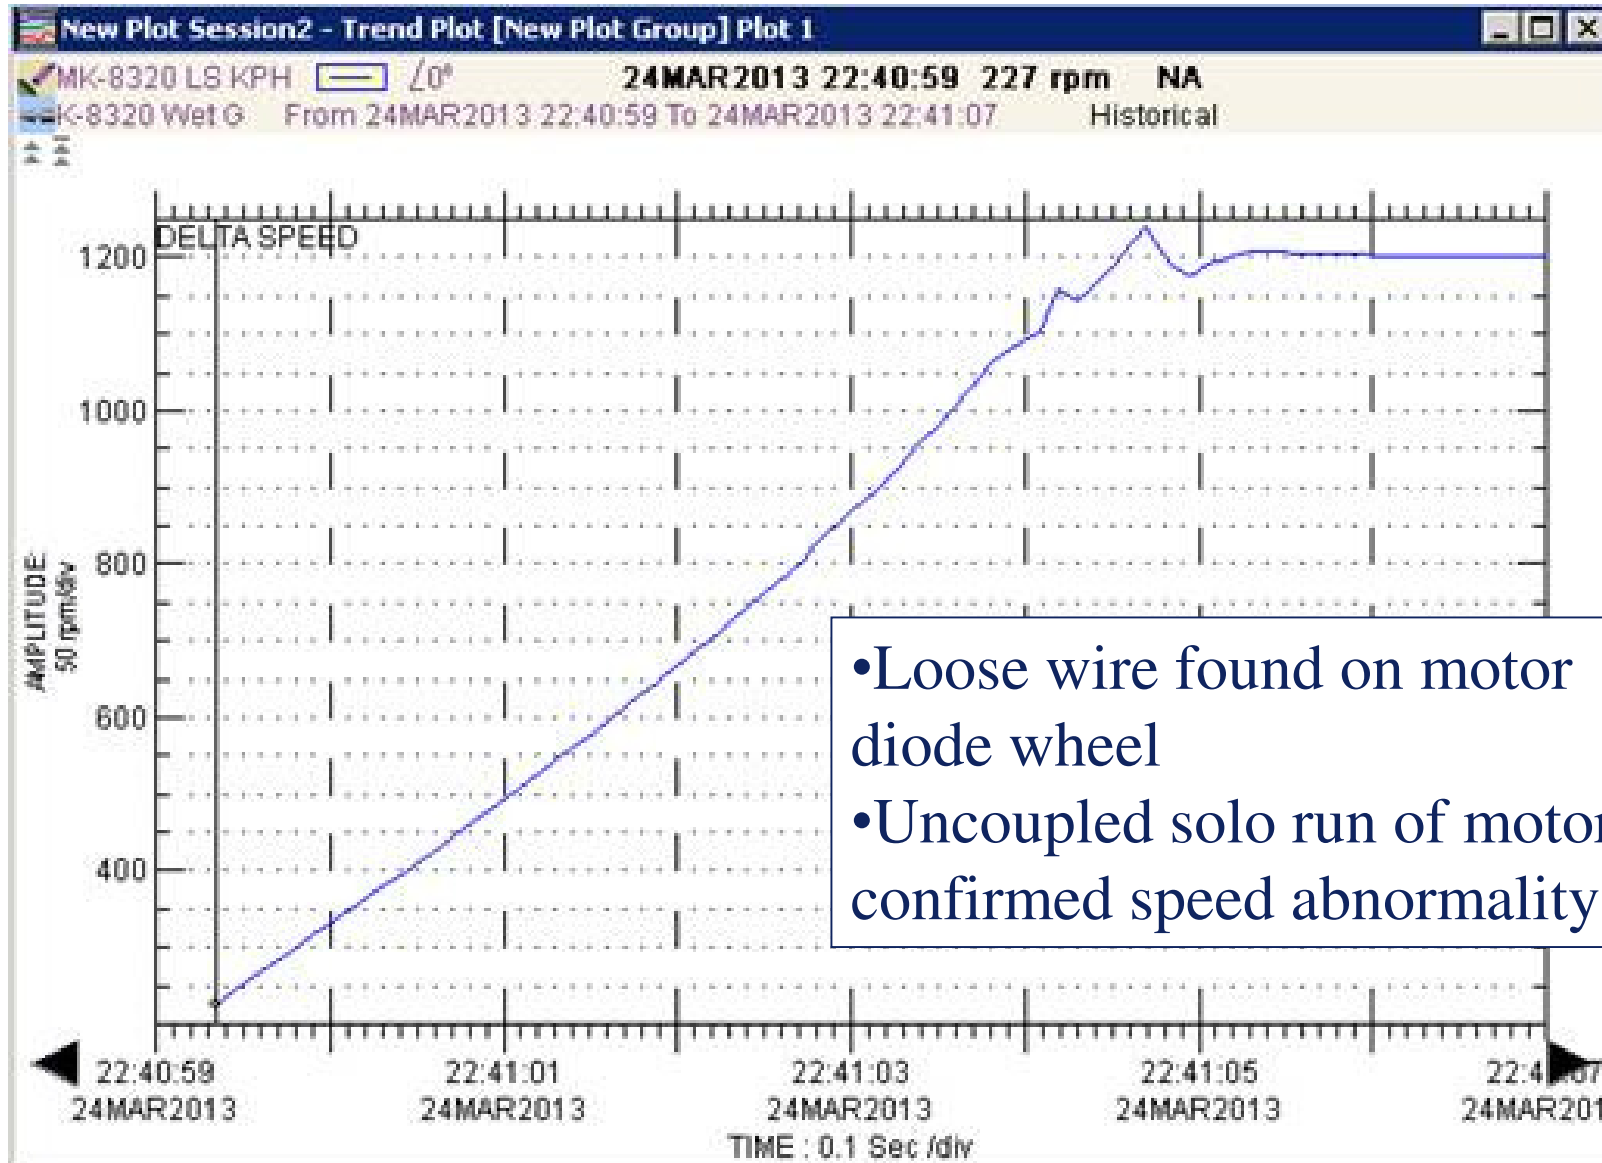
Motor Speed Data from Solo Run

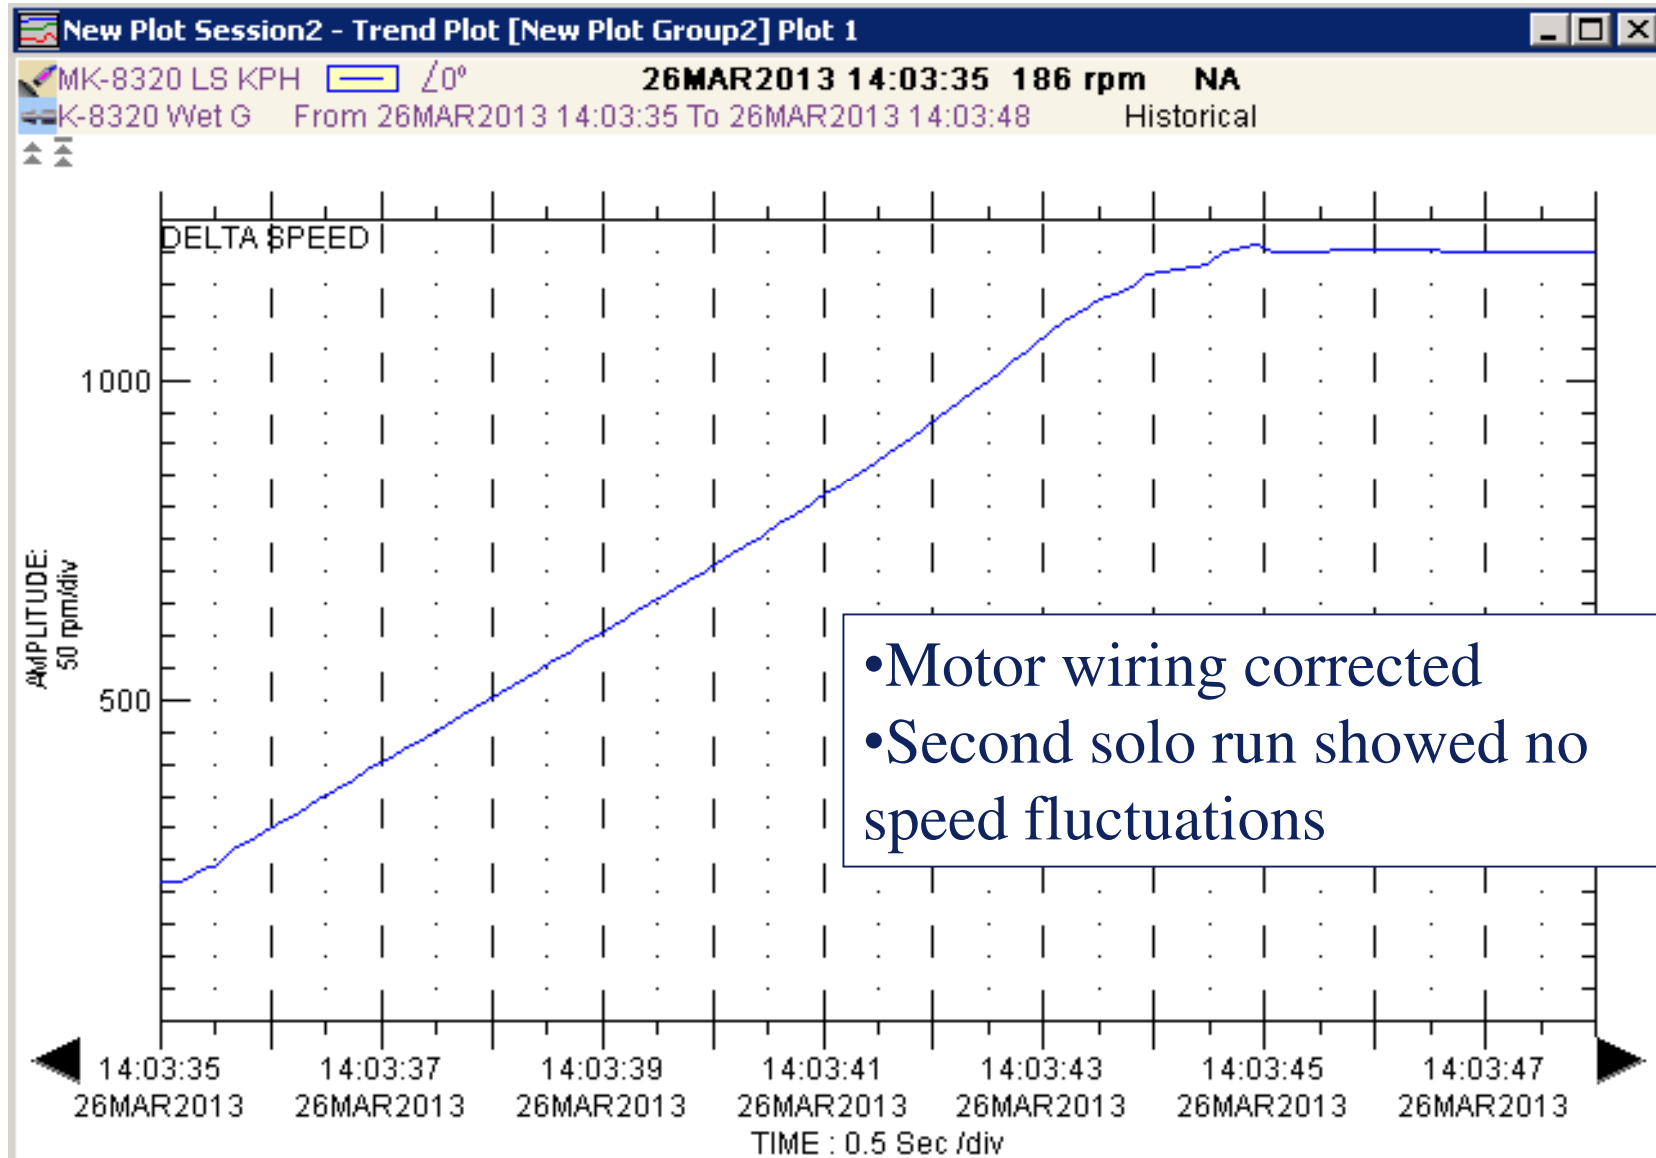
Loose Wire Repaired; Motor Speed Data from Successful Start up 3/26

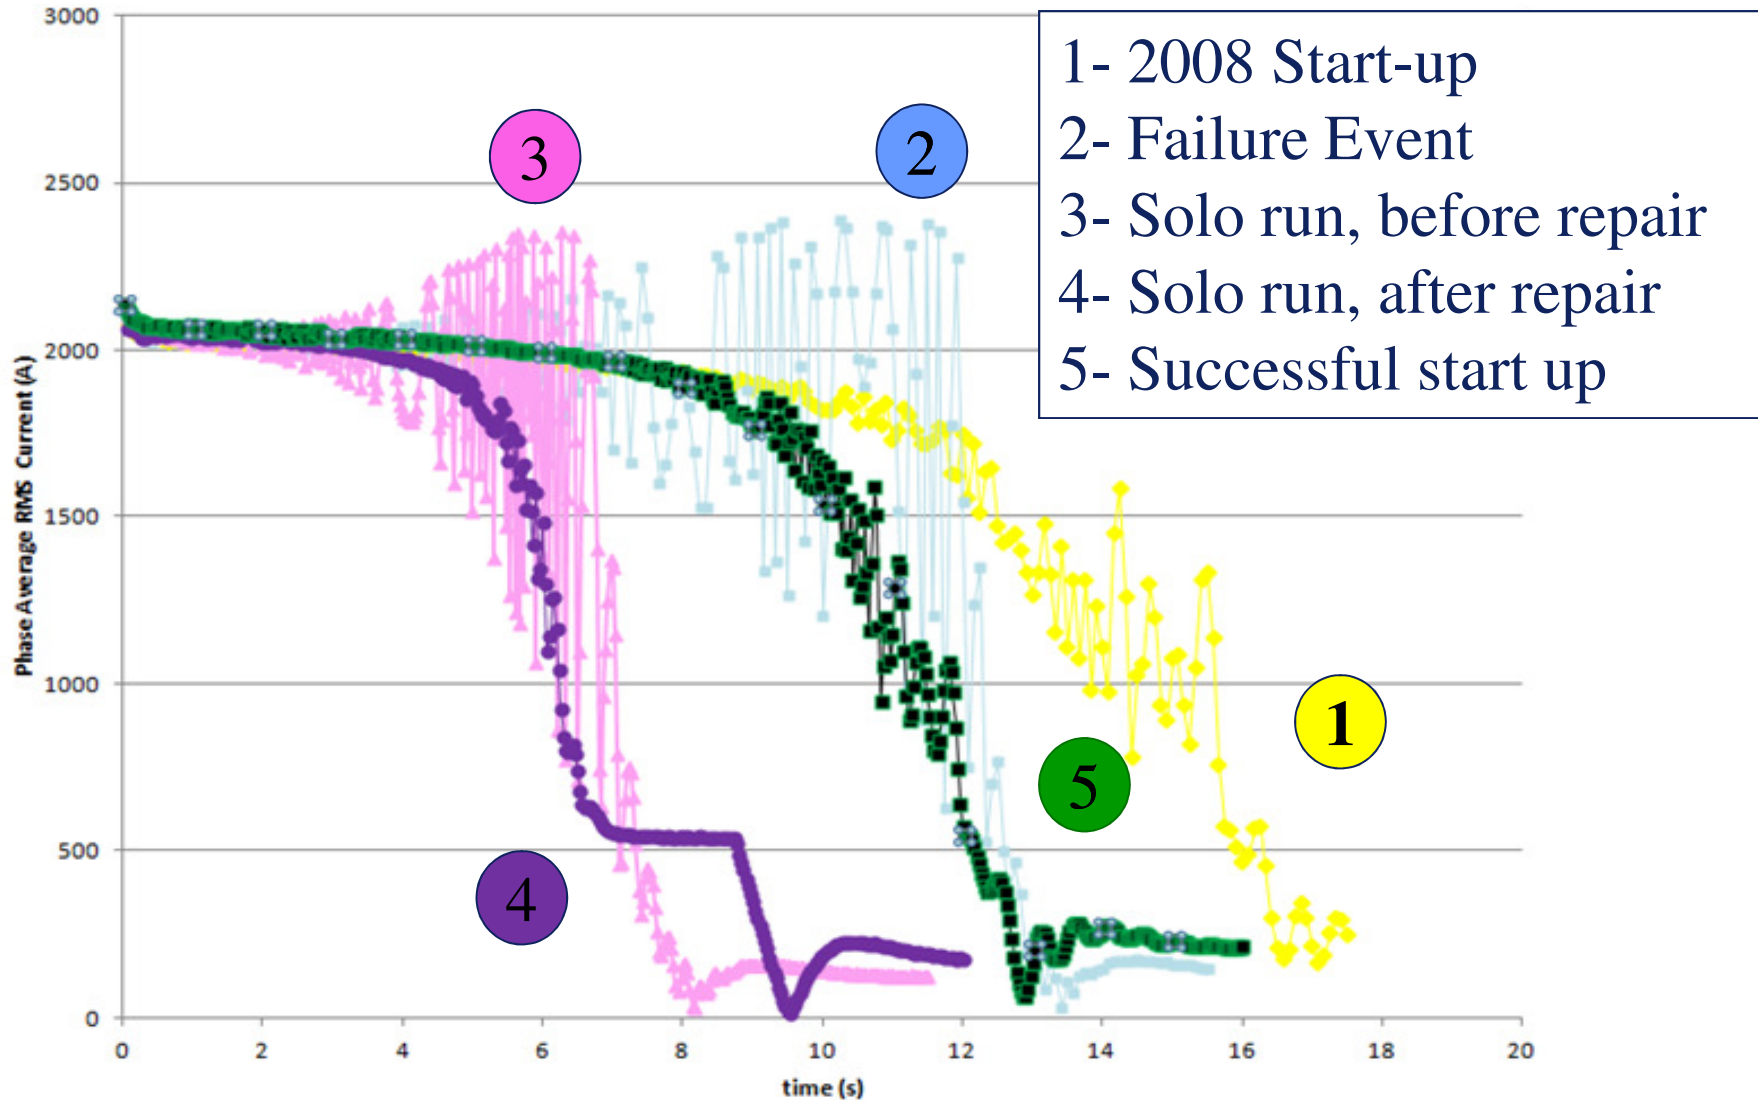
Coupled and Solo Run Electrical Data – Current Fluctuations – Source of Excitation

SEL 710 Start Data - MK 8320

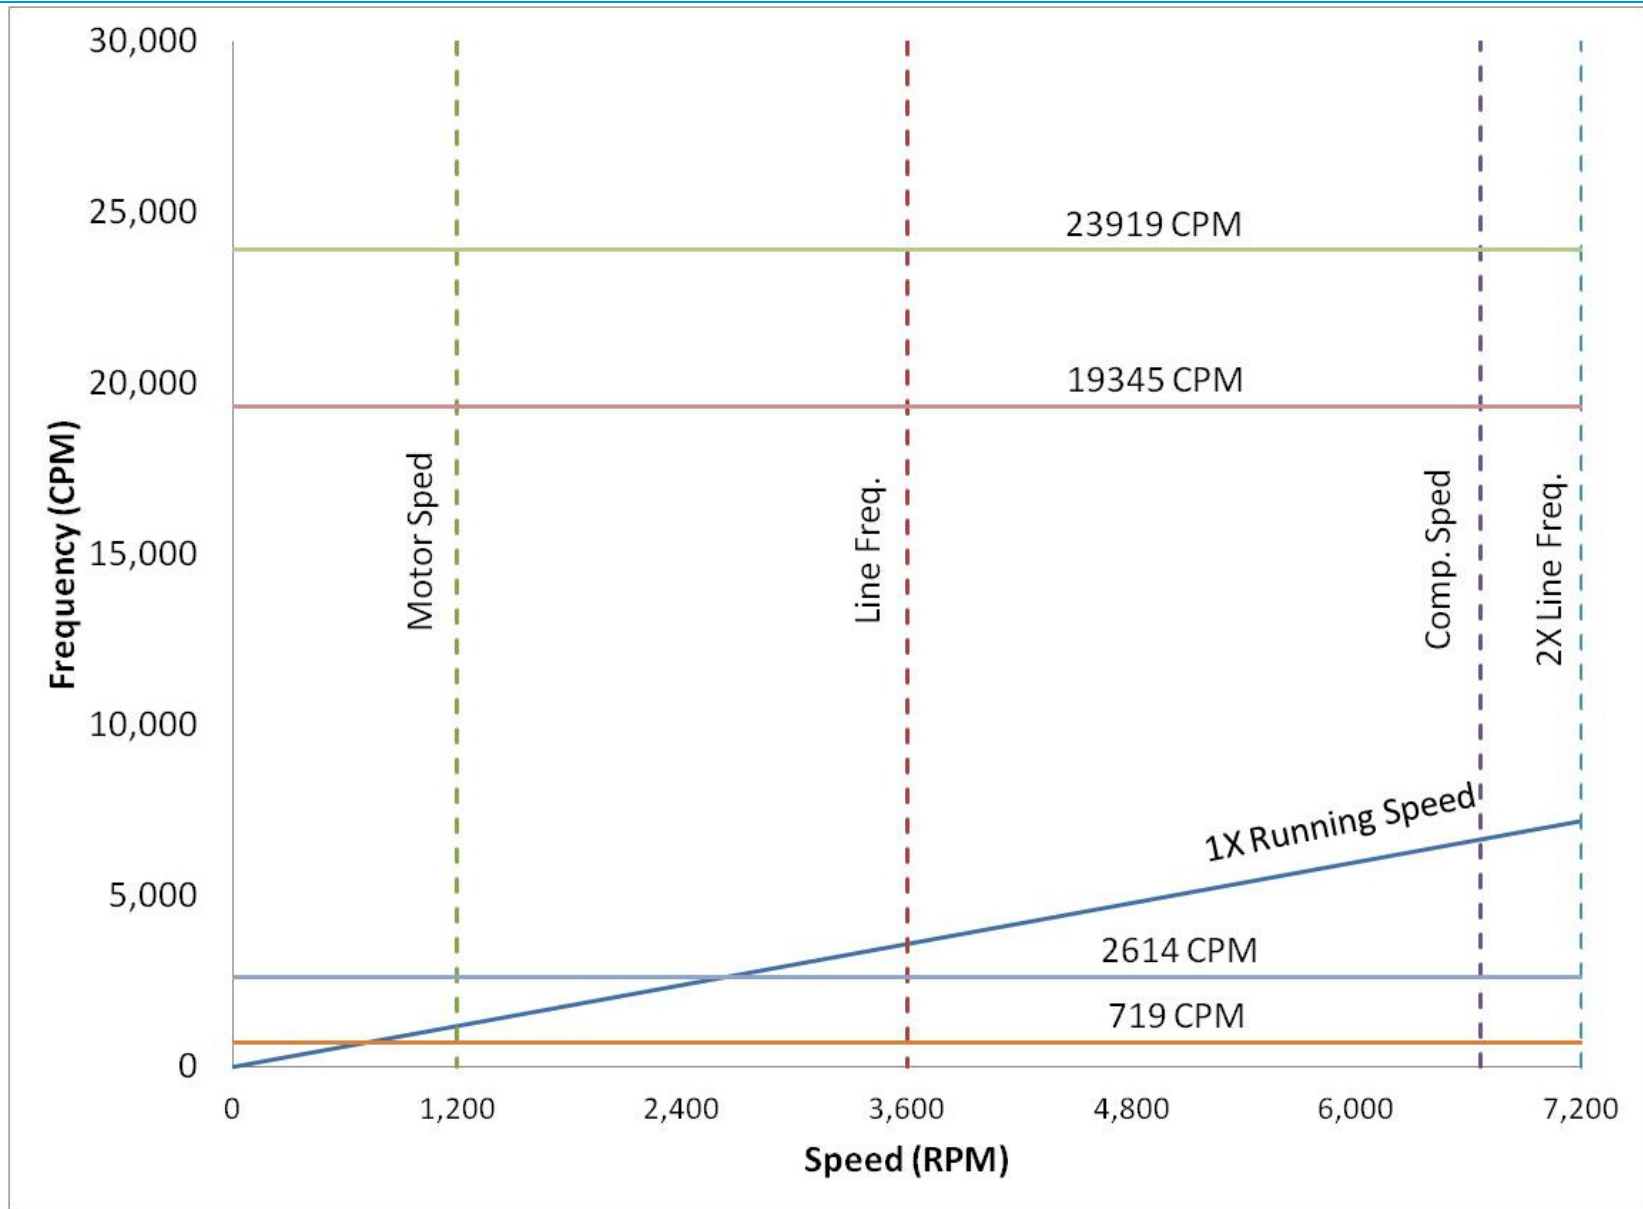
- Original torsional analysis reviewed
 - Frequency (11.25 Hz) of high radial vibrations found during start-up prior to failure appeared to be near a system torsional natural frequency
- New forced response analysis conducted
 - Wiring problem caused current fluctuations in motor, exciting torsional natural frequency
 - Need to determine effect of short duration torsional excitation at motor, resulting from diode wheel wiring

Campbell Diagram – 1st Torsional Mode at 11.9 Hz (719 CPM)

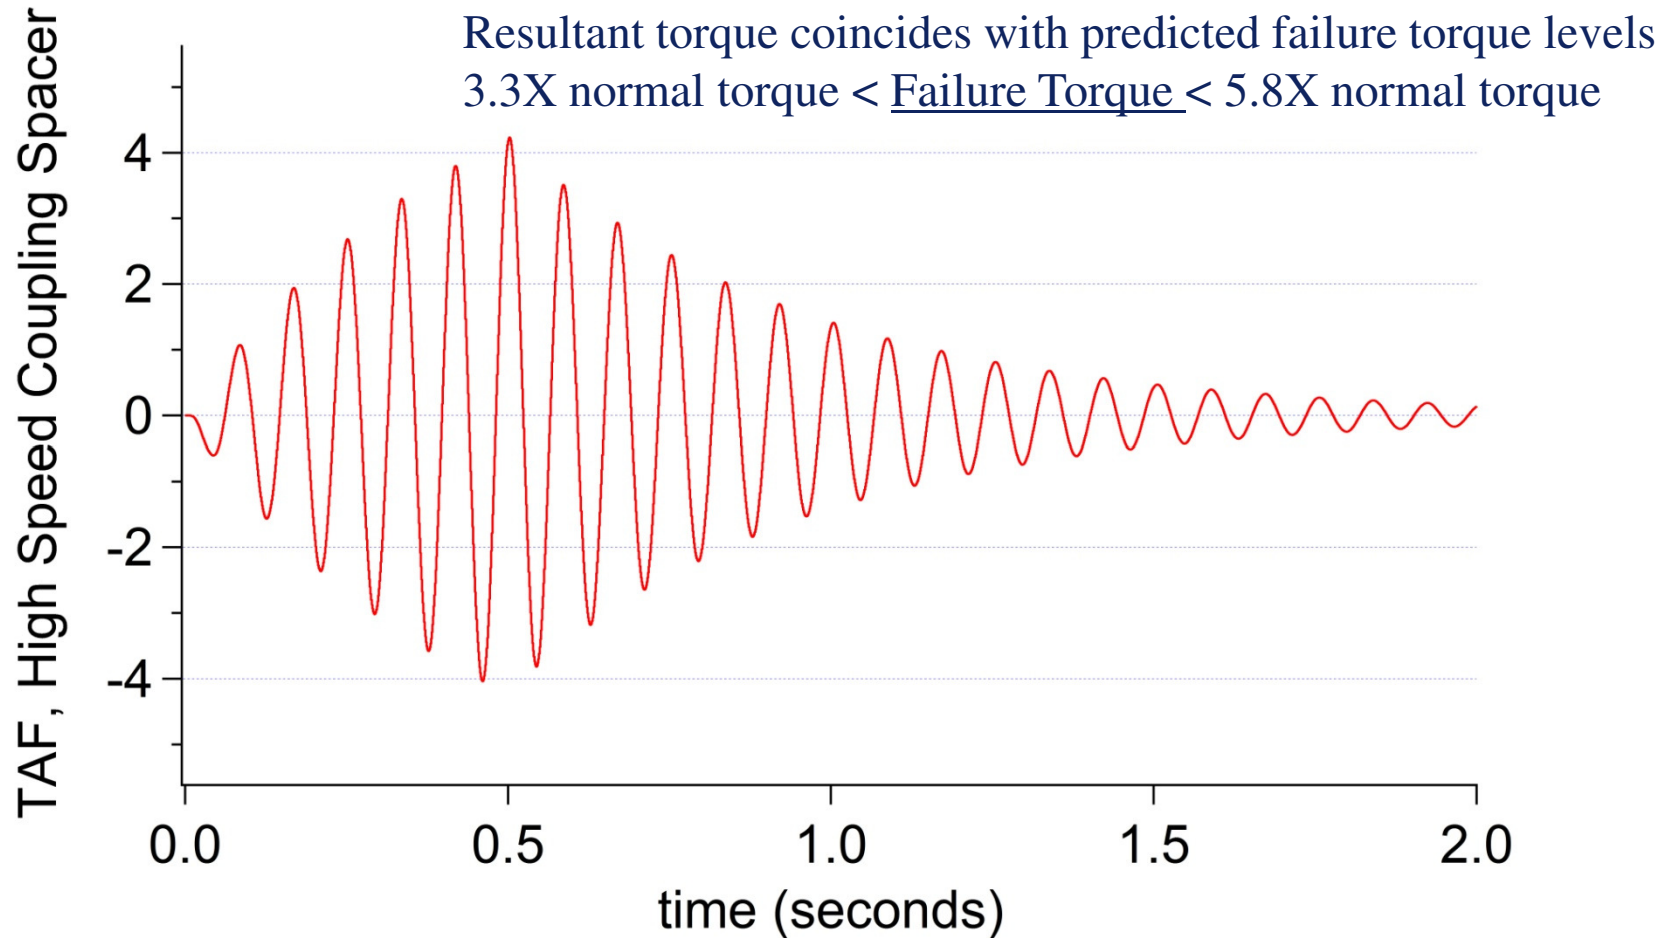
Calculated Torque on Coupling During ~4X Rated

TAF response of high speed coupling with 0.5 sec excitation of first natural frequency applied at motor, .013% damping included.

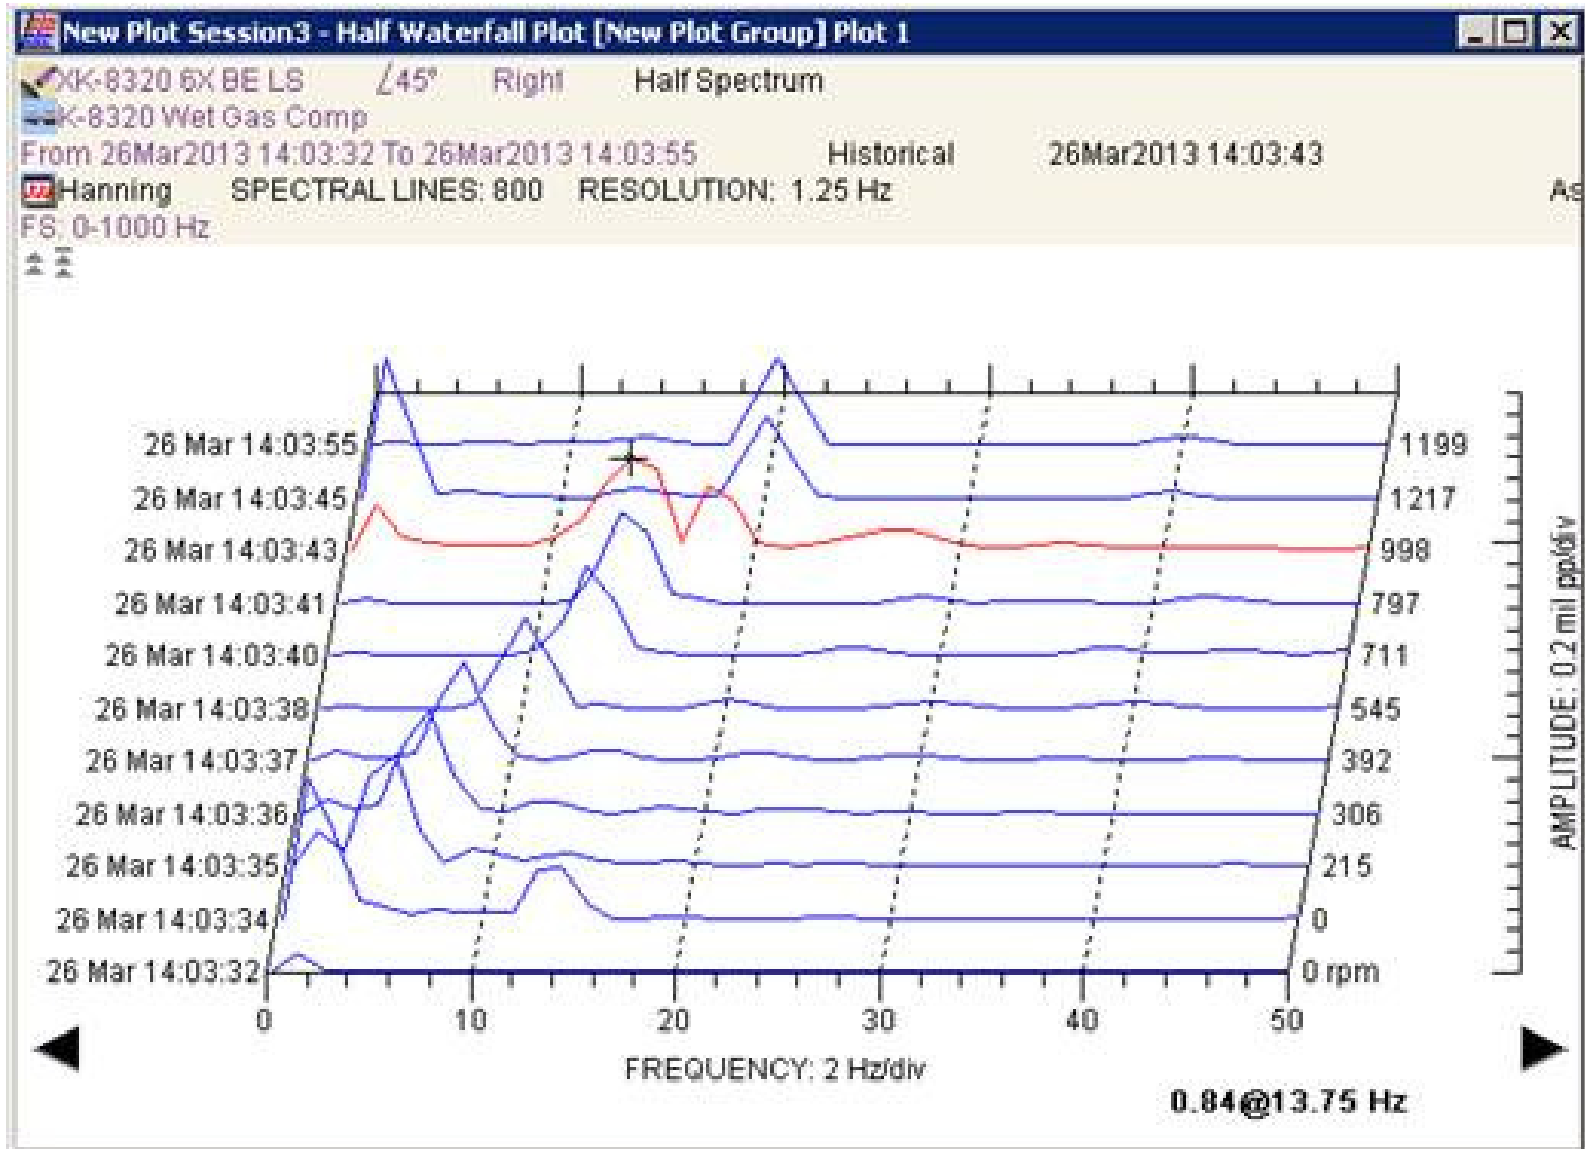
Vibration Data from Successful Start-up 3/26
