**43rd Turbomachinery
30th Pump SYMPOSIA**

DRY GAS SEAL FAILURES IN A RECYCLE GAS CENTRIFUGAL COMPRESSOR, CAUSES & REMEDIAL ACTIONS

VASANTH BHAT, SINGAPORE REFINING CO. PTE. LTD.

JIM DEMETRIOU, CHEVRON ENERGY TECHNOLOGY CO.

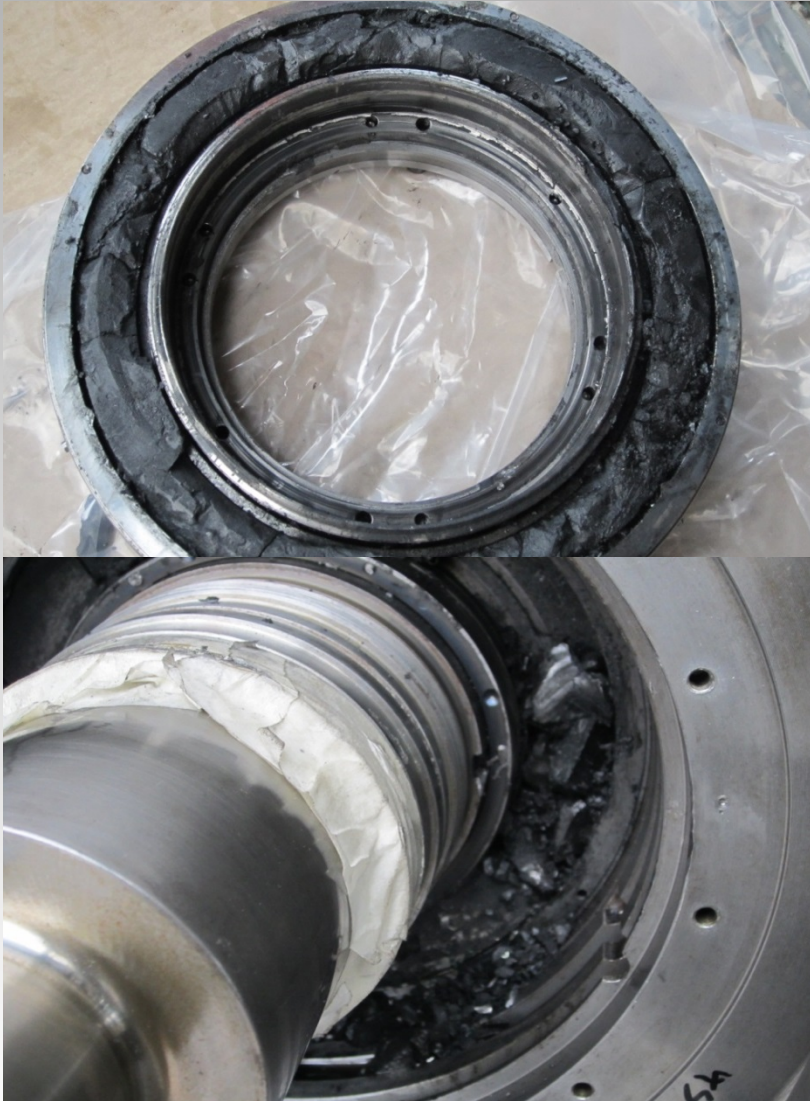
First Failure

- Compressor was started post turnaround.
- No compressor work was done during turnaround.
- After about 13 hours of running the compressor tripped on high primary vent pressure on the suction-side seal.

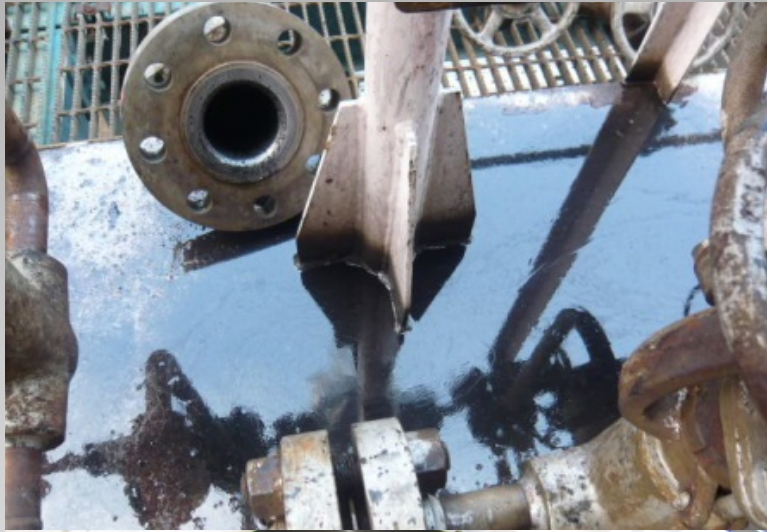
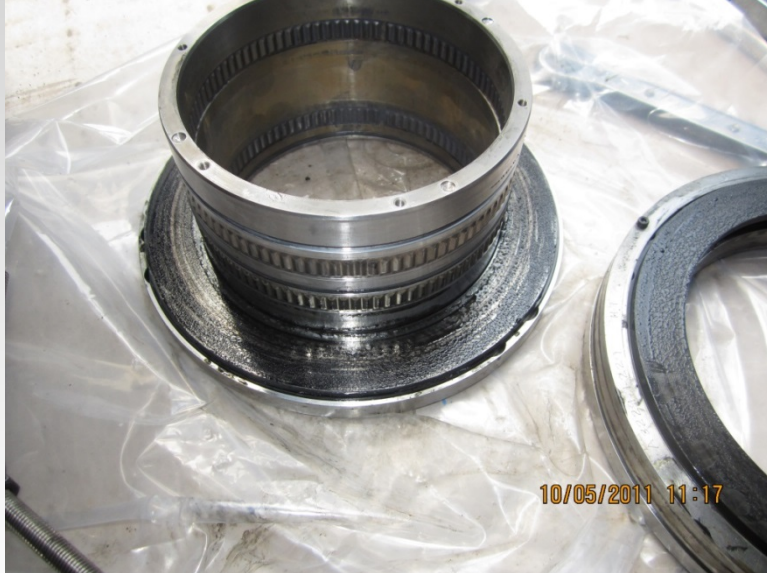
Causes of Failure

- Seal system found heavily contaminated with water-like liquid.
- Suction drum steaming for vessel entry during turnaround done with compressor suction and discharge ESVs left open resulting in condensate building up in the compressor and seal gas system.
- Seal gas take-off from casing bottom allowed for additional condensate to reach the dry gas seal, shattering the faces.

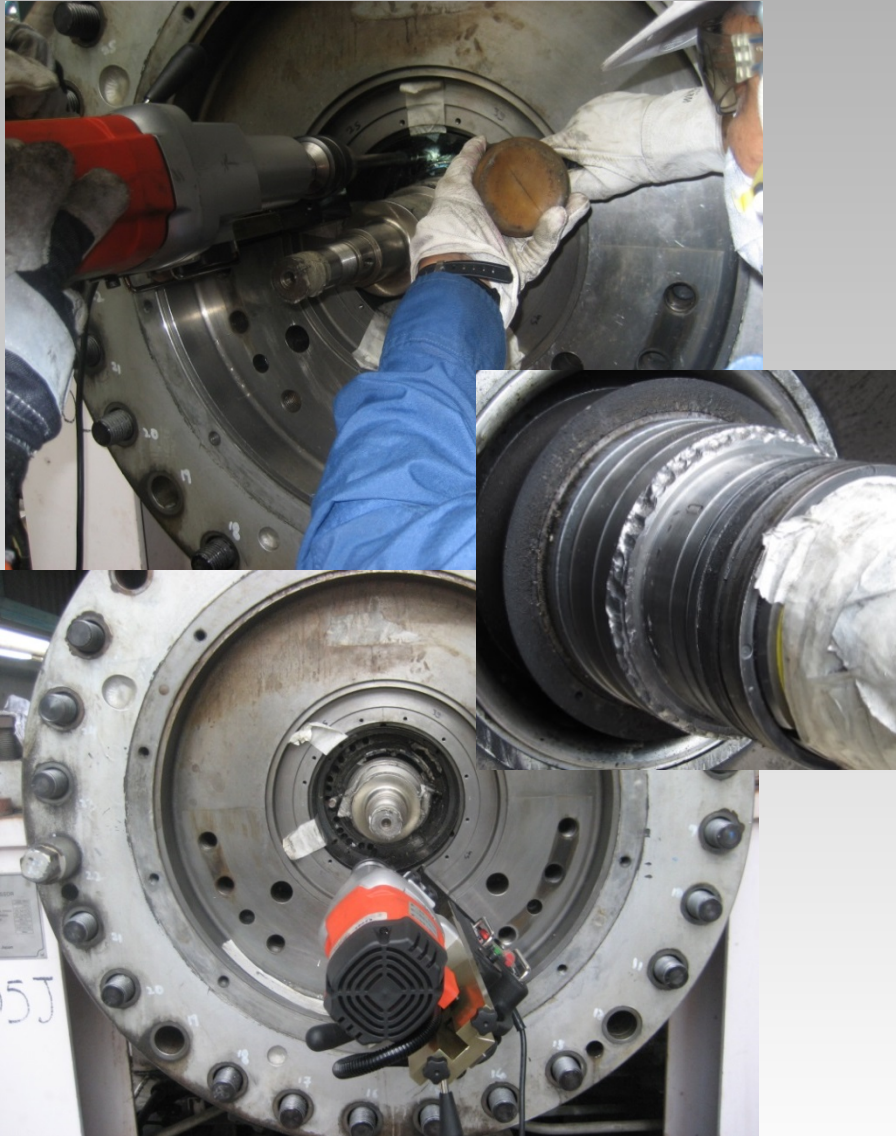
Challenges in restoration

- Dry gas seal rotating face fragments (WC) caused damage that impeded compressor disassembly.
- OEM's previous experience with similar failure: 4 weeks to grind out the stuck sleeve with pencil grinder.
- Spare rotor allowed for partially destructive drilling method for sleeve removal. Rotor was removed within two days and compressor was restarted in 11 days.

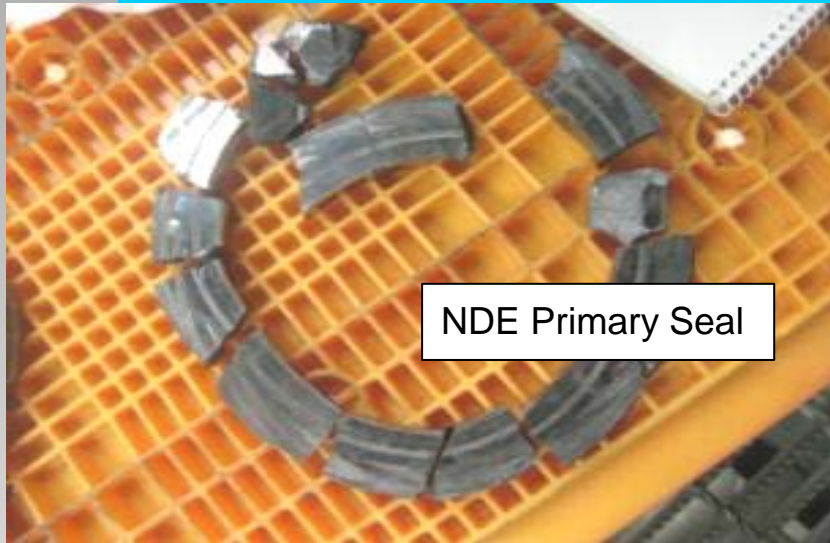
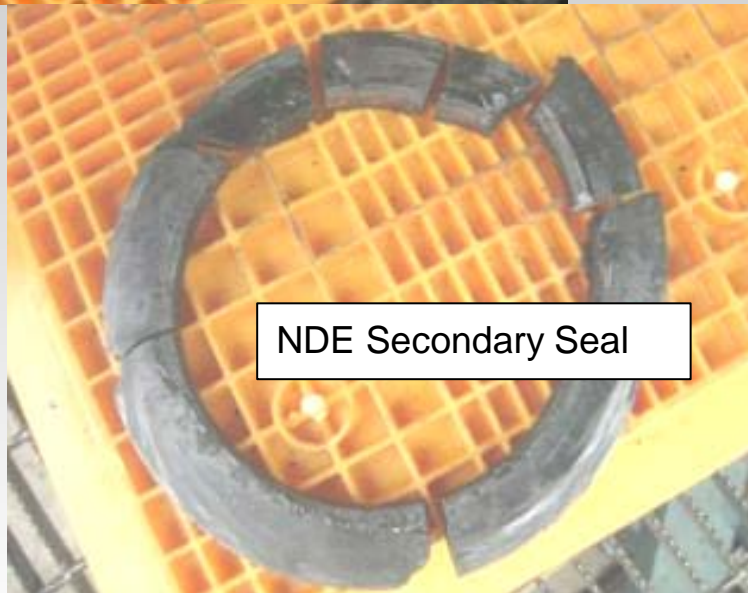
Second Failure

- Compressor tripped on high primary vent pressure on suction side exactly one month after the first post-failure start up.
- Damage similar to first failure with shattered faces and seal stuck on the rotor.
- ***No liquid found.***

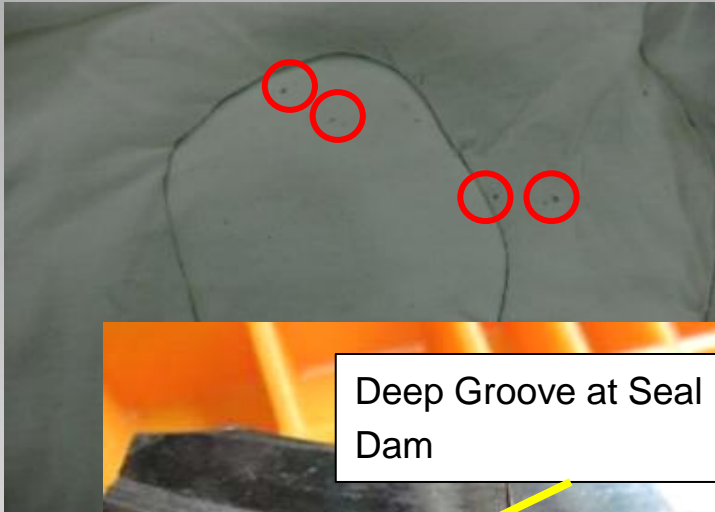
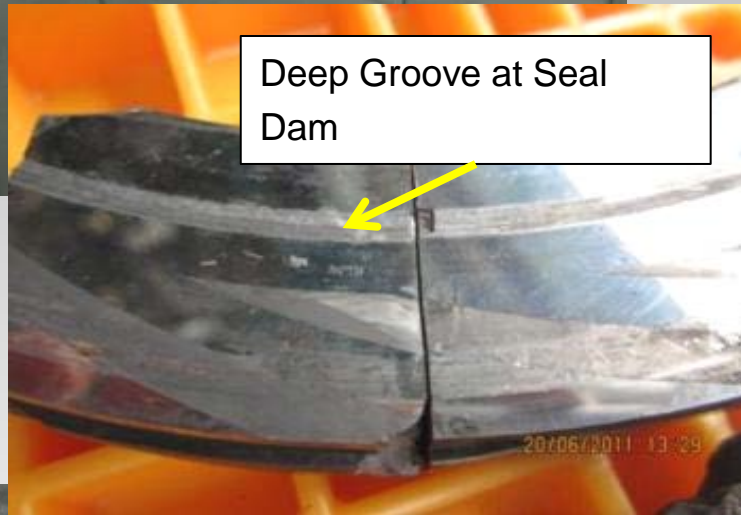
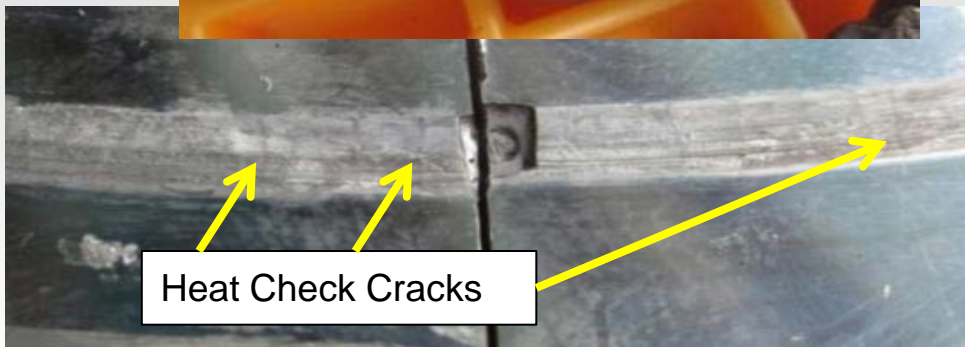
Causes of the Failure

- Presence of particulate contamination in the system due to improper cleaning following first failure.
- Seal gas system high flow excursion due to DP transmitter failure.
- Dry gas seal system vulnerabilities to contamination (both solids and liquids).

- No spare rotor & no spare seals.
- Sleeve was drilled using same technique as the last time but with added precaution to prevent damage to rotor.
- Rotor was repaired at the seal seating area using API recommended rotor repair techniques.
- The seal vendor was able to re groove the discharge end seal from first failure, test and return the seals within 4 days.
- Ensure the root cause is identified and mitigate risks by completing as many recommendations as practical.
- Compressor was restarted in 13 days from date of failure.
