**42nd Turbomachinery
29th Pump SYMPOSIA**

Proceedings of the Forty-Second Turbomachinery Symposium
October 1-3, 2012, Houston, Texas

CO₂ CORROSION ON NATURAL GAS COMPRESSORS: CRITERIA AND GUIDELINES

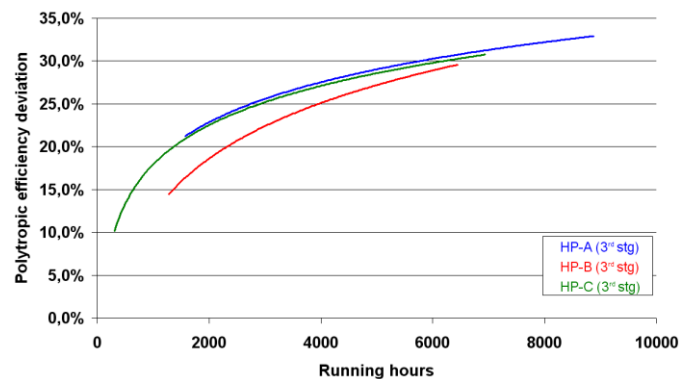
For case A, in the very beginning of the compressors operation, a deviation on the thermodynamic performance of the third section was detected by the maintenance team (Figure 2). The first hypothesis considered was wearing off labyrinths clearances due to a high number of starts.

Figure 2. Historical trend of polytropic efficiency deviation for case A compressors.

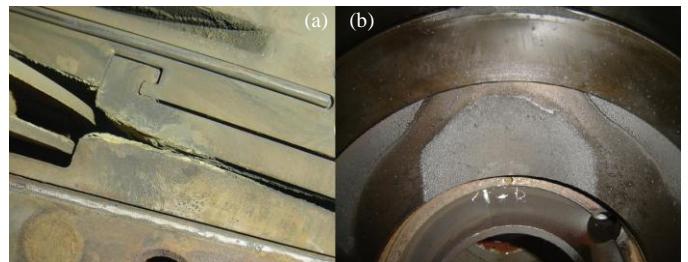
Due to the premature lack of capacity, an overhaul was scheduled for each HP compressor at 7,000 running hours. During the first overhaul of compressor B, it was noted that clearances were OK. Heavy deposit was found at first impeller and diffuser of second phase and suction volute was found corroded, as can be seen on Figure 3. Compressor B was completely cleaned and return to operation with restored performance.

Figure 3. Plugged diffuser (a); corrosion at suction volute (b).

The starting point of the investigation was the analysis of the deposits found at the first impeller and diffuser. An X-ray diffraction analysis detected that the deposits were mainly Siderite (FeCO_3), which is the corrosion product of carbon steel in CO_2 environment.

The results from deposits and gas analysis indicated that carbon steel was being corroded by CO_2 and its product was getting stuck in the first diffuser. The result was a reduced gas passage area (roughly to 30% of the original area), limiting the compressor performance.

Considering the expected life of the compressors, which should be, at least, 25 years of operation, and the fact that it was one of the possible sources of the corrosion product particles (see Figure 2), an action was needed to stop corrosion at suction volute of second section of high pressure compressor. A corrosion inhibitor system would be easier to implement, however, the operational cost would be much higher than protecting carbon steel surfaces of the compressors. Many alternatives were taken into consideration and, in the end, electroless nickel plating was chosen as a coating. Advantages

of this process are its hardness (effective to avoid erosion and diffuser plugging), small thickness (almost negligible to final dimensions of parts), strong adhesion and good capability to reproduce the base surface. Moreover, it could be applied on parts locally, without the need to ship the parts back to the compressor manufacturer, and at a far shorter time range than the manufacture of new parts in corrosion resistant materials. Casing, counter-casing, 1st and 2nd diaphragm sectors were coated. As all impellers were manufactured in 17-4 PH stainless steel and treated to achieve high hardness, there was no significant benefit to coat them as well.

As described above, the most probable cause for the adhesion of the particles at the first diffuser was the presence of condensate, which acted as a glue to gather the particles. Gas from scrubbers to suction flange is theoretically saturated, but few mist carry over is expected. Additionally, even if lines are completely insulated, a very small quantity of liquid is inherent to this kind of application. To completely avoid hydrocarbon and water condensate at compressors inlet, gas shall be superheated. The dew point of the gas coming from the 2nd compression section at this section discharge pressure was calculated to be around 48°C. As per design, compressor should run with 35°C at all the three sections suctions. For the third section suction, this meant that there would be liquid formation at suction scrubber and that the scrubber gas outlet would be saturated, if not with some liquid carry-over.

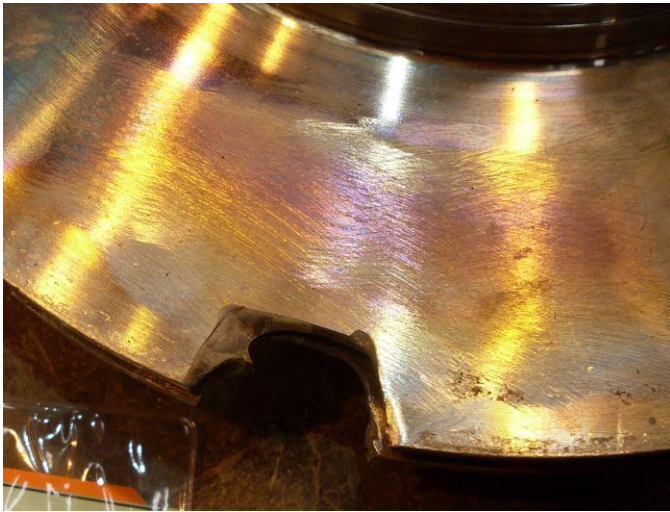
Figure 4. Failed impeller (cleaned).

During the second overhaul (compressor A), beside the same deposit and corrosion found on compressor B, the first impeller of second section was found damaged, with detached parts of the disc and cover at the outer diameter (Figure 4). Significant erosion on blades trailing edge was also detected, as presented on Figure 5. When later overhauled, compressor C was found in similar conditions.

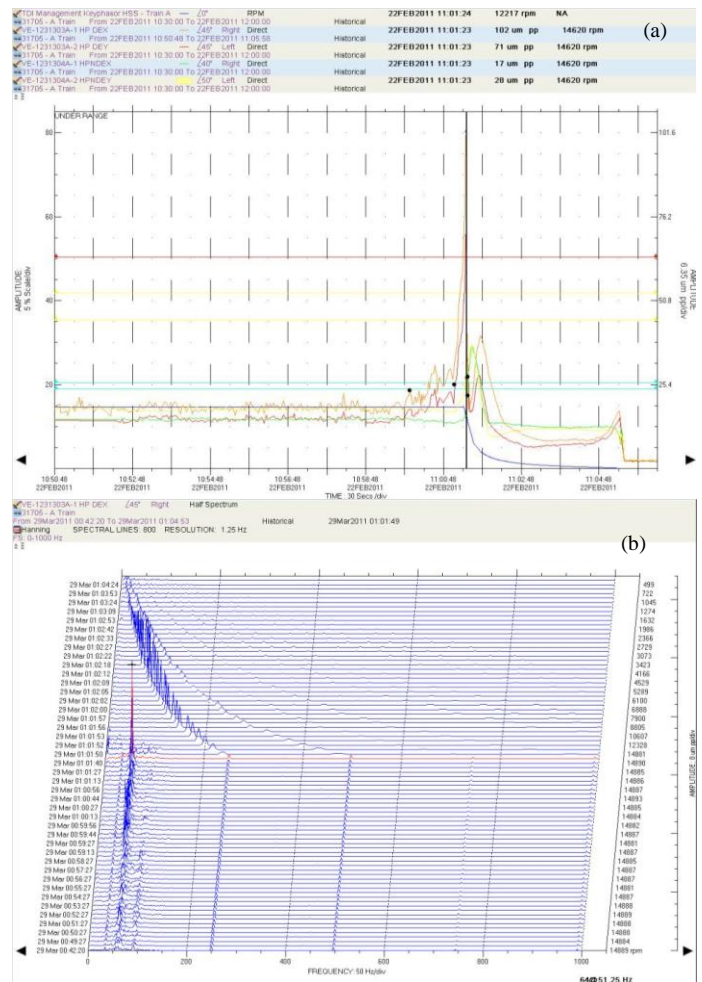
passages, no performance loss greater than the expected due to compressor fouling was identified. The issue only appeared once the compressors started tripping due to sudden very high vibration at the high pressure, straight-through, casing drive end. This would be the side of the suction of the third compression section. Further investigation using online vibration monitor systems identified the vibration as being majorly subsynchronous, roughly at 0.2X. Figure 6 presents this vibration behavior as captured by the vibration monitoring software. It was also observed that this particular vibration signature was highly dependable on flow through this compression section: at high flow, no particular vibration frequency other than the unbalance (1X) response, but as flow was decreased a diffuse, low amplitude rash would appear at low frequency (0.1-0.3X), before suddenly concentrating in a single peak that would in most times trip de compressor train.

Figure 6. Vibration trend showing sudden peak (a) and waterfall showing the subsynchronous frequency (b).

For an early detection of this issue through vibration, users should regularly monitor vibration for any unusual non-synchronous vibration. Small amplitude rash in a broad low frequency range of the vibration spectrum, visible especially at low flow operational points, could be a hint of pre-stall flow conditions. In such cases, compressor outage for overhaul could be postponed to allow for proper intervention planning, by operating at higher flows (for example, by partially opening the recycle valve), therefore avoiding the surge conditions. Such postponement may lead to more internal components being damaged and even consequences external to the compressor: in one case the anti-surge valves begun to stuck due to the presence of corrosion product particles in the gas.

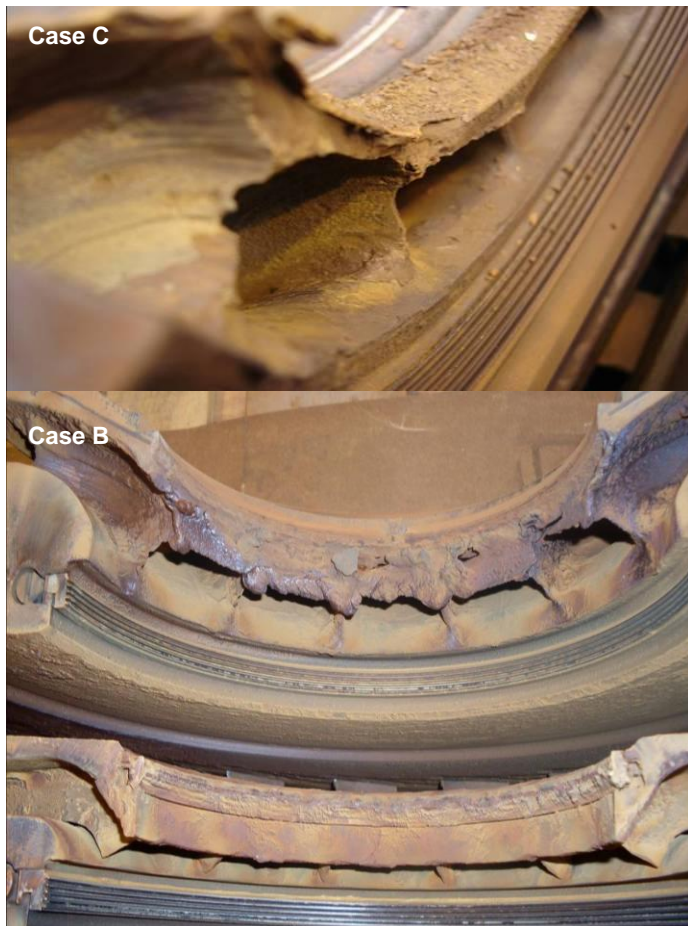
At the time, the issue was diagnosed as aerodynamic stall events. The diagnosis was later confirmed once the compressor bundle was opened and inspected. Corrosion and erosion had severely damaged the inlet guide vanes and the low solidity diffuser vanes of the third section, causing a significant gas path geometry change that led this section to be prone to stalling, as shown in Figure 7.

Figure 7. Damages found at inlet guiding vanes.

On the other cases, although no erosion was identified at the compressor impellers, it occurred at the low solidity diffuser vanes, to extend of causing some to detach from their mount on the diaphragms.

Because of these good, field-proven, results, the electroless nickel coating, jointly with stainless steel sleeves for exposed shaft parts, was adopted as solution for other similar cases and are under implementation. Although the superheating of the compressor suction gas could not be implemented in this other units due to operational limitations in the cooling water system, the authors believe that the electroless nickel coating will be enough to avoid large scale corrosion.

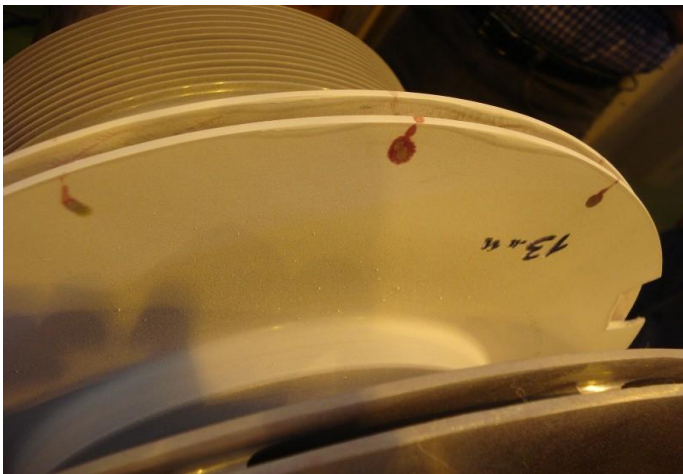
Inspections detected that fractures that led to detaching of parts were started at blades trailing edge. As can be seen in Figure 8, these edges were found heavily eroded: only a very sharp edge was left at the blade. This led to a stress concentration even higher than that resulting from the blades machining after the shop acceptance tests. Finite element analysis showed that the impeller cutback increased stress at edges but still far from yielding strength. The high localized stress at the blade edge led to crack nucleation and, over time, impeller failure. Dye penetrant test was performed at failed impellers and clearly detected cracks initiated at blades trailing edges (Figure 8).

Figure 8. Dye penetrant test at impeller outer diameter.

Two possible causes for the blades trailing edges erosion were considered: liquid ingestion and corrosion product particles. Although the presence of particles was confirmed, it was not clear if the amount of particles could have resulted in such fast and severe erosion. On the other hand, there was no reason to suspect that a significant amount of liquid was being ingested by the compressor: very few condensate (hydrocarbon or water) is formed at the third section suction scrubber, most of it having been knocked-out in previous compression sections, and there were no records of high liquid levels at these vessels.

Most likely, a combined effect resulted in the observed erosion. The liquid present at the compressor suction might have aggregated the thin corrosion product particles into big heavy drops that could more easily erode the impeller.

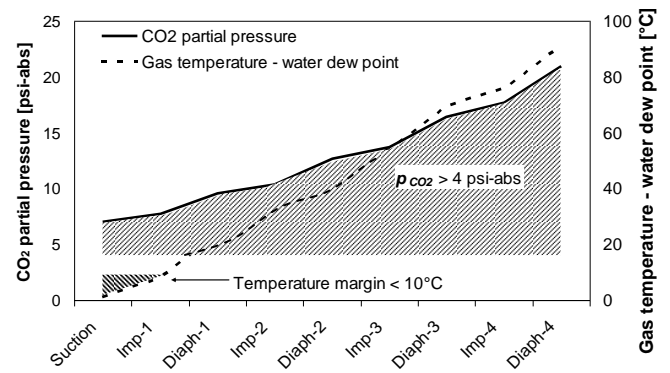
With these results, a map with the estimated gas conditions at each compressor component can be made, allowing the identification of the components that may be prone to CO₂ corrosion (Figure 9).

Figure 9. Example of a compressor CO₂ partial pressure and temperature to water dew point margin map. In this case, the gas path up to the first diaphragm is expected to be in conditions under which the CO₂ corrosion can occur.
