FIELD INVESTIGATION OF GEARBOX VIBRATION DUE TO CRACKED MOTOR ROTOR BARS

BY ROSS PINNER
AND TROY FEESE

42nd Turbomachinery
29th Pump SYMPOSIA

Problem Statement

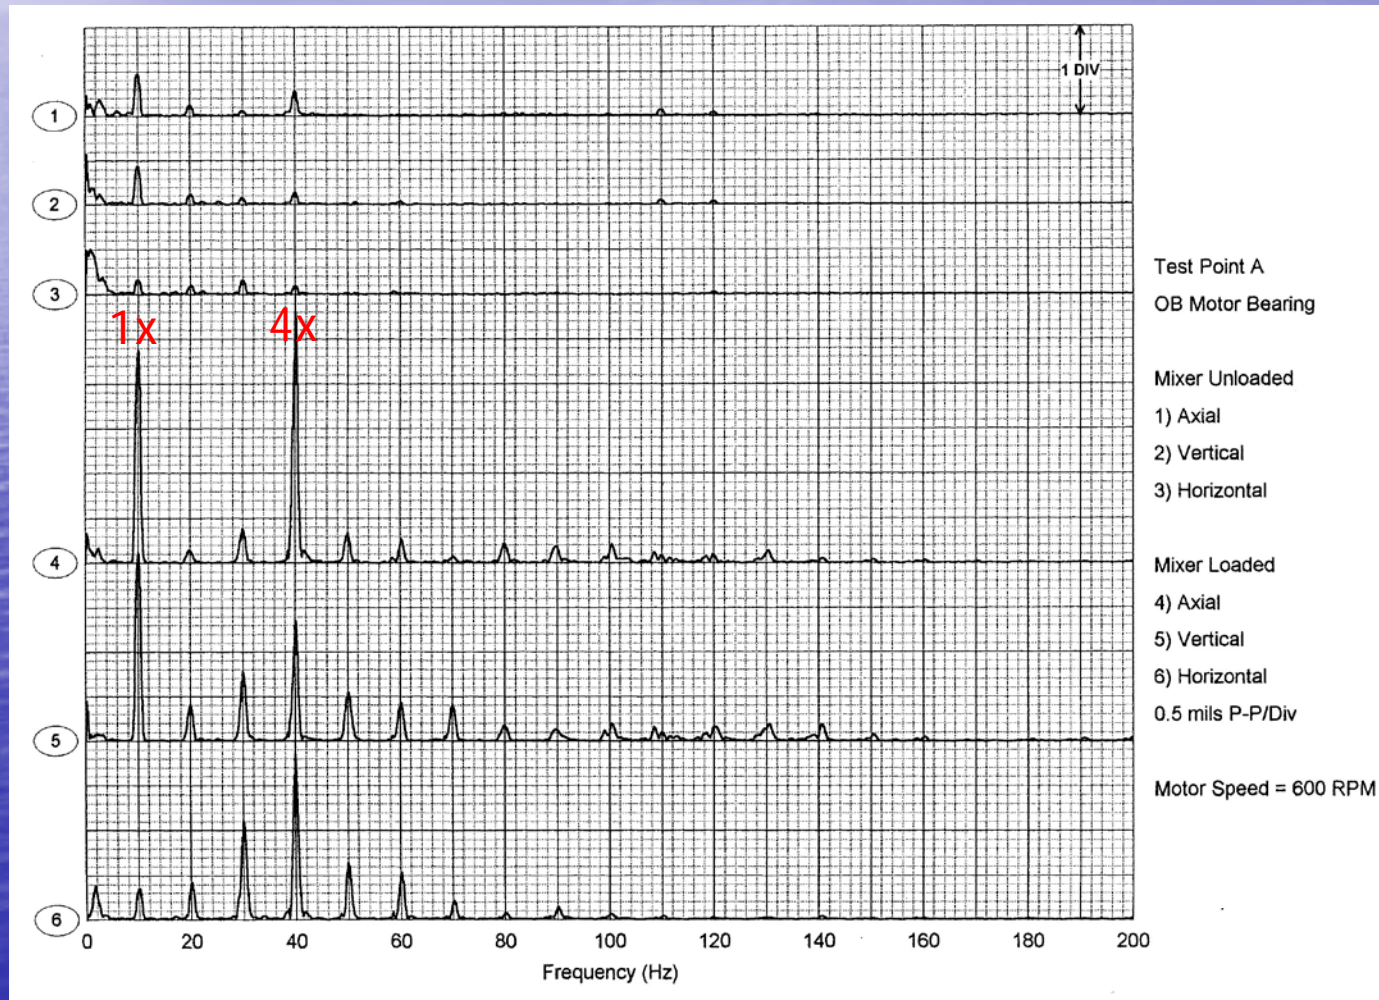
Note high vibration at 4x motor speed when mixer was loaded.

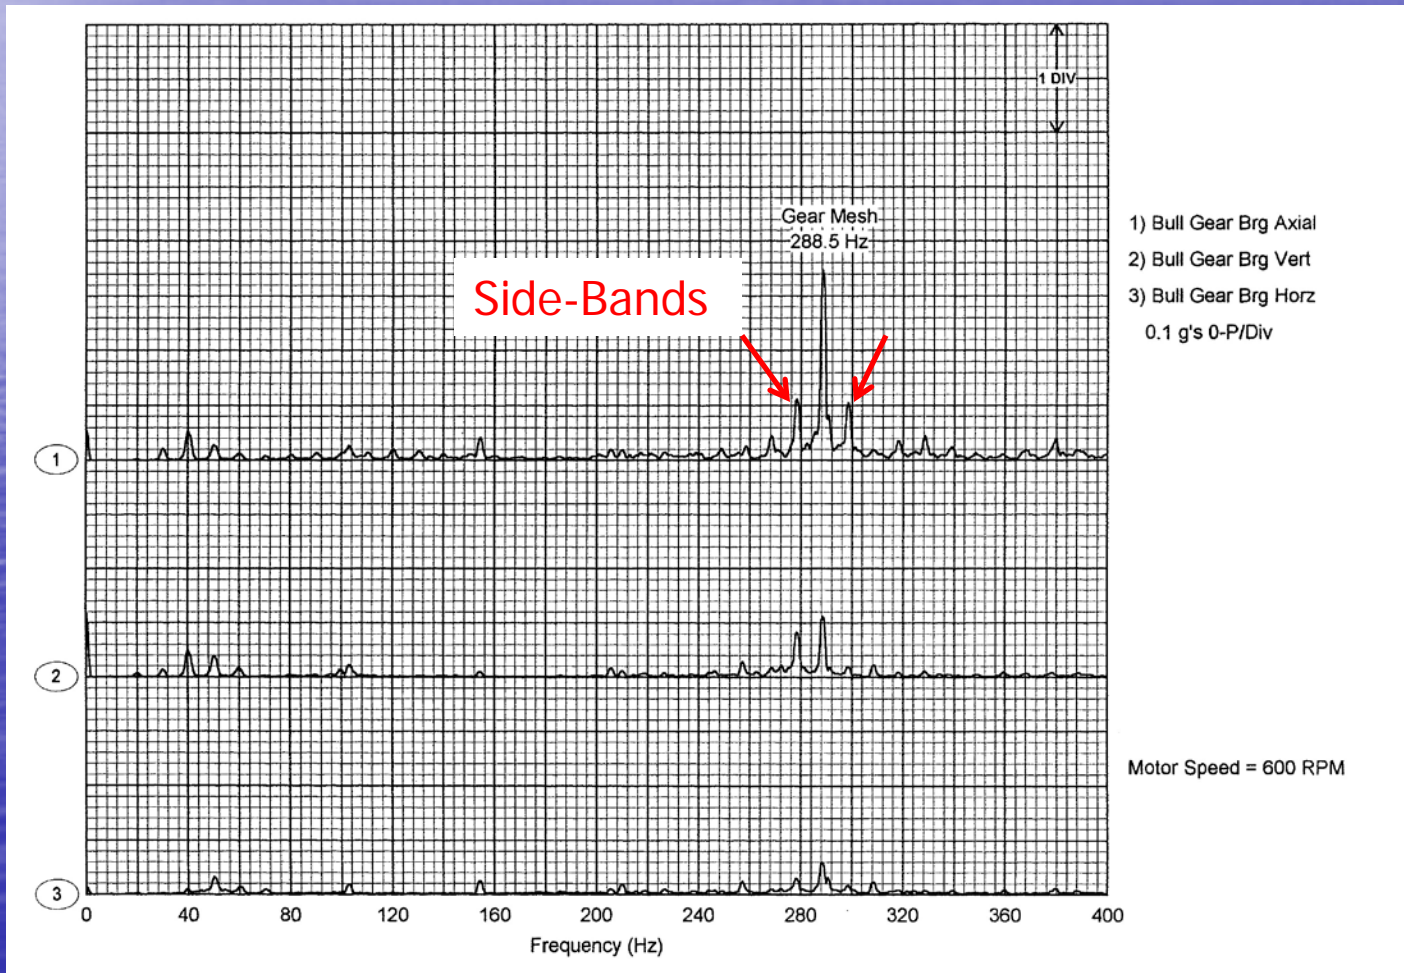
0.17 g's peak at gear mesh frequency
Note side-bands with 10 Hz spacing
This indicates fluctuating motor speed

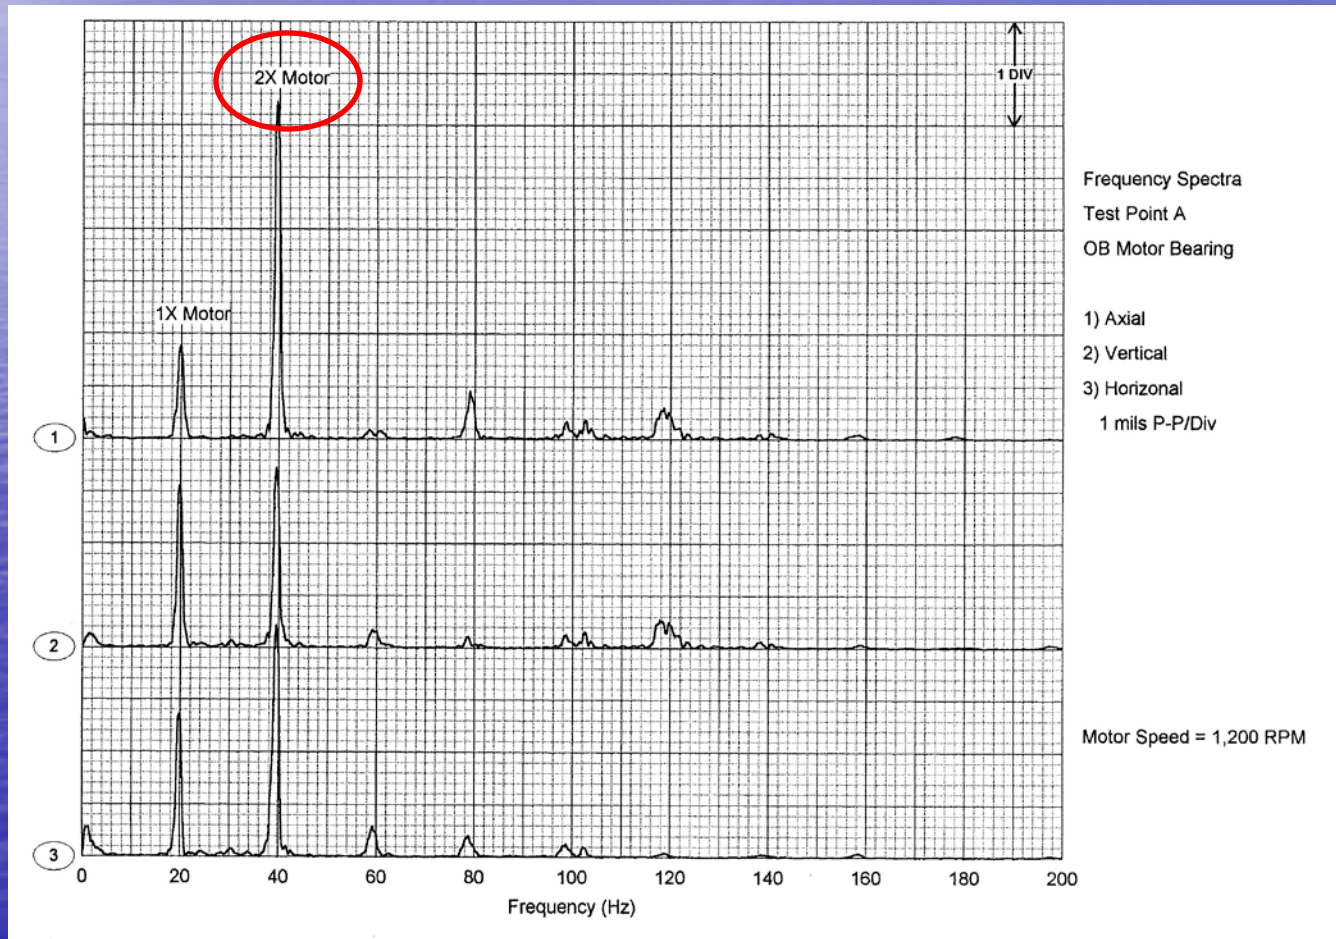
Motor Vibration > 3 mils p-p at 2x Running Speed

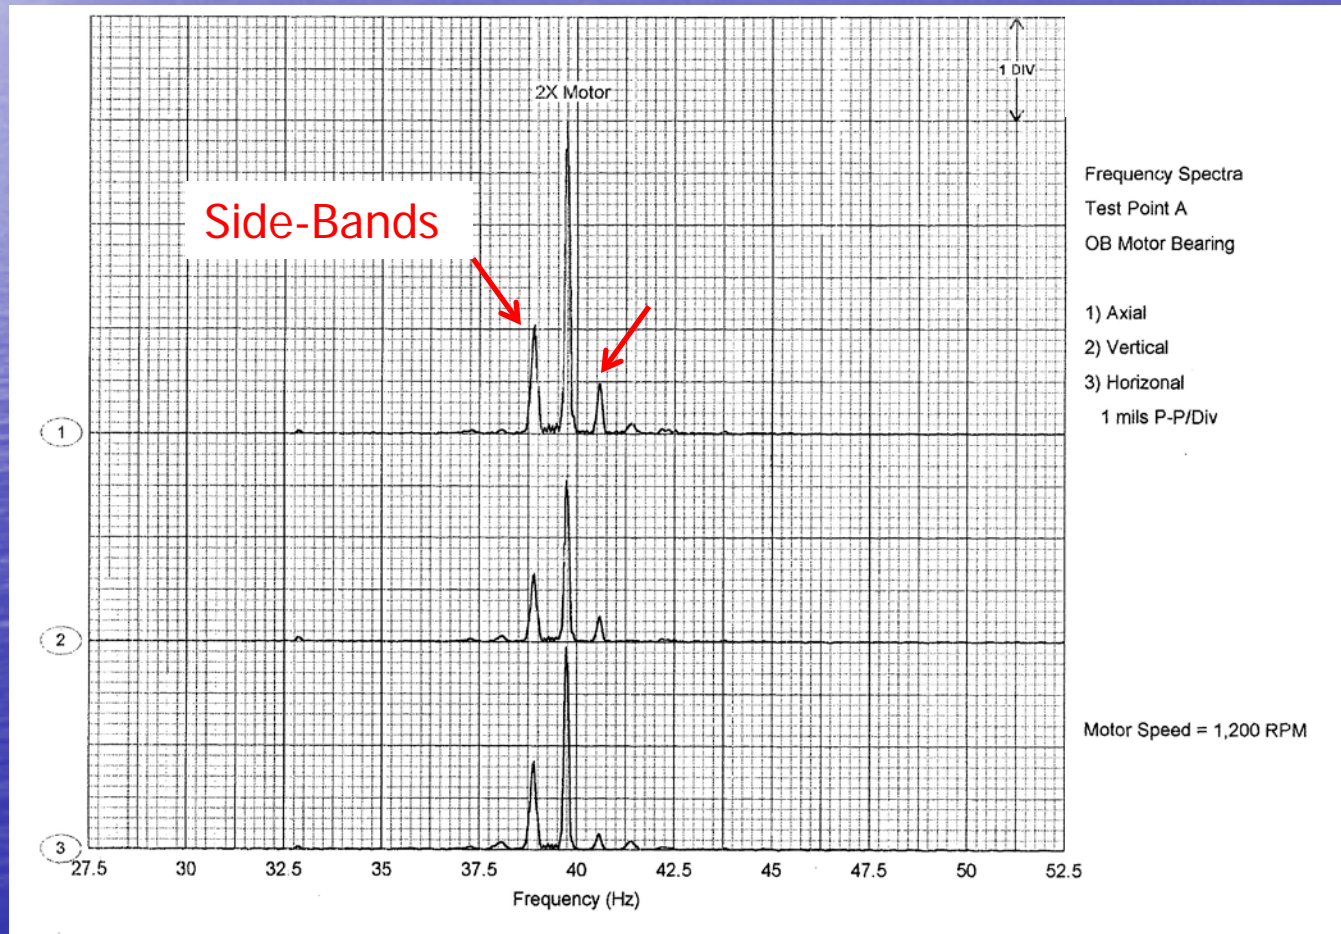
Frequency Zoom Window of Motor Vibration

- No problems found with new gearbox.
- Cracked motor rotor bars caused vibration of motor, gearbox, and plant floor.
- Vibration and current analysis used to diagnose motor rotor bar problem.
- Was not previously detected by motor shop because not tested under load.
- The Babbitt in the motor bearings was also damaged.

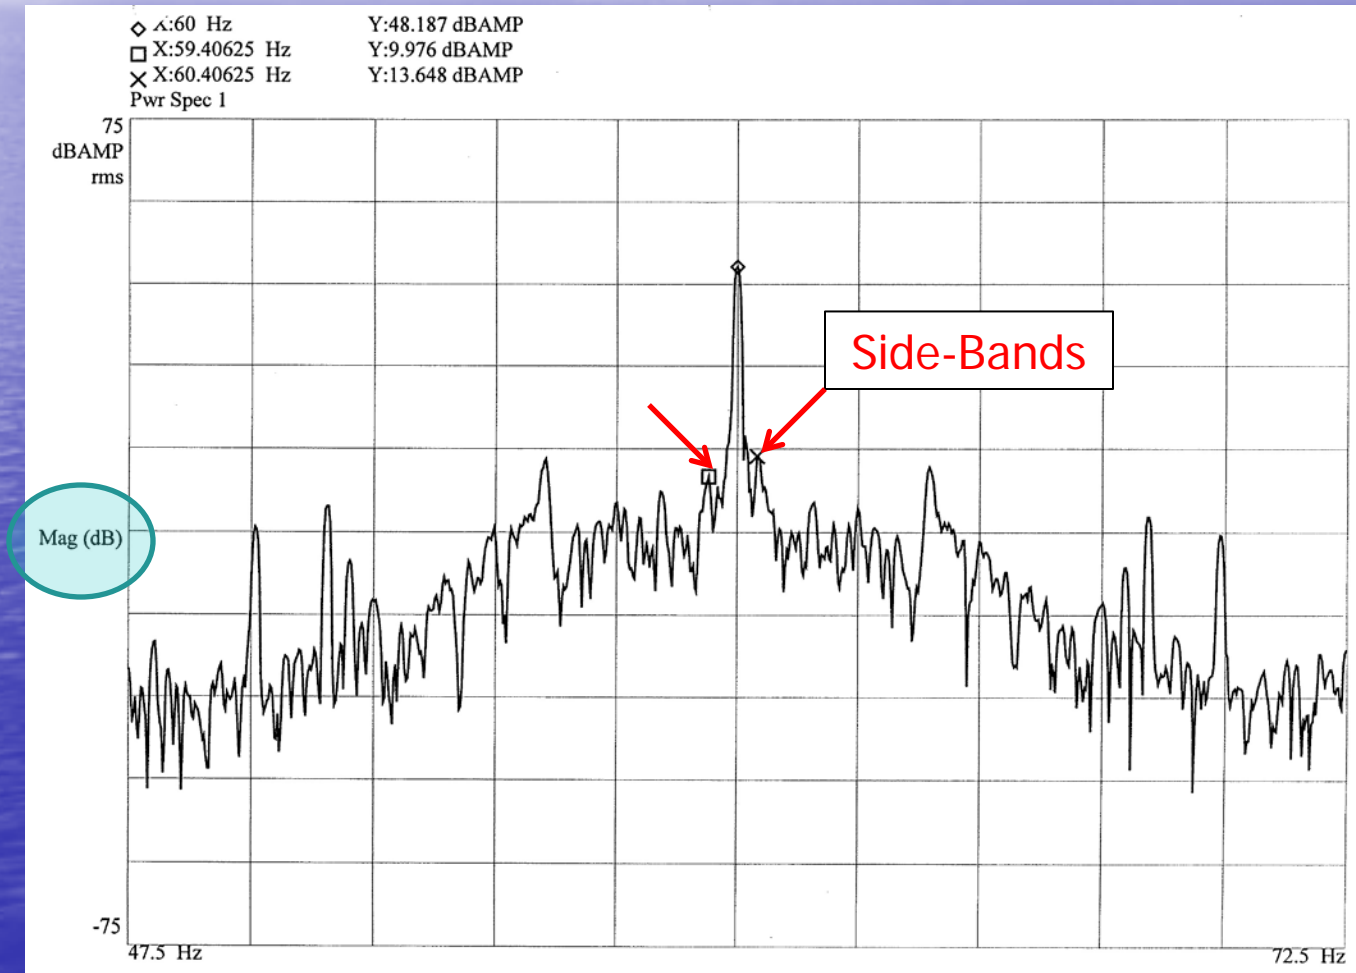
- Mixer not loaded long enough at low speed.
- At high speed, side-bands less than 45 dB below line frequency indicates a problem.
- Motor Speed at Full Load = 1192 RPM,
Slip Frequency = 8 RPM or 0.1333 Hz
- Spacing of Side-Bands =
Slip Freq x No. Poles ($0.1333 \times 6 = 0.8$ Hz)
- Repeated loading / unloaded hard on motor and believed to cause fatigue cracks.

48 - 10 = 38 dB Perform Vibration Test
48 - 14 = 34 dB Overhaul ASAP
