**INNOVATIVE DESIGN IN EXPANDER WHEEL-SHAFT  
ATTACHMENT REPLACES HIRTH COUPLING  
FOR  
HIGH SPEED, HIGH TEMPERATURE AND HIGH POWER  
APPLICATIONS**

**HOUMAN SHOKRANEH, PH.D.  
DIRECTOR OF ENGINEERING  
L.A. TURBINE**

**42<sup>nd</sup> Turbomachinery  
29<sup>th</sup> Pump SYMPOSIA**

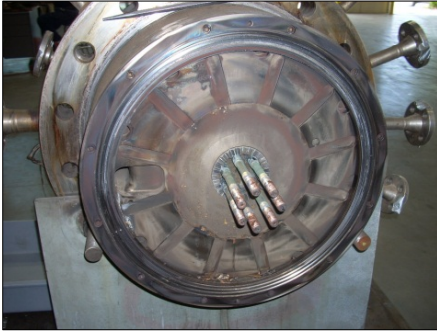
2007

- Hirth coupling attachment was failing on all previous designs.
- Inconel 718 retaining bolt was also failing-either severely bended or completely cut off.
- Because of above reasons, in all failures the expander wheel was completely separated from the shaft, and it was rubbing to the follower and the housing, thus not much evidence was left for useful metallurgical analysis.

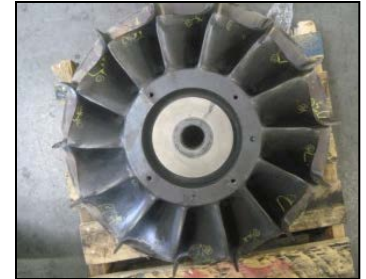
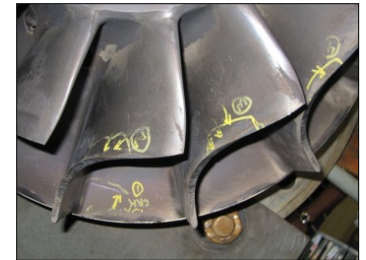
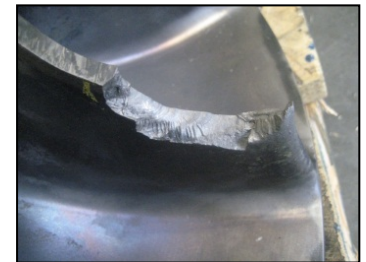
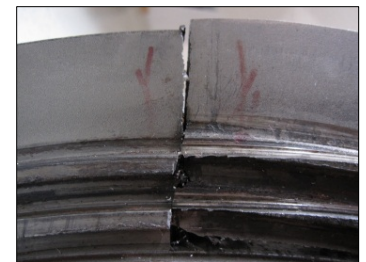
1. Expander wheel was attached to the shaft and retaining bolt was intact.
2. Build-up from the operating steam was firmly attached to the blades OD and was causing friction between expander wheel blade and the follower.
3. Expander wheel blades were cut off in several locations, signs of high cycle fatigue observed.
4. Expander wheel disc had cracks in three locations on the OD.

- No change made to shaft-wheel attachment.
- Increased the clearance between the expander wheel and the follower to avoid rubbing on blade's outer edges.
- Wheel resonance reevaluated on complete rotor assembly and with the maximum stretch on the retaining stud. Few blade frequencies observed to be close to the operating speed. By cutting blades in front and on the OD, safety margin increased on these frequencies.
- Back wheel seal design changed to increase the clearances and consider the wheel expansion by centrifugal forces and temperature.

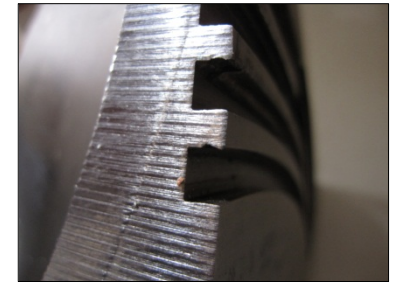
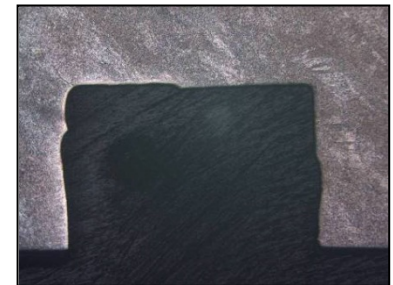
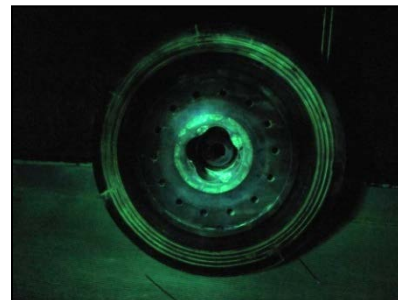
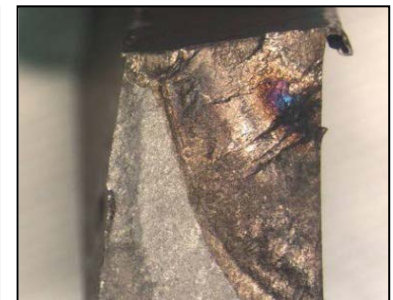
5. Disc cracks were initiating from the third stage of the back wheel seal on all three locations.
6. Signs of severe rubbing were observed between the wheel and back wheel seal inside all four stages of the back wheel seal. Material property changed locally and became brittle.
7. Discovered electrical current was passing through the unit. Signs observed on blades between each crack and between shaft and wheel shoulder surface.

- New grounding system implemented on all casings on four different locations, and on two places on the shaft with higher capacity brushes to eliminate current migration through the unit.
- Moved sphere pivot to 55% position under each pad to improve the bearing stability.
- Used new Cr-Cu material for bearing casings to transfer heat faster to the bearing housing.
- Repaired both oil pumps to ensure the maximum capacity of oil flow is reachable.
- Cleaned up oil piping and filters.

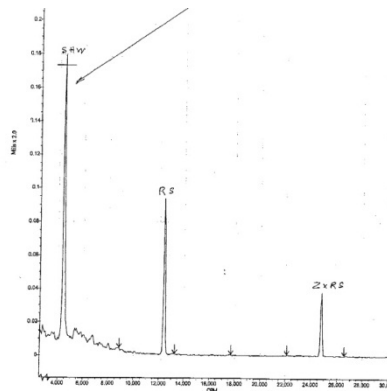
8. Serious instability observed during operation after the start-up but the vibration limit was steady and less than two mils.

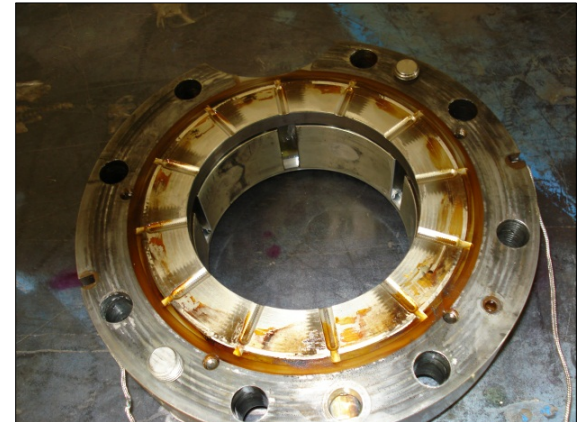
9. On both bearings, journal pads and thrust faces were showing signs of high temperature exposure.
