RCFA for Recurring Impeller Failures in a 4.7 Mtpa LNG Train Propane Compressor

ABSTRACT

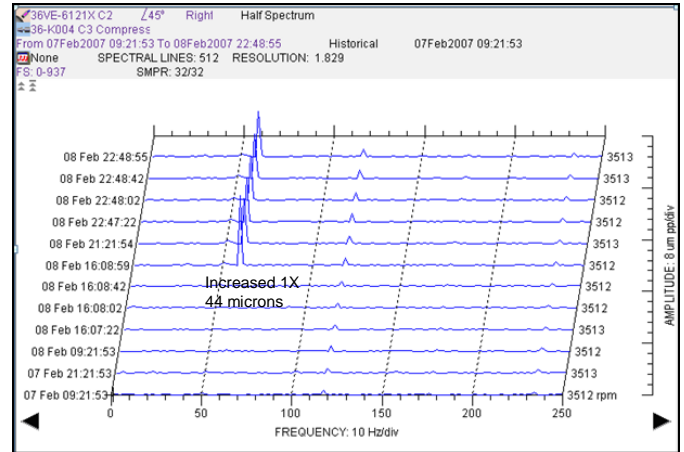
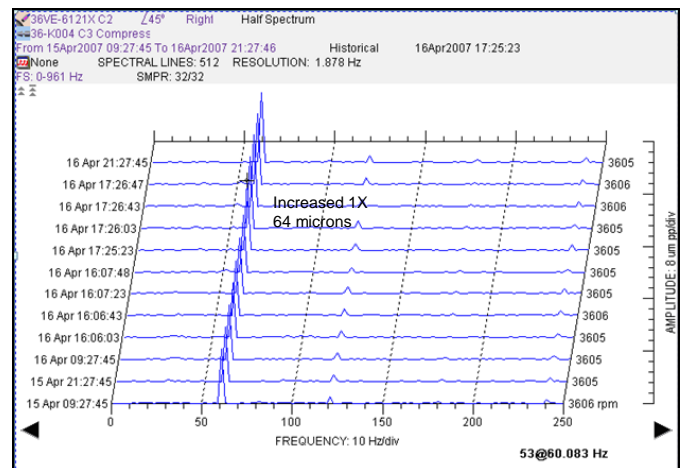
A vibration step change increase from 0.63 to 1.73 mils (16 to 44 microns) was measured at the non drive end journal bearing on 8th February 2007. This remained constant until 16th April 2007, when a second step change increase to 2.52 mils (64 microns) was measured. Analysis of the vibration spectra using waterfall diagrams is shown in Figure 3. The step change occurred during steady state operation at 3600 rpm indicating a rotor unbalance increase and possible mechanical damage.

First Step Change on 8th February 2007, right half spectrum

Second Step Change on 16th April 2007, right half spectrum
Figure 3. Waterfall plots for non drive end journal

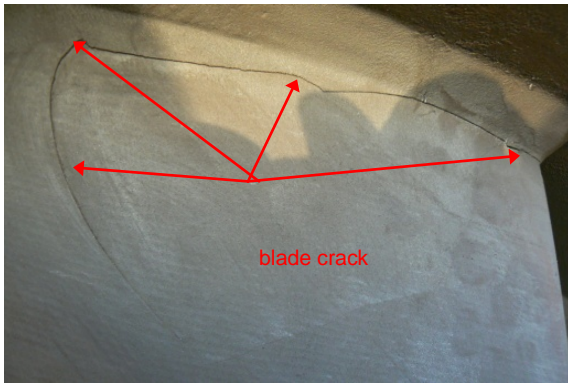
Although the vibration level was high, it remained steady and below the alarm limit of 3.15 mils (80 microns). The End User decided to accept the risk of continued operation until the next scheduled maintenance outage on 12th June 2007. At this point, the rotor had reached 29,000 operating hours. Upon inspection, one blade on the third impeller was found to have cracked and two adjacent blades on the fourth impeller had cracks with large released pieces. The fifth impeller had also

Figure 4. Third Impeller cracked blade leading edge – June 2007

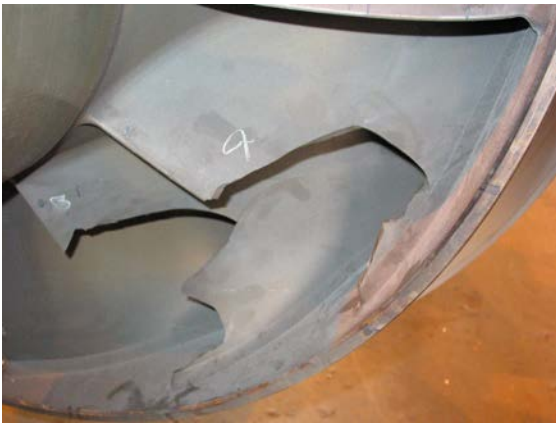
Figure 5. Fourth Impeller released pieces from blade leading edge – June 2007

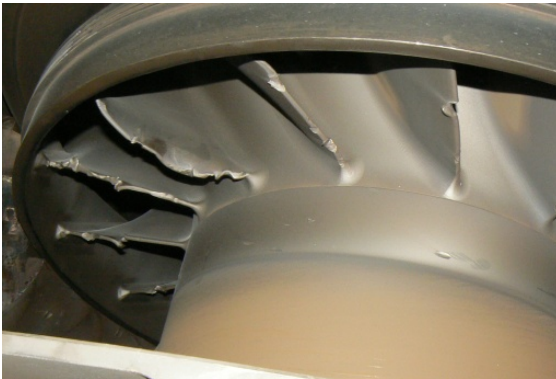
suffered blade leading edge damage from collision with the upstream released pieces. Photographs of each impeller are shown in Figures 4 – 6. The whole rotor was replaced with the warehouse spare during the scheduled shutdown. The damaged rotor was immediately packaged and shipped to the OEM for detailed inspection and repair. In total, the damaged rotor caused an additional six days of downtime, which resulted in significant losses in LNG production and revenue.

Figure 6. Fifth Impeller blade leading edge damage – June 2007

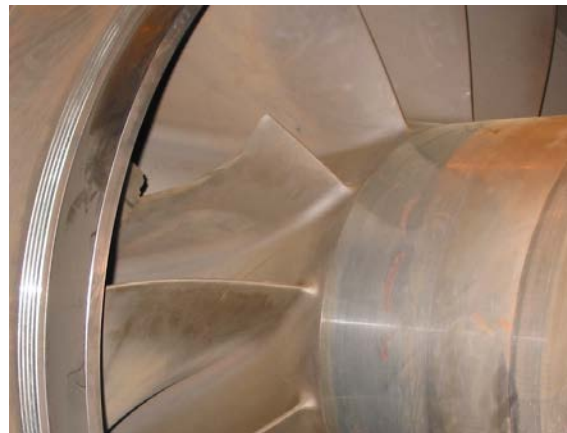
Inspection of the opened unit revealed that the fourth impeller had a single cracked blade with a large released piece (Figure 8). Similar to what was observed in 2007 (Figure 5), the crack appears to initiate at the leading edge of the blade close to the cover. It follows the toe of the weld before turning into the blade and returning back to the leading edge near the mid span of the blade.

Figure 8. Fourth Impeller released piece at blade leading edge – June 2009

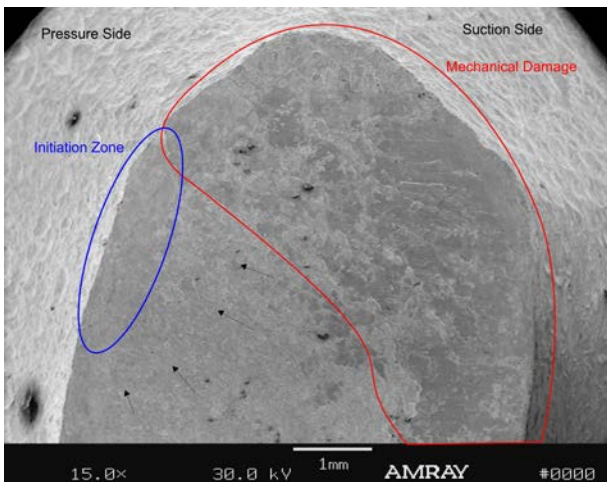
Figure 9. SEM image showing the fracture surface at blade leading edge

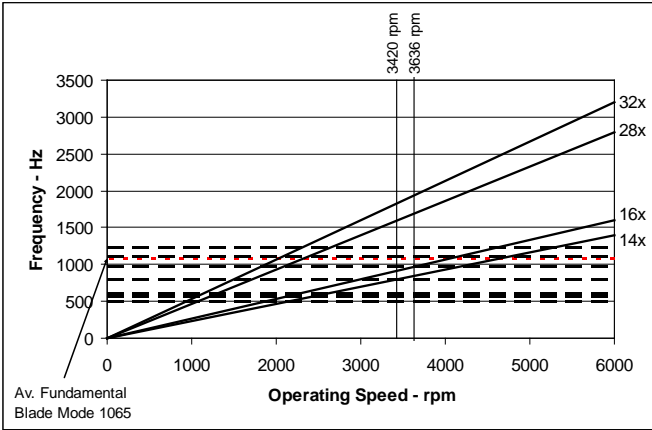
Figure 10 is the Campbell diagram generated from the test measurements on the 2007 failed third impeller. The 14X and 16X vane wake frequencies, as well as twice these frequencies (28X and 32X) are plotted. Three excitable 3-diameter modes were found, one of the disk and two of the blades. The minimum percent separation margin for minor resonance is 11 percent below the 16X return channel vane wake frequency and 36 percent below 32X return channel vane wake frequency. Five 1-diameter modes were found, three of the disk, and two of the blades. The minimum separation margin for each of these excitable minor resonances is 19 percent above the 14X side load vane wake frequency and 19 percent below 28X side load vane wake frequency respectively. The 1-diameter disk mode is inherently difficult to excite due to shaft coupling.

The highest vane pass excitation from the 16X return channel vanes of 970 Hz is 7 percent below the lowest blade leading edge mode of 1040 Hz which is considered marginal. However, the blade with a long crack without a missing piece still had a blade frequency with margin from 16X speed. Although not plotted in Figure 10, the 17X and 18X signals would intersect the lowest blade mode frequency of 1040 Hz below the maximum continuous shaft speed. This was the main potential cause of blade resonance discovered from the testing. The side load with 14 vanes is a 90-degree inlet so that flow is non-uniform giving higher harmonics above 14X that could excite blade modes for the third and fourth impellers.

Figure 10. Third Impeller Campbell Diagram from 2007 failure

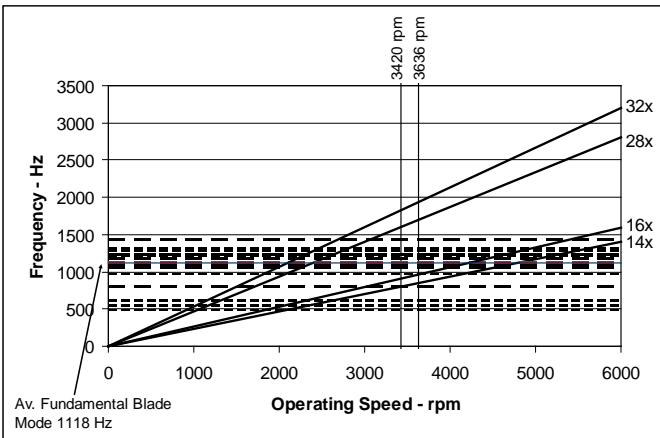
Figure 11 is the Campbell diagram generated from the test measurements on the 2009 failed fourth impeller. The same vane wake frequencies, as for the third impeller are plotted. One 3-diameter mode was found of the disk. The percent separation margin for excitable minor resonance is 11 percent below the 16X return channel vane wake frequency. Three 1-diameter modes were found, two of the disk, and one of the blades. The minimum percent separation margin for each of these excitable minor resonances is 16 percent above the 14X side load vane wake frequency and 23 percent below 28X side

Figure 11. Fourth Impeller Campbell Diagram from 2009 failure

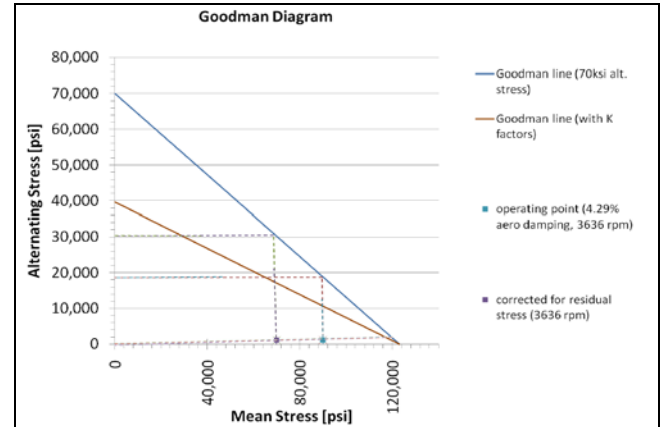
The Goodman Diagram (Figure 17) has two individual plotted points. Two endurance limit lines are plotted; one with and one without the alternating stress K factors. Moving from right to left on the diagram; the first point represents conditions at 3636 rpm which is maximum continuous shaft speed. Applying the compressive residual mean stress of -20 ksi (-137.9 MPa) moves this point on to the second. This is located at a mean stress of 70 ksi (482.6 MPa) and the impeller endurance limit should be judged here. It indicates that a very high Goodman safety factor of 1.7 exists with an applied aerodynamic damping of 4.3 percent. The calculated alternating stress is only about four percent of the fatigue strength. If damping were to reduce to 0.16 percent it would exceed the lower endurance limit line and lead to probable blade failure. This value does seem low but is valid only under the assumption that no weld flaws were found at failure initiations, which could not be confirmed.

the 1-diameter cover/blades mode with the 16X return channel vane wake frequency results in significant but acceptable dynamic stress at the toe of the weld on the blade.

Figure 17. Fourth Impeller Goodman Diagram for 1-diameter cover/blades mode

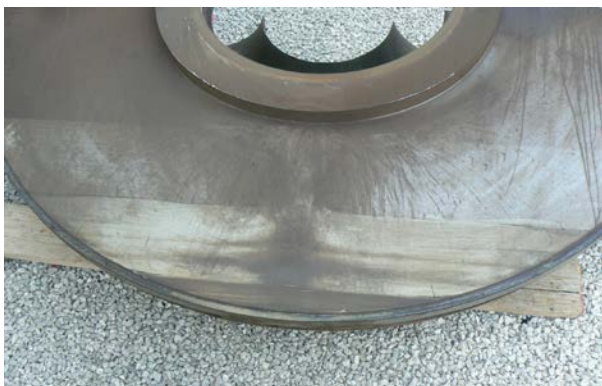
Evidence that liquid ingestion may have occurred was presented during the RCFA performed after the first failure. Figure 23 shows a horizontal stain on a diaphragm taken from the compressor. Swirl patterns (Figure 24) were found on all of the impellers. Erosion damage was found on the pressure side of both the third and fourth impeller blades. This possible cause was a point of contention, but was not pursued further since it was believed that sufficient precautionary measures were in place and the erosion damage was caused by the large amounts of solid deposits which were also found in the gas paths of the impellers. Because it was left as an unclosed item, it was revisited in more detail during the current RCFA.

Figure 23. Photograph showing stains on a diaphragm

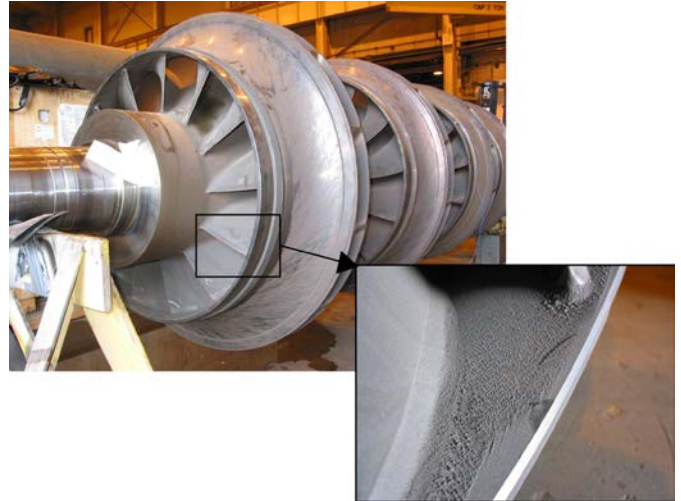
Figure 24. Photograph of the 2007 failed rotor showing swirl patterns on the impellers.

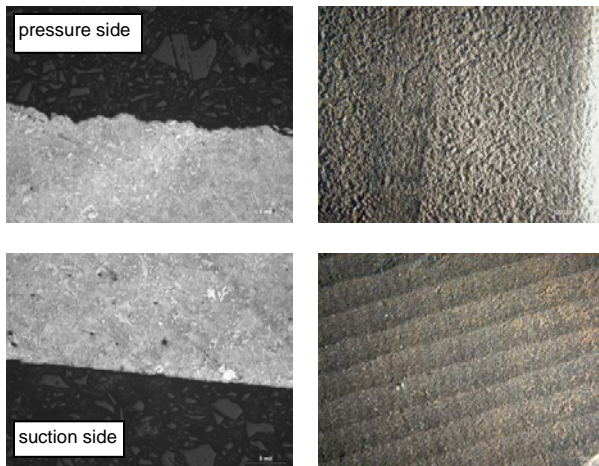
Comparing the cross sectional images in both figures, it is evident that the pressure side of the blade is irregular, while the suction side is essentially flat. As expected, the same observation can be made by comparing the surface images. The suction side surfaces still show the machining marks from the manufacturing of the impellers.

Figure 26. Images of 2007 Fourth Impeller released piece

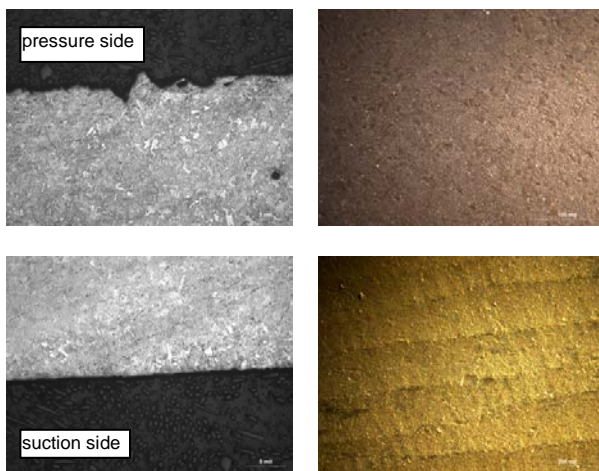
Figure 27. Images of 2009 Fourth Impeller released piece

These marks are no longer visible on the pressure side surfaces. It is very clear that the pressure side of the blades were subject
