# Reliability Improvement for Reciprocating Compressor Valve in CCR Reformer (Case study)

Lee Sang Suk (SK Innovation, Korea)

40<sup>th</sup> Turbomachinery Symposium

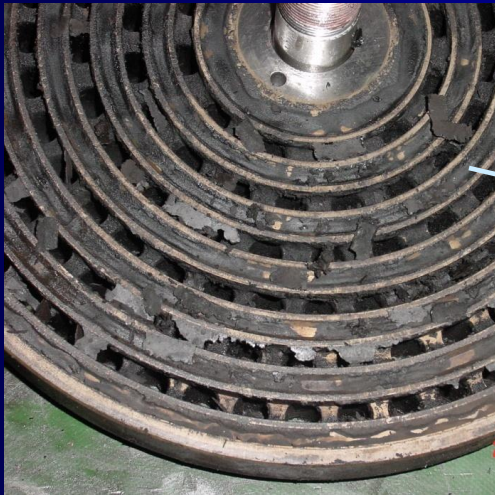
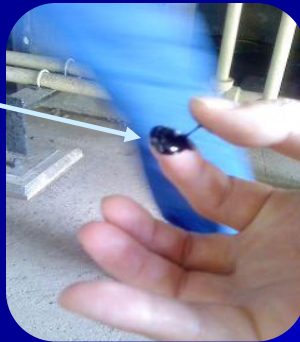
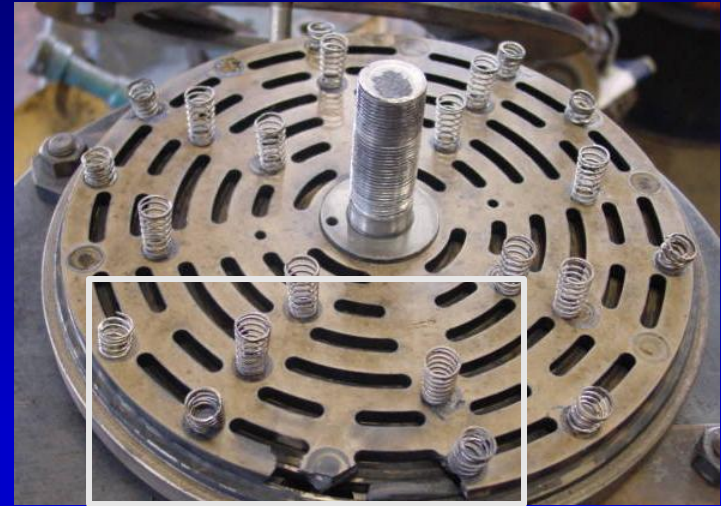
1<sup>st</sup> stage discharge valve failed **every 3 months** after the revamp. **Sticky hydrocarbon deposit** on the valve and large amount liquid found in the cylinder

- ✓ **Heavy Hydrocarbon Deposit**  
: Liquid phase at running
- ✓ **PEEK Plate / Spring Failed**
  - Typically **edge of valve plate** failed with its springs

- ⑤ Solution to **minimize late closing influence** of valve is provided by changing valve type

Possible Cause	Solution	Implementation Phase
✓ <b>Excessive valve impact stress</b> by late closing at a presence of sticky hydrocarbon	⑤ To change valve type from plate to "poppet" valve to minimize sticktion	Phase I

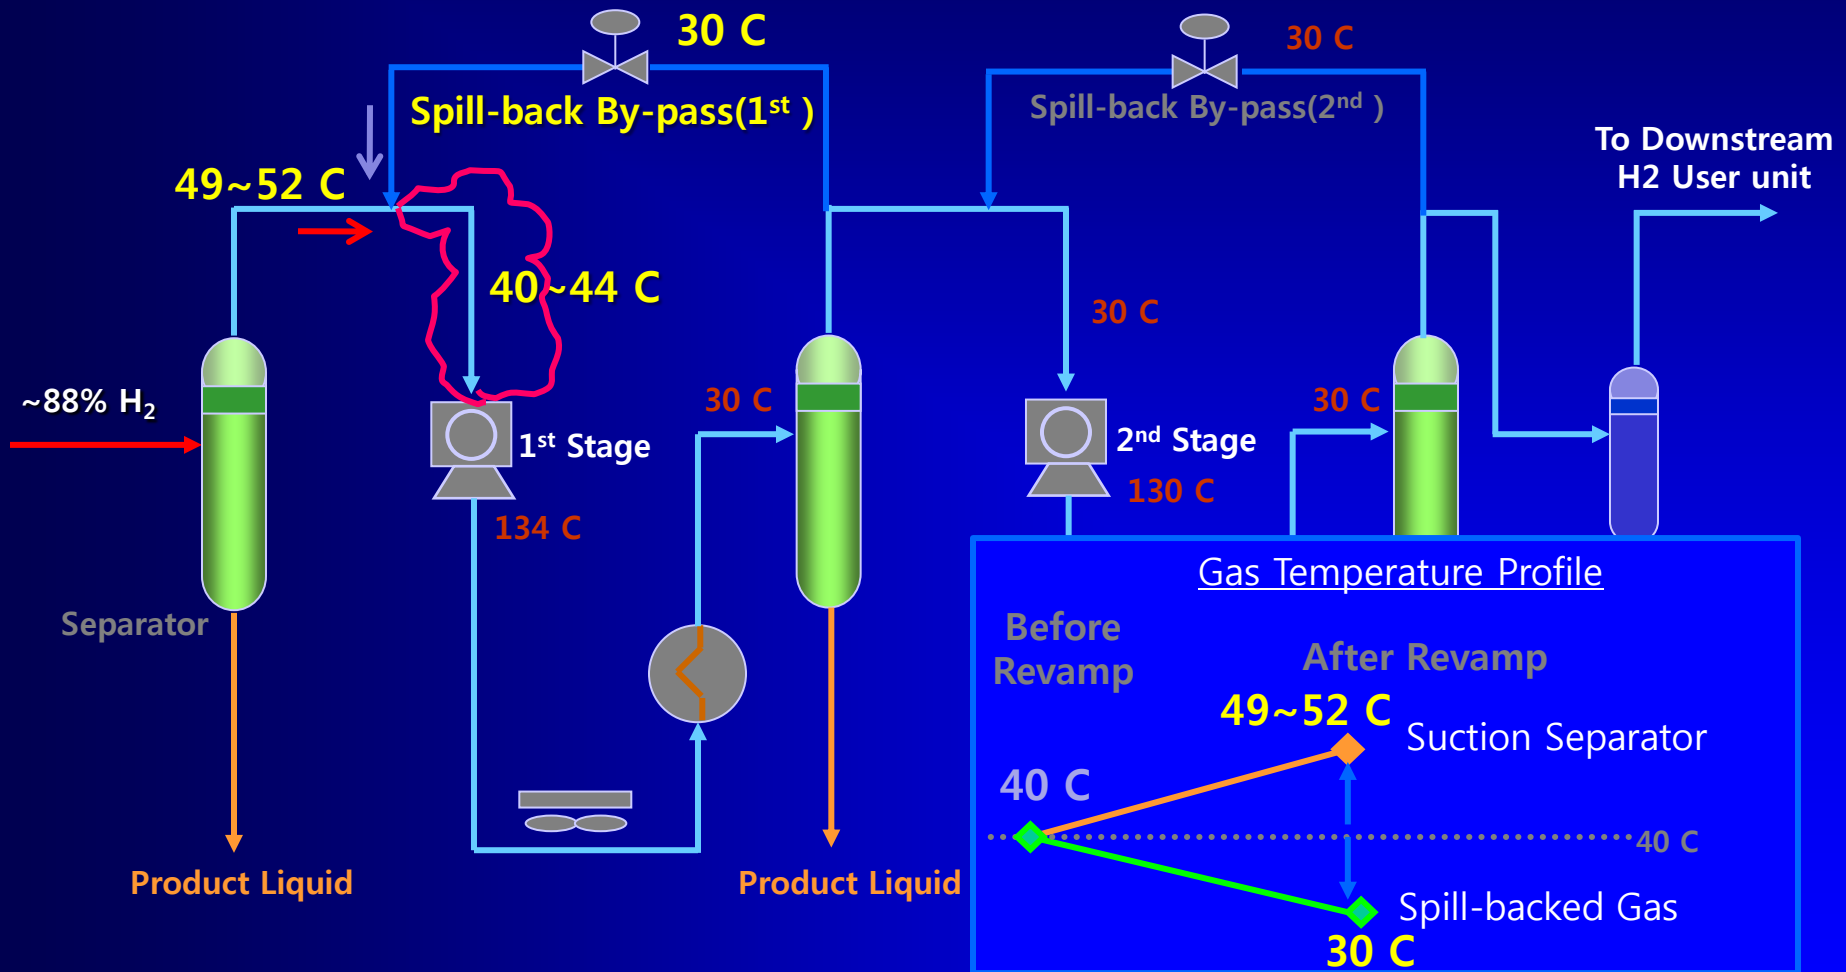
Cooled spill-backed gas seems to condense suction gas because of temperature difference after revamp

※ Area where gas seemed to condense (Cloud Mark)

- ② To reduce spill-back flow by partial load operation (two compressor run at 75%)

Reducing inlet flow condensing by reduced cold spill-back flow makes expected to give positive effect influence to compressor valve

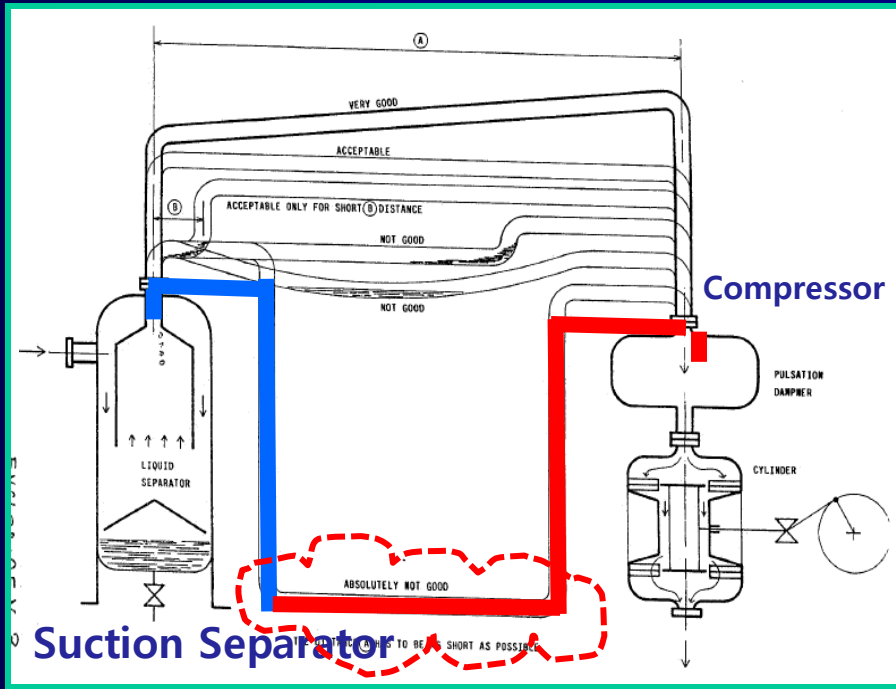
ISO Drawing (1st Suction)

Condensed liquid will be collected at suction manifold piping and can be ingressed to compressor suction as liquid slug because of its layout

- ③ **Drain traps were added** at end point of suction manifold to prevent accumulation of condensed liquid and let manifold **piping sloped** to ease collection to trap

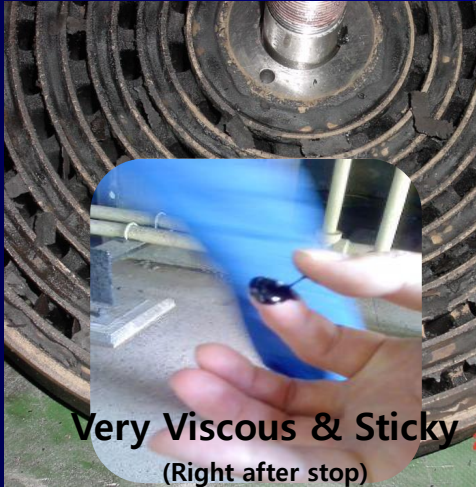
Liquid phase hydrocarbon is very viscous and sticky which is composed of **inherent process reaction**

**Green Oil**  
(Typically generated at CCR)

**Condensed H/C**

**Corroded**

**Catalyst**

**C17~ C20 Hydrocarbon**

**Al<sub>2</sub>O<sub>3</sub>**

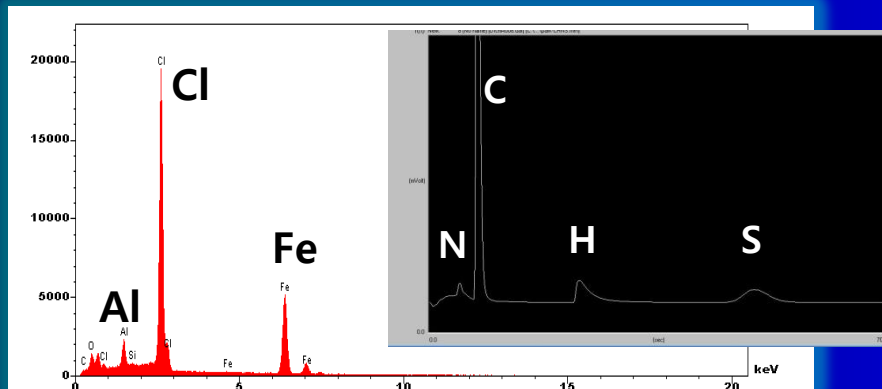
EDX / EA Result (Deposit)

Component found

Cl, Fe, Al, N, Si, C, H  
N (0.9~3.7%)

NH<sub>4</sub>Cl, FeCl<sub>2</sub>, Al<sub>2</sub>O<sub>3</sub>

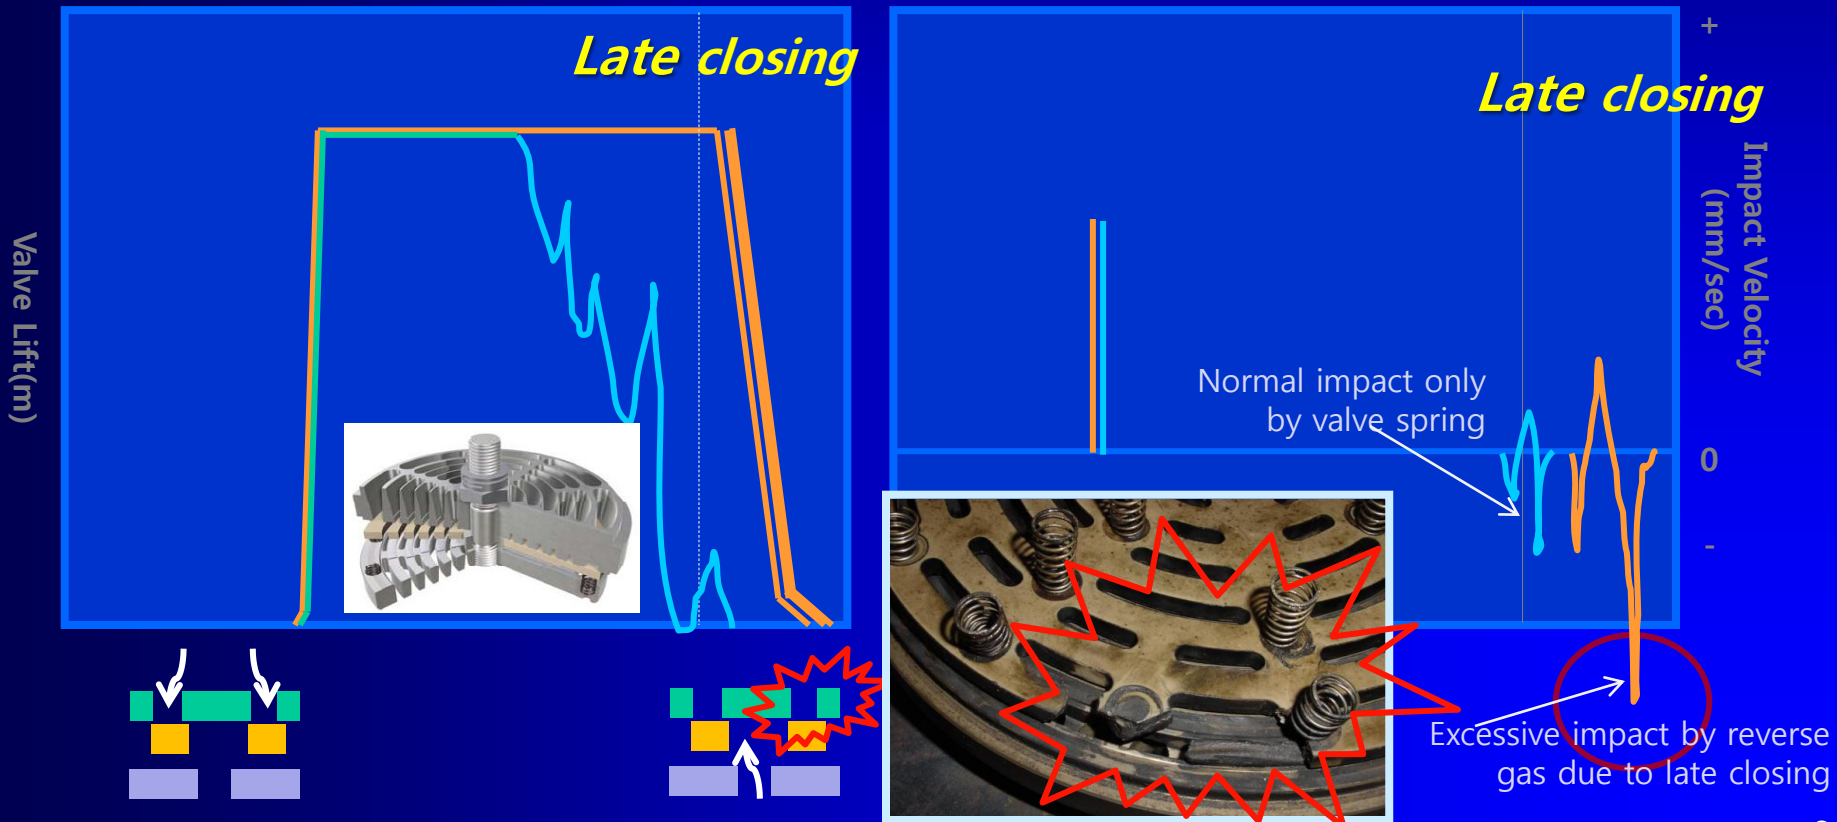
Valve Dynamics Diagram (@ Late Closing)

Valve late closing caused by sticky liquid (sticktion) seem to cause excessive valve impact consequently during valve closing by gas flow

Liquid slug could slam the valve and seemed cause excessive stress on the plate & spring
