40th TURBOMACHINERY SYMPOSIUM

CASE STUDY

‘BALANCE INSTABILITY AND VIBRATION ON A 6 MW INDUCTION MOTOR ROTOR’

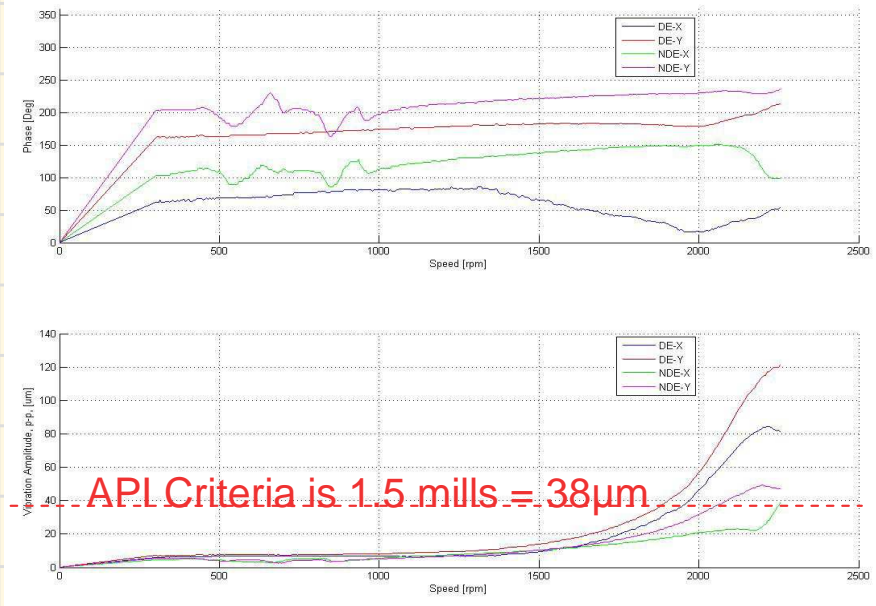
Factory Acceptance Test Results

- High vibration levels during over-speed test
- Vibrations above normal for the machine type at running speed (1800 rpm)
- High vibrations during over-speed test led to bearing failure

Bearing Vibrations during
Overspeed Test

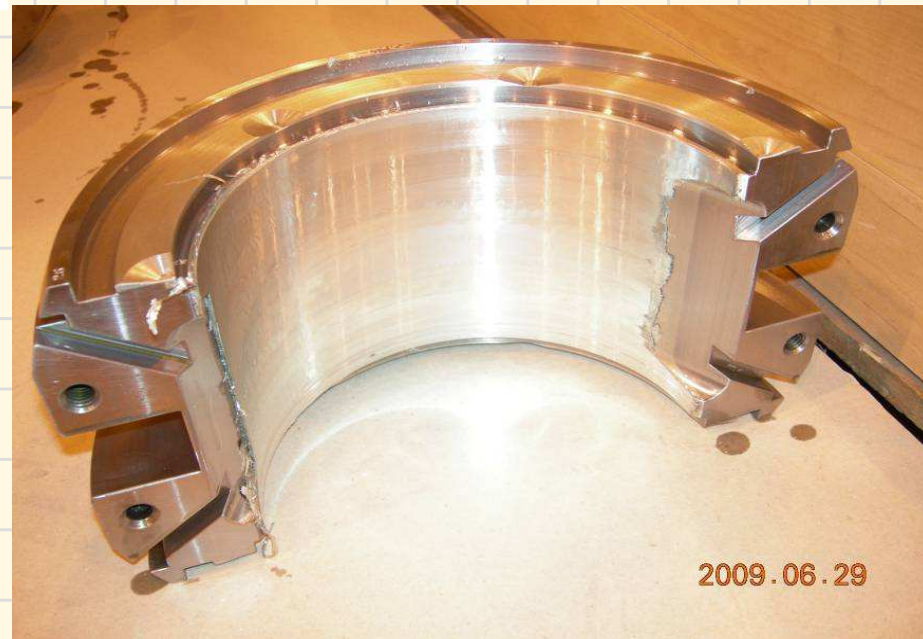
Failed NDE Bearing during 4
hour Mechanical Run Test

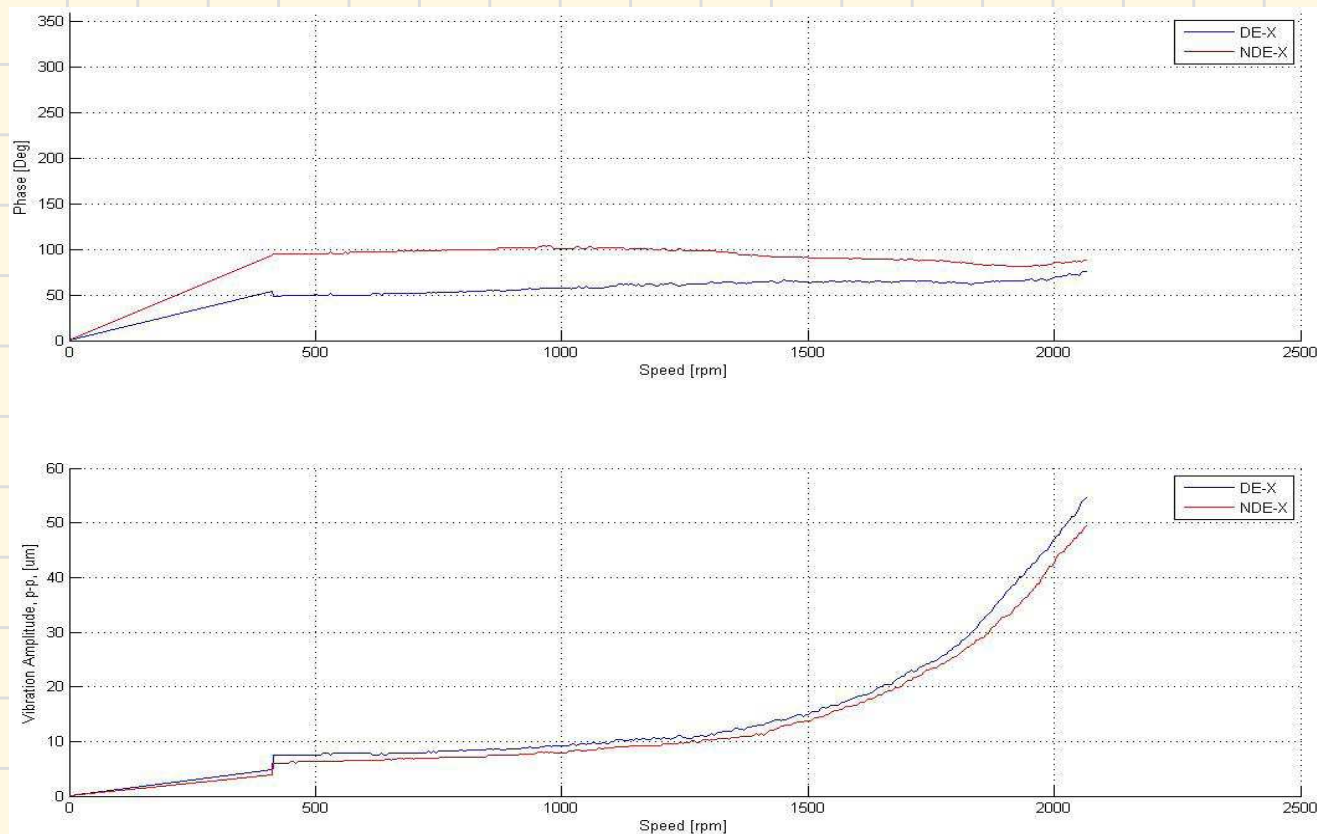
Residual Un-Balance After Re-Balancing

Balancing plane	FAT		After Re-balancing		API 541 requirement residual unbalance mass [g]
	Residual unbalance [kg mm]	Residual unbalance mass [g]	Residual unbalance [kg mm]	Residual unbalance mass [g]	
DE	33	117	2	6.2	7.8
NDE	47	169	1	2.1	7.8

Bearing Vibration Results After Re-Balancing

- Assumption:
 - The vibrations are caused by unbalance in the rotor due to initial settlement during the first heat run and/or over speed test
- Decisions
 - Residual Unbalance Check → Re-Balance at Low Speed (1000 rpm) → New Test
- Result
 - Vibrations still not meeting the requirements

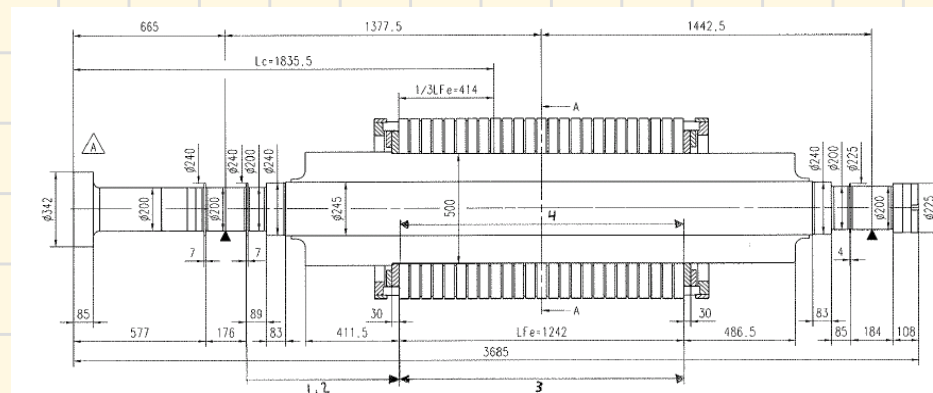
- Measurements showed that individual sheets in the lamination were skewed/buckled
- Centrifugal force acts to 'straighten' the sheet metal plates which could lead to changed balancing state

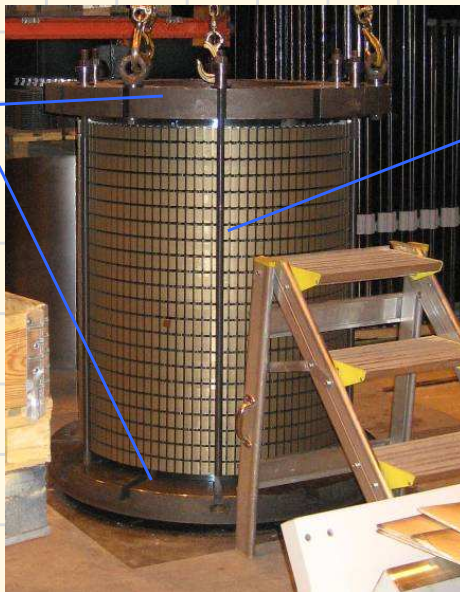
Rotor Core Compression

- Attempt to recompress the rotor core lamination to make it perpendicular to the rotor centre line
- Result:
 - Improved vibration but still not meeting requirement, balancing state still changes with speed
- Conclusion:
 - Recompression not working due to high friction between rotor core and spider shaft

'Pull-rods'

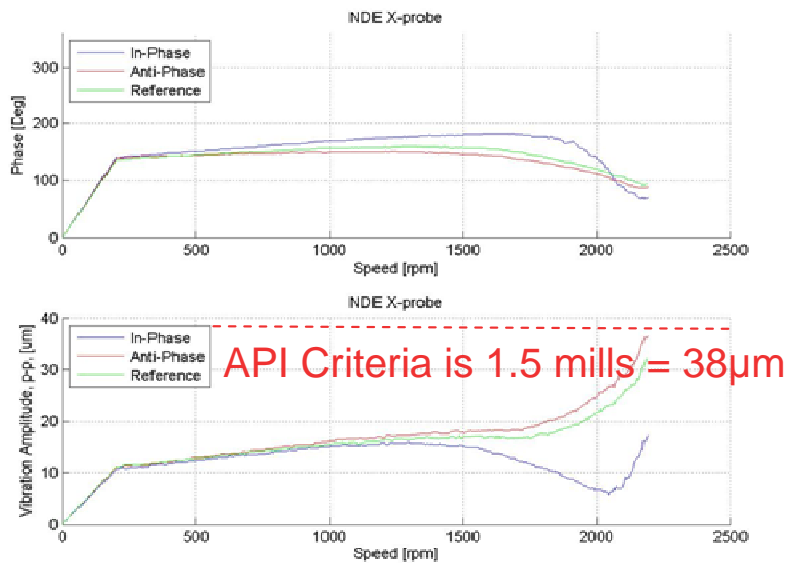
NDE X-direction

- Solution for the problem:
 - Balancing of rotor at full speed (settling effects within balancing)
- Results
 - After full speed balancing vibration levels are within required limits
- Forced unbalance tests for final verification

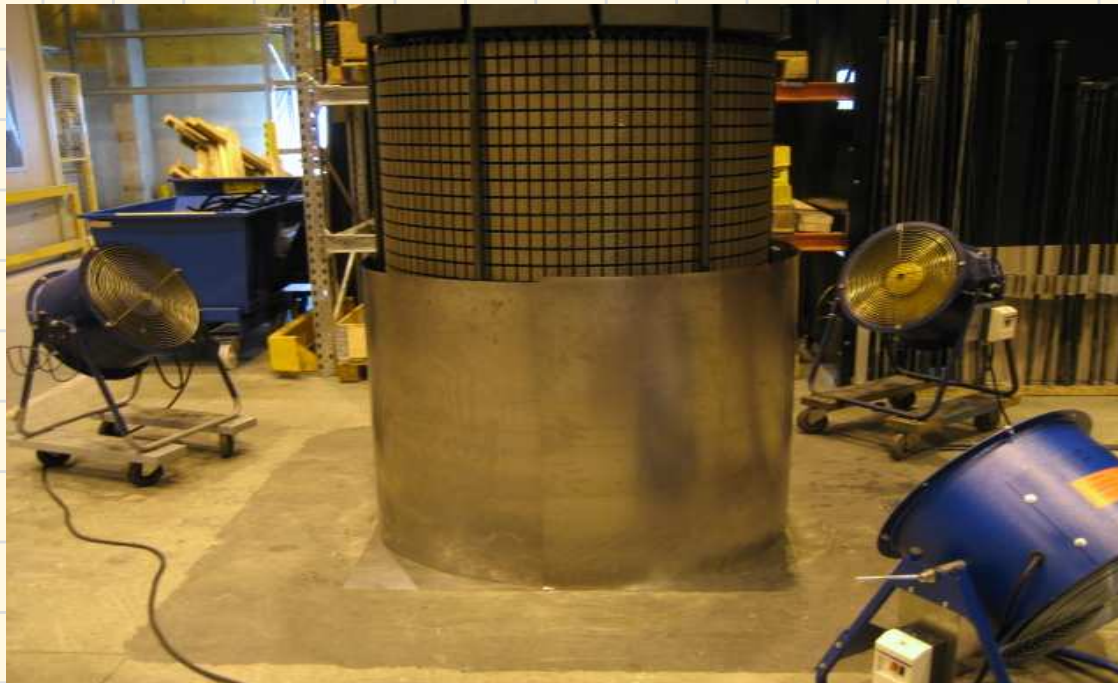
Rotor core cooling

Fans to cool 'Top Part' of rotor core

'Insulation' around bottom part of rotor core

- New process for shrinking the core onto the shaft:
 - Cooling from the top down to get axial pressure on the entire length of the rotor core

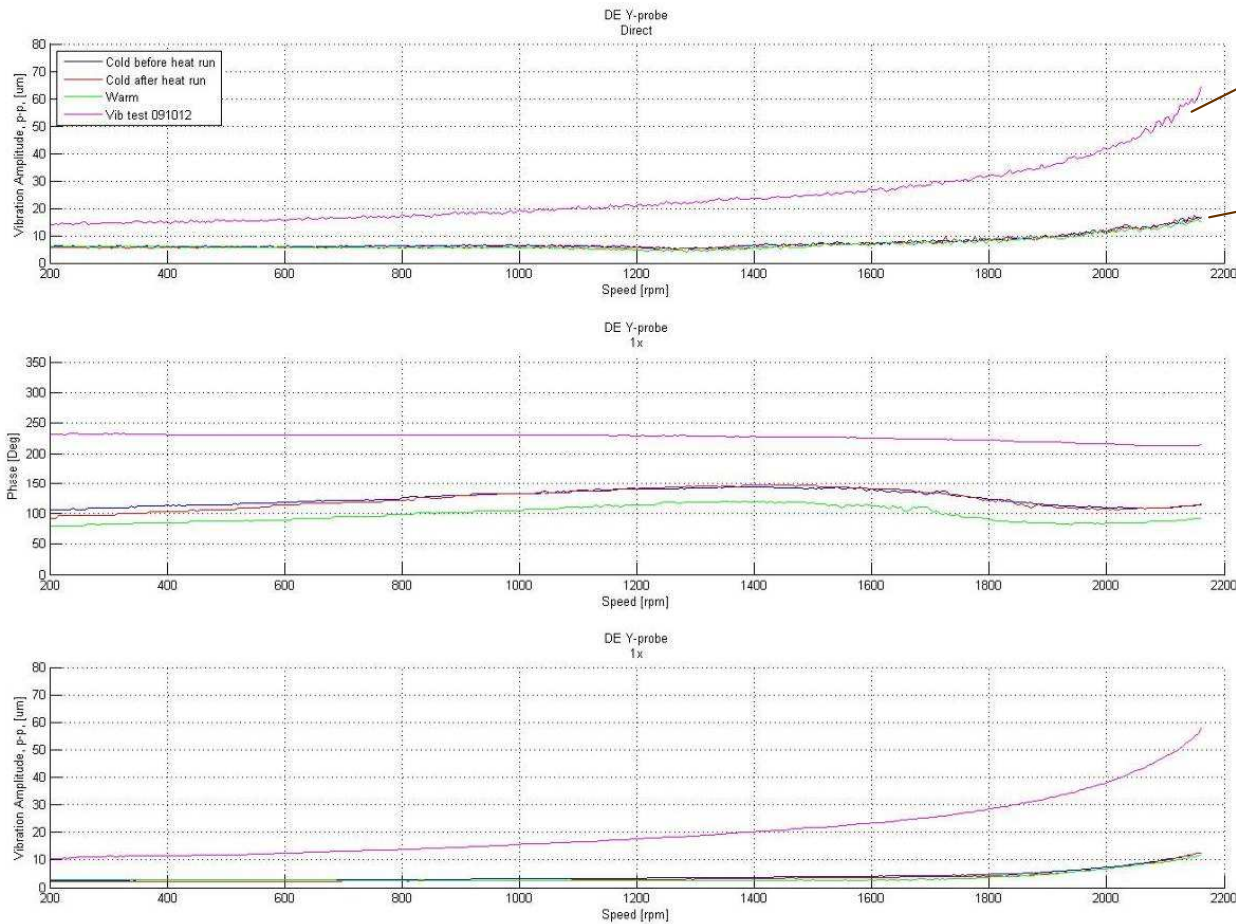
New Rotor: Residual Unbalance & Vibration Tests

Old rotor

New rotor
