Correction of Chronic Thrust Bearing Failures on a Refrigeration Compressor

September 15, 2011

Presenters: Matthew D. Moll
Rotating Machinery Consultant
DuPont Rotating Machinery Group

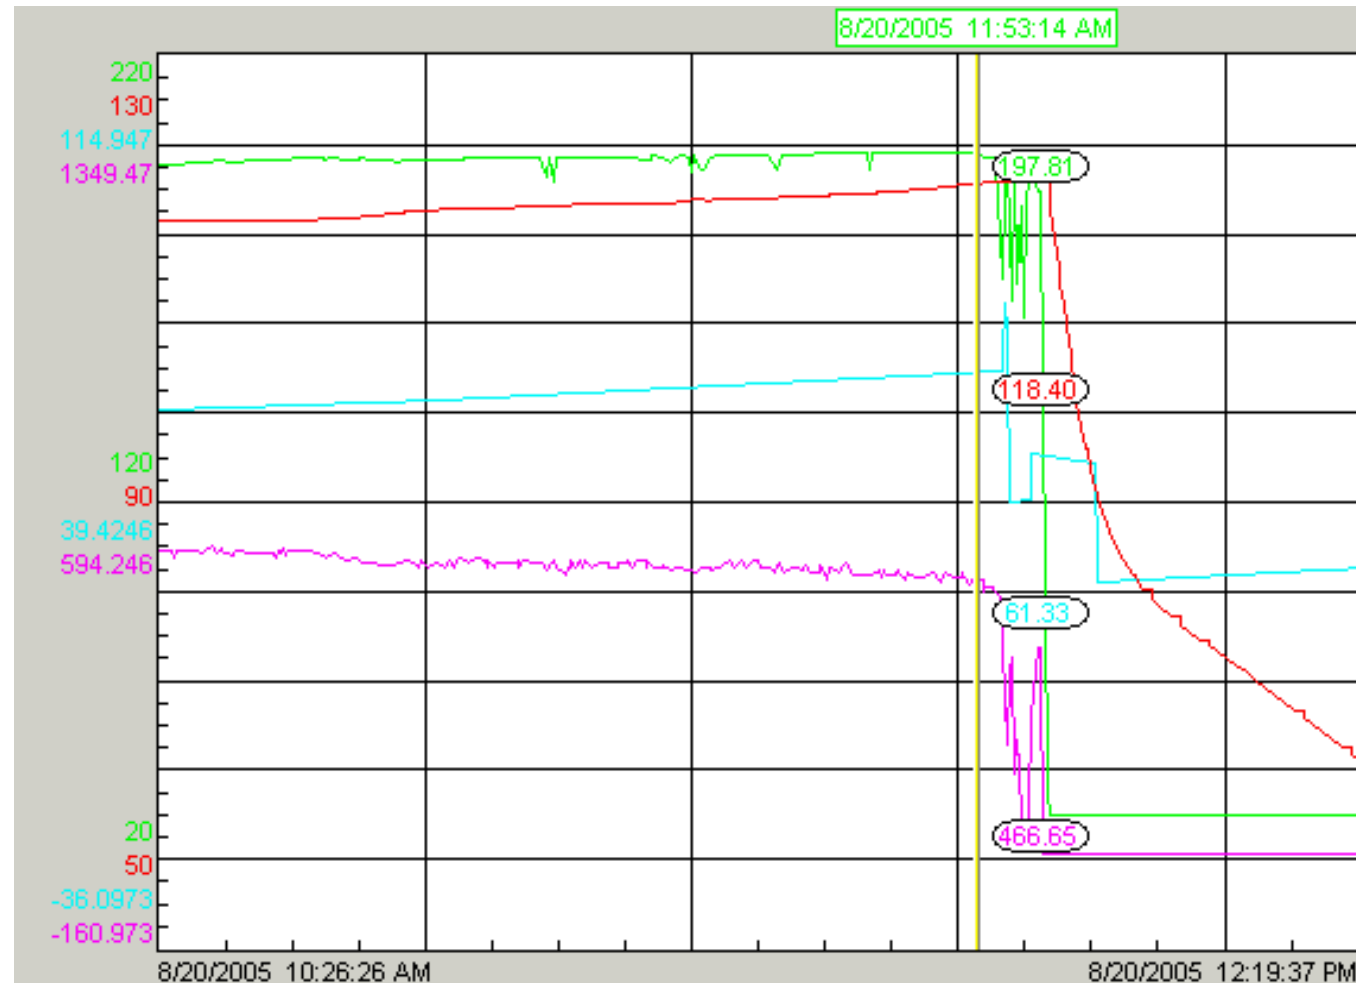
- New rotor improved performance, however not over entire operating range
- High head conditions resulted in excessive discharge temperature and sometimes compressor surge

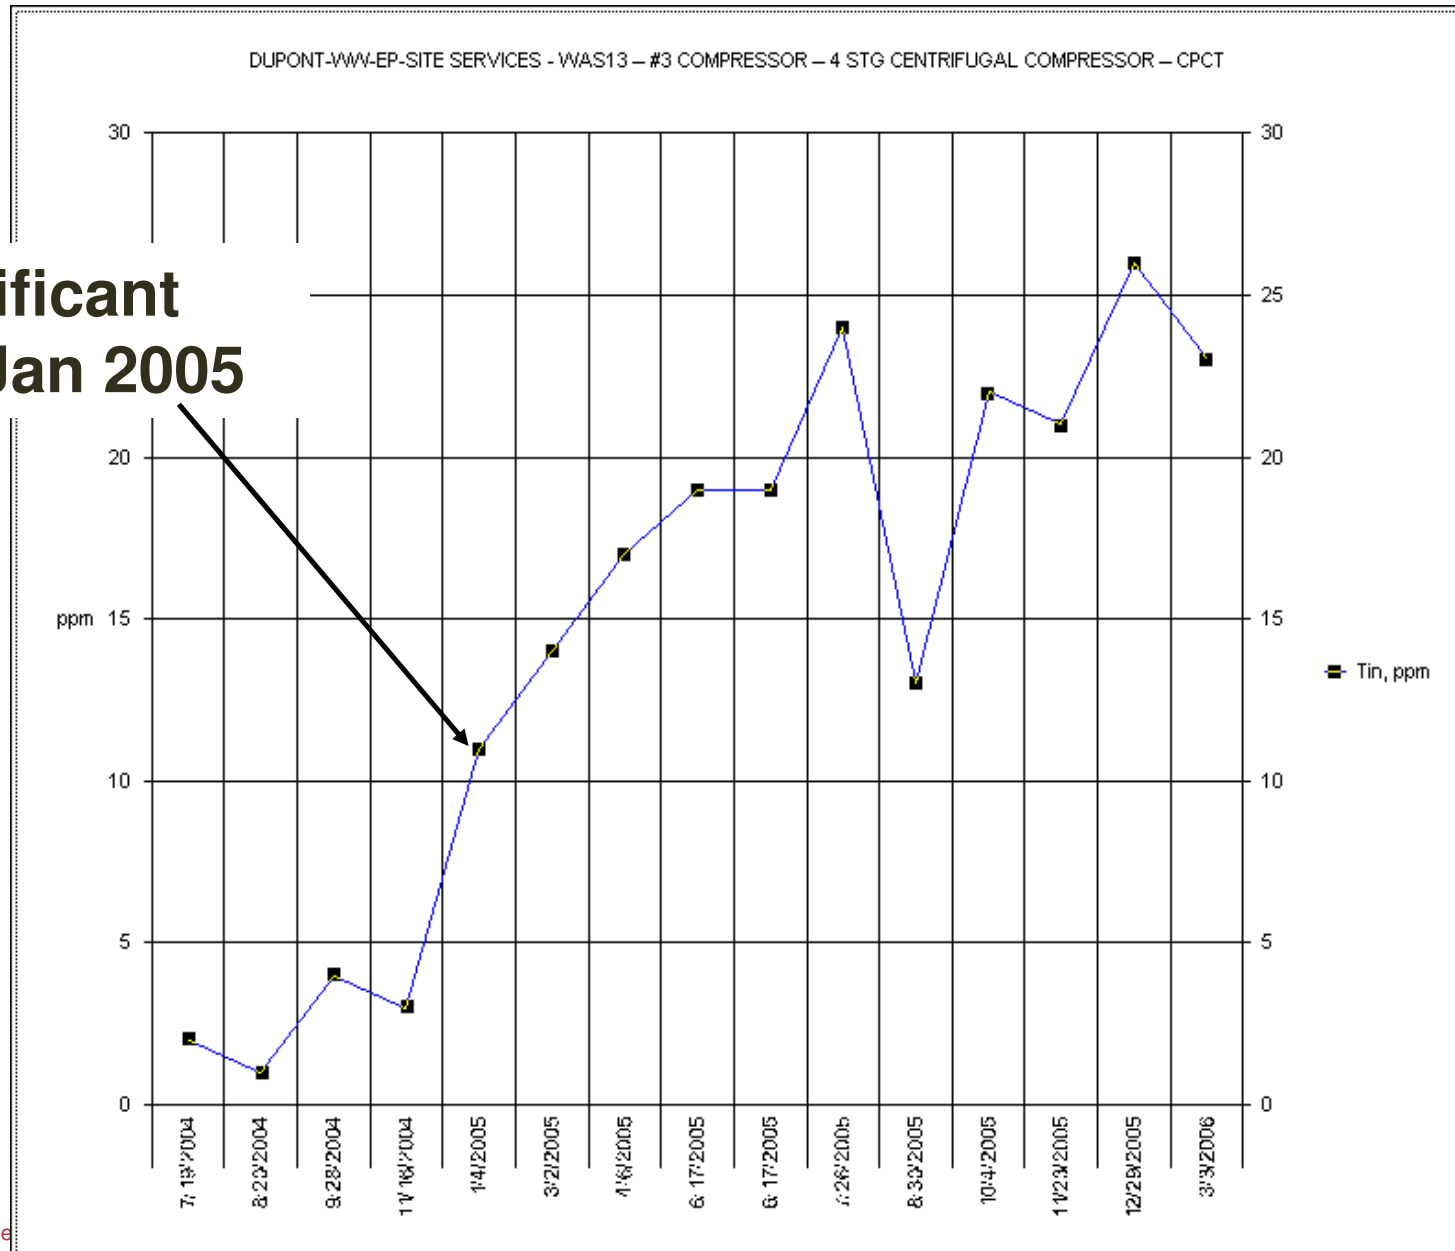
First Significant Increase Jan 2005

Thrust bearing distress was first detected by routine oil analysis

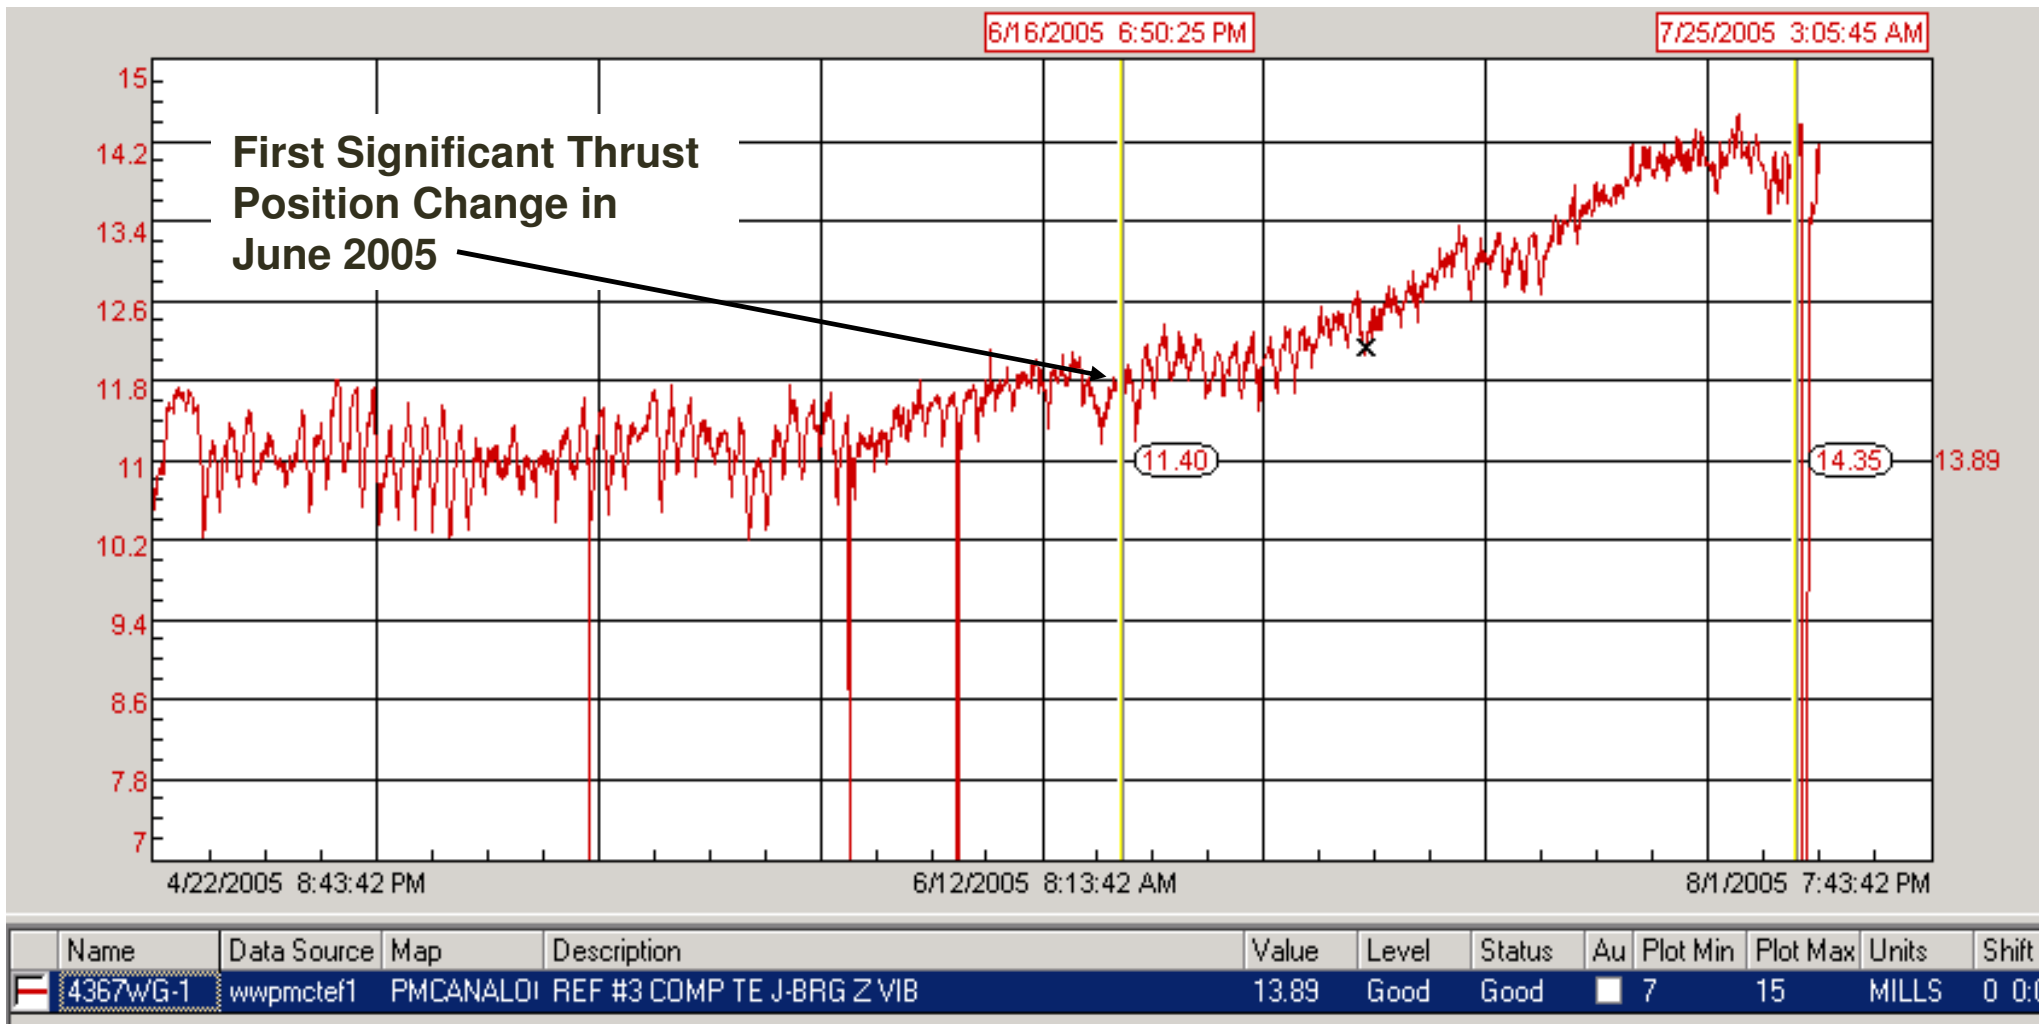
Compressor rotor running position would suddenly change after about six months to two years stable operation to + 1.5 mil (0.038 mm) per month in active direction. This rate of change would suddenly plateau for a month or more then reinitiate the climb

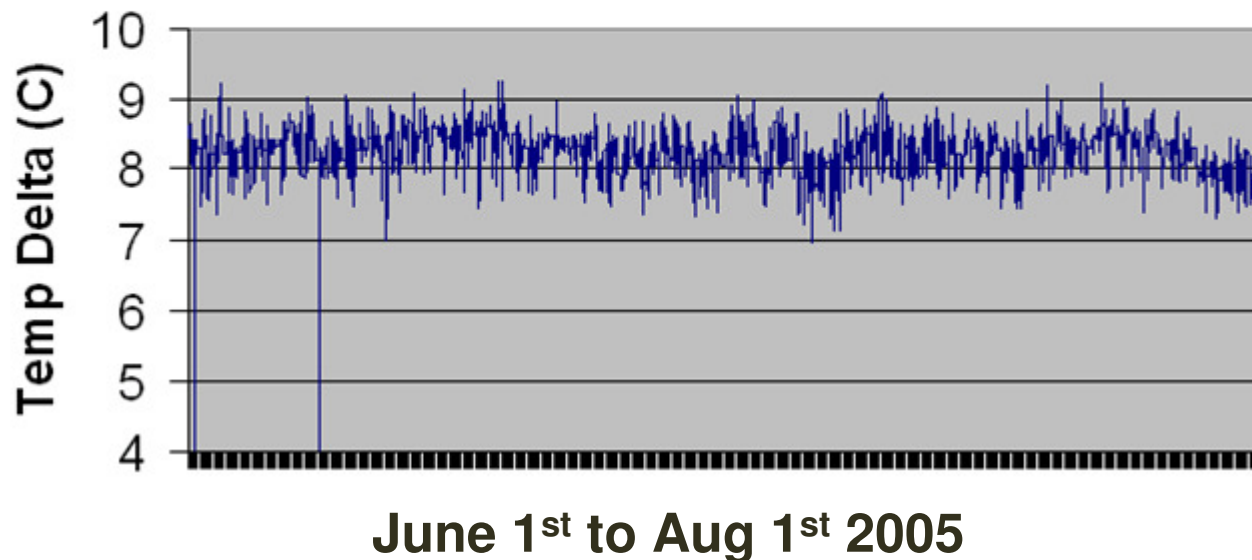
Oil Temp Delta Across Thrust Bearing

Lube Oil Temperature – not an effective indicator of bearing distress dT 8 deg C (14.4 deg F)

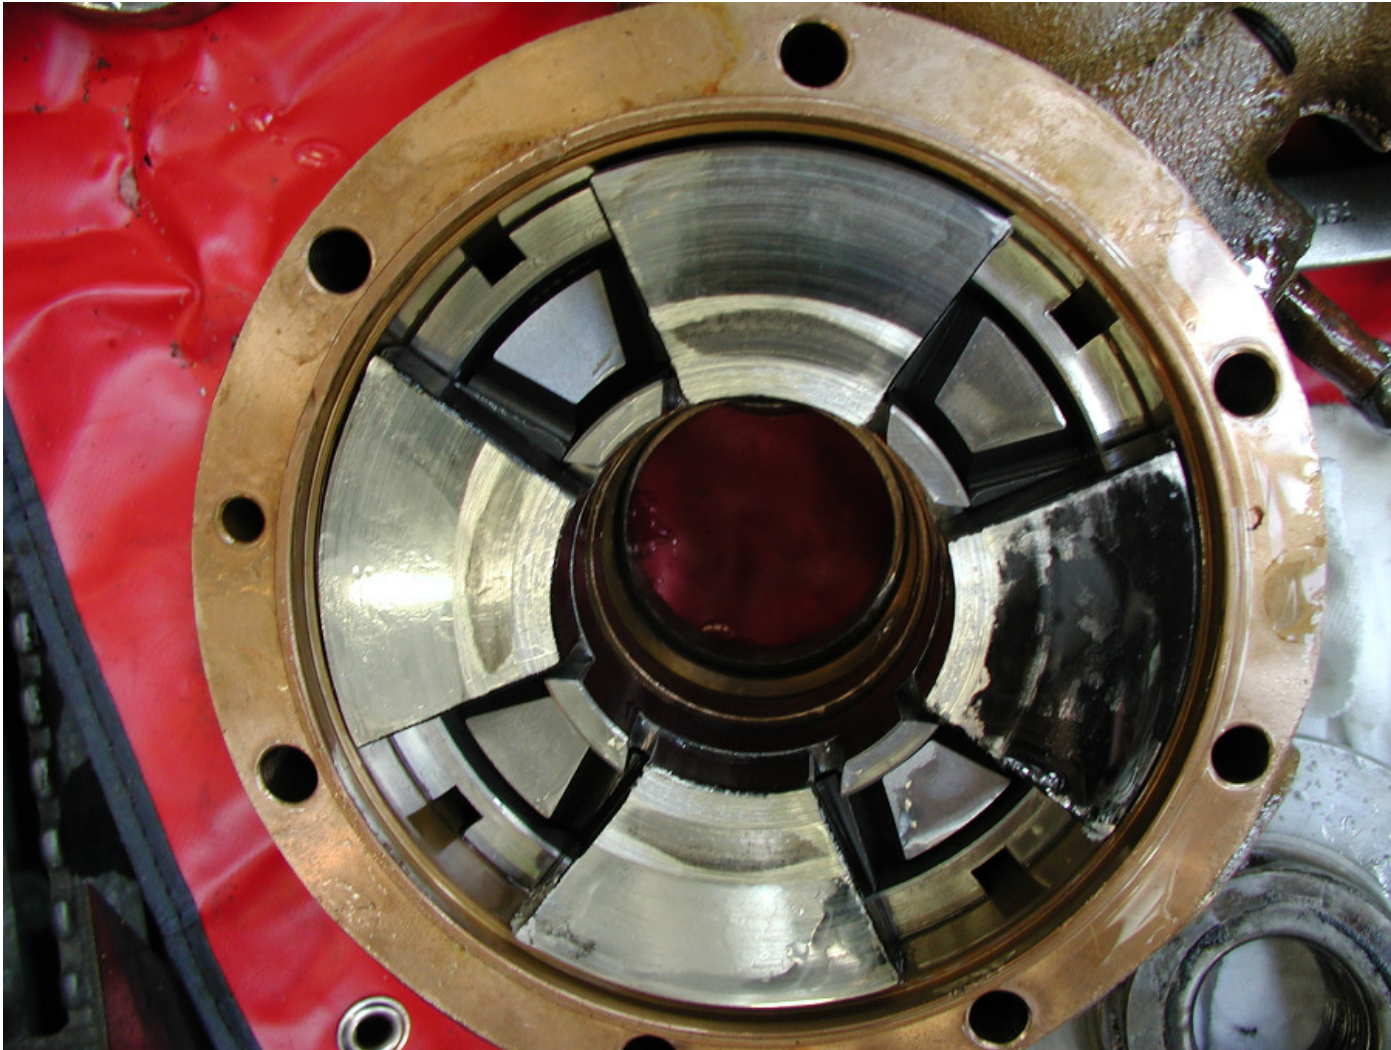
Thrust bearing removed from service February 2006 (Third Bearing)

- OEM calculations combined with operating experience converged on a overloaded thrust bearing as being the root cause of the failures.
- Those familiar with compressor design understand that resizing the balance piston is the most elegant solution to solve this problem.
- Those familiar with compressor fabrication and maintenance understand that resizing the balance piston is an expensive procedure.
- Site management did not desire to absorb the cost associated with taking the compressor out of service to retrofit or the lost production.

- The preferred solution was to redesign the thrust bearing with increased load carrying capacity to reduce the risk of failure.
- To keep a low cost modification, the thrust bearing had to be used in the same envelope as the original OEM bearing, with no modification to the bearing housing.

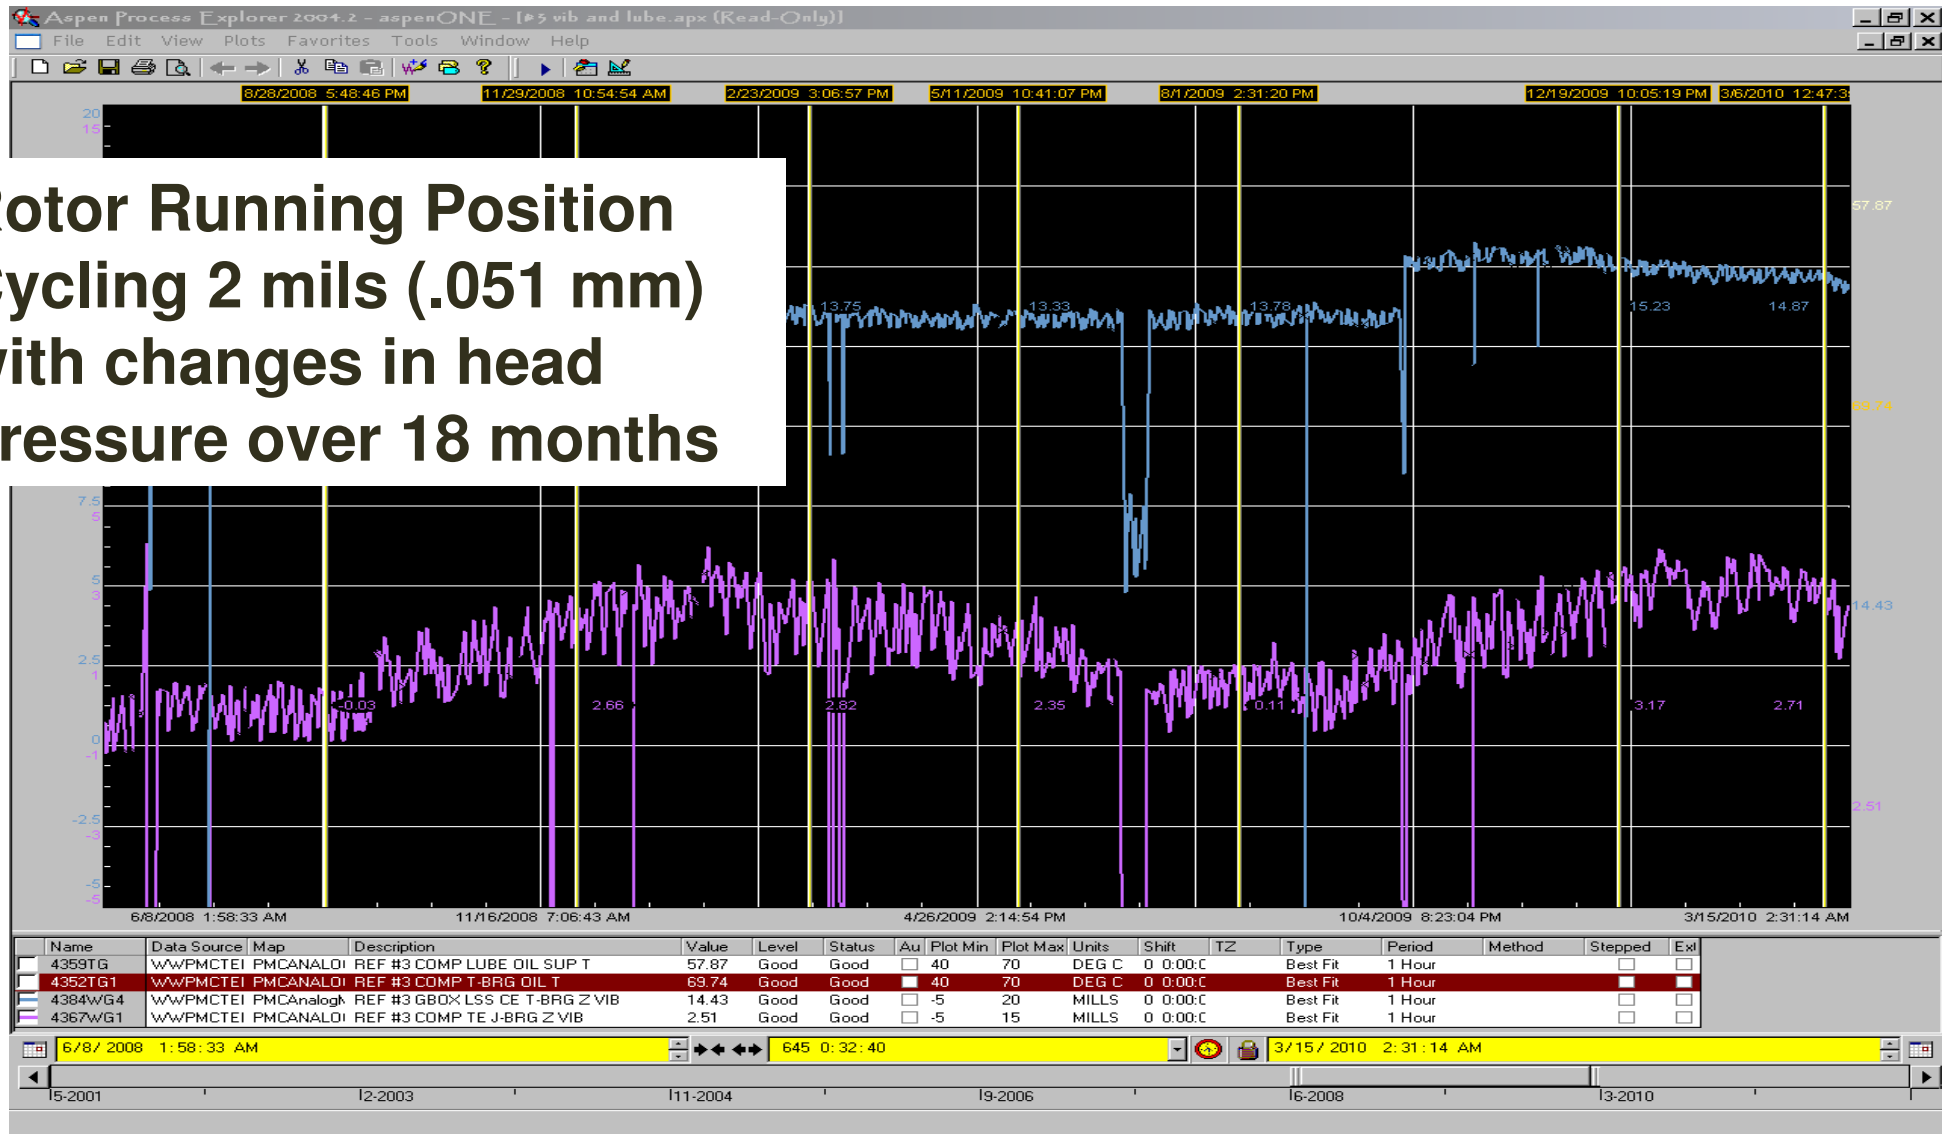
Lower trend line indicates thrust position of rotor from Aug 2008 to March 2010

**Rotor Running Position
Cycling 2 mils (.051 mm)
with changes in head
pressure over 18 months**

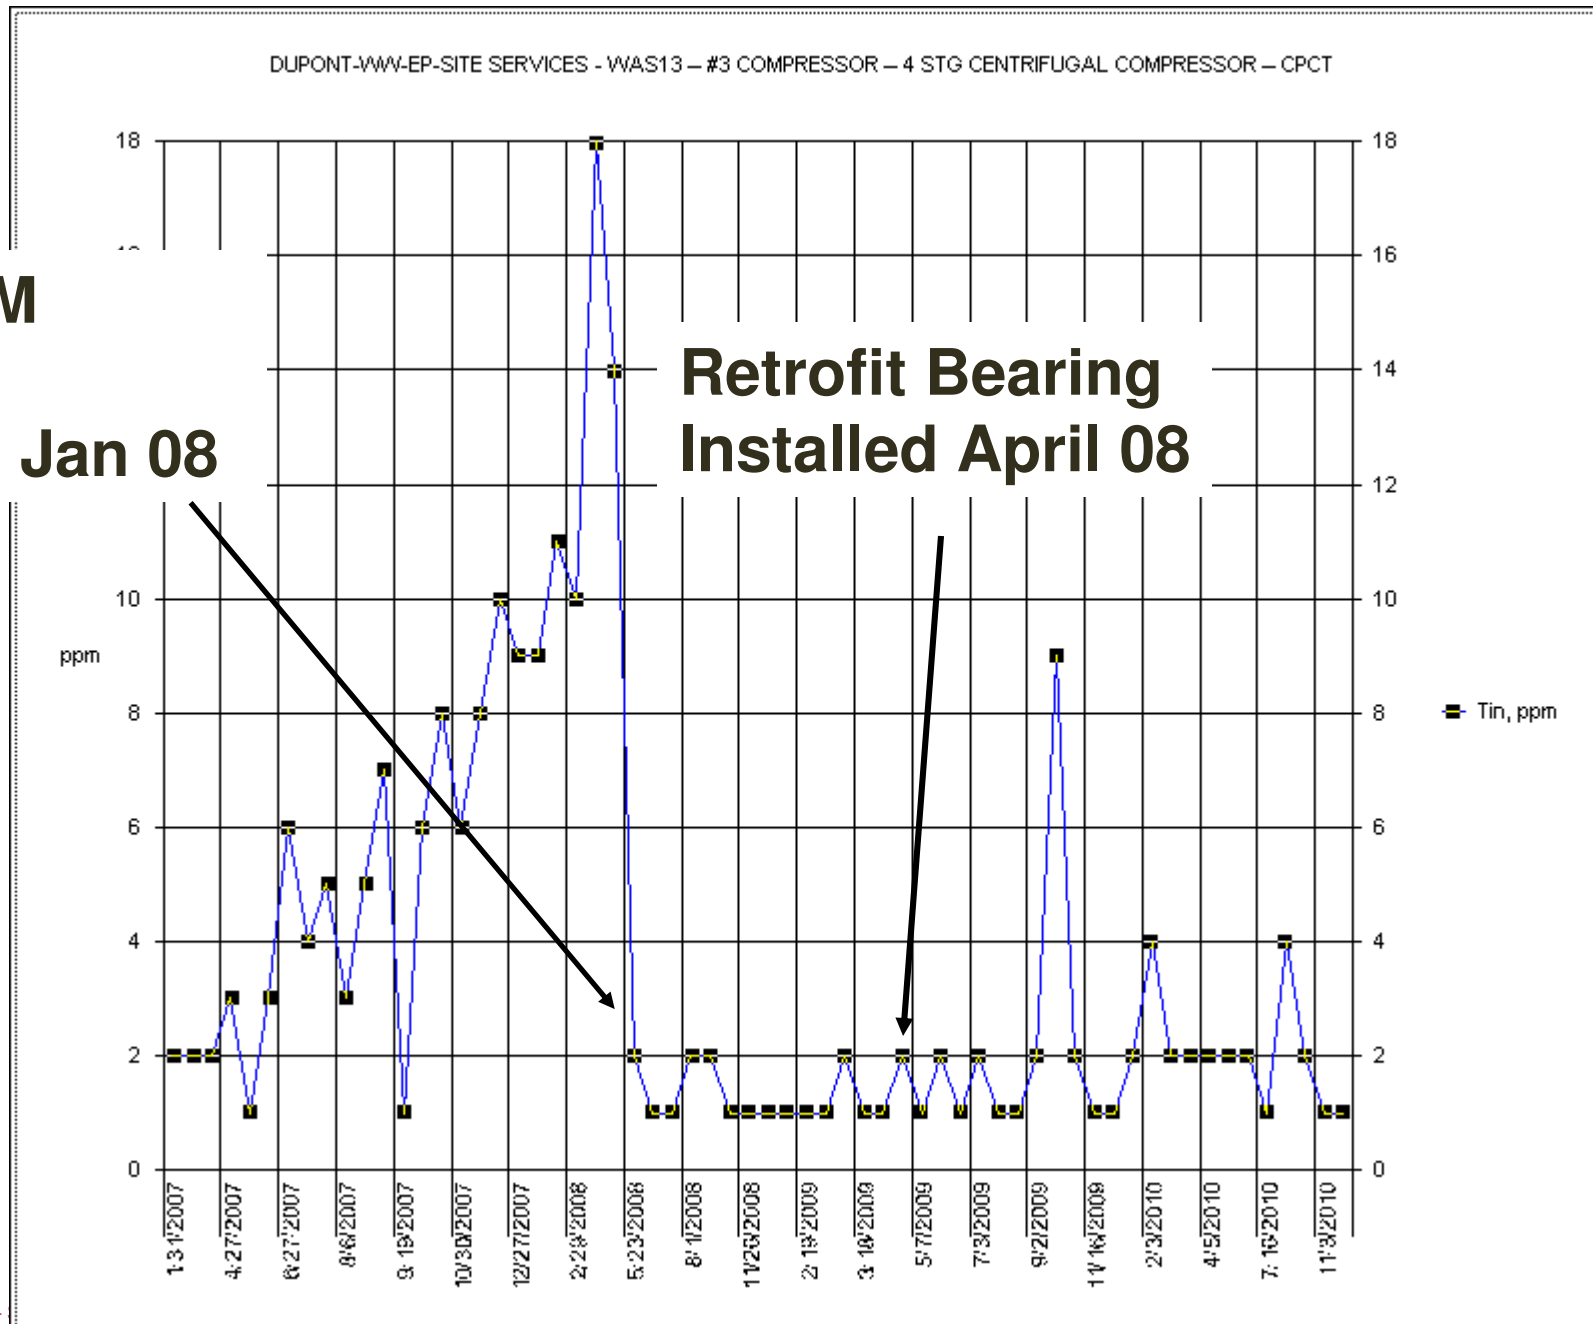
**New OEM
Bearing
Installed Jan 08**

**Retrofit Bearing
Installed April 08**

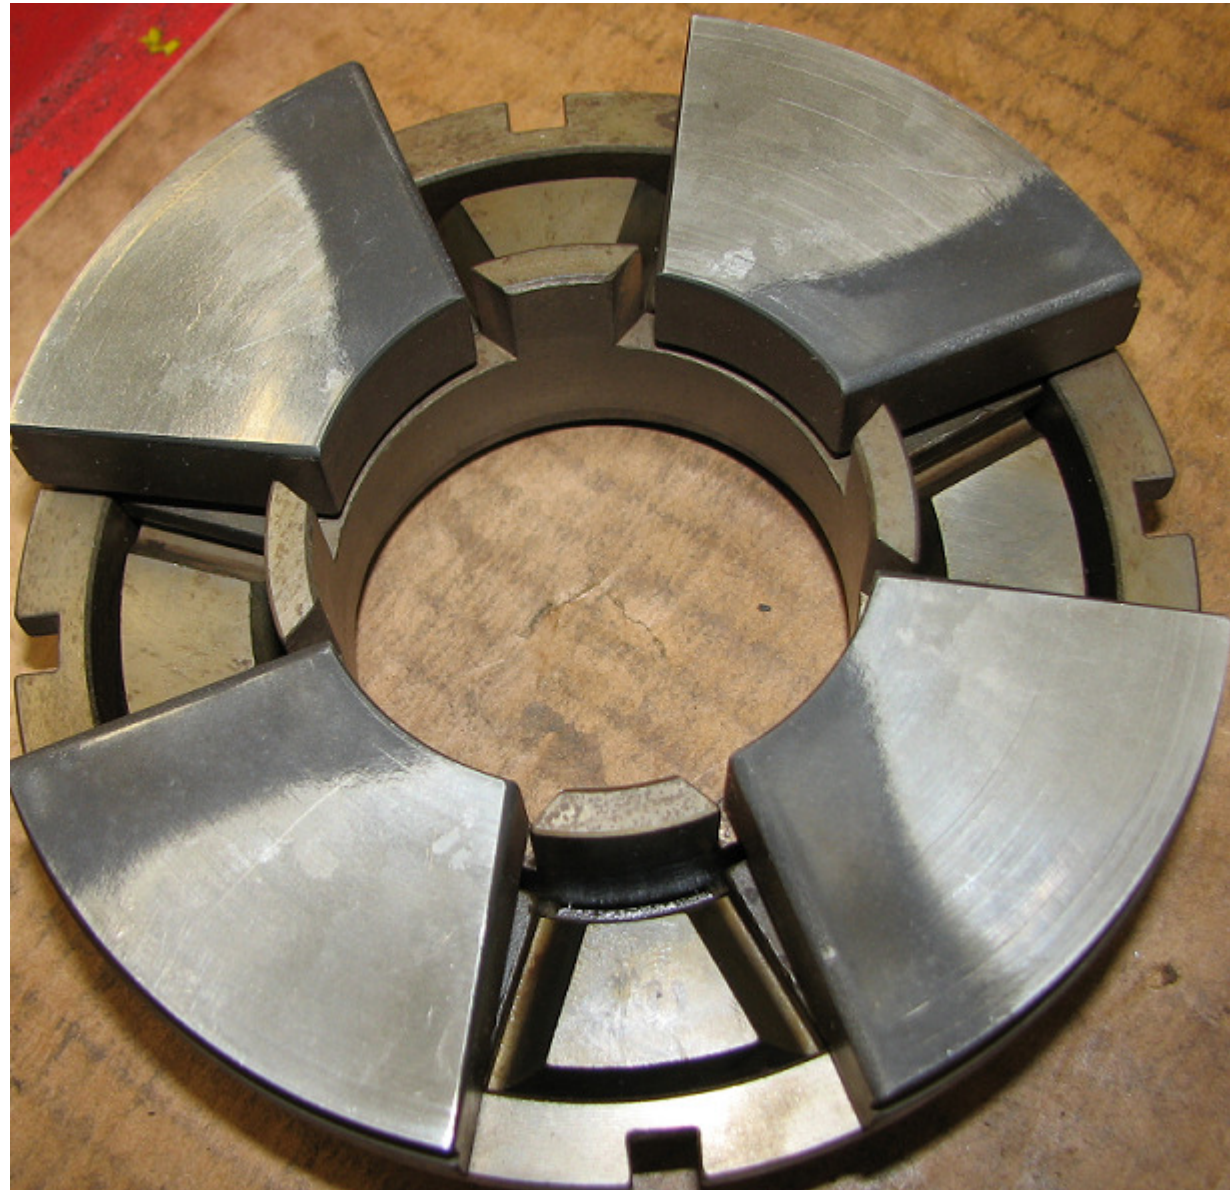
OEM thrust bearing installed between January and April 2008

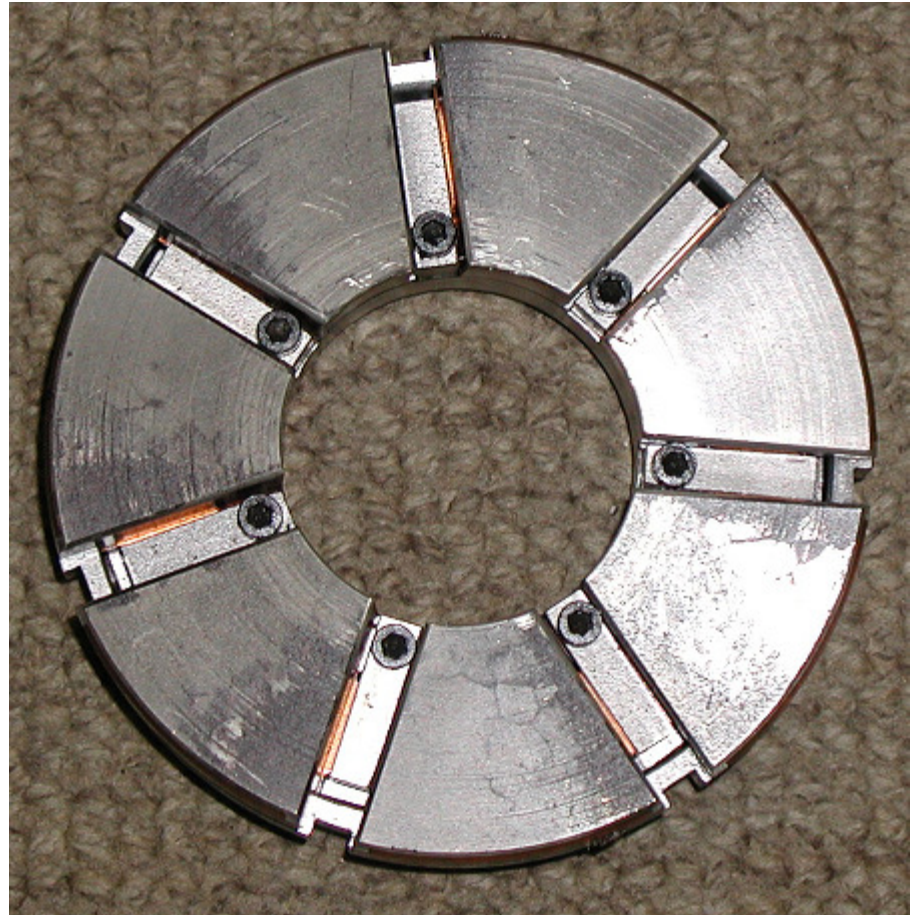
- Retrofit Thrust bearing was installed in April 2008 and demonstrated successful operation for ~24 months, at which time it was replaced
- Replacement bearing is demonstrating similar performance in the same timeframe.
- Oil analysis laboratory results indicate significantly less bearing material circulating in lubricating system.
- The average oil temperature change across the bearing increased from 8.5 deg C to 10.3 deg C (15.3 deg F to 18.54 deg f) with the retrofit, as expected for the additional frictional losses.

**Retrofit thrust bearing
after 24 months of
operation**

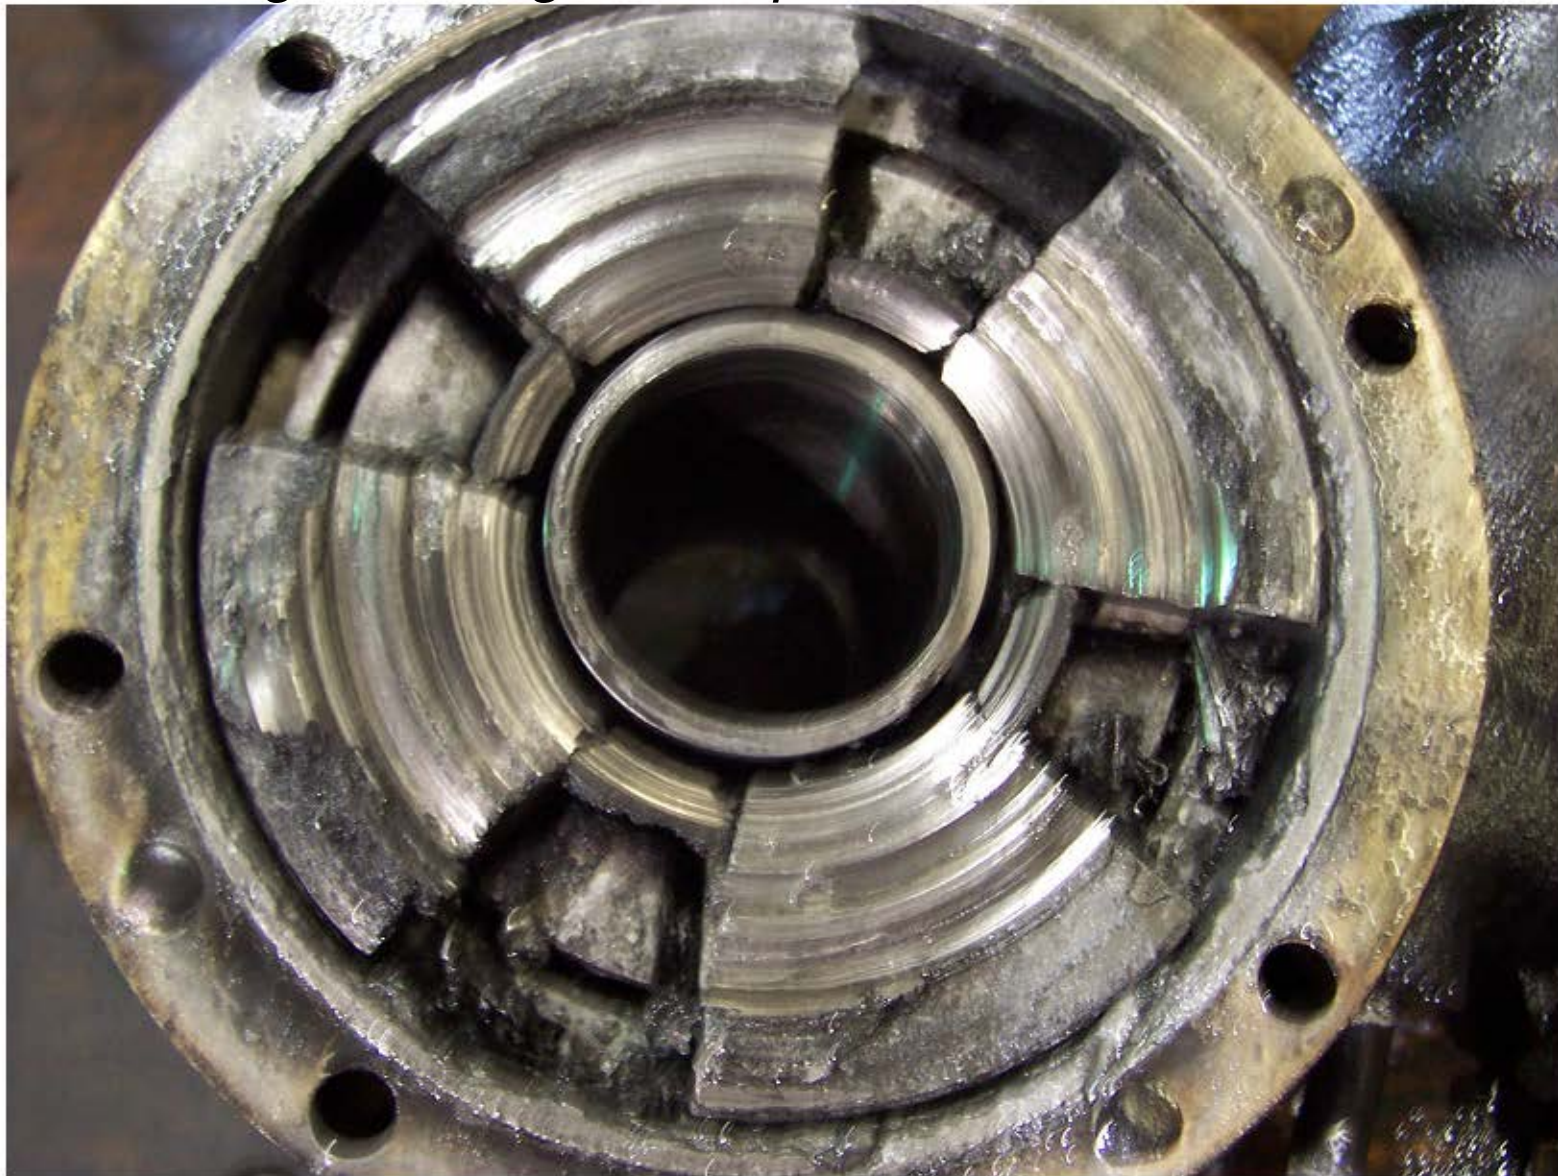
A discharge bearing oil temperature interlock that actually tripped!
