39th Turbomachinery Symposium

PREVENTION OF SHAFT END DAMAGE DUE TO HIGH CONTACT PRESSURE

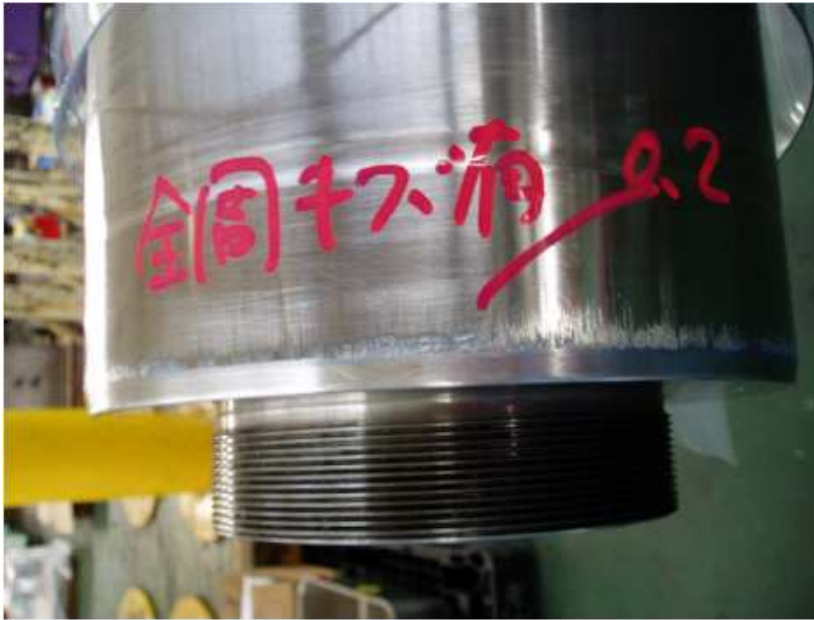
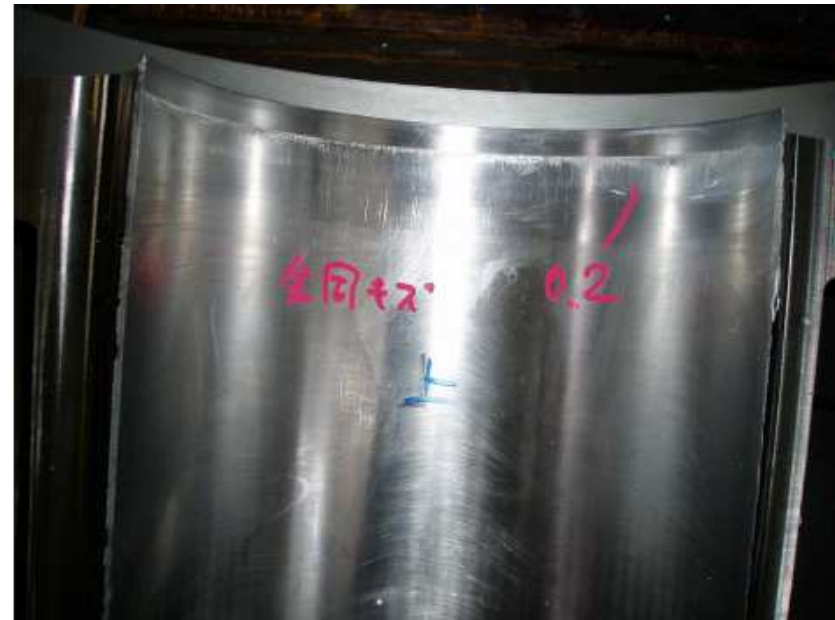
Photo of Abrasion in 8 inch Shaft/Hub Edge

The hub had been successfully installed and removed three times, but after the fourth installation, the hub could not be removed from the shaft and had to be cut off.

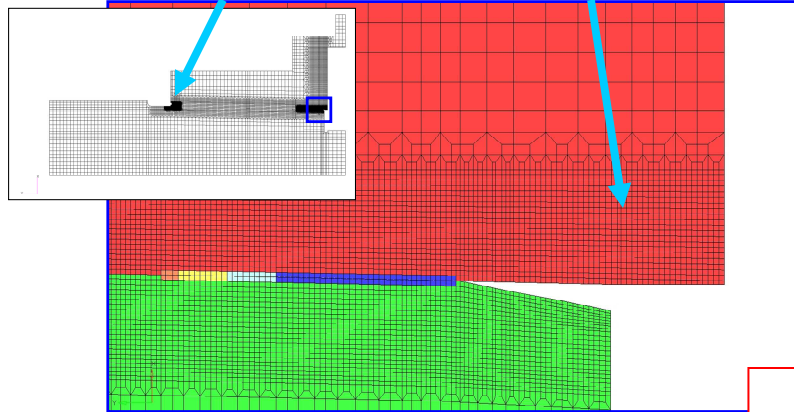
Current Configuration

(With groove at large end and overhung mass)

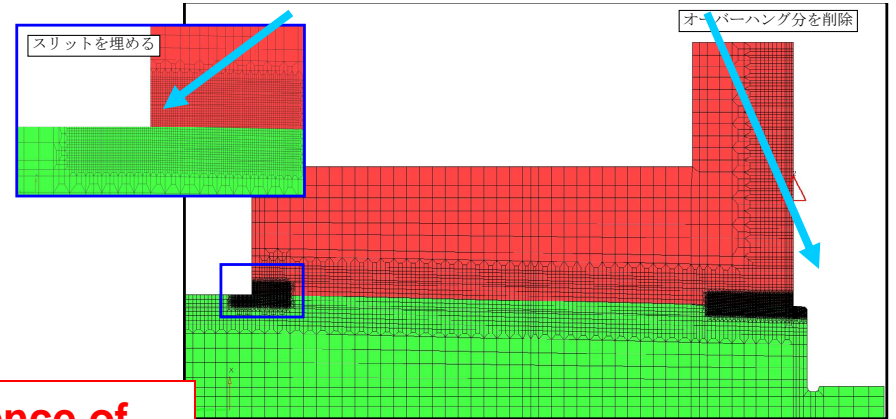
Study Model

(No groove at large end and no overhung mass)

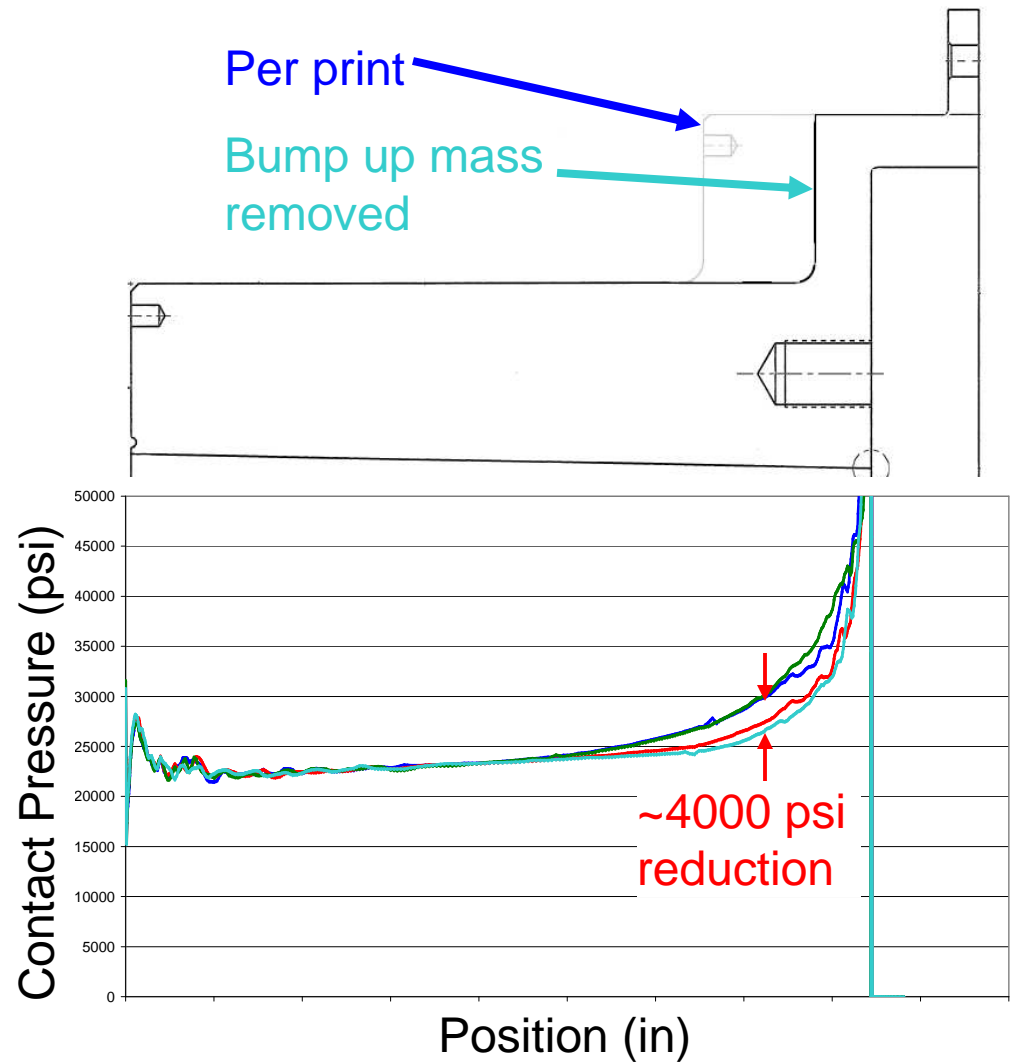
Influence of “Bump Up” Section

- Second investigation evaluated effect of material mass on contact pressure
- Contact pressure reduced ~4000 psi in area of shaft damage

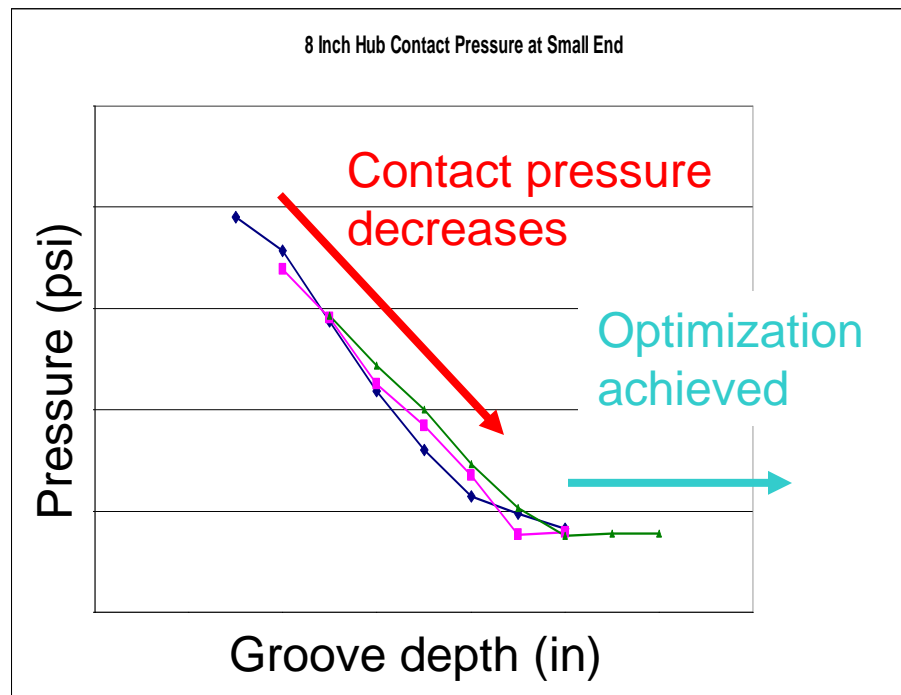
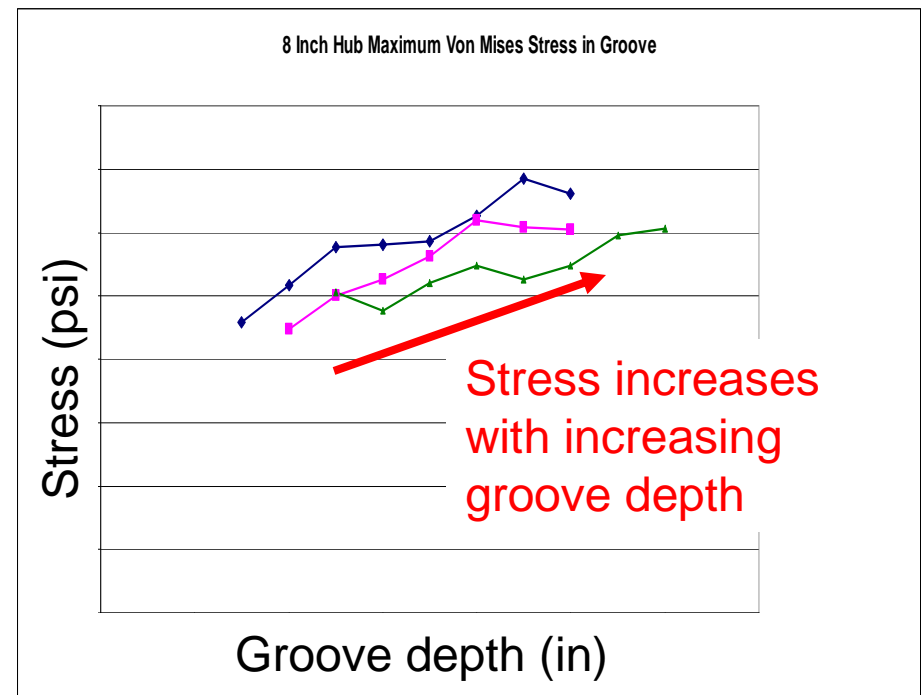
Groove Dimension Study

- Effects of various groove geometries investigated using finite element analysis
 - Groove depth increased to reduce pressure, until a minimum pressure was reached where increasing the groove depth had no effect
 - Groove depth optimized for stress consideration and manufacturability

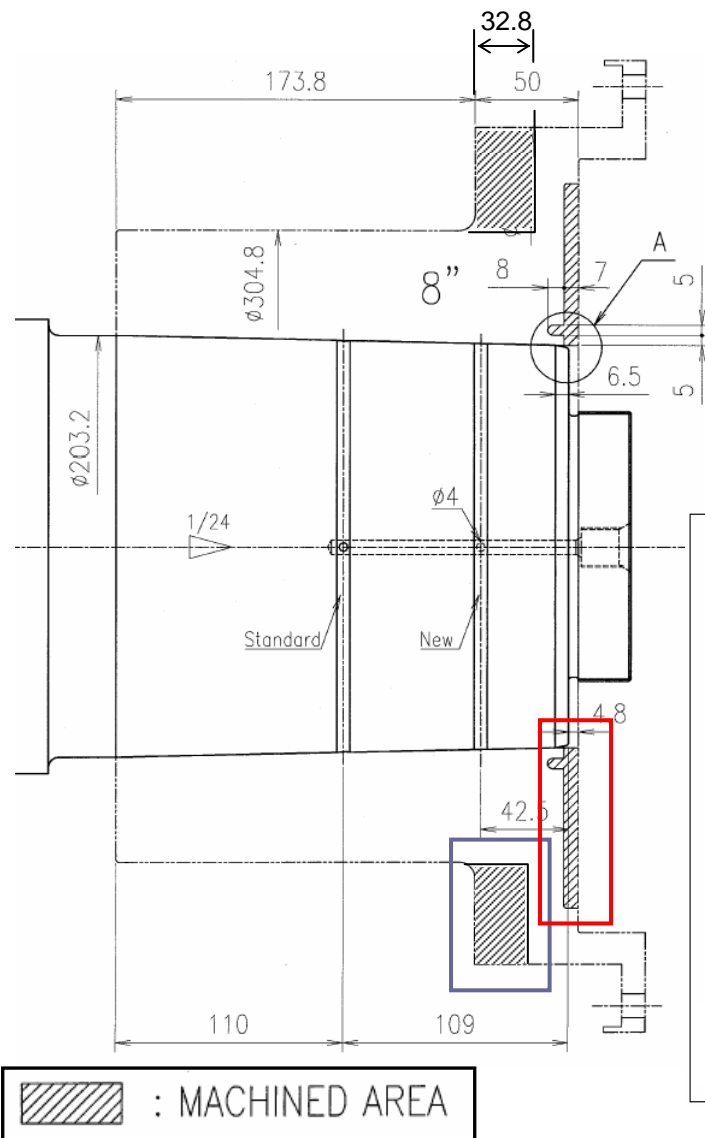
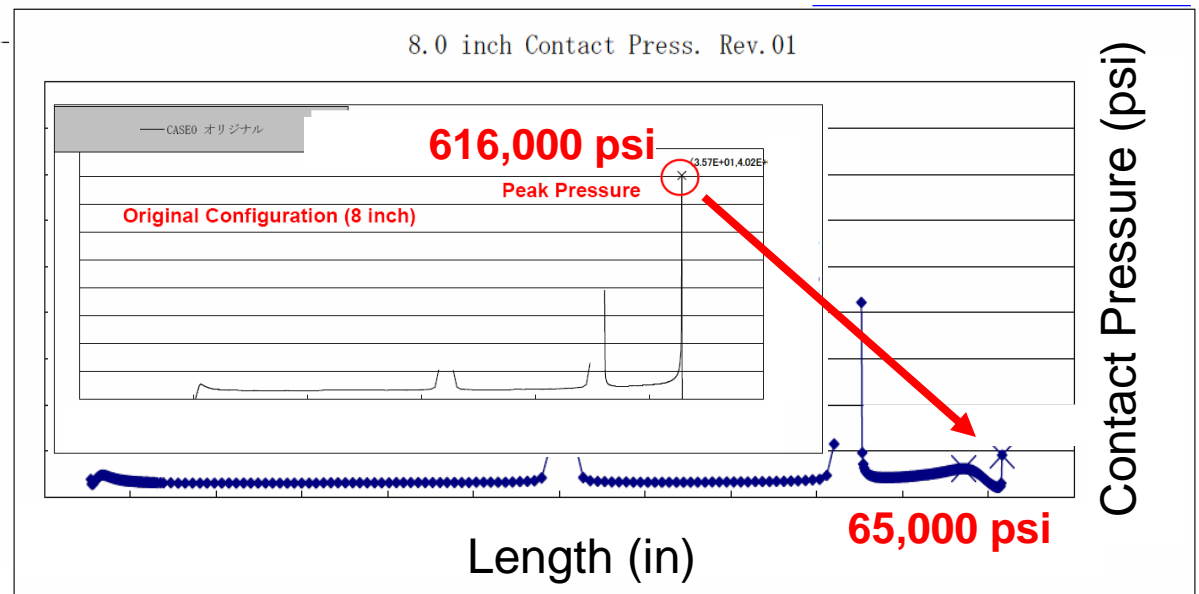
Hub Modification Plan

Solution: Reduce the shaft edge contact pressure (Area "A")

- Reduce overhung mass and apply groove at small end of bore
- Reduce bump up mass

Both ideas would be applied

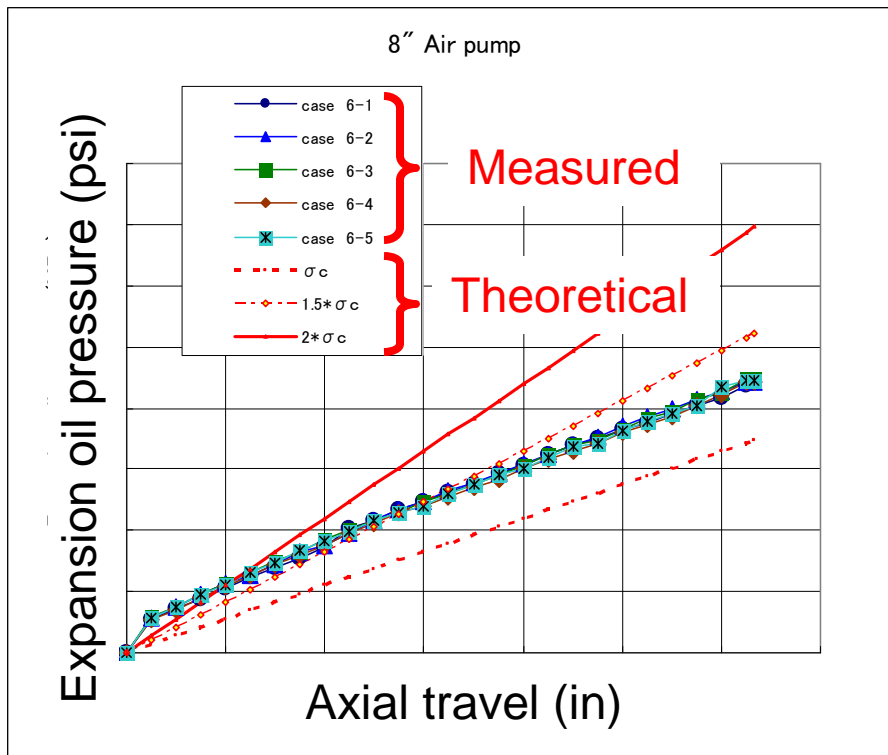
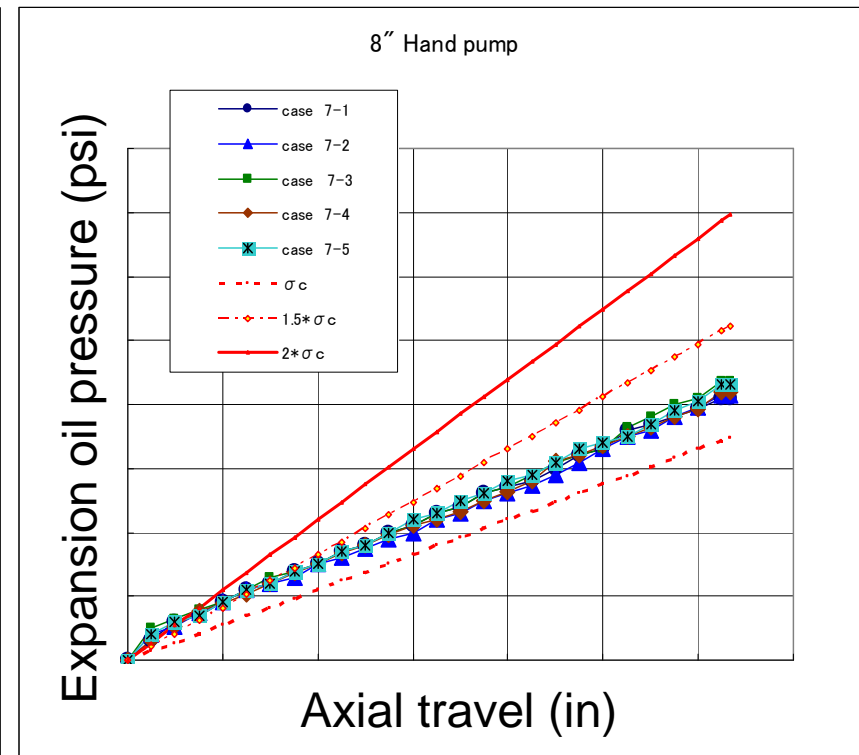
Results of Mock-up test (8 inch hub)

Measured expansion oil pressure with air pump and hand pump

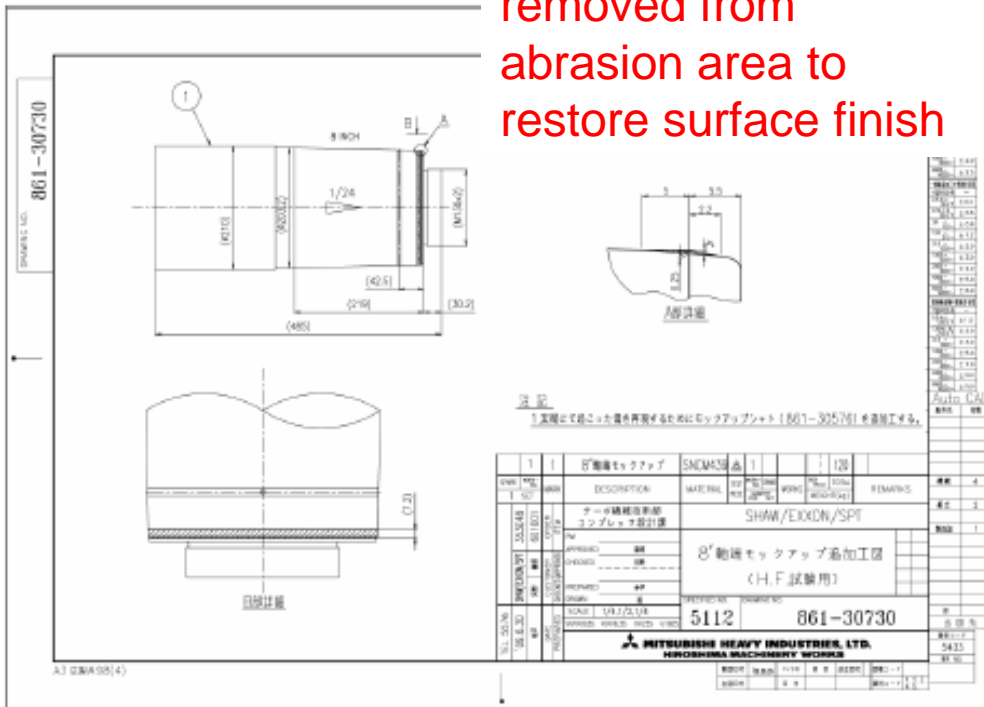
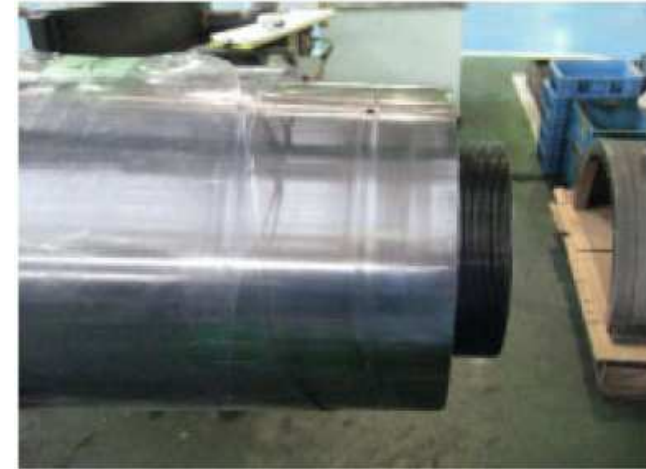
Additional material removed from abrasion area to restore surface finish

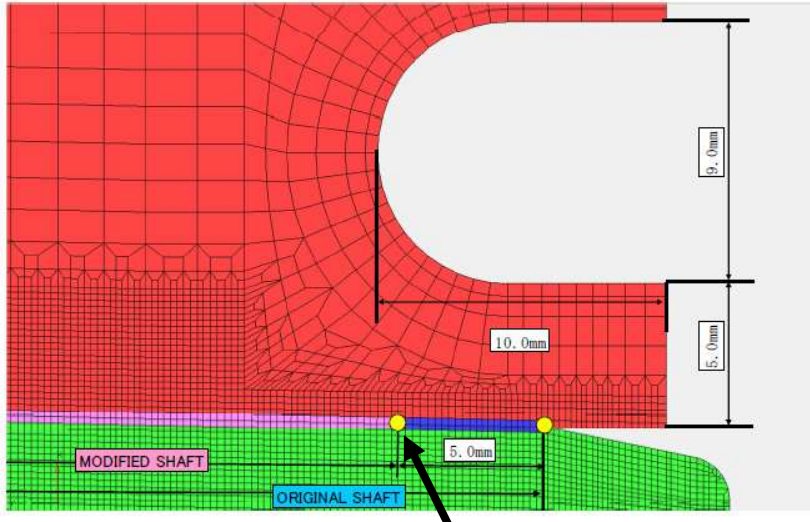
Study for Effect of Shaft Geometry

High contact pressure was noticed during installation of the hydraulic hub due to the reconditioned shaft geometry

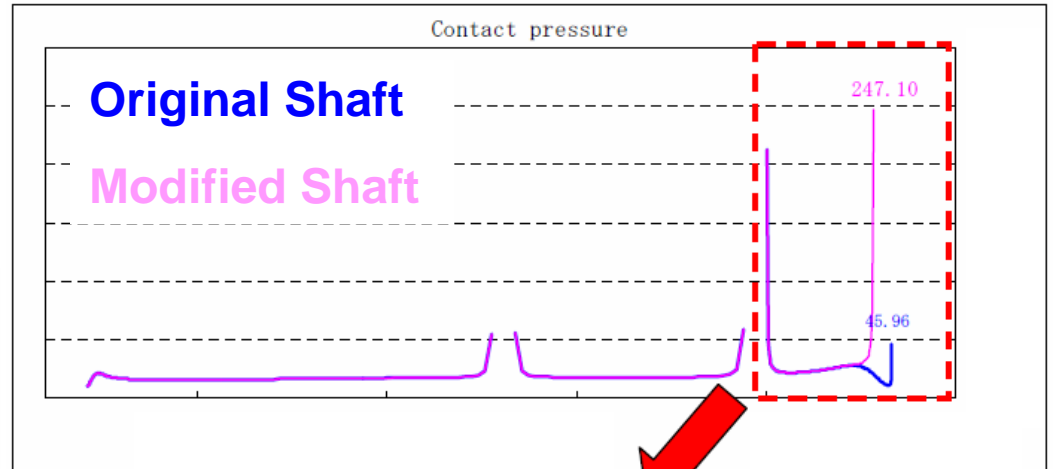
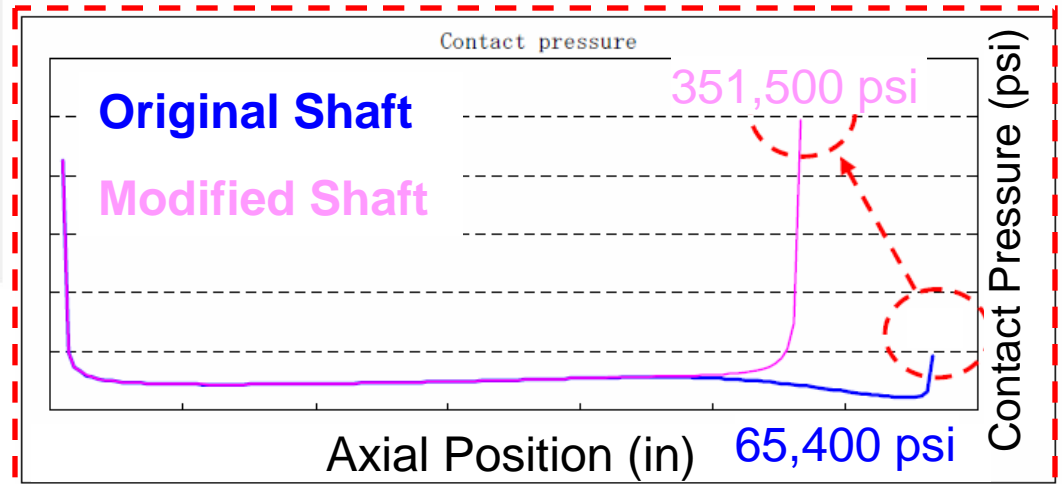
Relief groove has minimal effect on modified shaft due to relative position of groove to high pressure area.

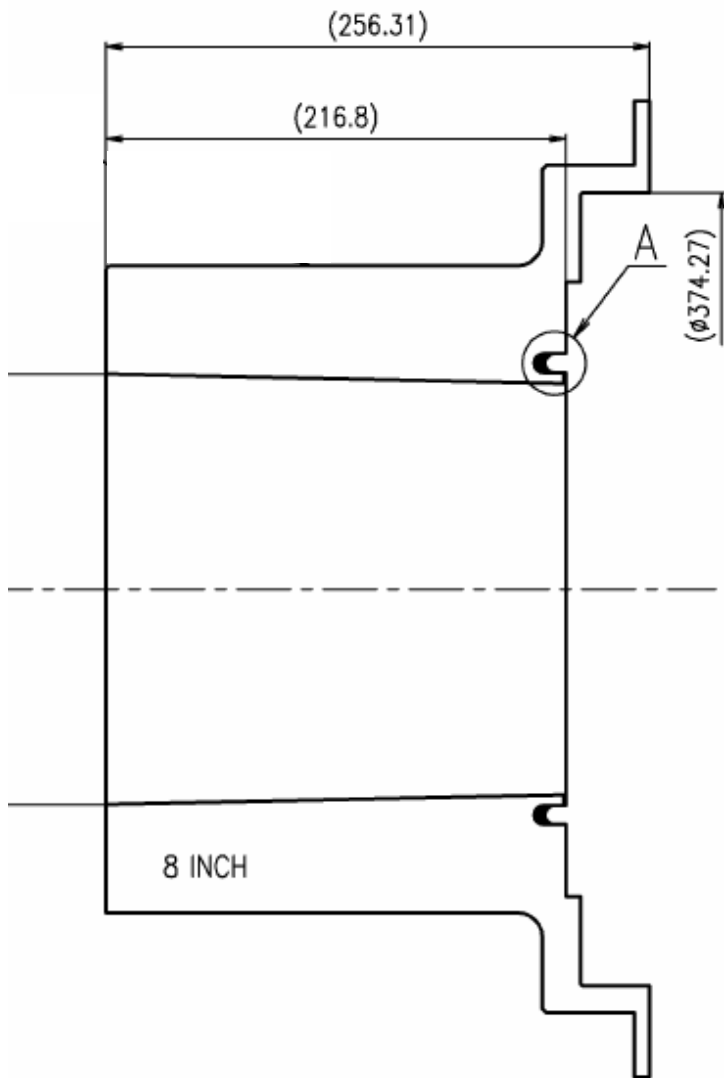
Result of additional mock-up test

Additional mock-up test was successfully completed.

Relief groove depth was increased to prevent damage.
