# Intermittent Spikes on Vibration and Motor Current Caused by Water Carry Over on the 3rd stage of a Centrifugal Air Compressor.

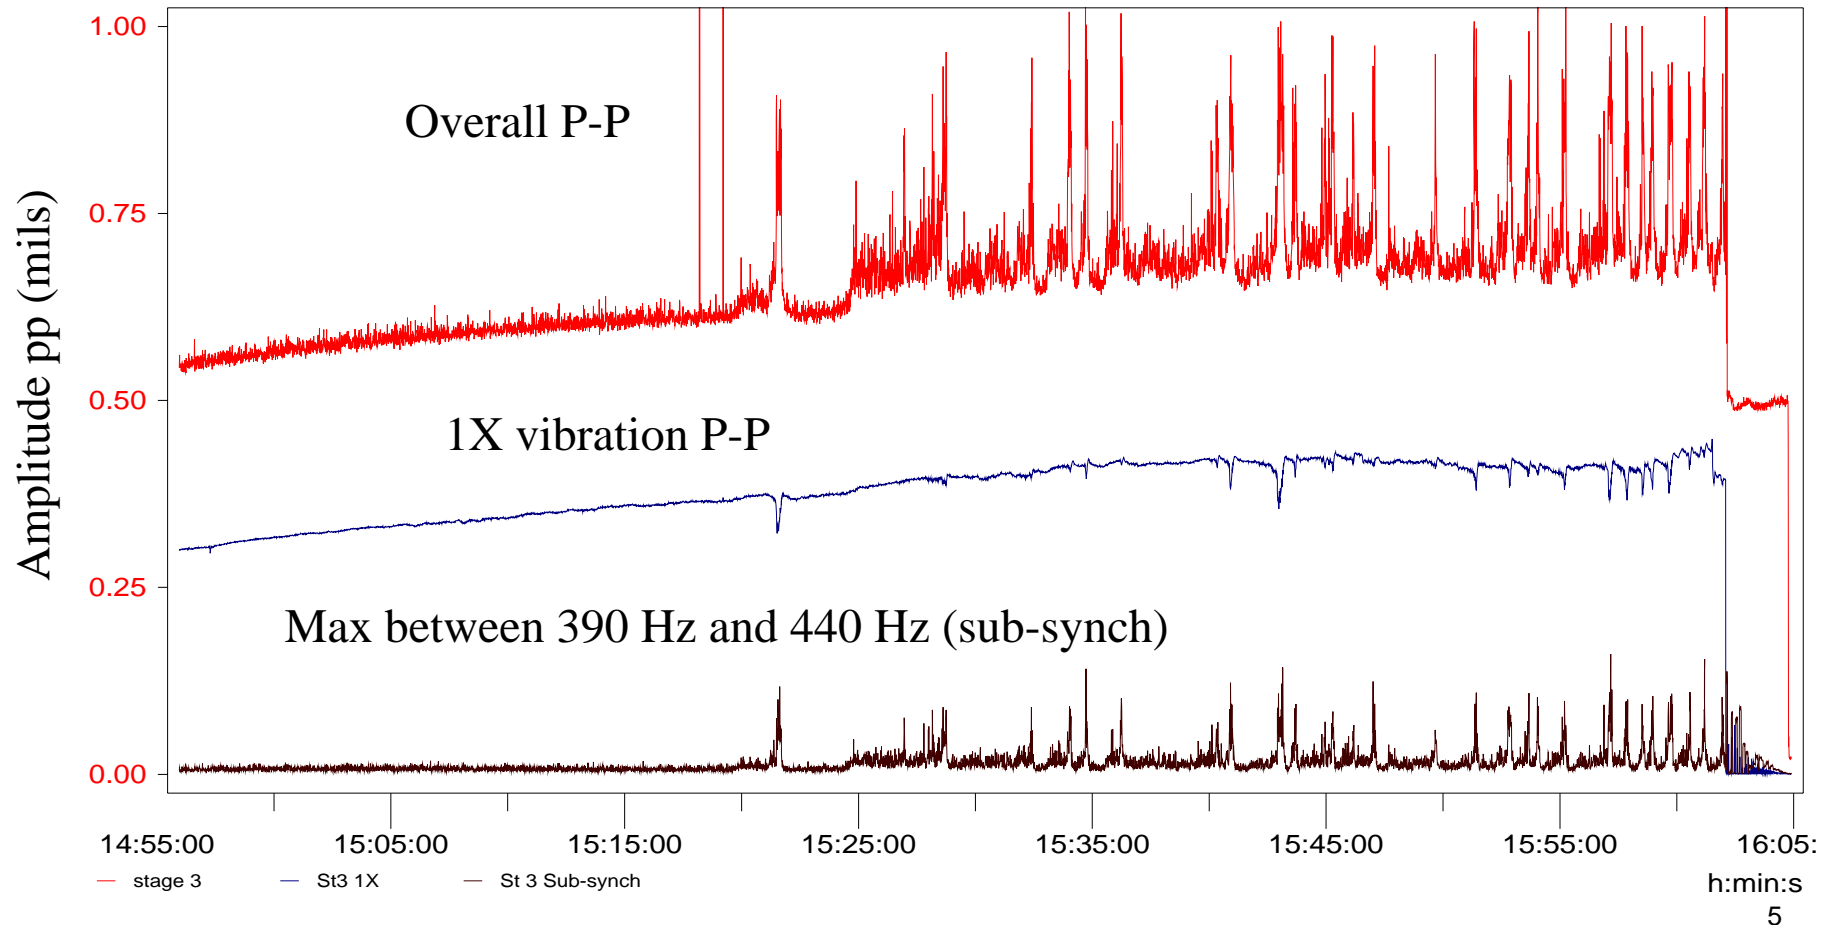
# Vibration data on 3<sup>rd</sup> stage

- Scratch on the probe indicating surface
- The upset incidents on 3<sup>rd</sup> stage coincided with Motor Amps oscillations
- The vibration on the bull gear and the 1<sup>st</sup> and 2<sup>nd</sup> stages was steady
- Sub-synchronous vibration indicated that the 3<sup>rd</sup> stage was marginally stable

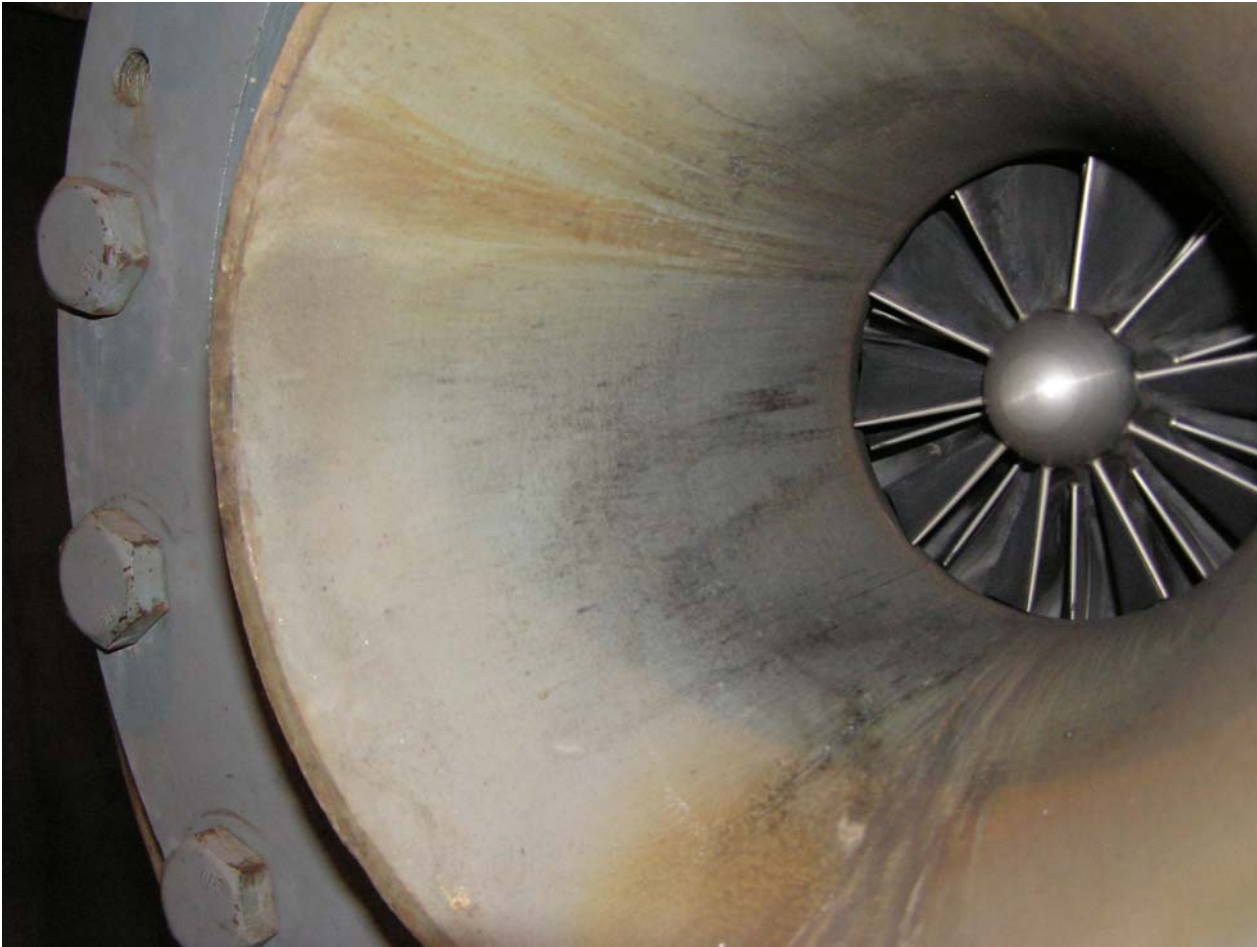
Inlet cone of the 2<sup>nd</sup> stage.

Picture shows normal wear.

The first intercooler and inlet piping showed only normal wear as well

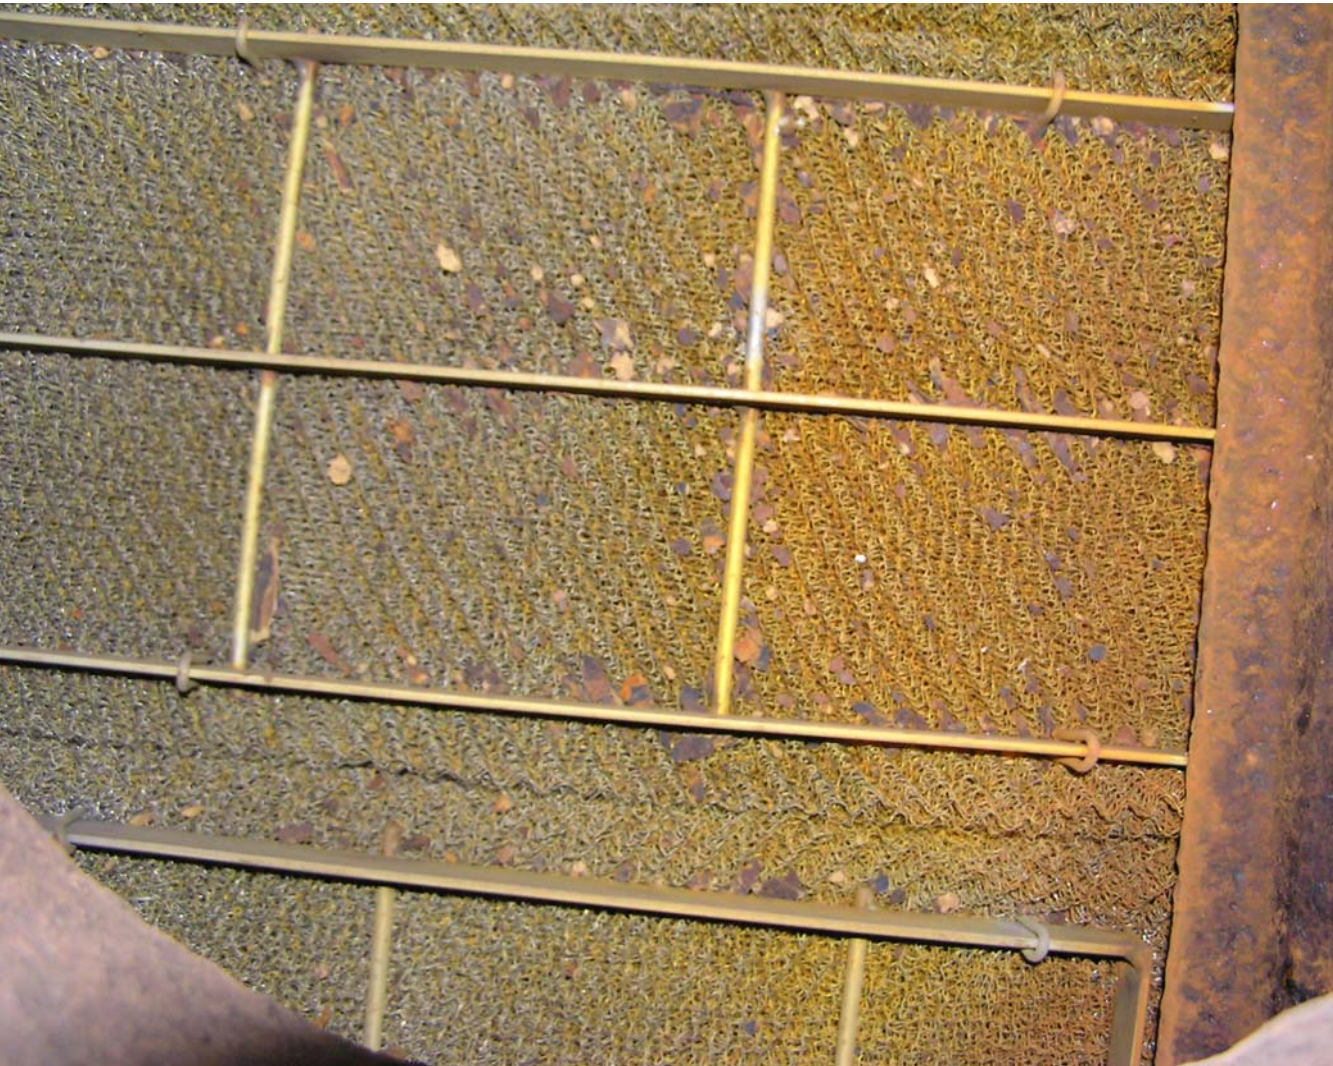
Demister pads on Second Intercooler (between 2<sup>nd</sup> and 3<sup>rd</sup> stage) showing rust and corrosion scale

- ❑ The old style float traps are not well suited for this application.
- ❑ Water in the 2nd intercooler would not drain out.
- ❑ The water accumulated on the back of the demister pads which became flooded, and periodically released a mist of water which caused the increase in overall vibration.
- ❑ The water carry-over was increasing the mass flow rate, changing the load on the third stage, which was seen as spikes in motor amps. The increased load, coupled with low damping on the bearings, was enough to create the sub-synchronous instability.

- The water also rusted out the 2nd intercooler shell, fouled the demister pads, badly corroded the 3rd stage inlet pipe and caused erosion at the base of the blades on the impeller.
- Water did not exit the 2nd intercooler drain line as expected. High velocity air along the bottom of the cooler was pushing water to the back of the cooler and preventing it from draining properly at the centrally located drain connection

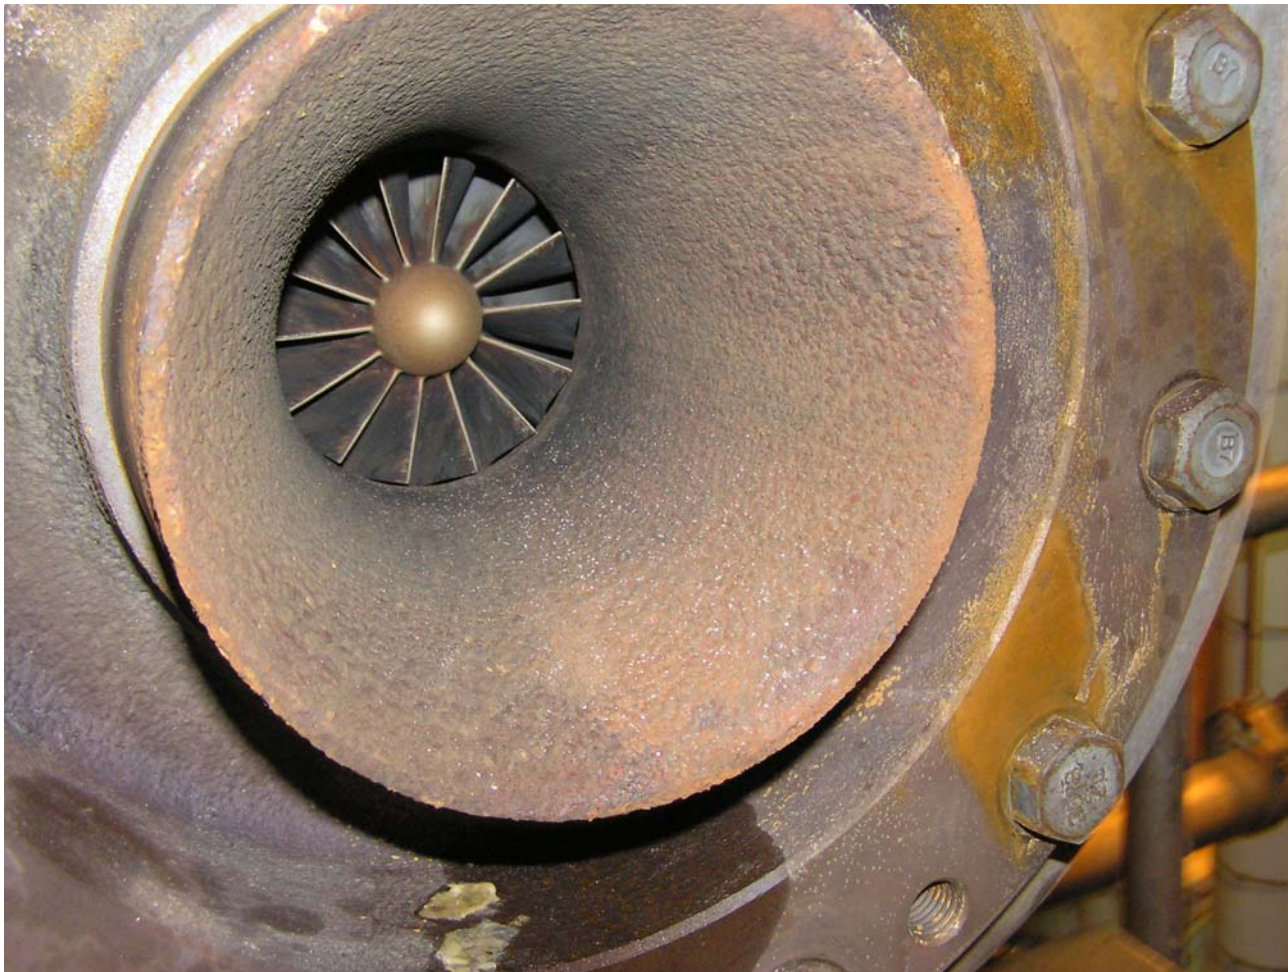
Inlet cone of the third stage. Picture shows heavy rust on the cone and deposits on the impeller.

The inlet pipe was corroded beyond repair.

- ❑ Replaced the rusted 3<sup>rd</sup> stage inlet pipe with a new stainless-steel inlet pipe.
- ❑ Coated the second intercooler shell with epoxy (Carboline 450)
- ❑ Replaced the 3<sup>rd</sup> stage original bearings with a new flex-pivot bearing that was designed as an upgrade retrofit.
- ❑ Installed a baffle above the 2<sup>nd</sup> intercooler drain connection.
- ❑ Added a second drain connection at the rear of the 2<sup>nd</sup> intercooler where we believed we had standing water.
- ❑ Replaced the old, malfunctioning water traps with “Drain-Alls.”

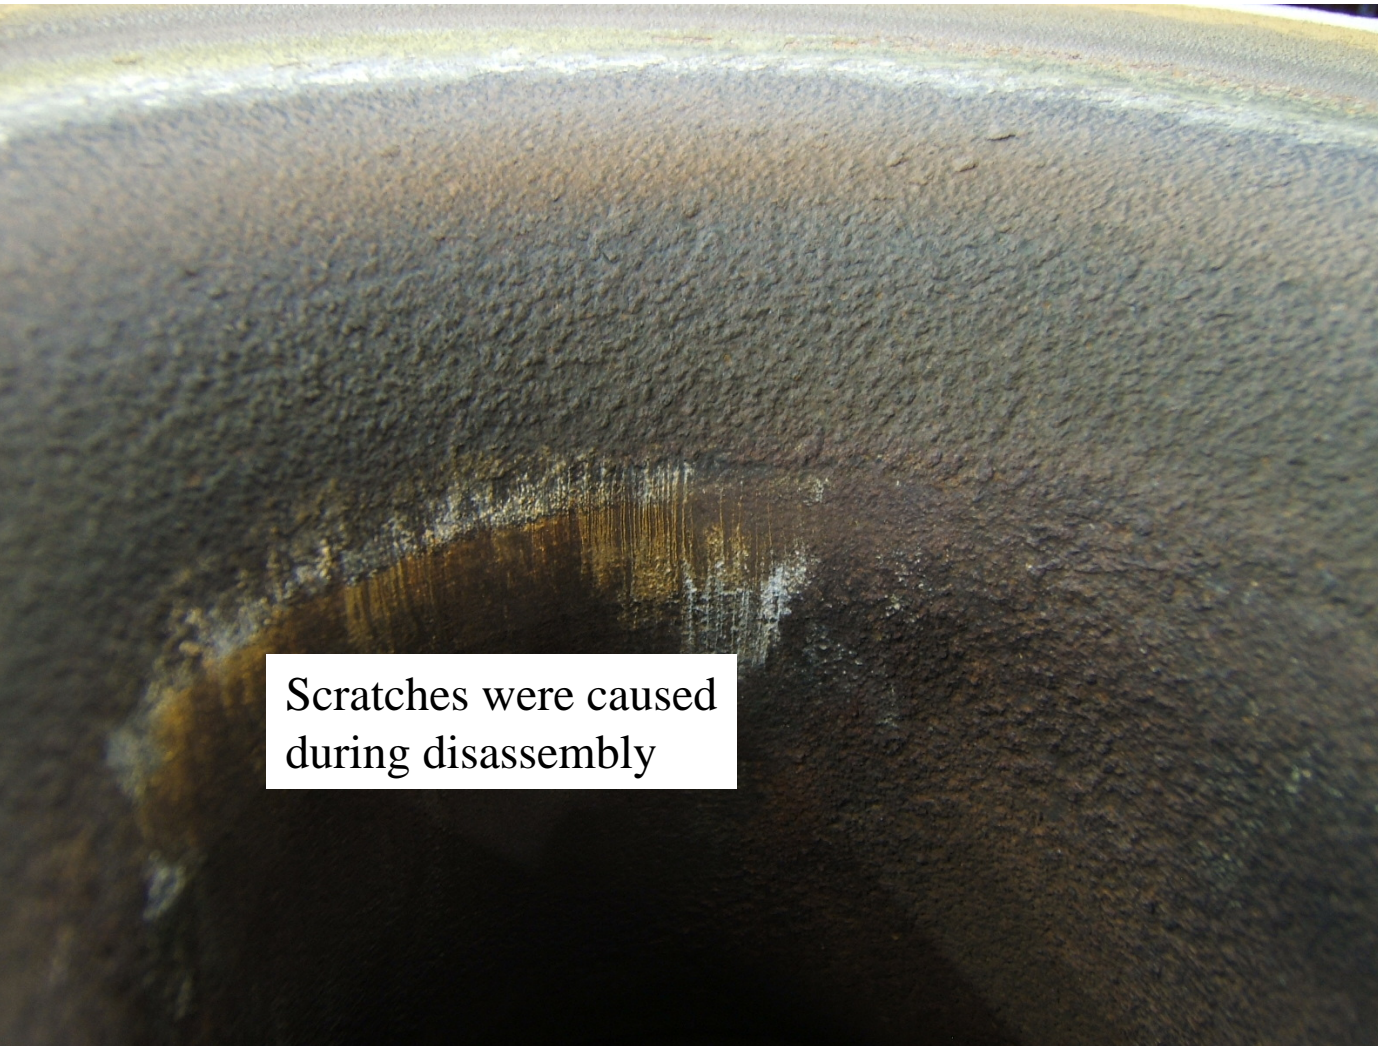
Close up of the 3<sup>rd</sup> stage inlet cone. It shows deposit and rust

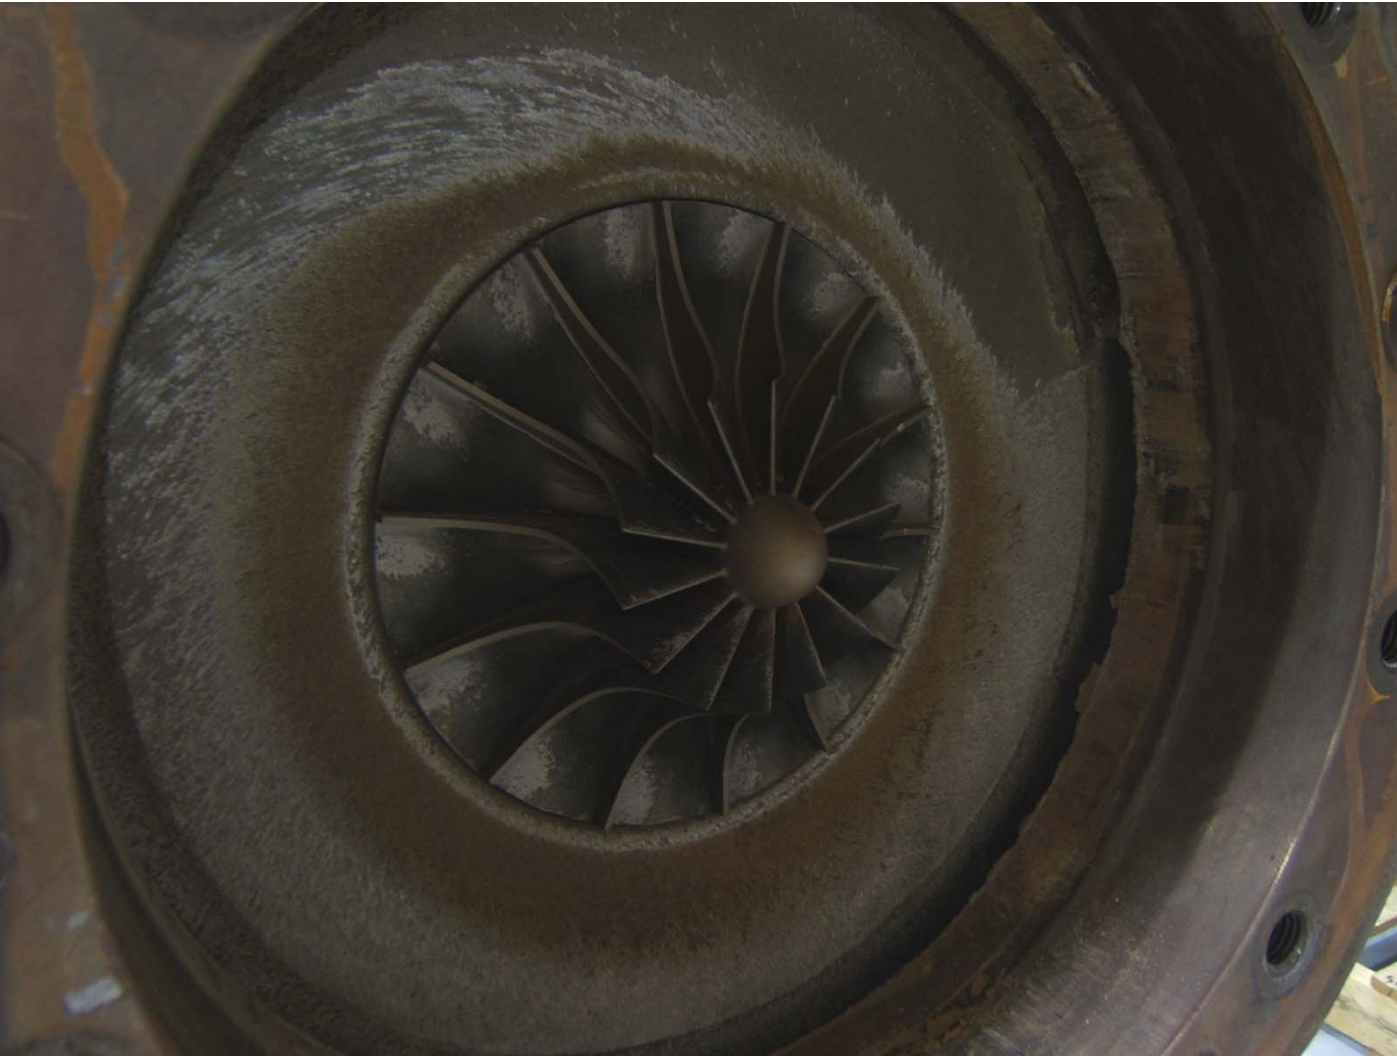
3<sup>rd</sup> stage  
discharge  
with heavy  
deposits

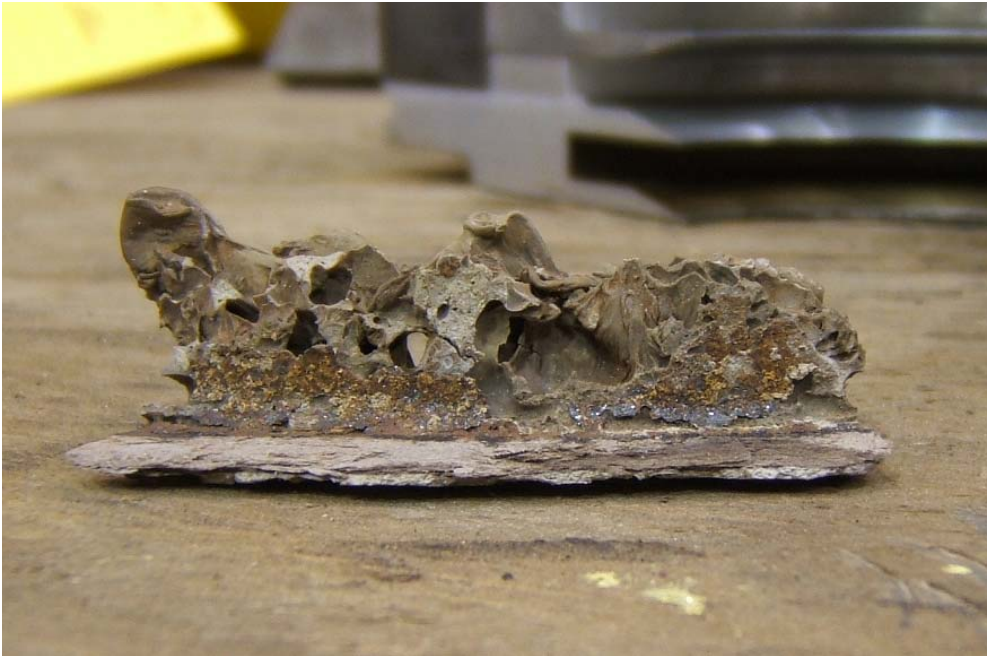
Deposit found inside the 3<sup>rd</sup> stage volute.

Analysis showed just ordinary silicates, “dirt.”

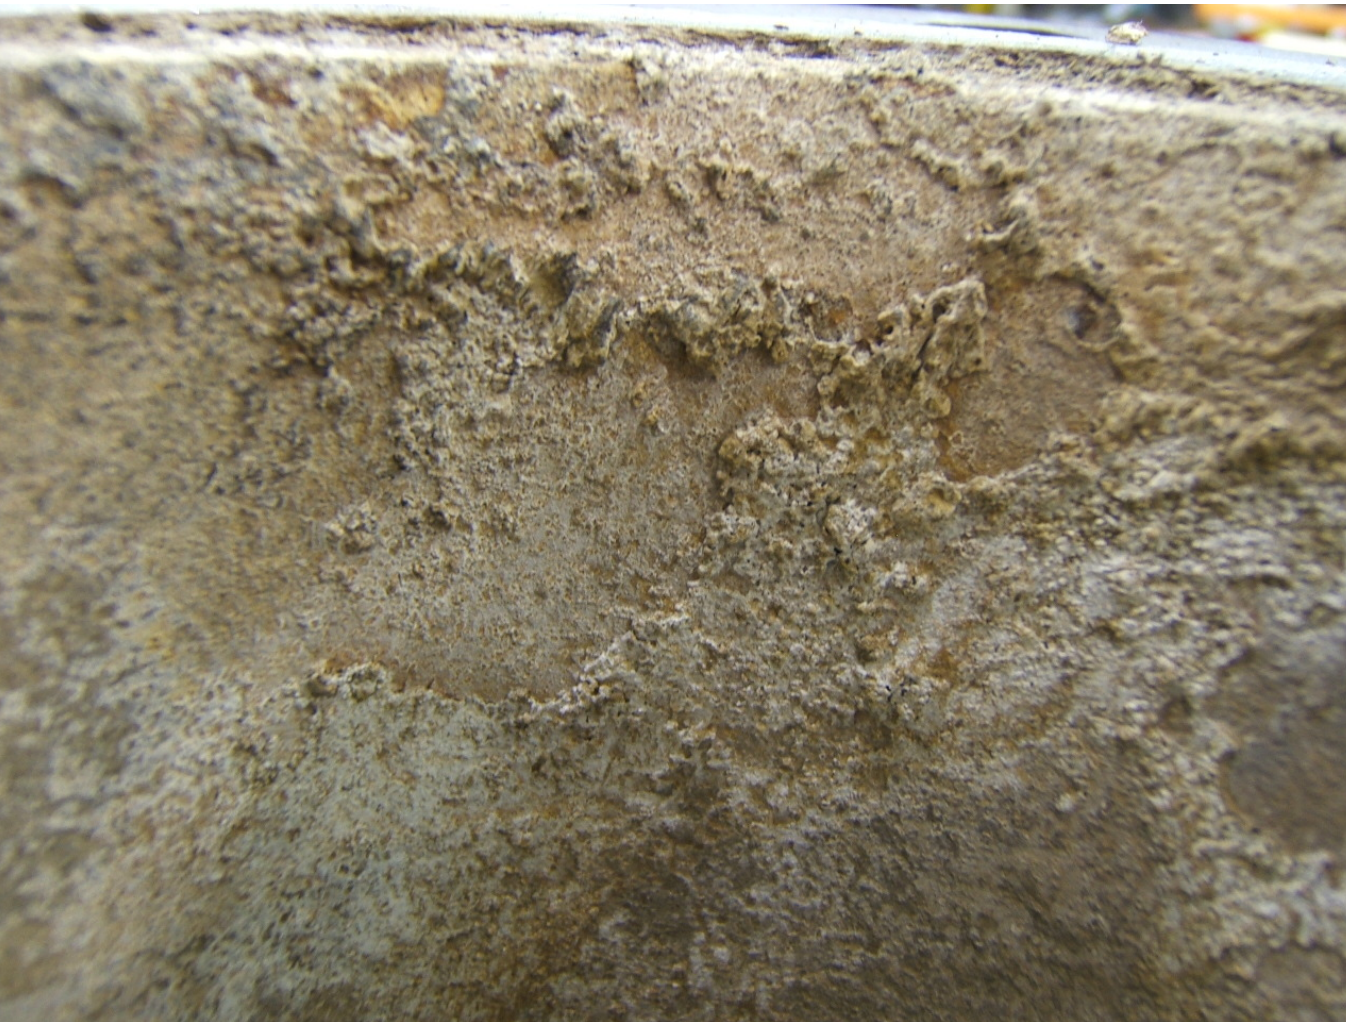
Scales found in the 3<sup>rd</sup> stage discharge horn.

Seems to be the same kind of material deposit as found in the volute.

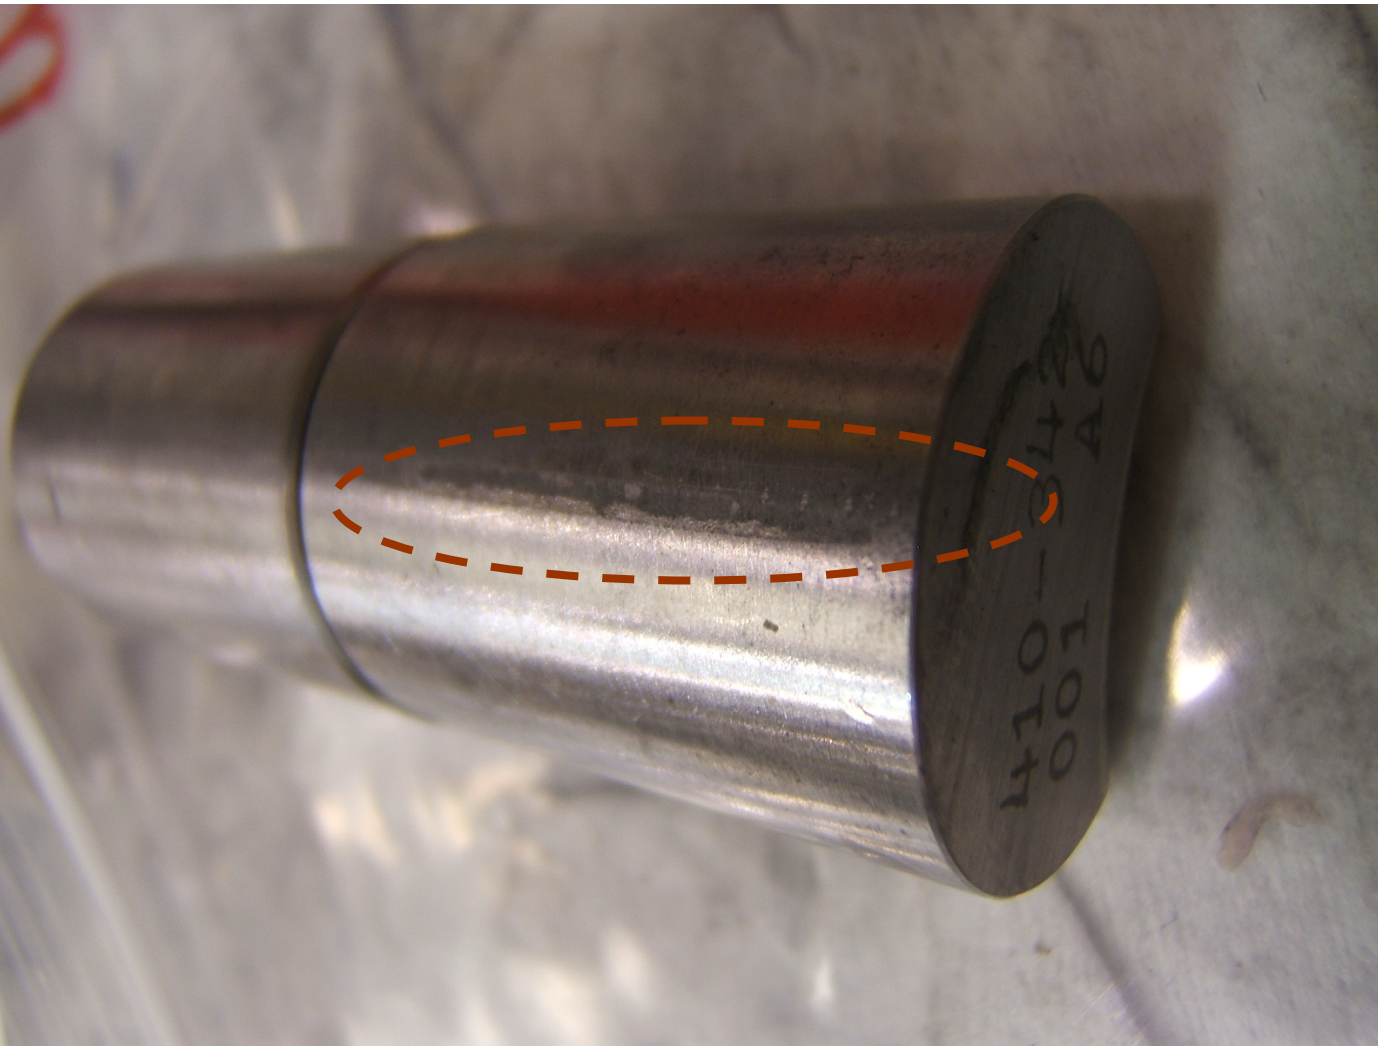
Flattened portion of the back of one of the loaded pad on the bearings of the third stage

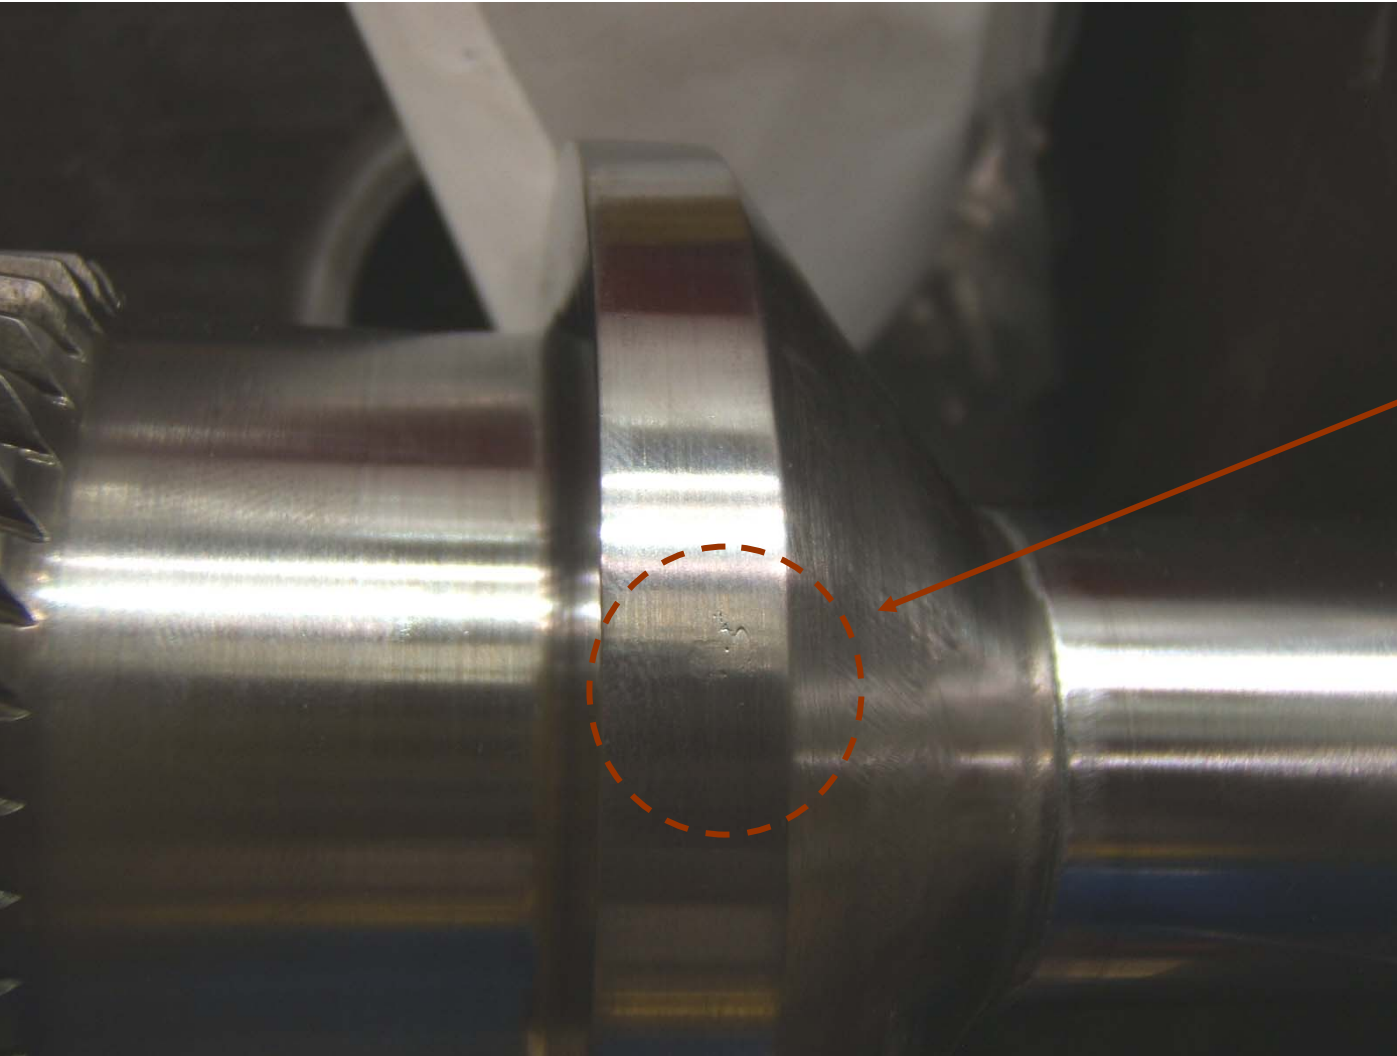
Found damage on probe indicating surface of the 3<sup>rd</sup> stage, impeller end
