Wire Wool Failure of a Compressor Rotor

38th Turbomachinery Symposium Case Study

LyondellBasell Specialty Engineering Group

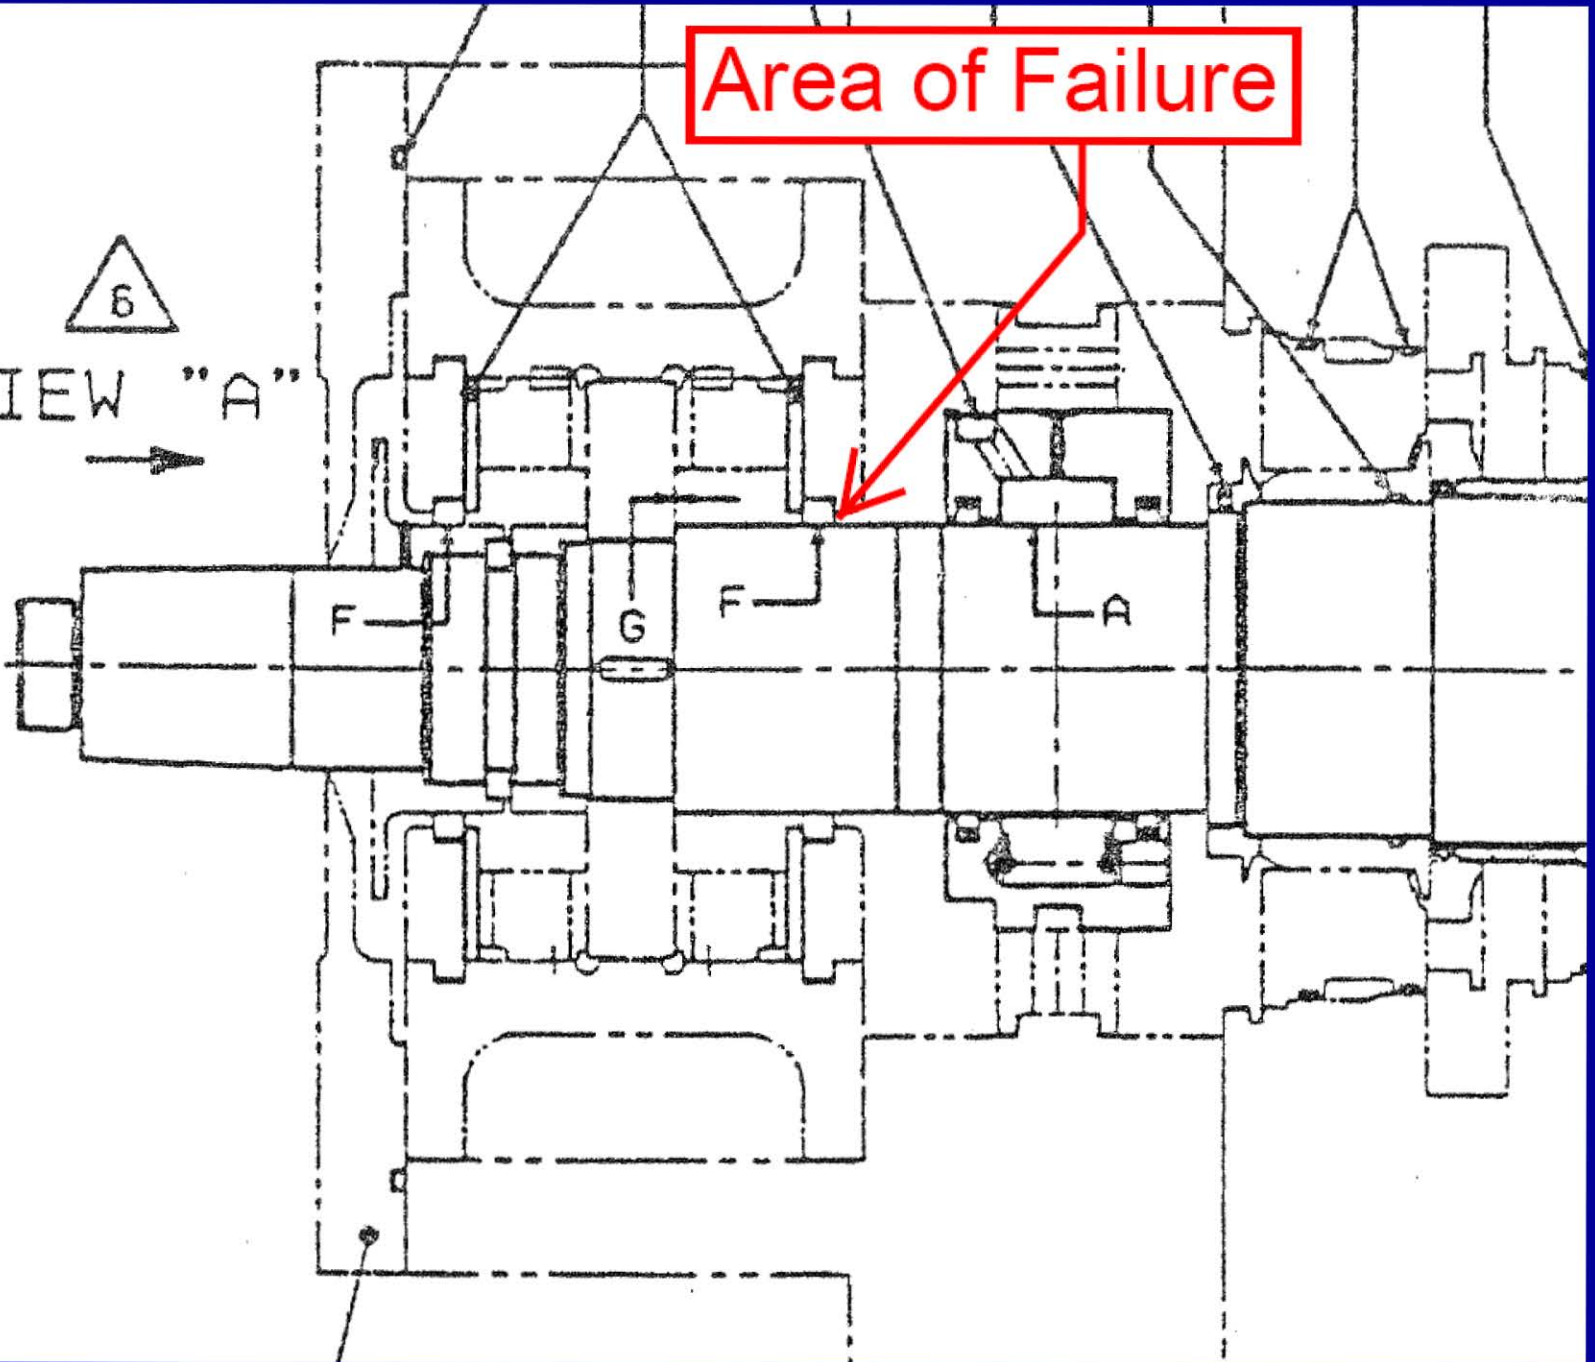
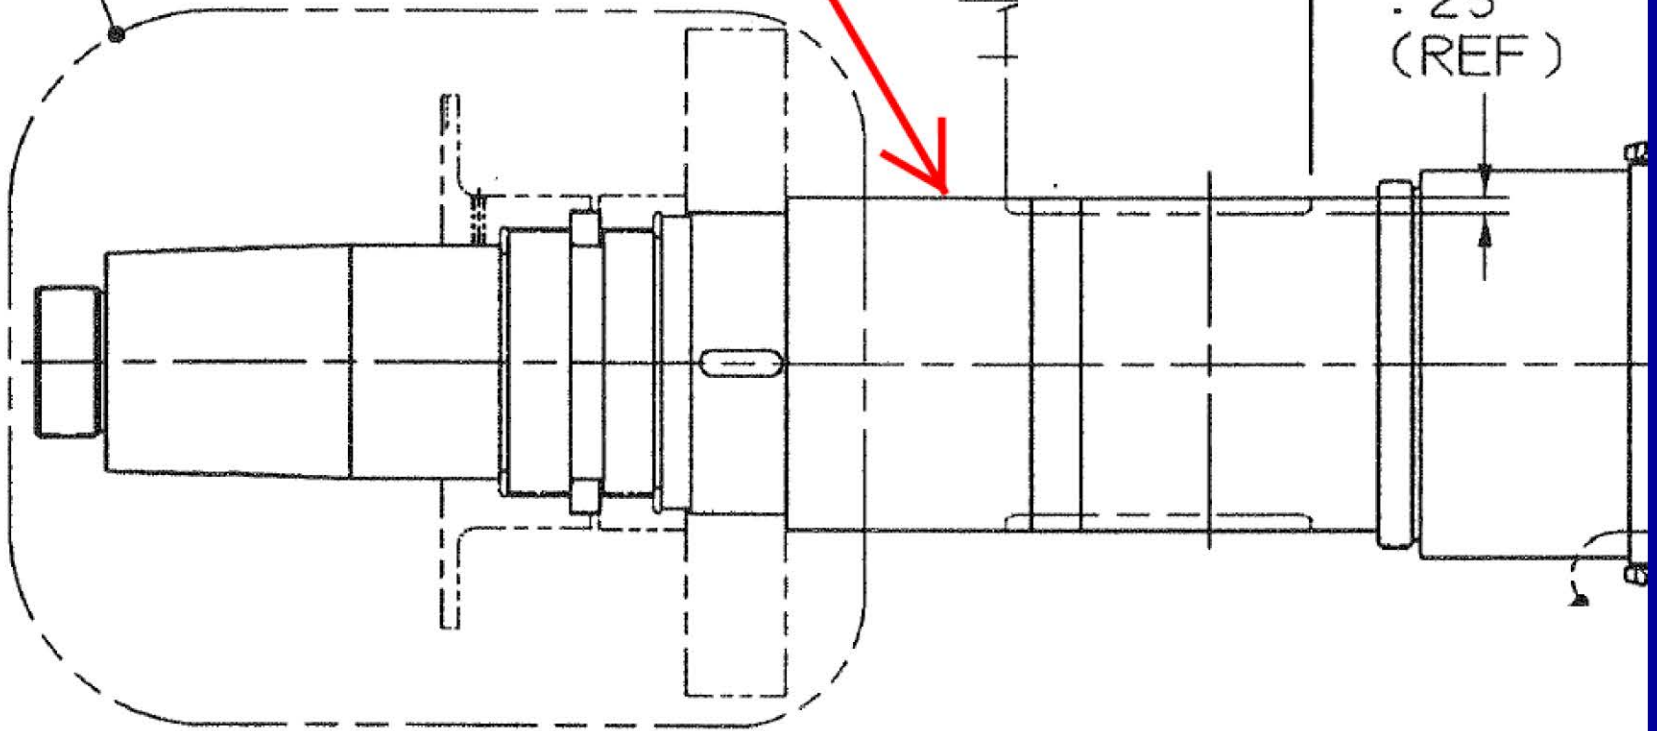
- Double flow beam type centrifugal compressor driven by an electric motor on one end and a steam turbine on the other
- 13,390 HP
- 8676 rpm
- 15-5 PH shaft material with low carbon manganese steel overlay in bearing journal areas

Area of Failure

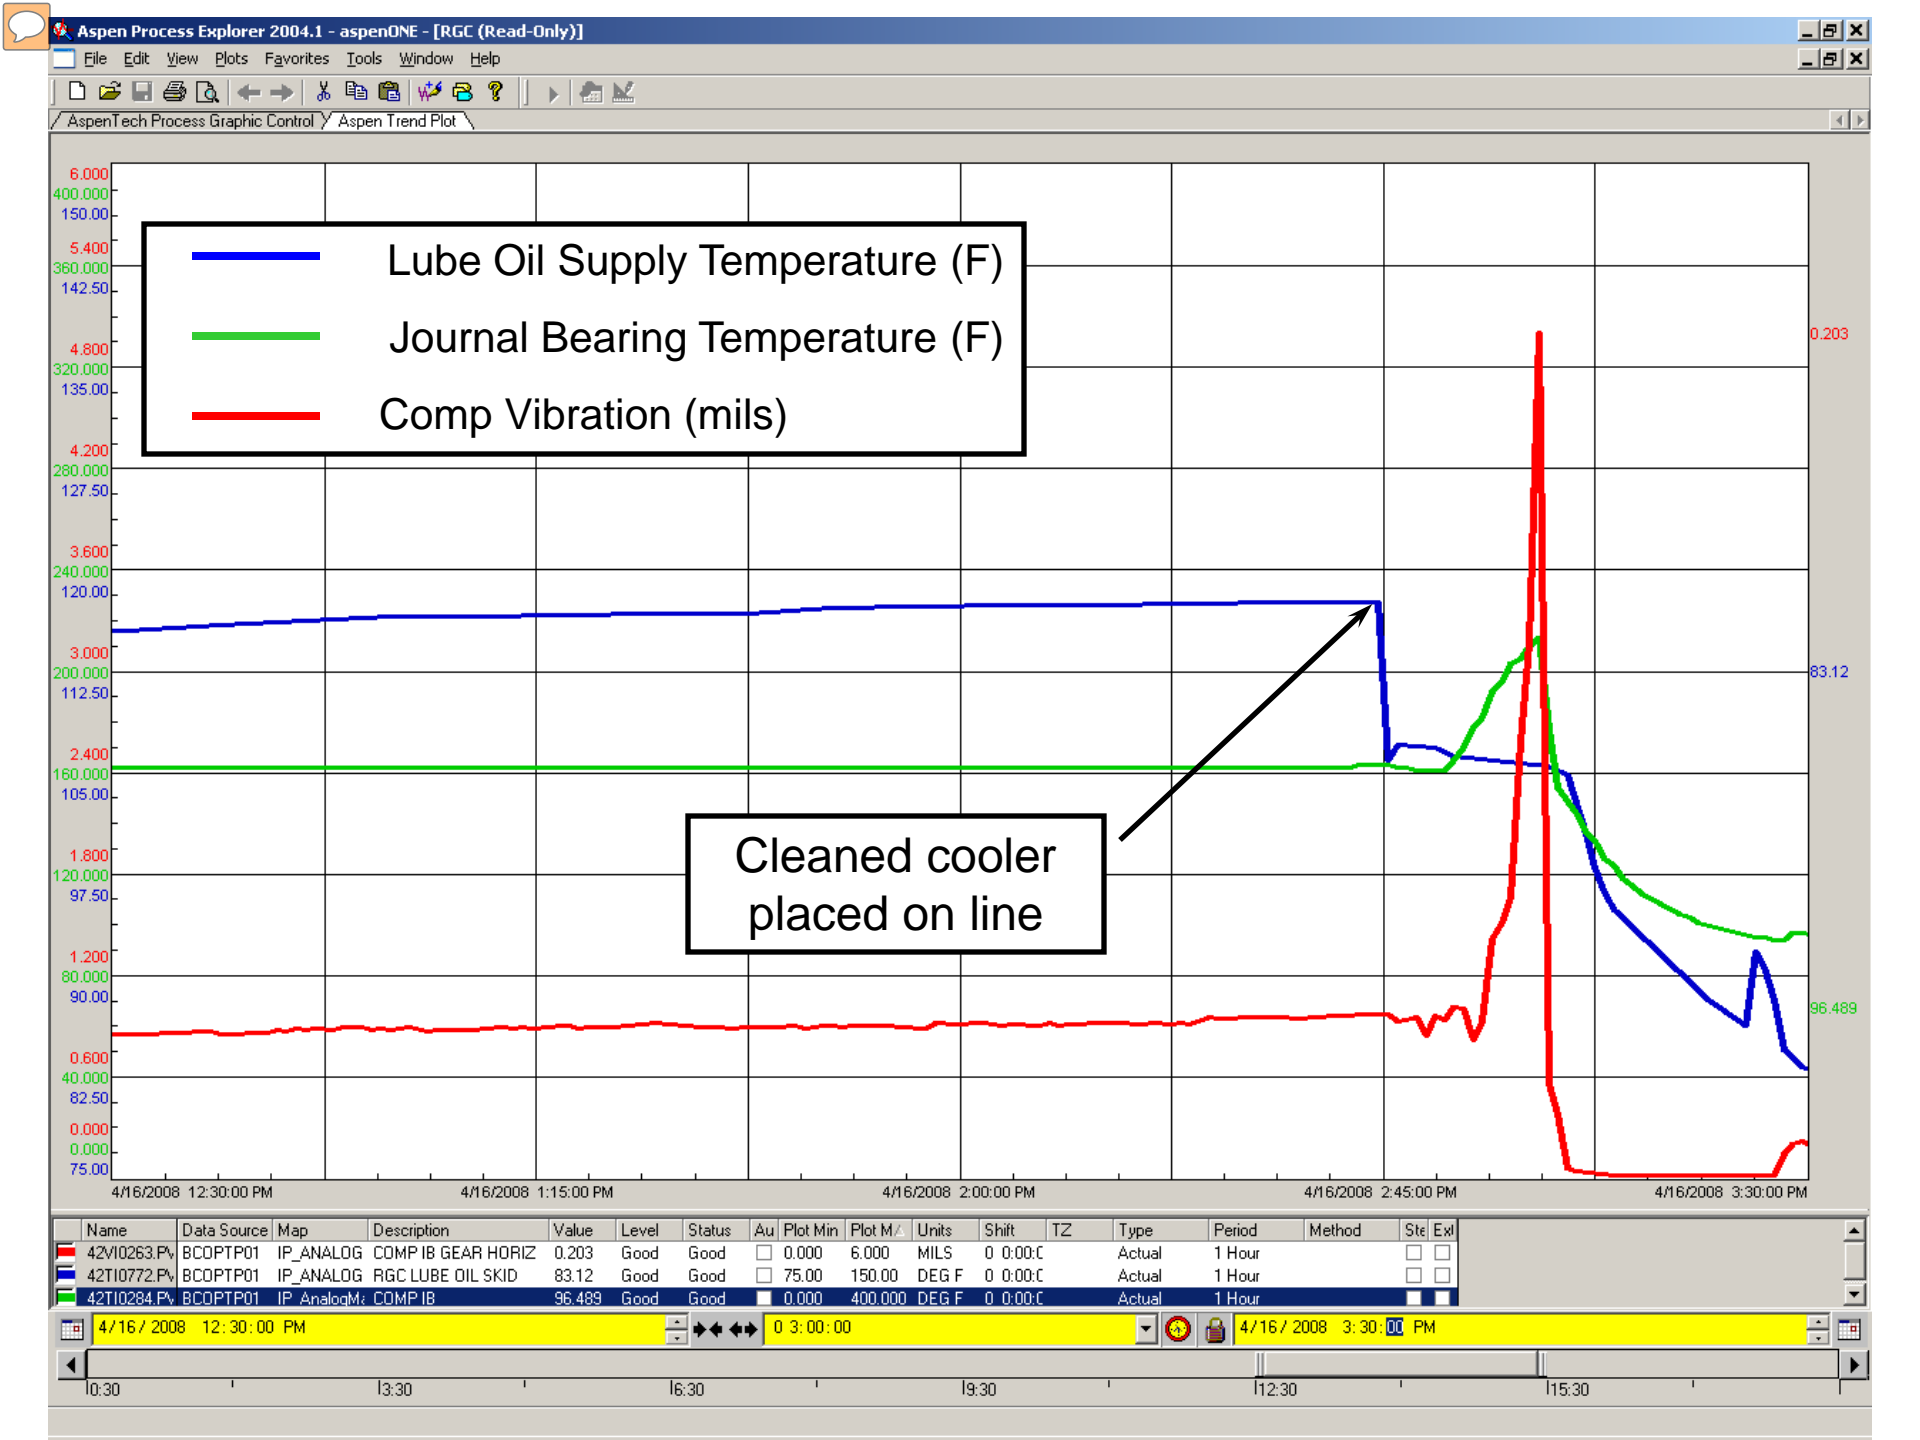
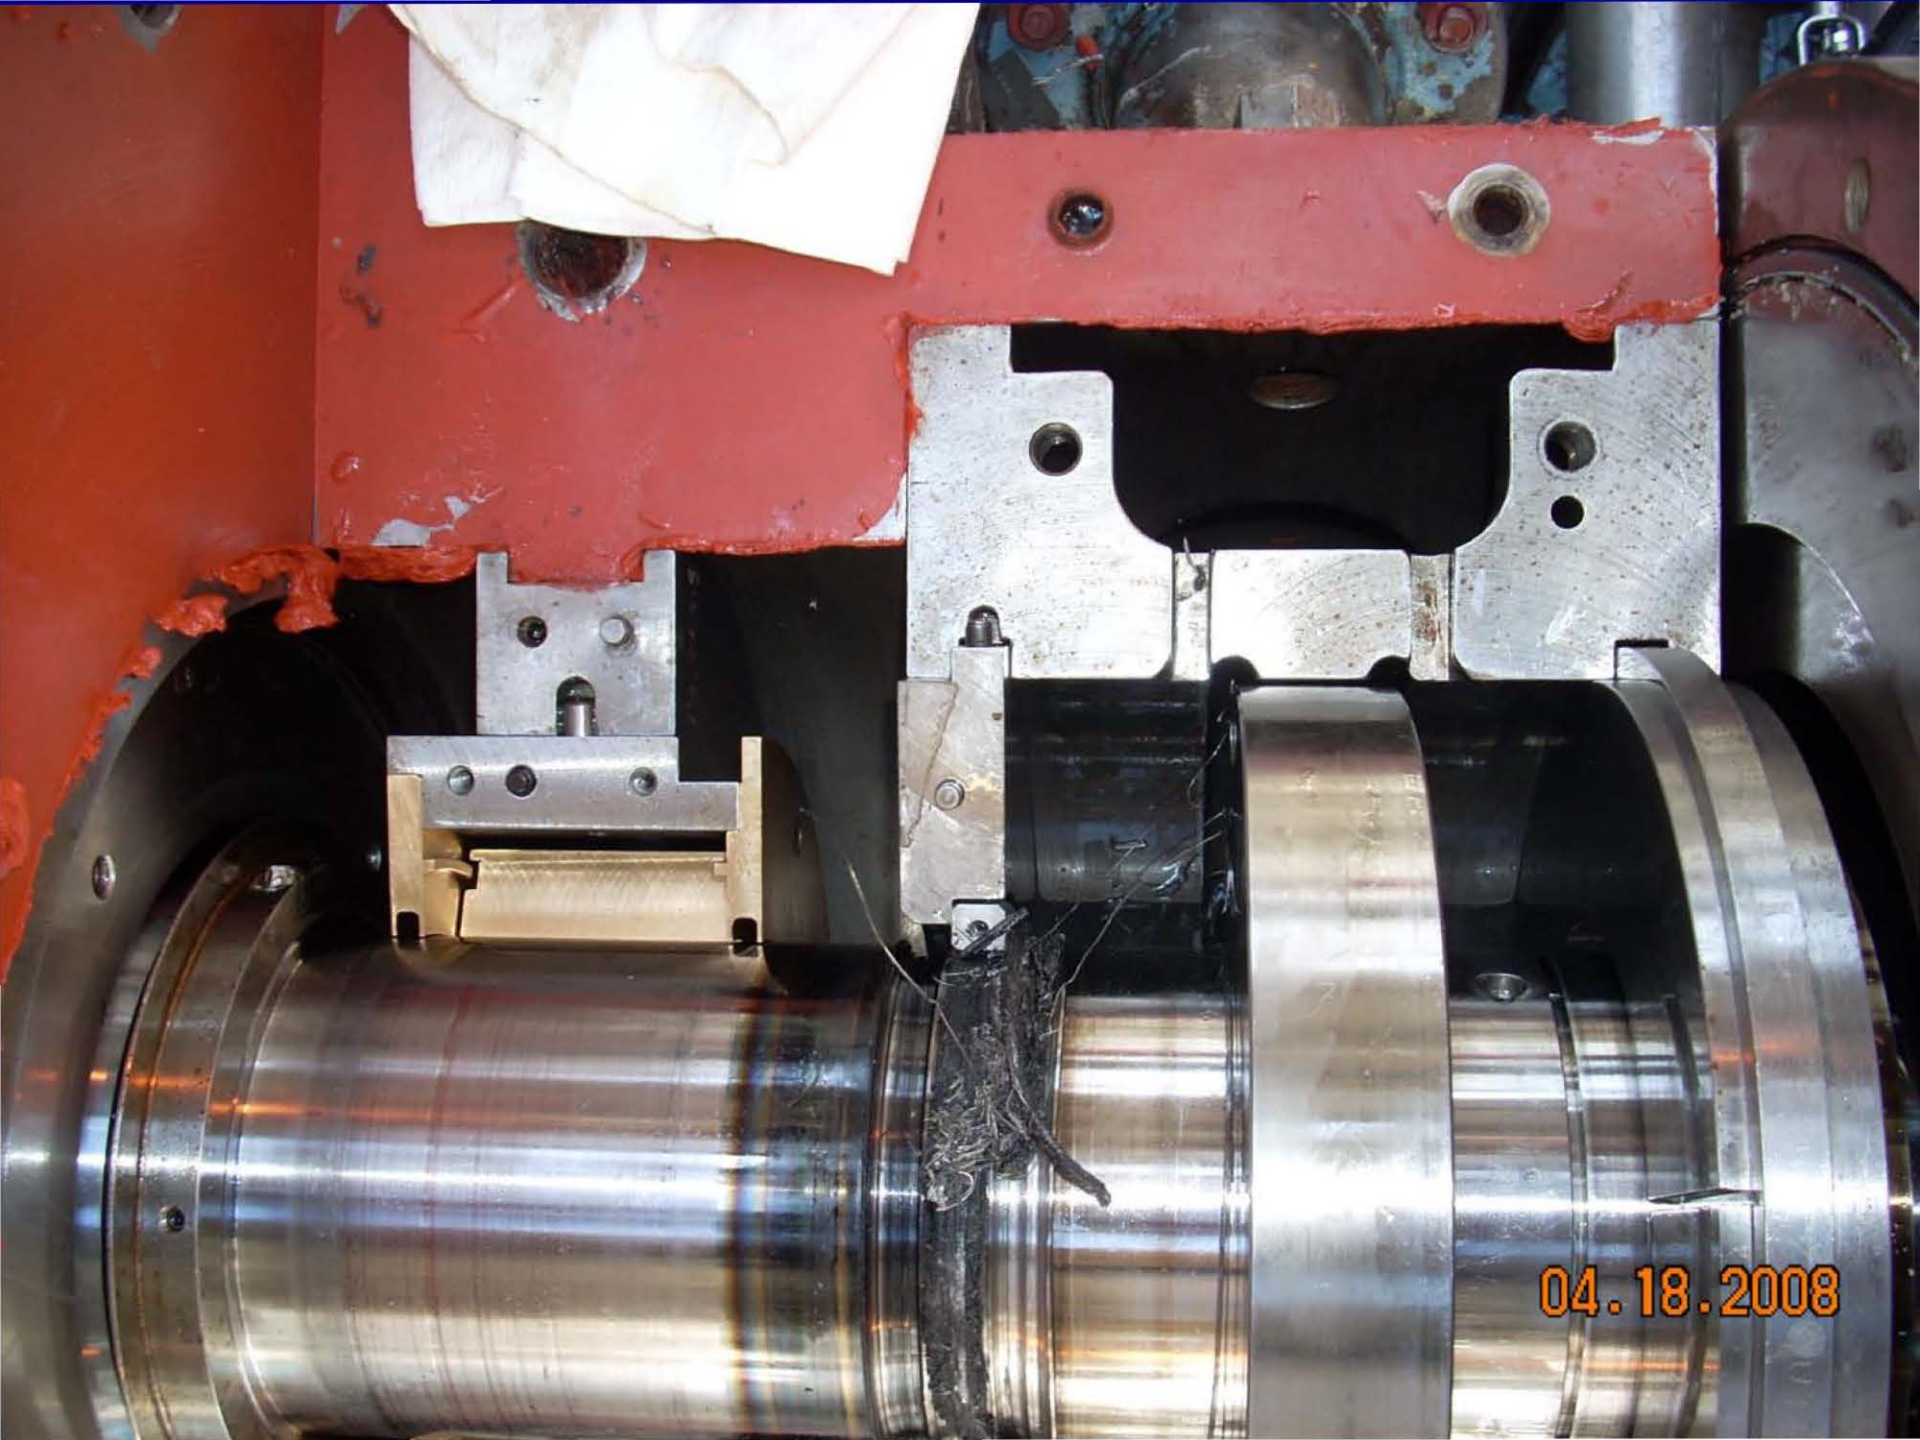
- With machine disassembled it was readily apparent that it had experienced a wire wool failure.
- Debris from machining appeared as wire wool.
 - Pre-disassembly
 - Shaft runout approaching 25 mils TIR
 - Spiral windings in oil drain line bull's eye

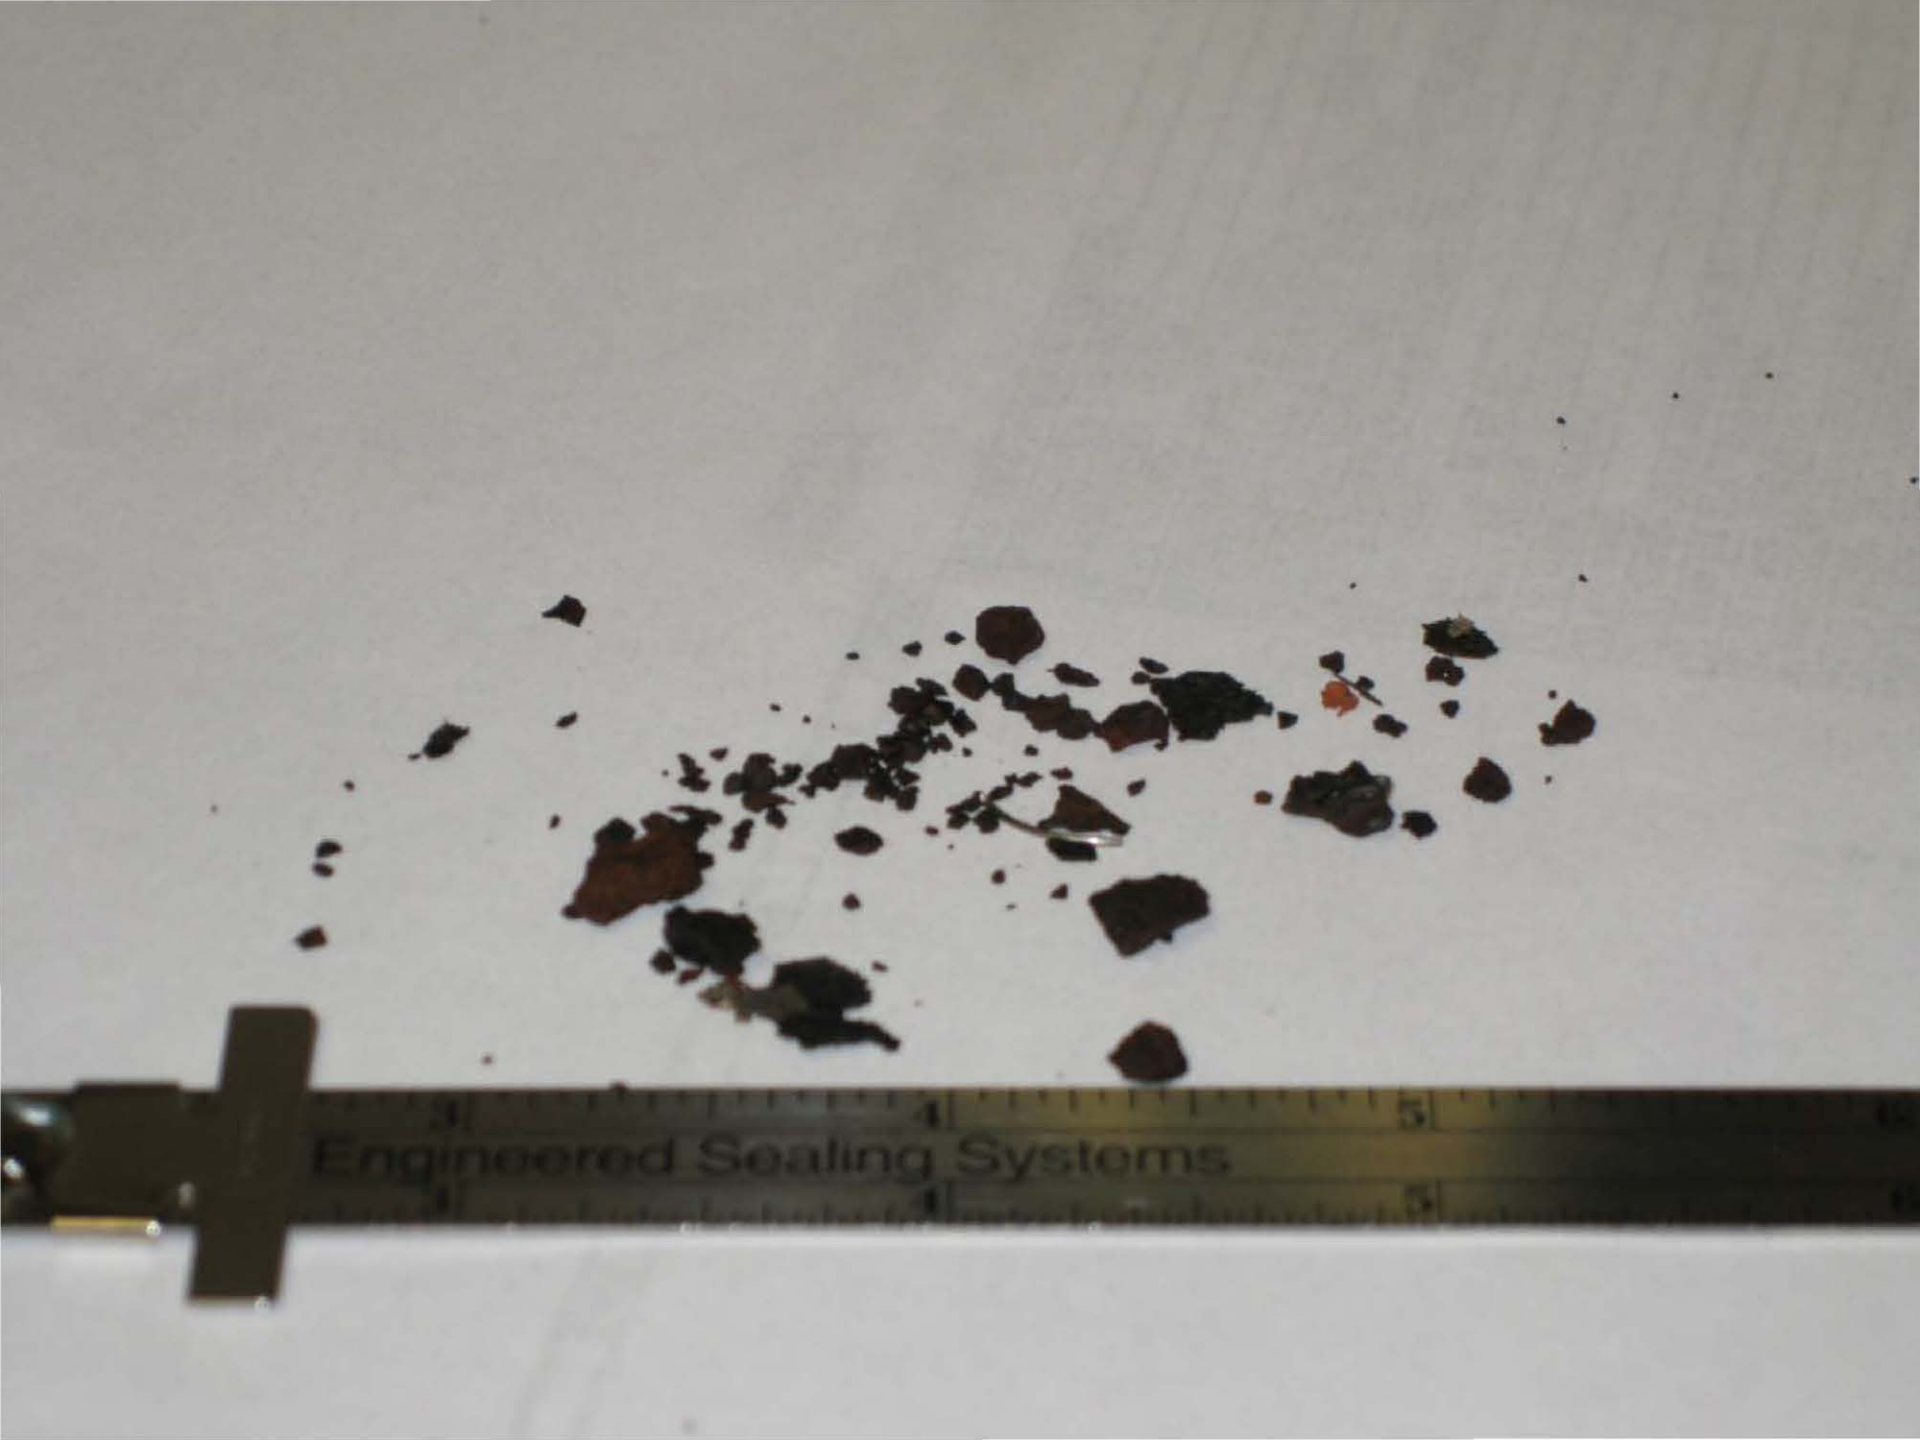
- Other bearing journals exhibited scoring
- Oil filter housing contained significant amount of large debris
- Oil pump suction screen mesh much tighter than large debris

- Debris originated from:
 - Lube oil supply high temperature swings performed additional “cleaning”?
 - Oil temperature excursion to 170 F
 - Sudden oil temperature drop when cooler placed on line
 - Contaminated oil cooler bundle?
 - Would require passage through filter
Reference *Dynamic Filter Efficiency*
 - Combination of above?

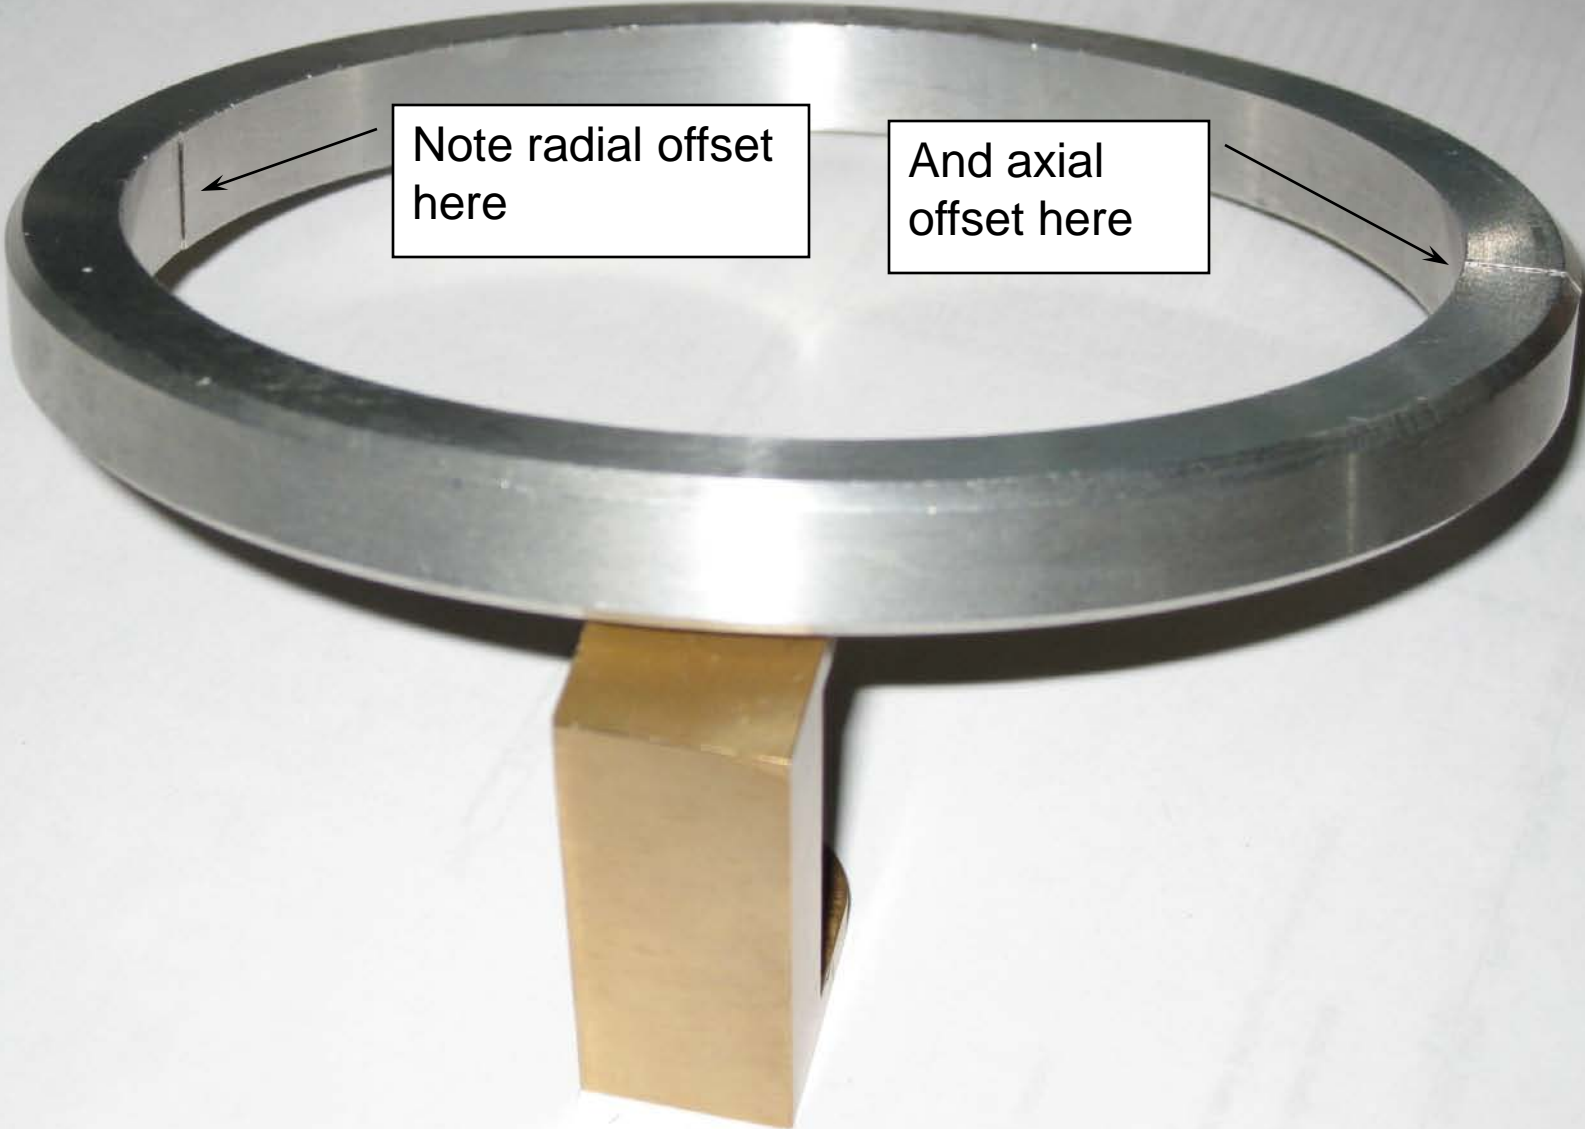
Spare Oil Seal – Example of Design and Manufacturing Flaws

- Oil seal
 - Split design incorporated due to coupling on thrust bearing end
 - Spare thrust bearing oil seal had offsets at splitline
 - Existing oil seal design could lock up thus further forcing any trash against shaft

Note radial offset here

And axial offset here

- Match marked halves
- Add dowels to splitline to improve alignment capability.
- Add anti-rotation slot to the lower half holder. This ensures that the anti-rotation pin does not accidentally get hung in the existing hole in the upper half. Plugged hole in upper half.
- Axial clearance changed to .005 to .010" (old design clearance was .002" to .005").
- Seal captured by bolted cover vs. relying on thrust bearing
