Development and Testing of a Very High Speed Oil Lubricated End Face Mechanical Seal

16 MWe Expander-Generator

Very High Speed Wet Seal Application

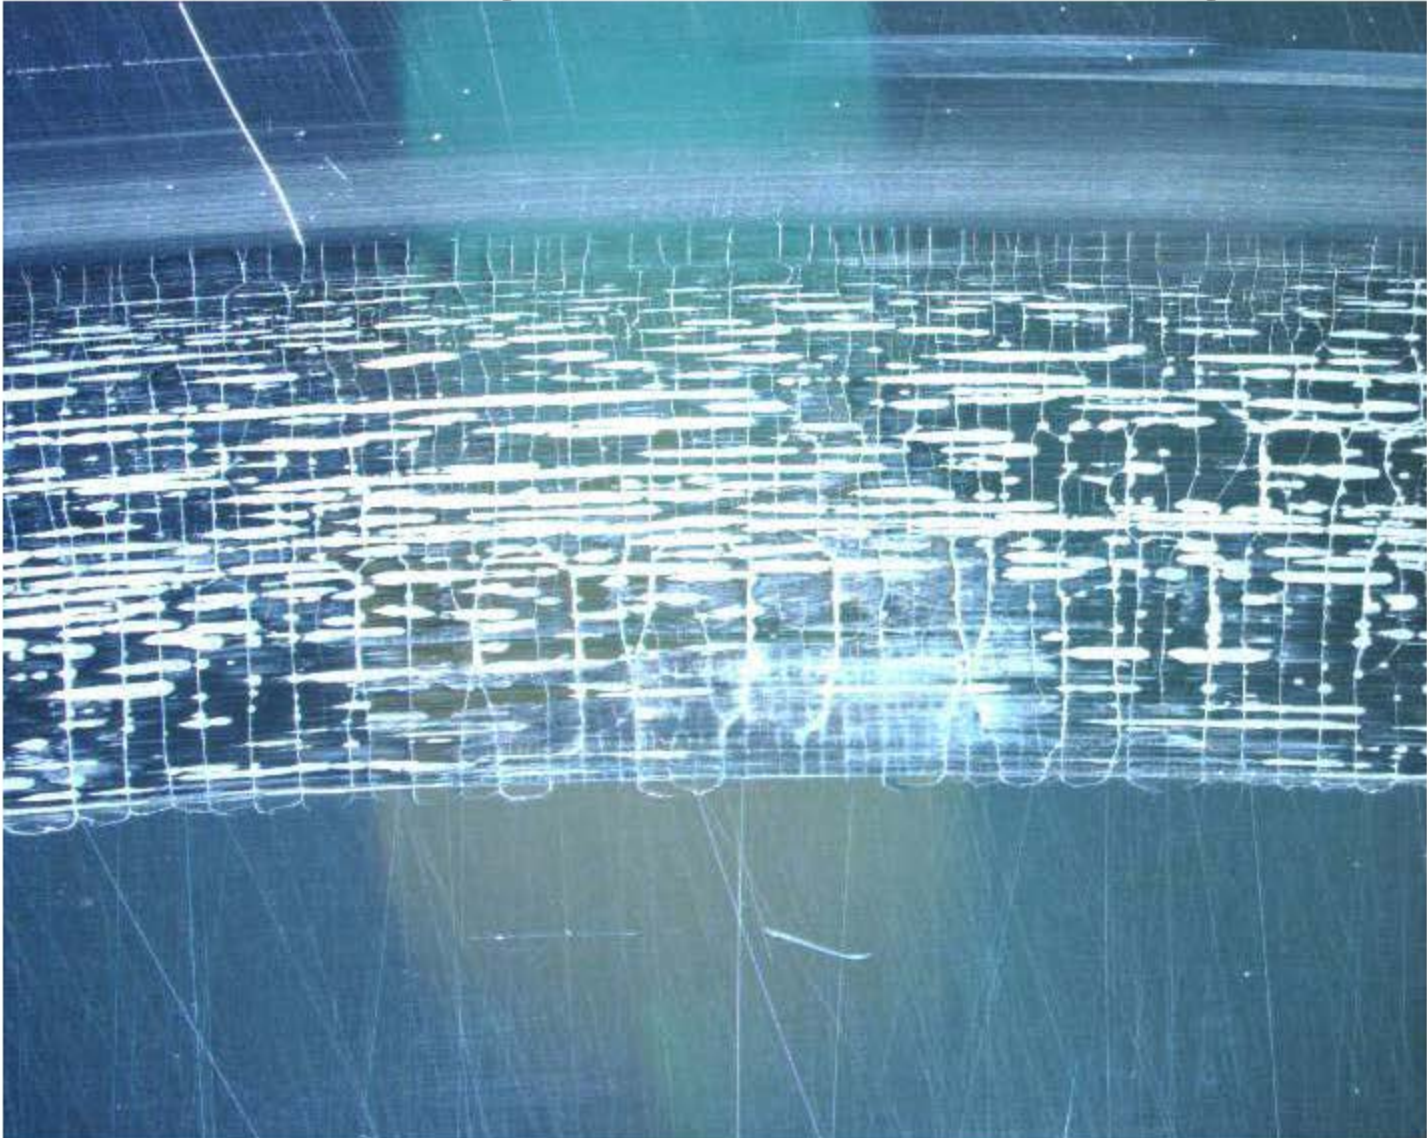
Rotating Face Damage

- The seal vendors had almost no experience at these tip speeds.
- Initial seal had “standard” seal faces (plain) and “standard” balance ratio.
- Initial testing looked good: Low leakage during test.
- Disassembly showed that seal faces had rubbed hard, and heat checking occurred.

- Reduced face loading.
- Added patented face pattern to stationary faces.
- Testing again went well.
- Disassembly showed no problems.
- First machine shipped to field with this seal.

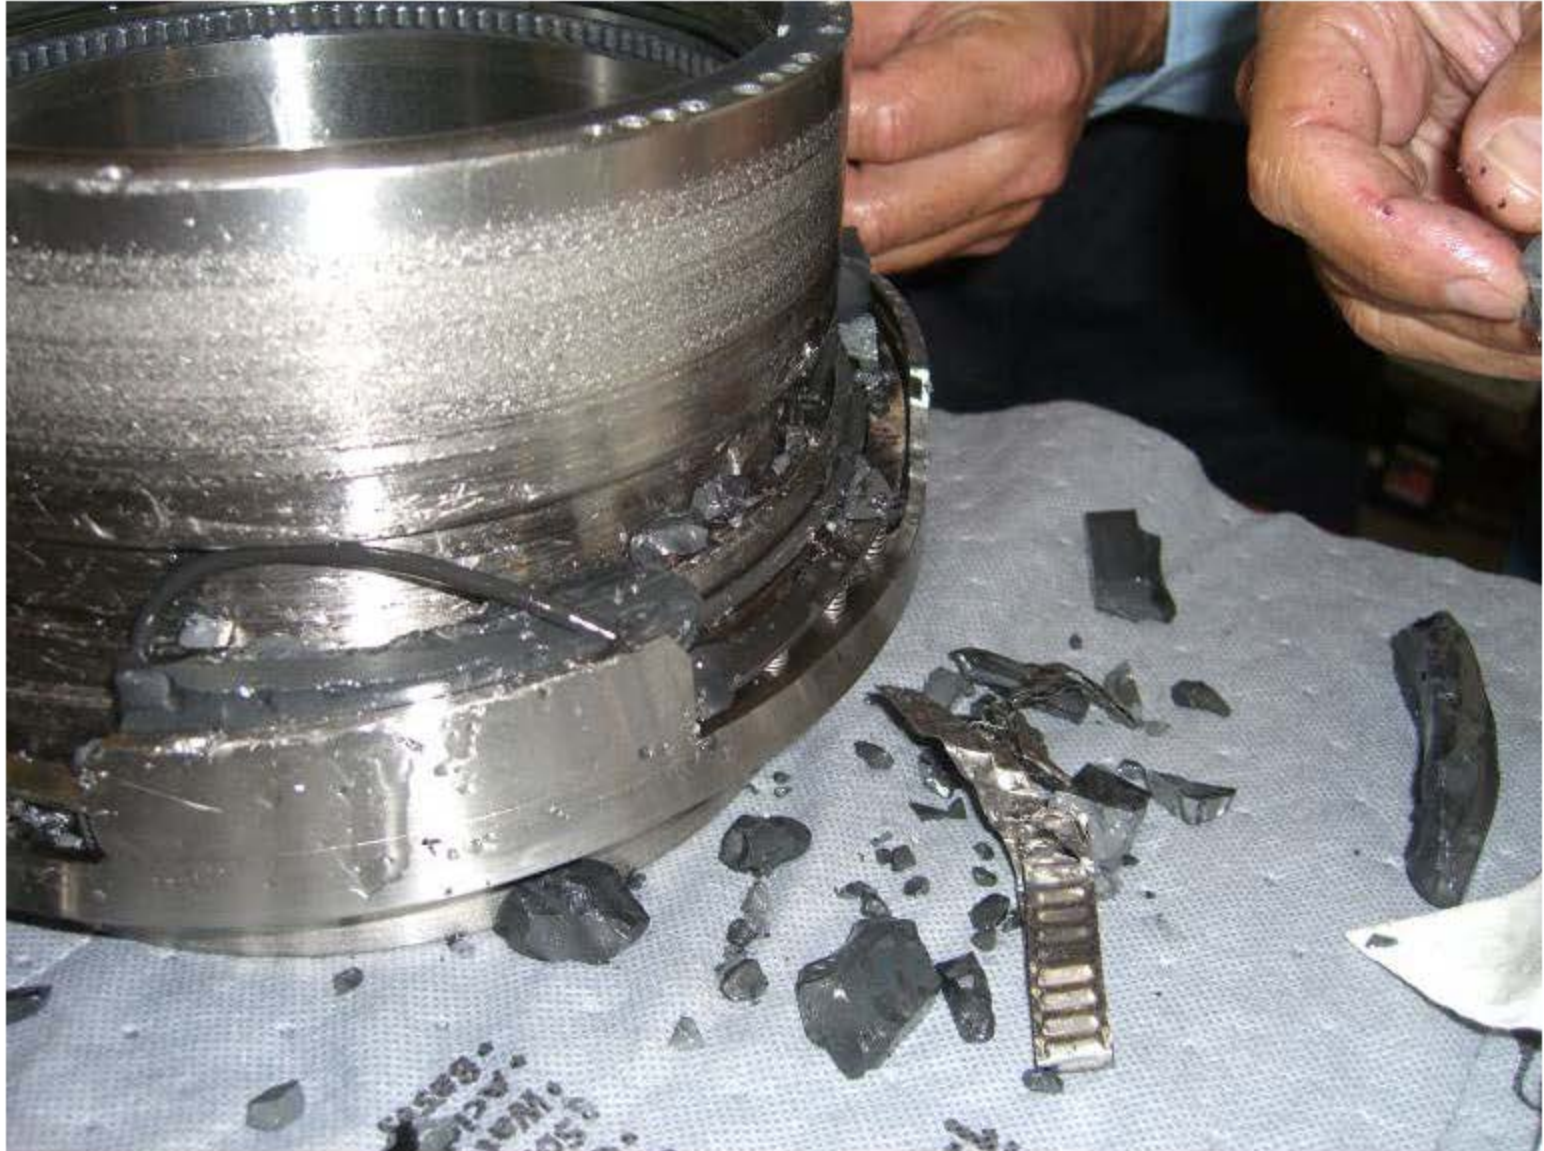
Seal Damage

- Machine was run to “Trip Speed” at beginning of test.
- After 15 minutes at Trip Speed, machine speed was reduced to MCS.
- After a brief run at MCS speed, the seal self-destructed.
- Disassembly showed major damage to all seal parts and cartridge assembly.

- Failure caused by hoop stress overload.
- Hoop stress overload caused by thermal growth of sleeve into bore of rotating ring.
- Failure mode very much like overspeed (also from high hoop stress).
- Subsequent overspeed of identical rotating ring showed very similar surface.

- Stronger material for rotating ring.
- Axial pin drive for lower stress concentration factor.
- Drive slot drilled before sintering (no EDM).
- New, lower thermal growth sleeves with more clearance when operating.
- 10,000 rpm overspeed testing on rings (154% of design speed).

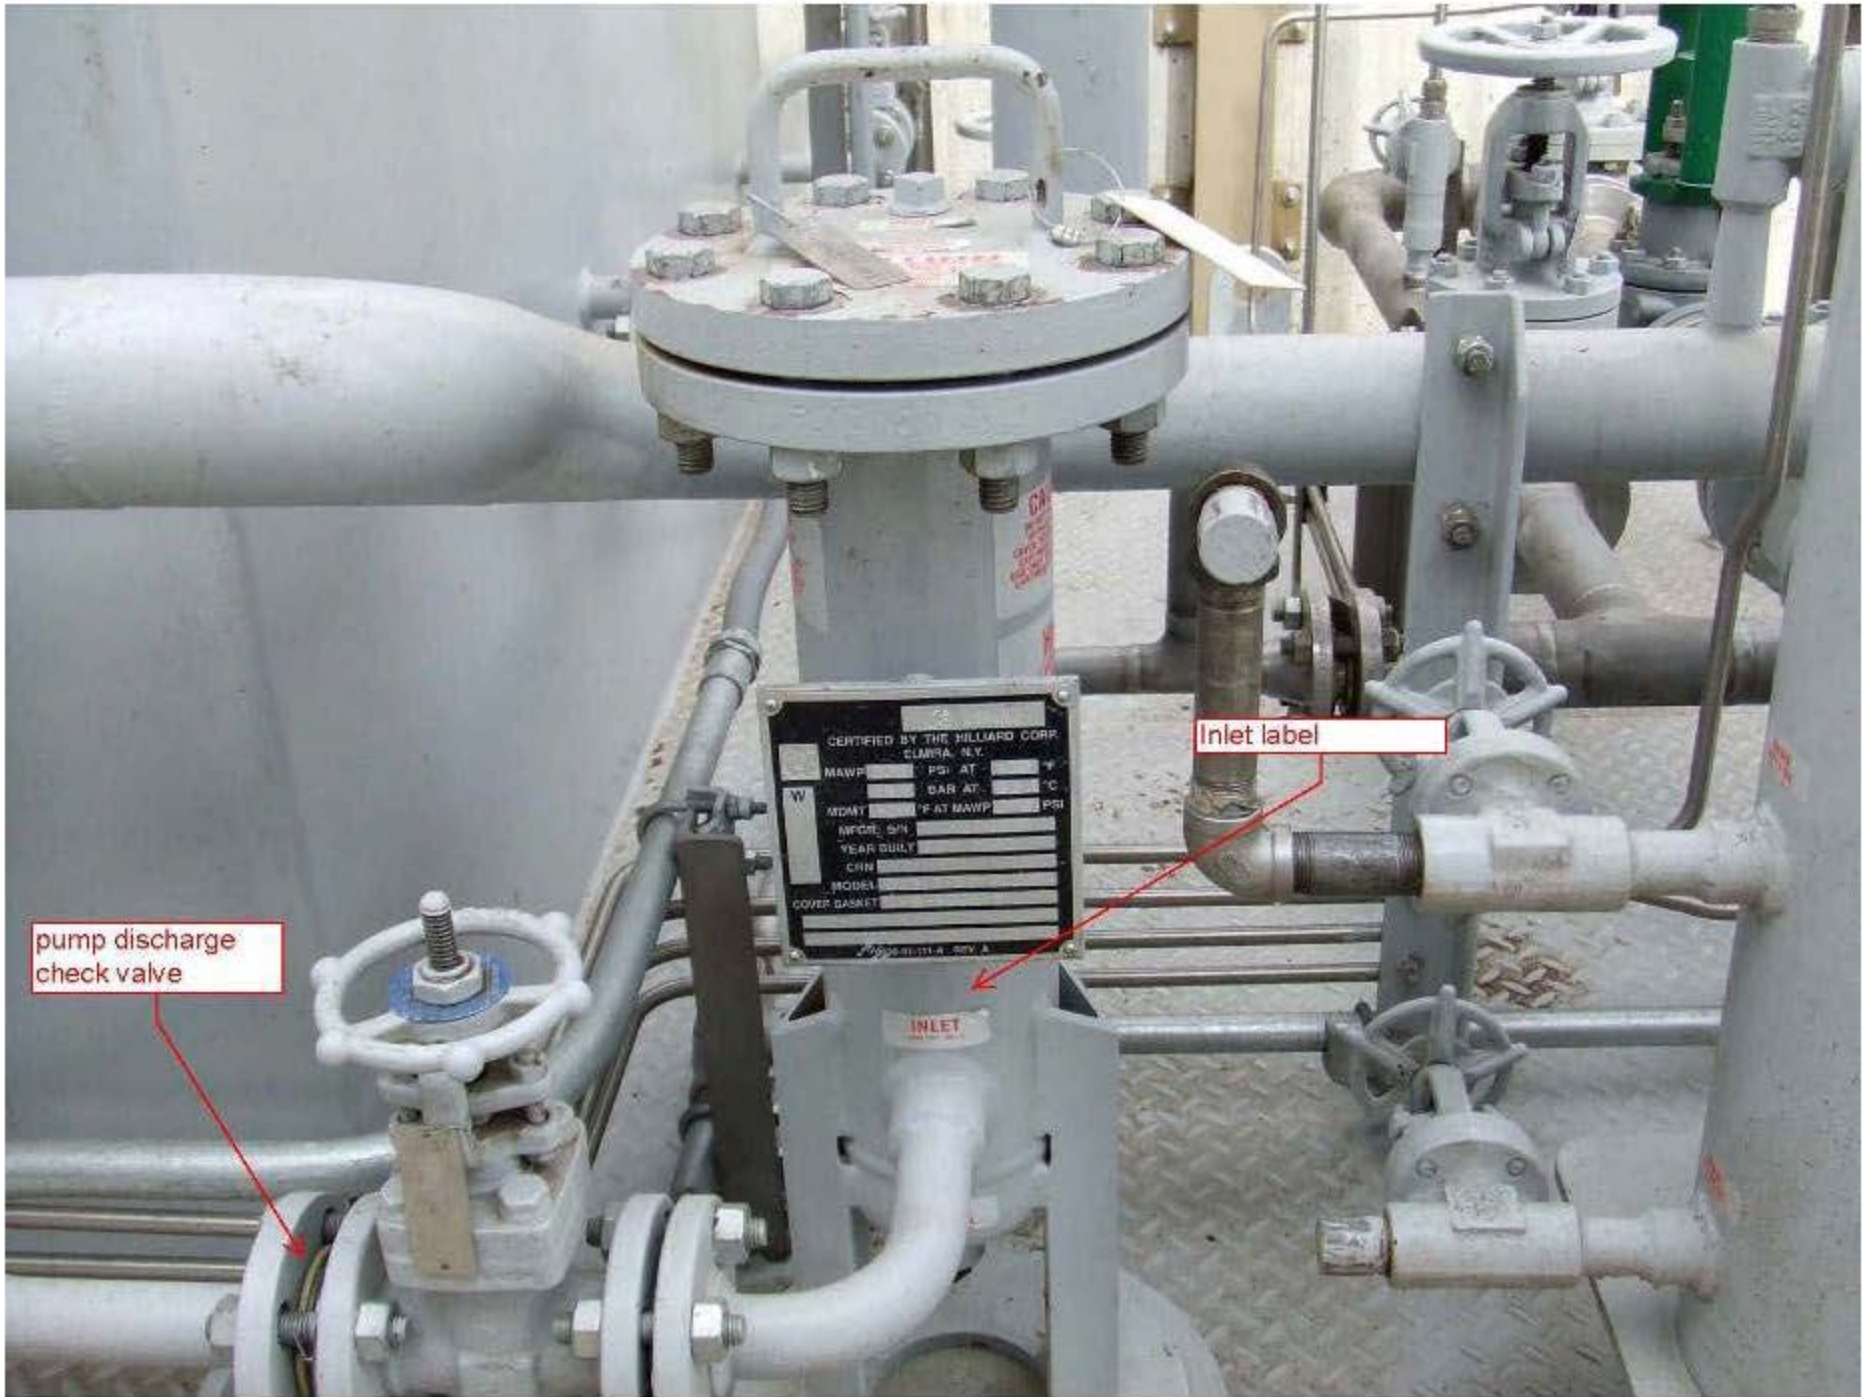
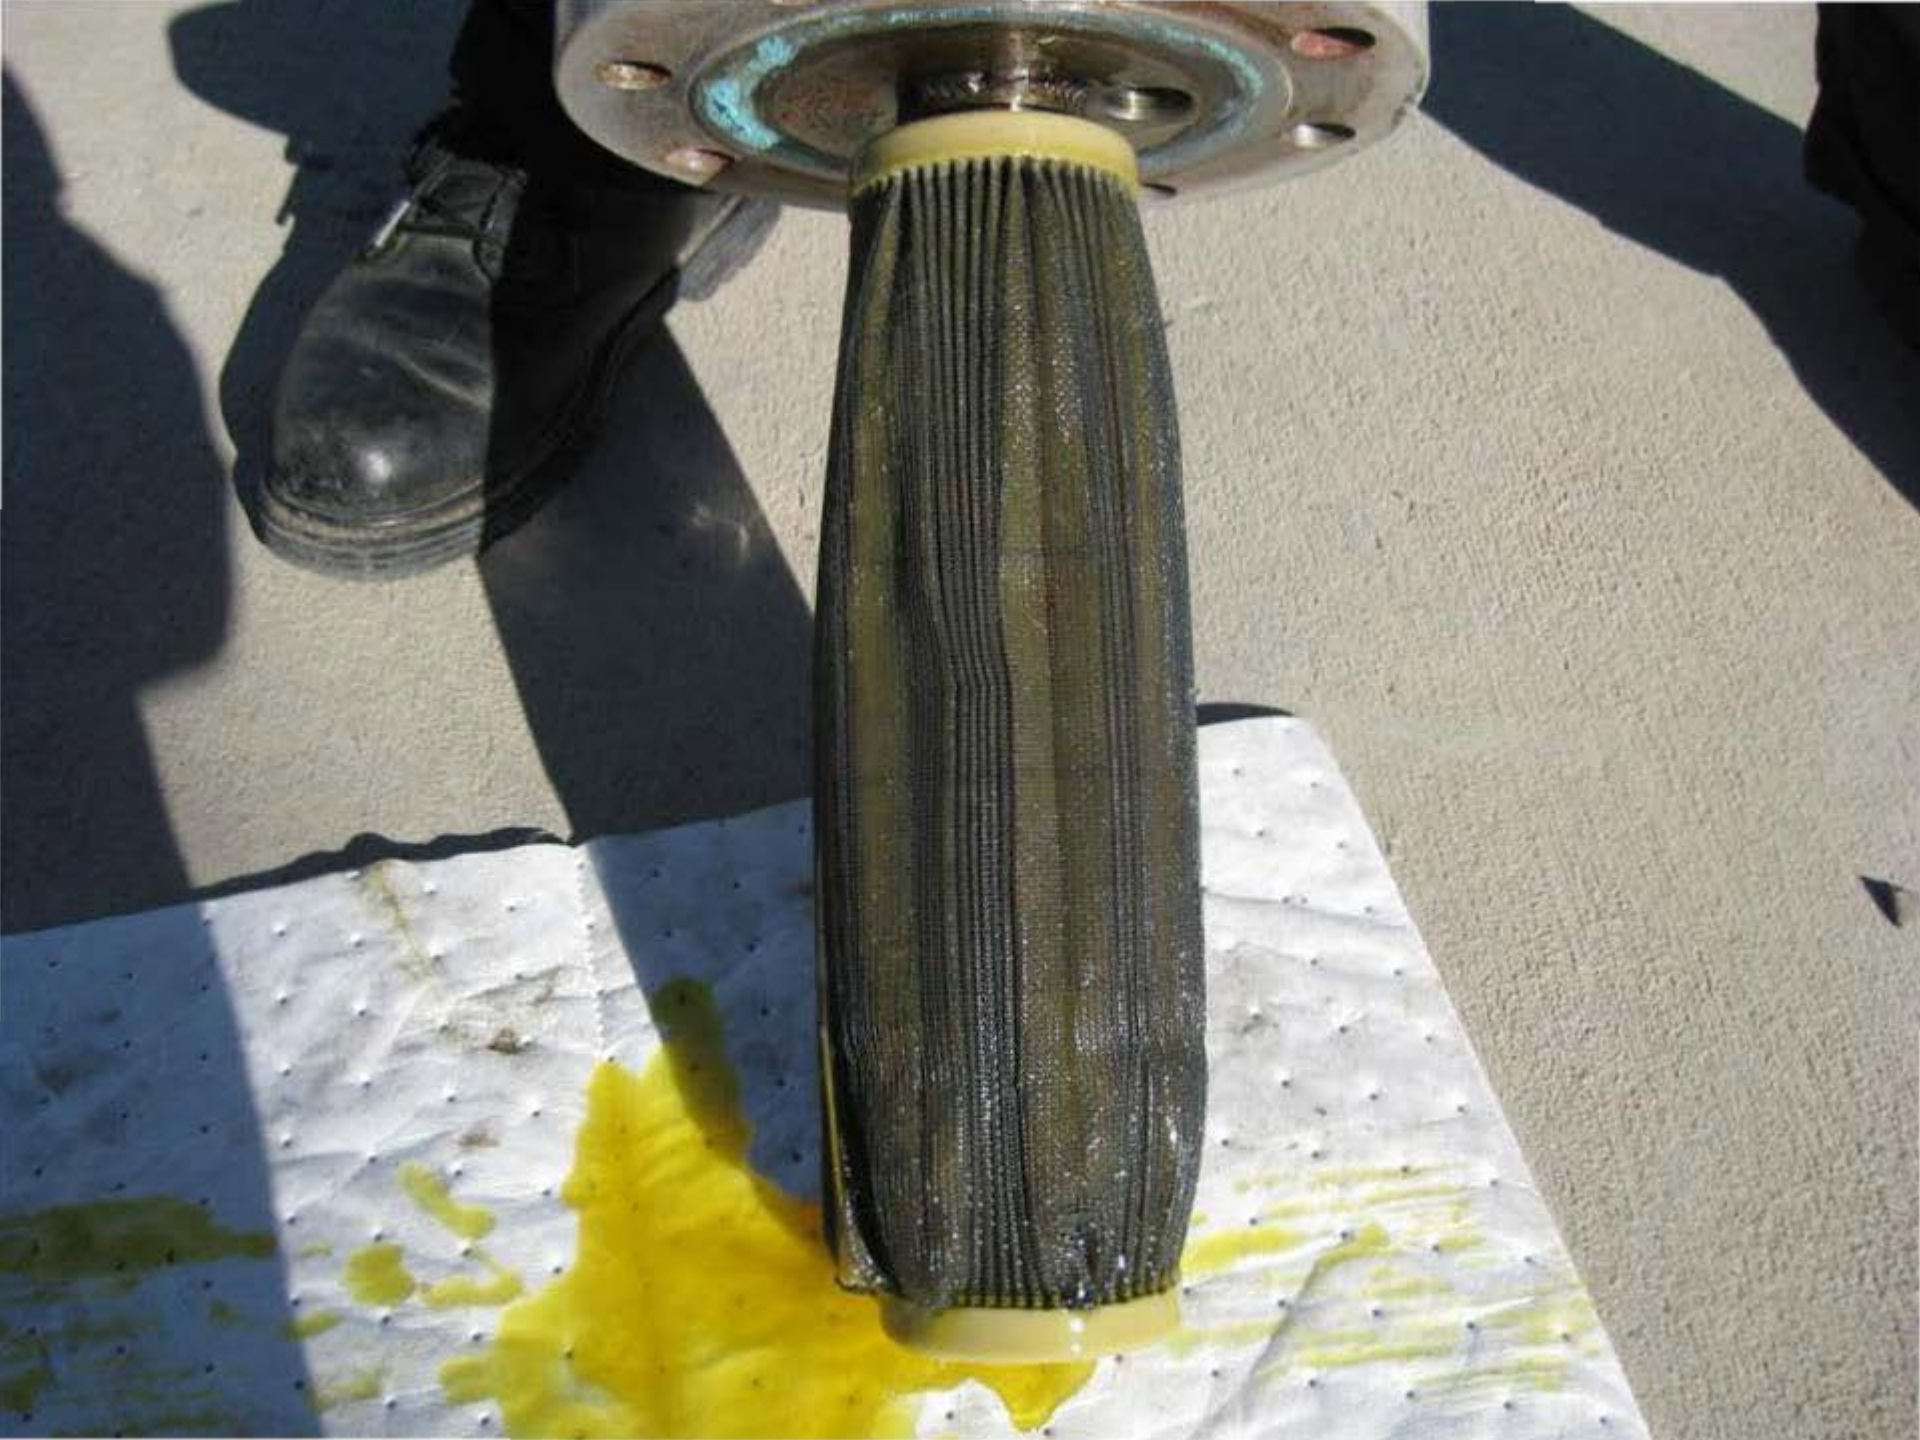
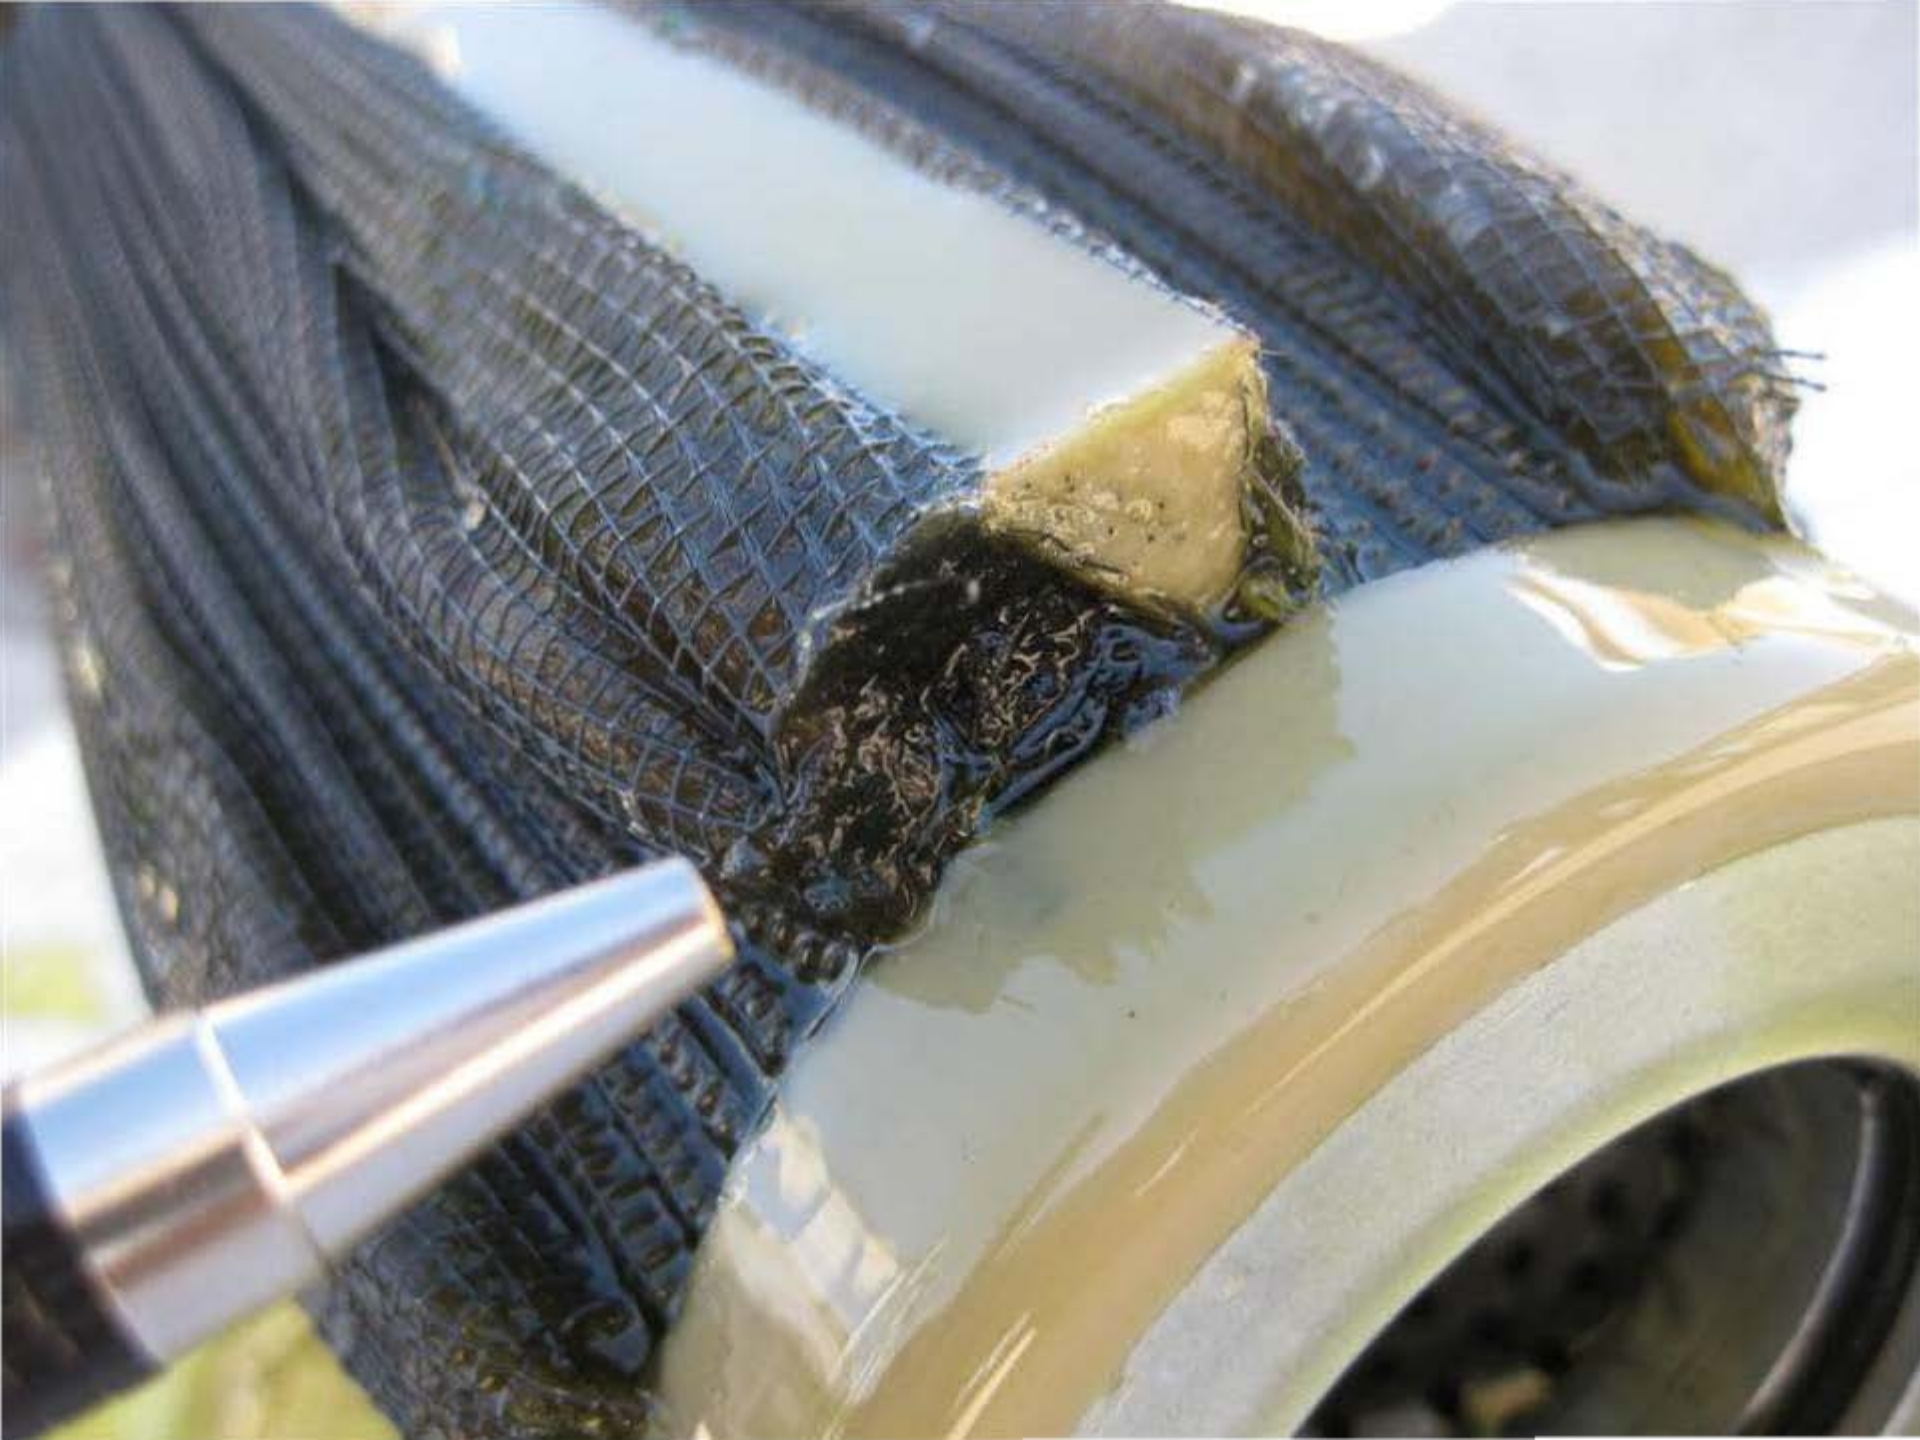
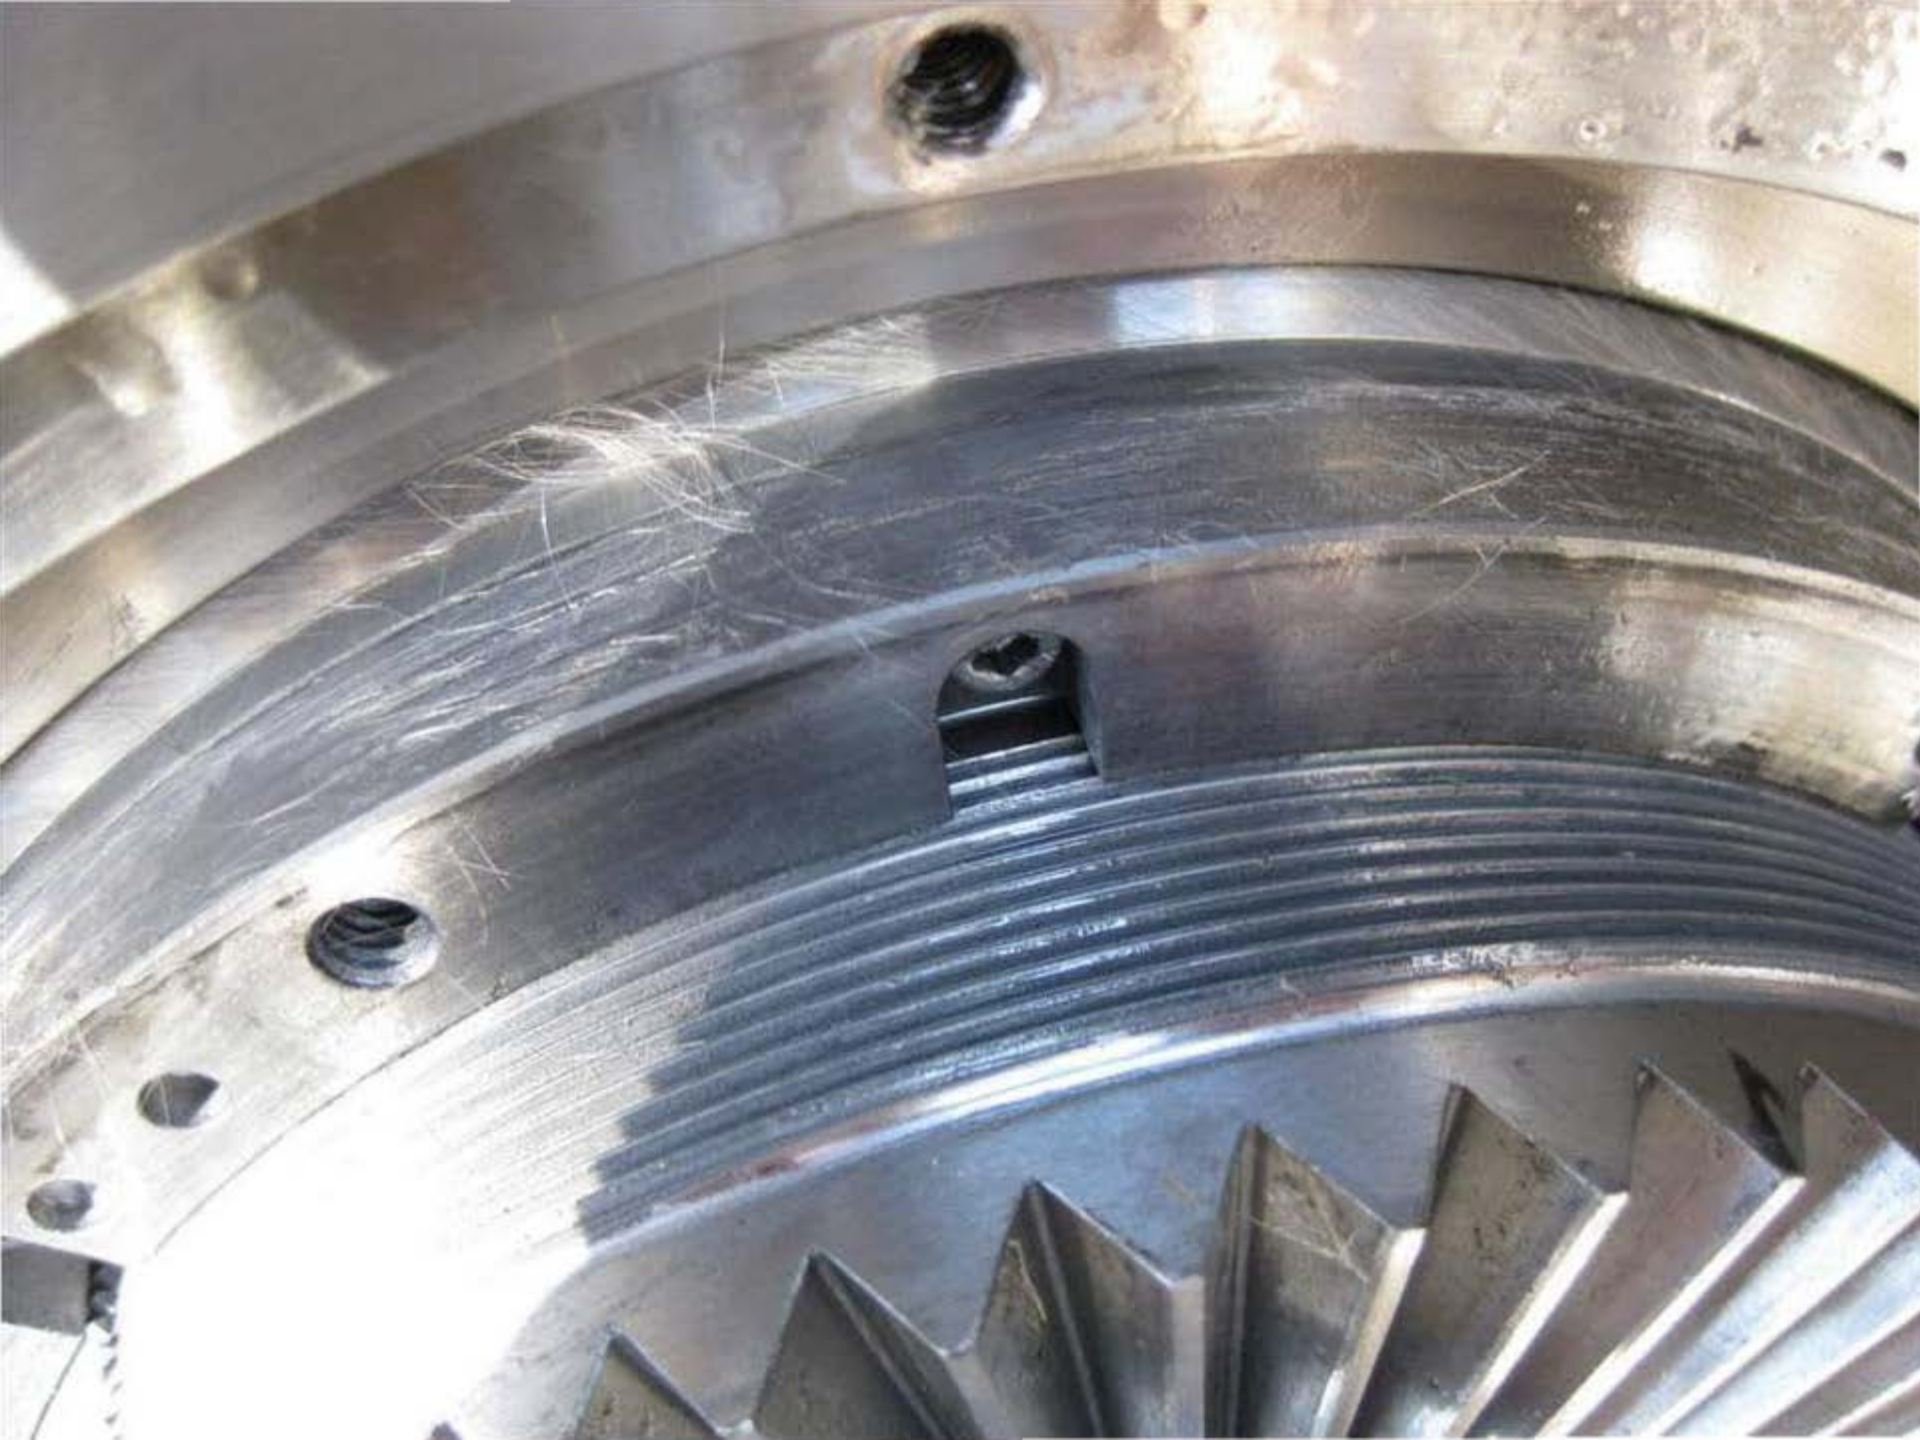
- All six machines have been commissioned in the field (Q1 of 2009).
- All six seals seem to be working properly.
- Two of the seals have been replaced due to damage caused by bad filter housings.
- The oil leakage rates cannot be measured precisely, but they appear to be better than guaranteed.

- All six machines continue to run well.
- All six filter housings were found to be marked (and thus installed) backwards!
- Four of the six machines continue to work with seals that experienced filter failures, but did not cause high seal leakage.
- Two seals that began leaking after filter failure were replaced and running fine.
