**37<sup>th</sup> Turbomachinery Symposium**

**Case Study:**

***TORSIONAL OSCILLATION TROUBLE ON VFD MOTOR DRIVEN RECIP COMPRESOR***

***High vibration problems including failed coupling parts on a VFD motor driven reciprocating compressor are analyzed and the root causes and solutions are discussed in this costly field issue.***

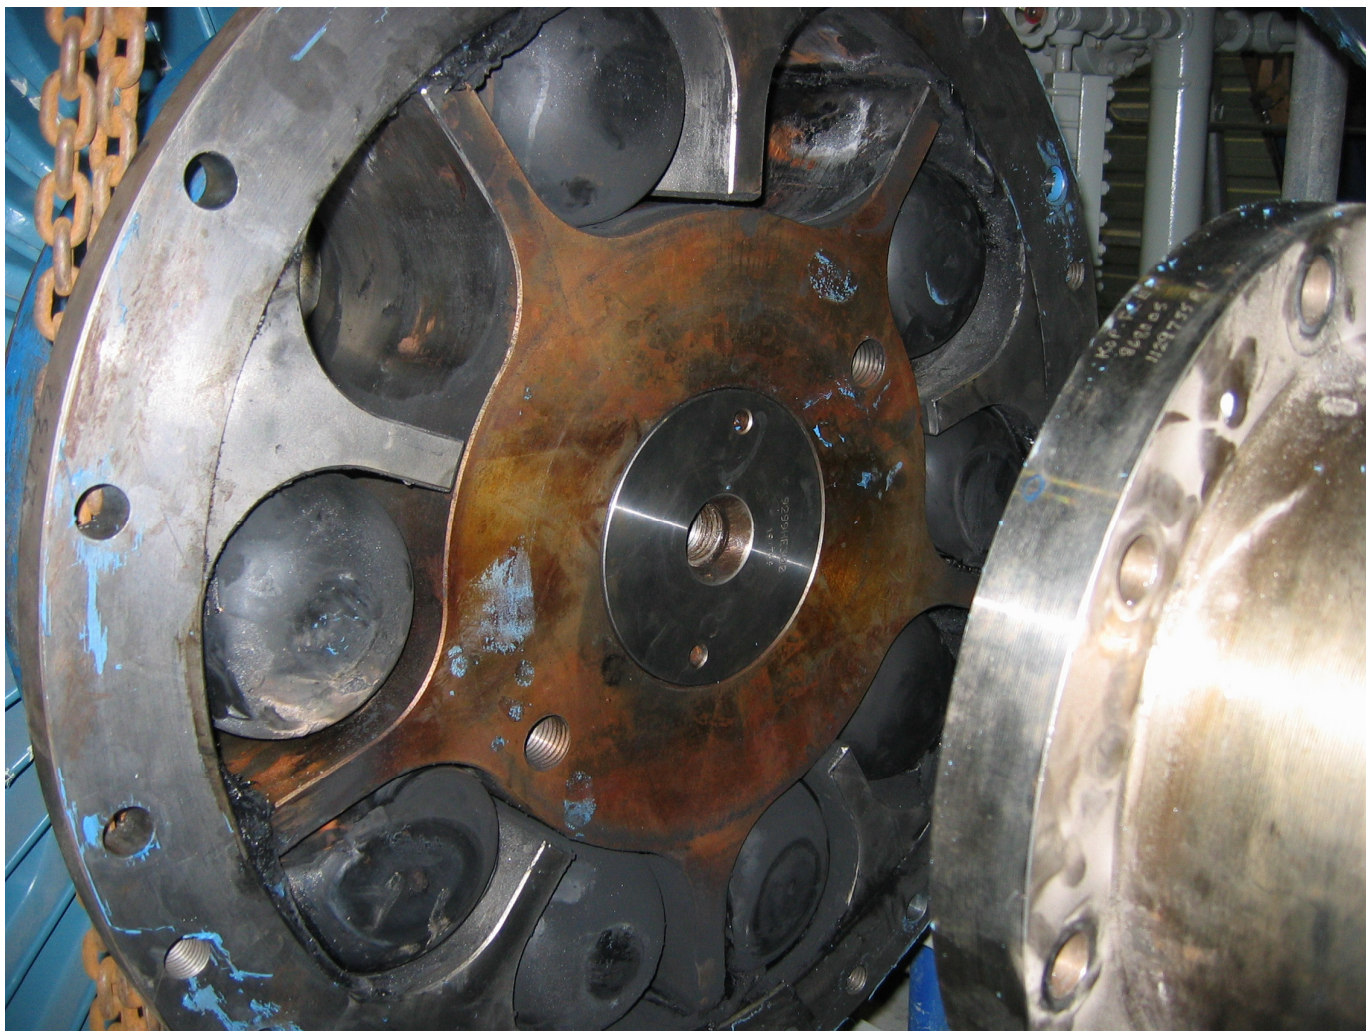
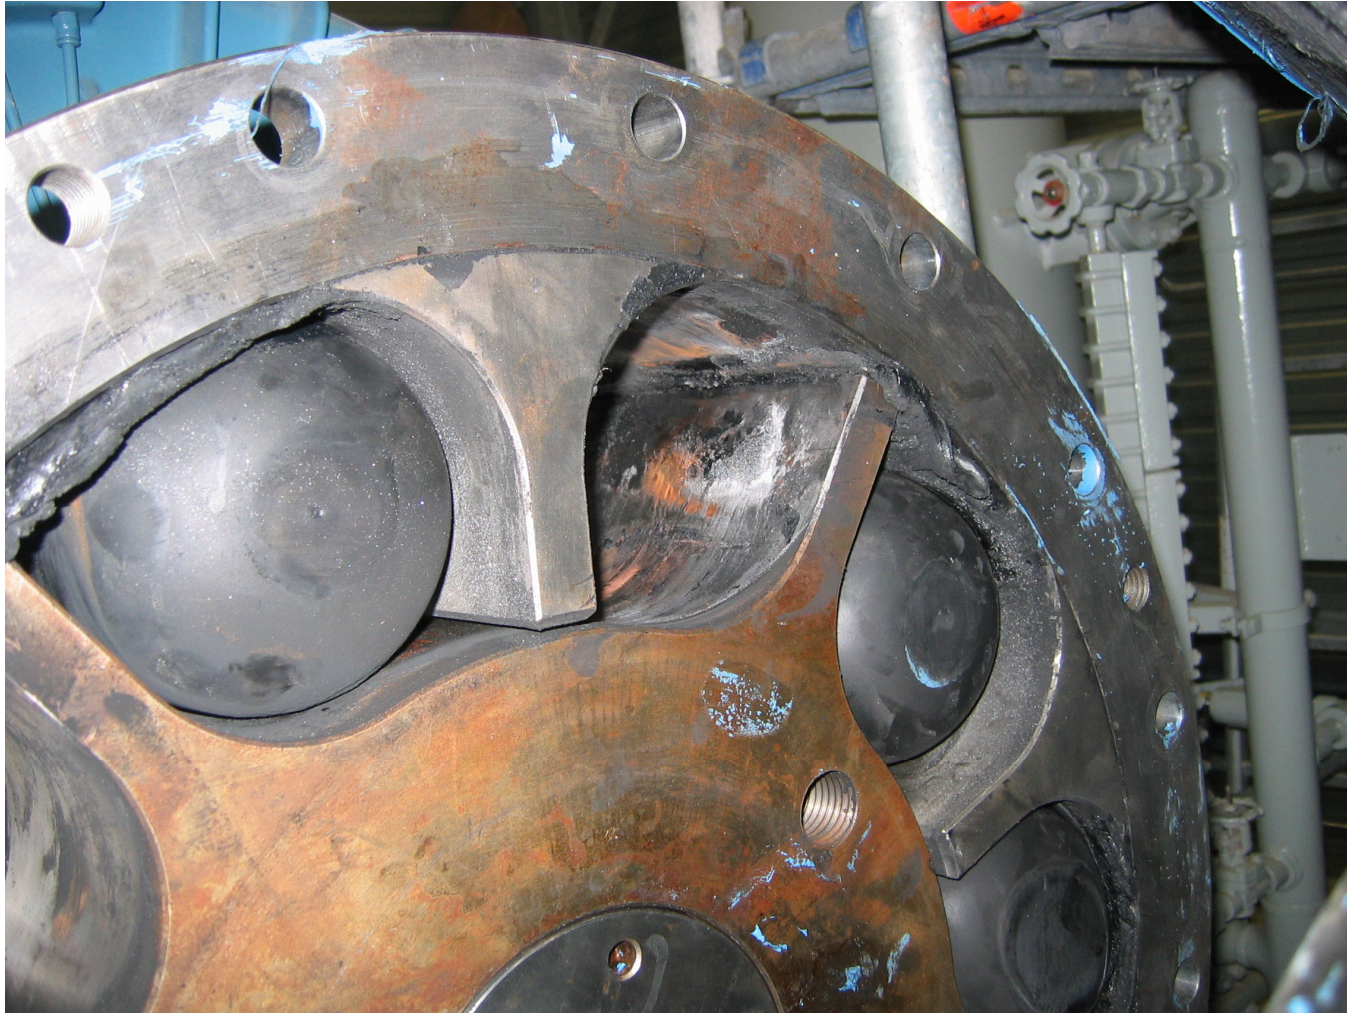
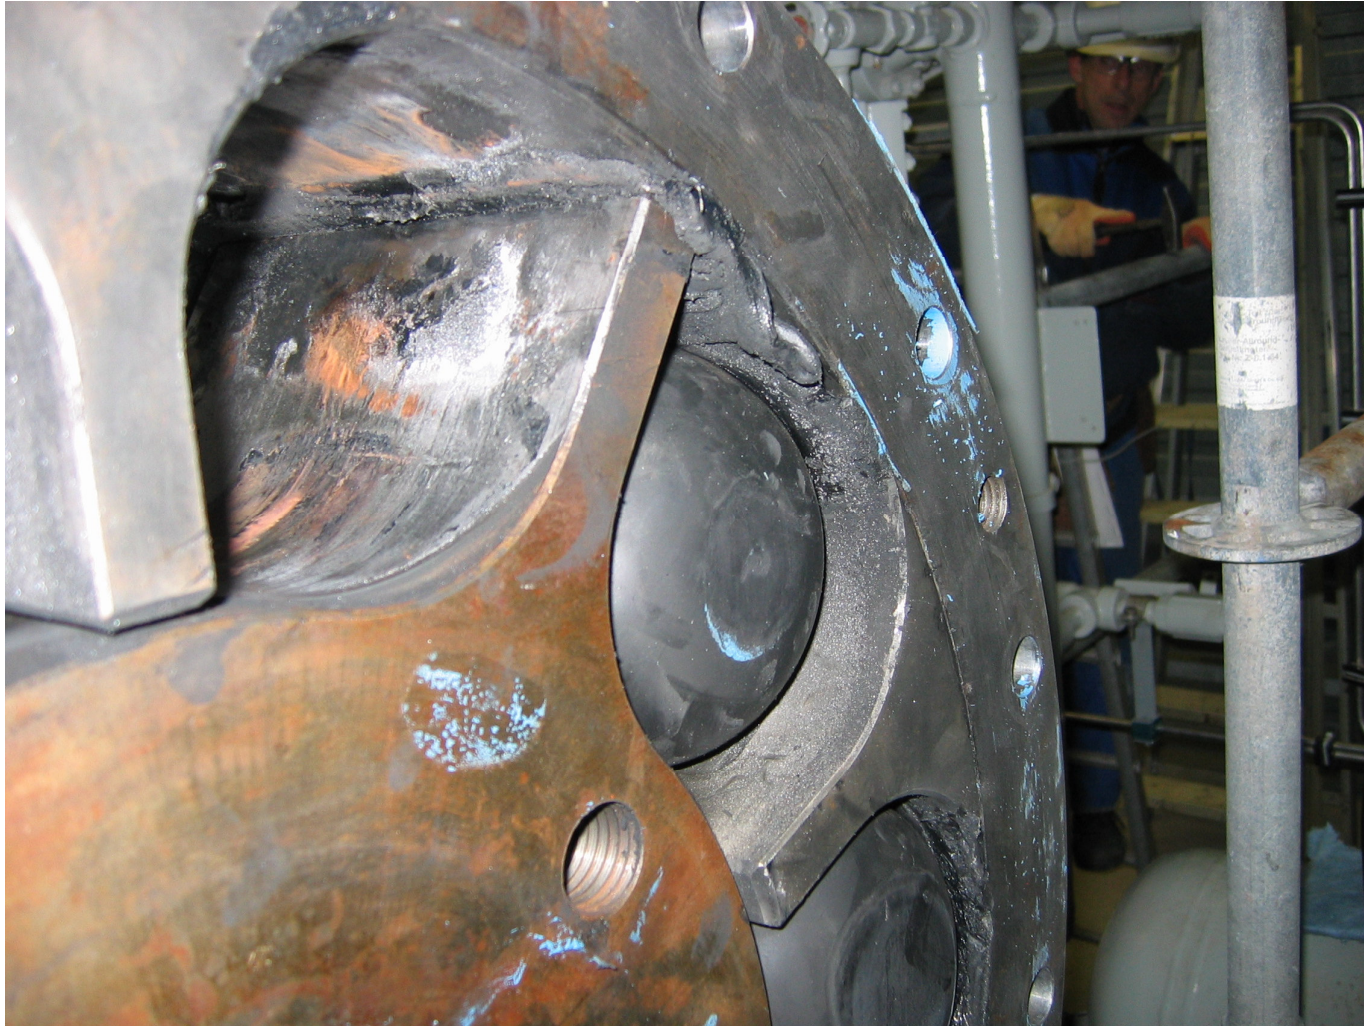
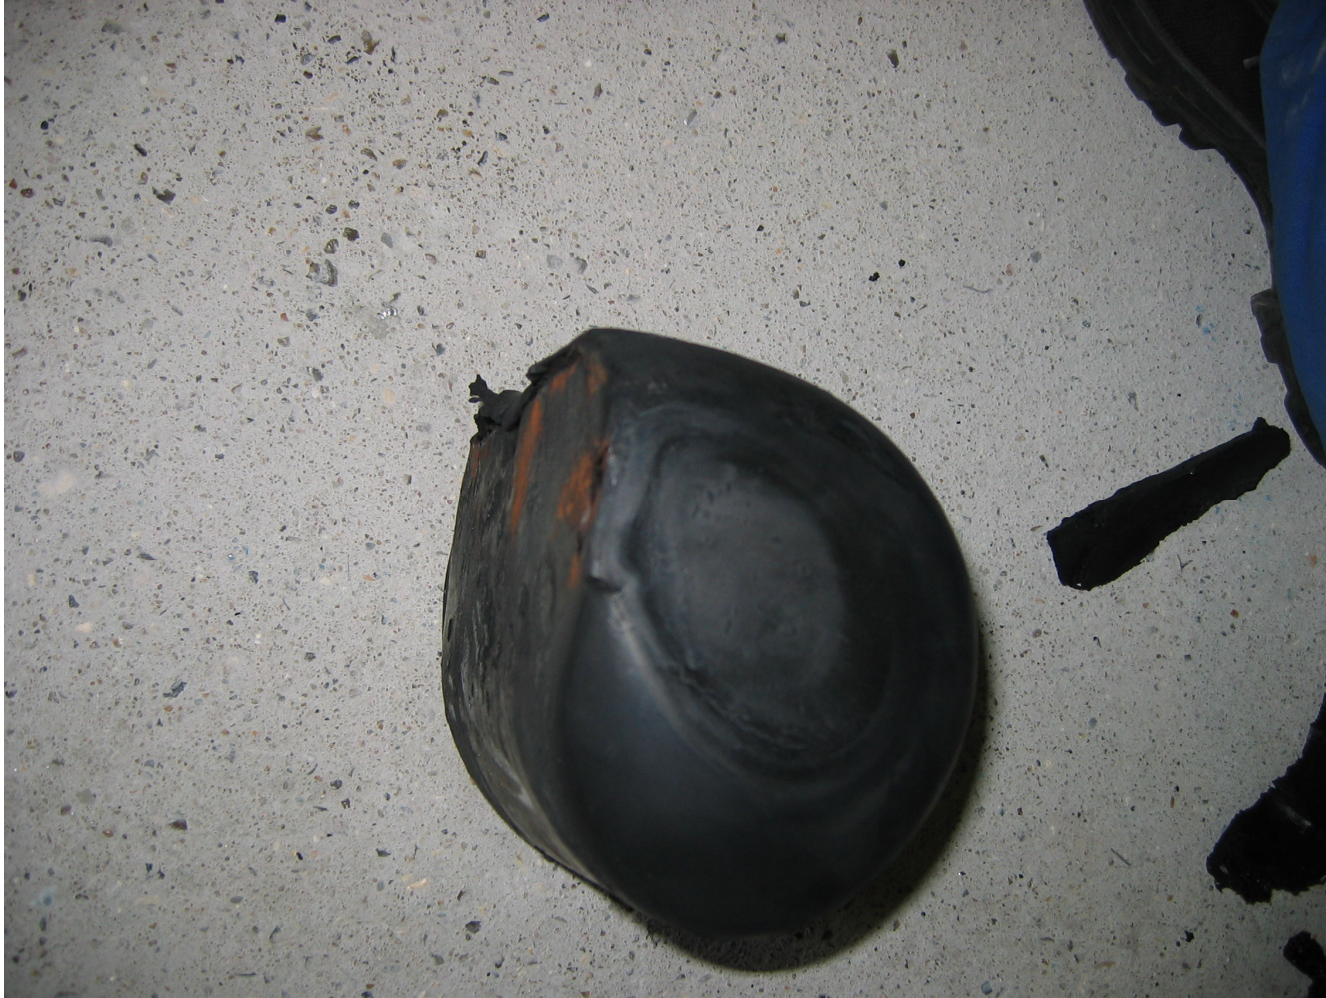
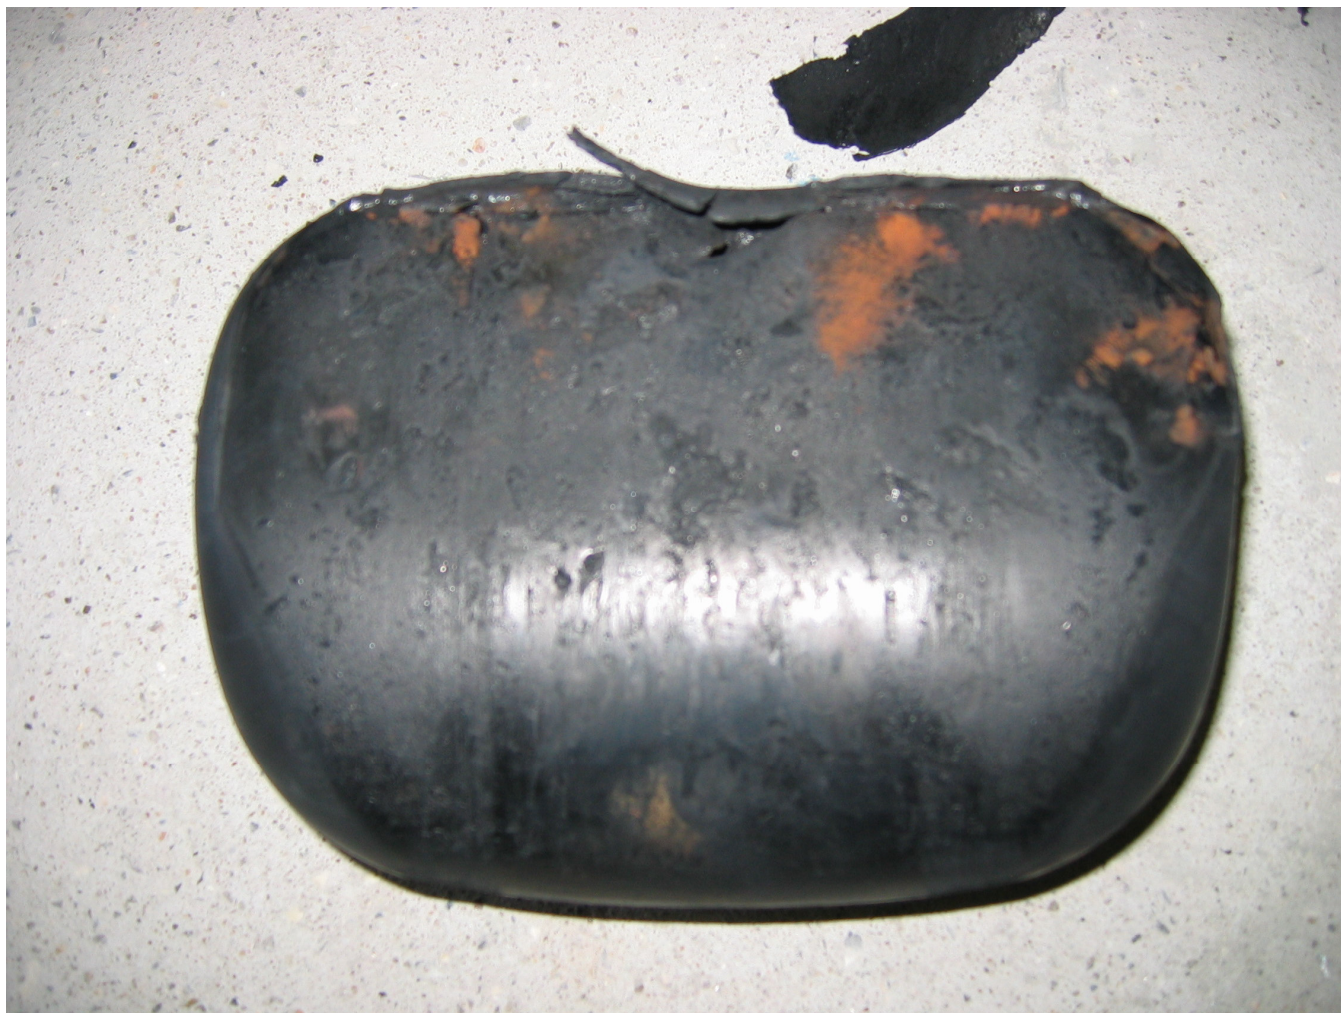
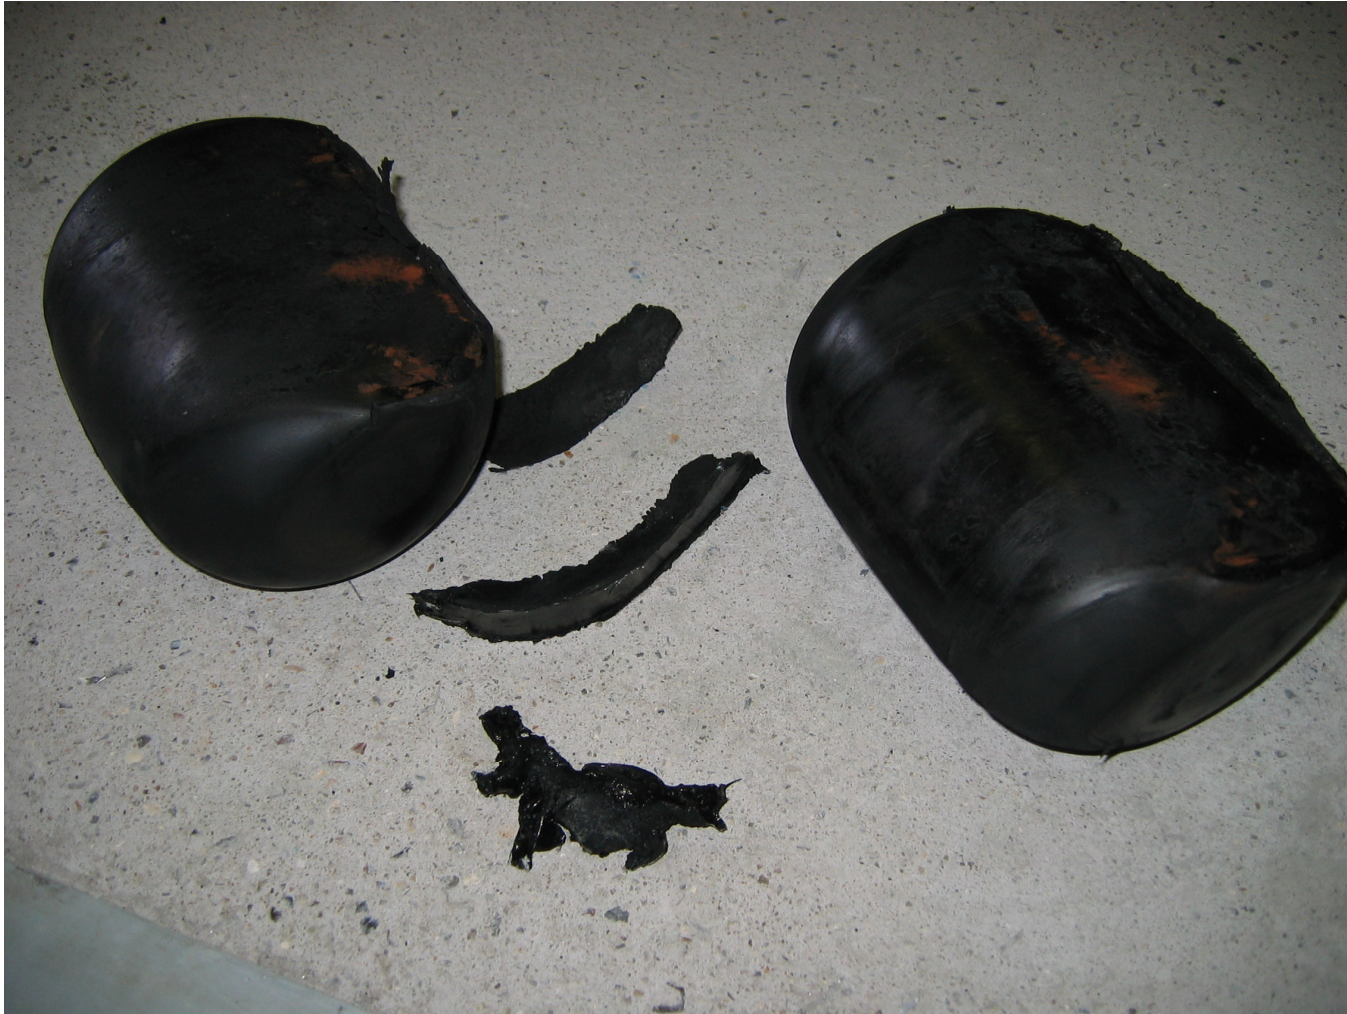
- Motor Foot Bolts RegROUTED
- At or About the Same Time the “Smell of Burned Rubber” was Noticed Around the Machine
- At the First Opportunity, the Machines were Shut Down for Inspection
- Rubber Blocks were Damaged

- Most Importantly, the Vibratory Torque Capacity of the Blocks was Exceeded

- A Large Flywheel Bolted to the Coupling Hub/Spacer Connection
- Plus Using High Damping Material Blocks of the Same Size as Before but with Lower Dynamic Magnification Factor (3 vs. 5)
- This Put Resonant Points into the Running Speed Range, but the Magnitudes were Sufficiently Reduced to be Within the Coupling Vibratory Torque Capacity

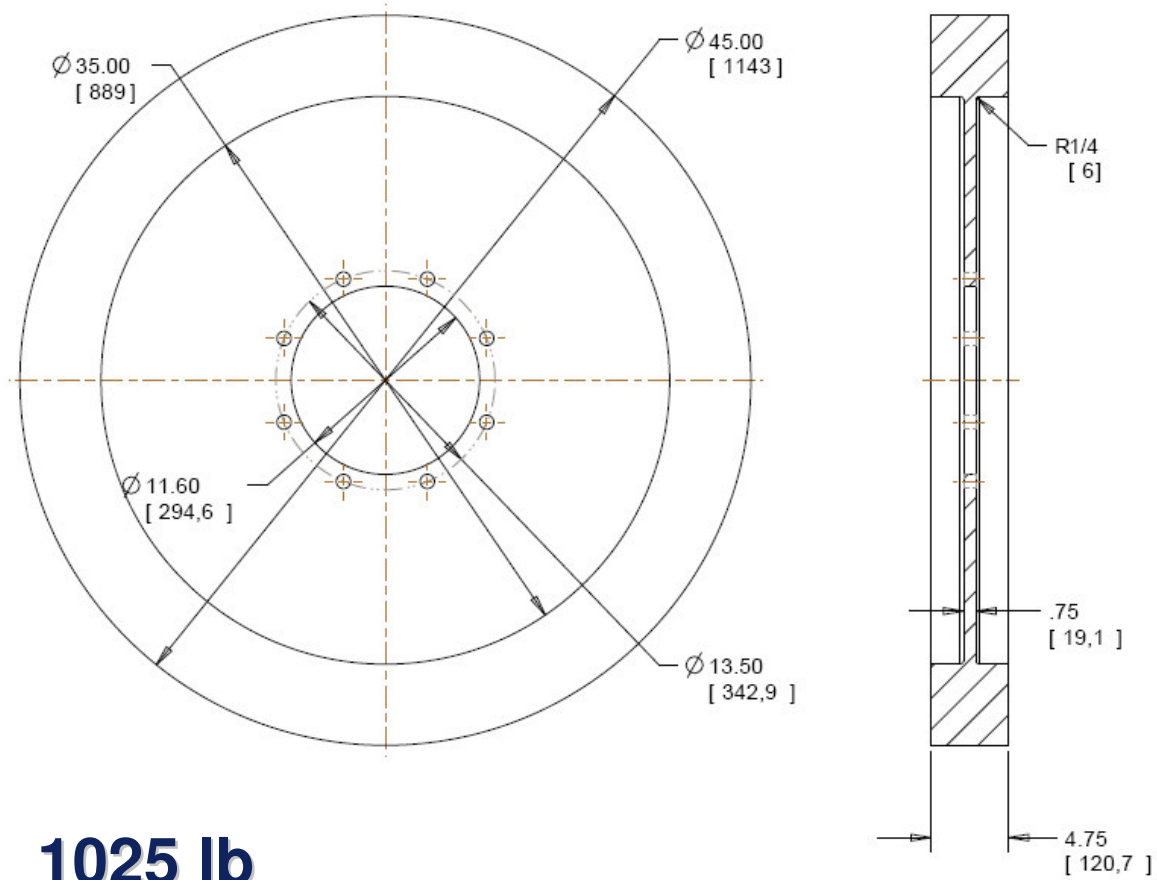
**1025 lb**  
**375000 lb-in<sup>2</sup>**
