TurboExpander Wheel Damage Analysis

A Case Study

Introduction

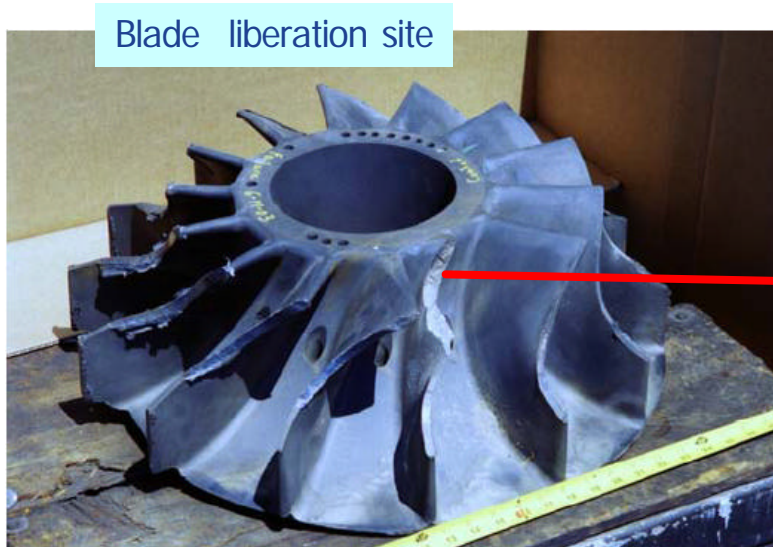
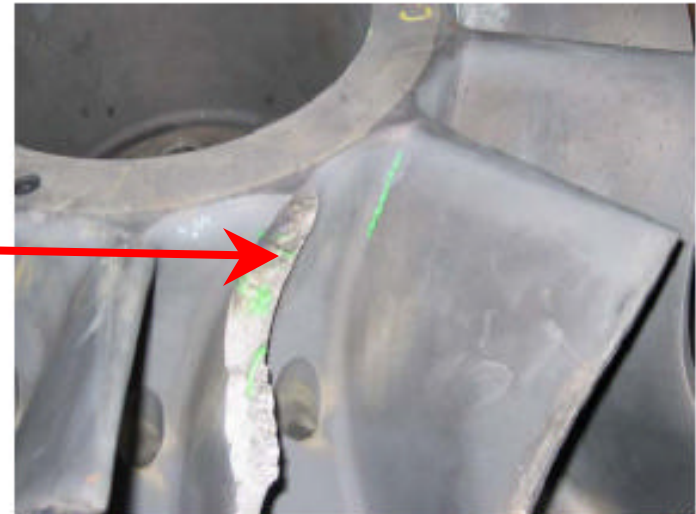
- The crack initiation was determined to be started on impeller blades although all resonance frequencies were cleared near synchronous speed. This has been checked by Campbell diagram based on test data. The estimated stress level was within acceptable limit per Goodman diagram of the material.
- Cracks were initiated from the blade root and sidewalls. Surface cracking was caused by SCC in the Ti-alloy.

Macro photograph (flash and black light) showing the secondary crack in the radius of the adjacent blade to the primary fracture.
IMG_4273.JPG

- Wheel material was upgraded to Ti-64 grade 29 with high Ruthmanium content,
- Impeller root radius was Laser shock peened,
- Tungsten-carbide coating added to flow path surfaces,
AND
- process changes were made.

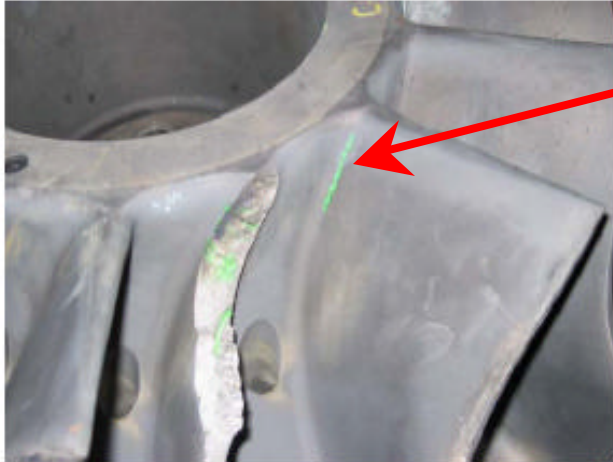
Macro photograph (flash and black light) showing the secondary crack in the radius of the adjacent blade to the primary fracture. IMG_4273.JPG

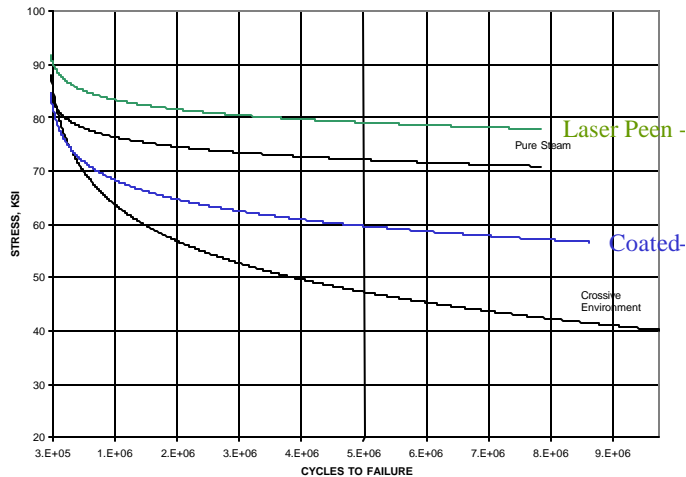
Ti 64 Fatigue Capability

- Physical inspection of non-failed blades showed coating cracks

- Laser shock peening of root radius is a significant benefit for improving fatigue strength
- Tungsten Coating- significant benefit to environmental protection BUT has much lower HCF capability than Titanium substrate

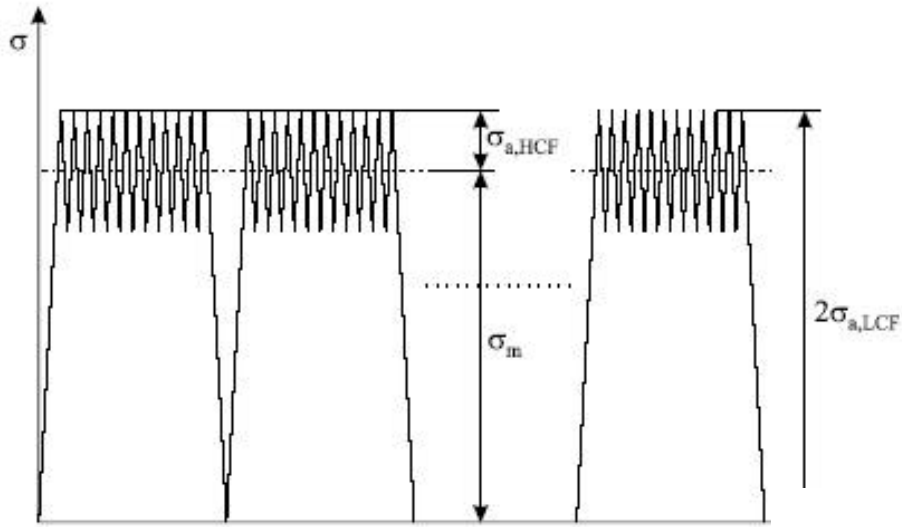
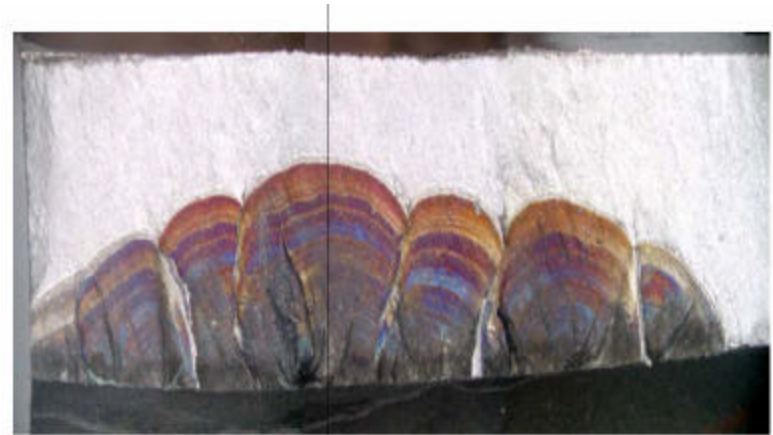
Inspection of the fracture generated surface

Startup, normal operation, and shutdown cycles stress profiles on blades

Two issues LCF and HCF

- LCF can initiate crack
- HCF propagate the crack

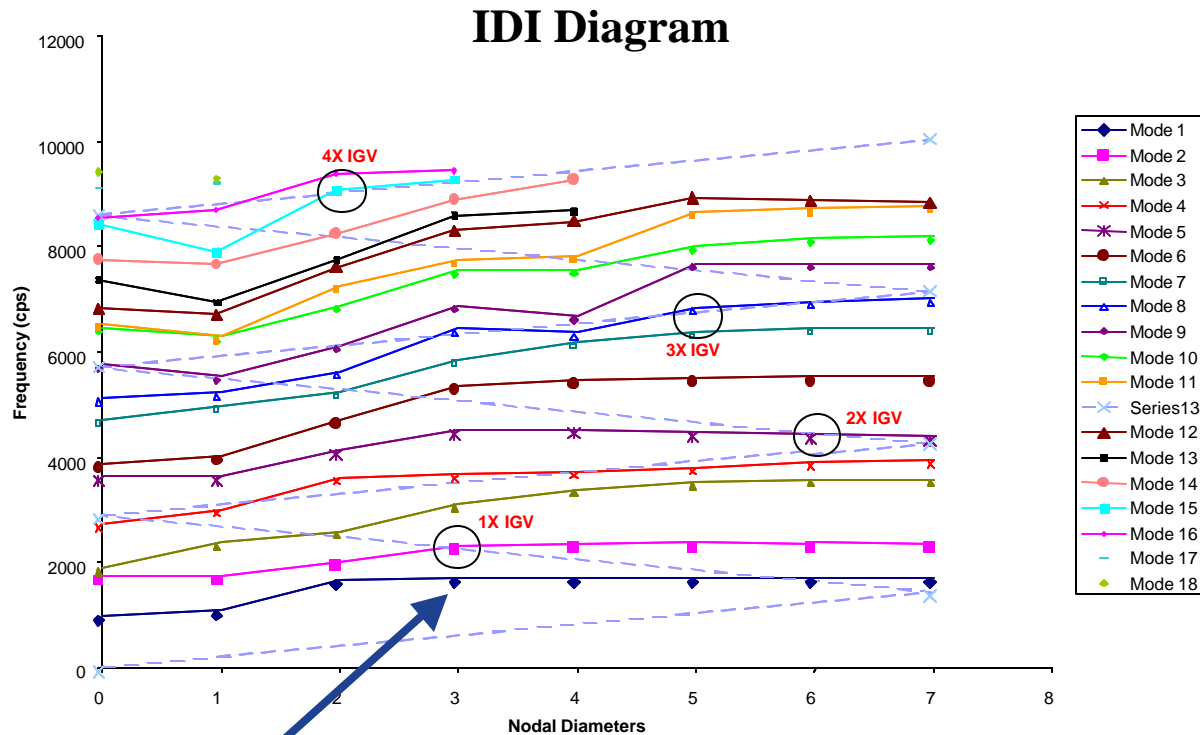
Mode can be excited during start up

There is a 3XND mode that can be excited by 1XIGV during start up

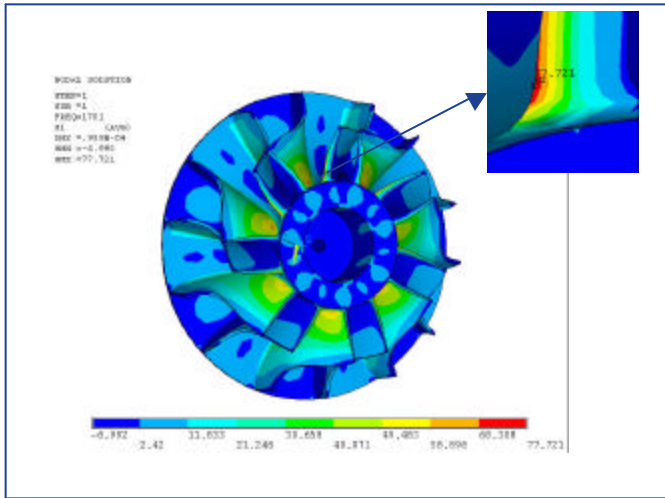
Peak/ ALT stress amplitudes were examined from Forced Response analysis to the fatigue seen in blade....

No one mode had alternating stress within 10X of that from SEM results.

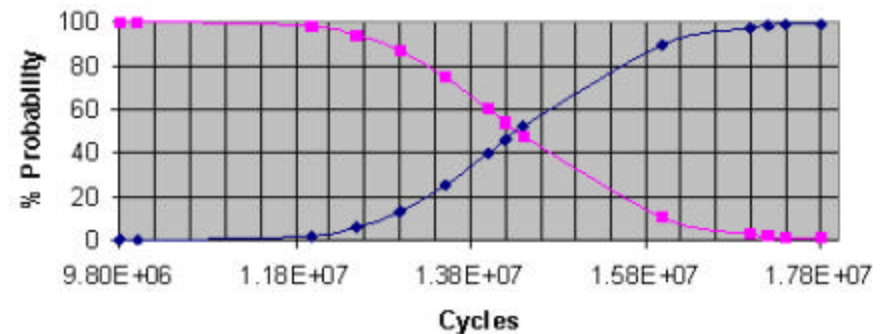
% Probability vs. Cycle for Crack Growth in the Substrate

a probabilistic life assessment has been completed for broader understanding of risk associated with various operating lives and starts / upset conditions.

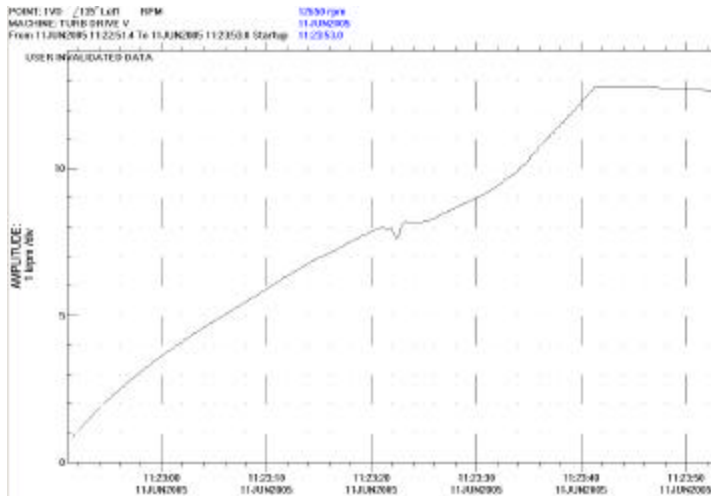
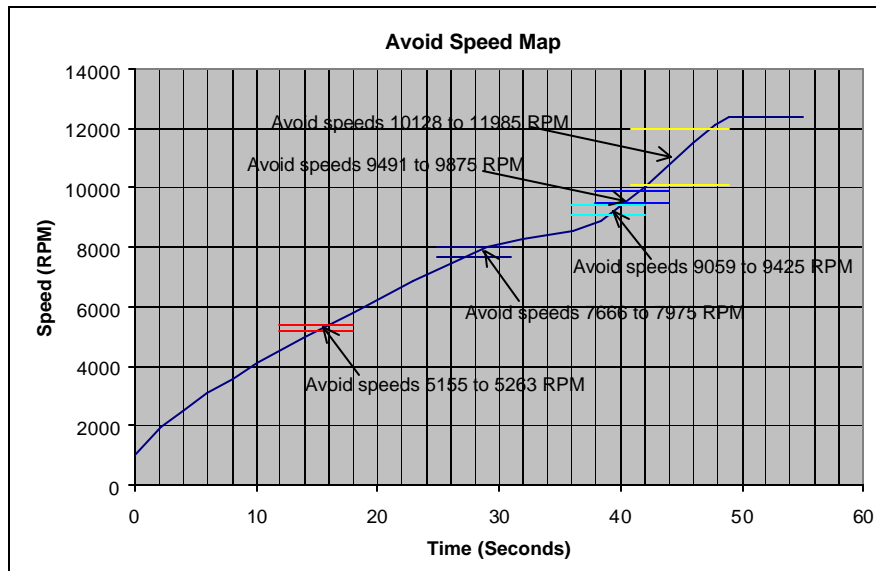
Starts stresses have been proven significant at the multiples of the IGV stimulus nodal diameters.....

Can the operations live with modified start to ensure 'quick pass' through the resonant modes?

Control system was examined....and generally the answer is 'YES', again further reducing and change for damaging cycles
