USE OF SIX SIGMA[®] TECHNIQUES IN GAS SEAL PANEL TROUBLESHOOTING AND SEAL FAILURE ANALYSIS

ROBERT A. HUFFMAN
MANAGER, CENTRIFUGAL COMPRESSOR ENGINEERING
GE Energy - Conmec

2004 Turbomachinery Symposium
Houston, TX

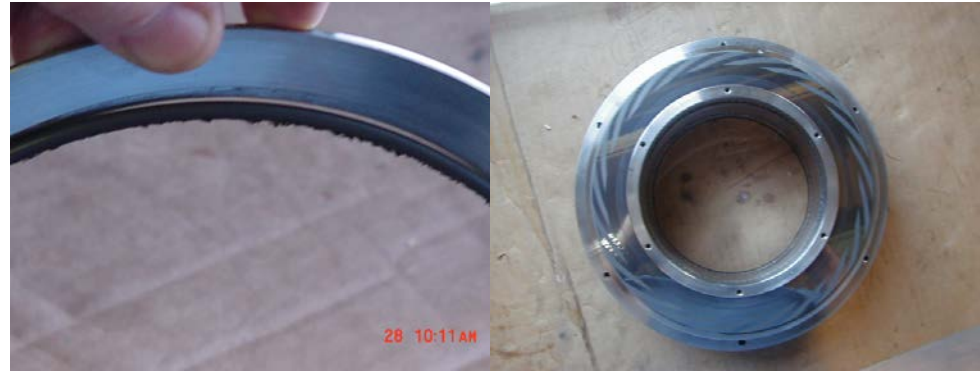
- > Discharge End DGS O-ring show's signs of heavy nibbling and a white substance in the compressor ports, some small amount of residual oil in ports found
- > Barrier seal shows signs of damage to carbon ring and face springs

Primary Seal O-Ring and Tungsten Face – As removed from Compressor

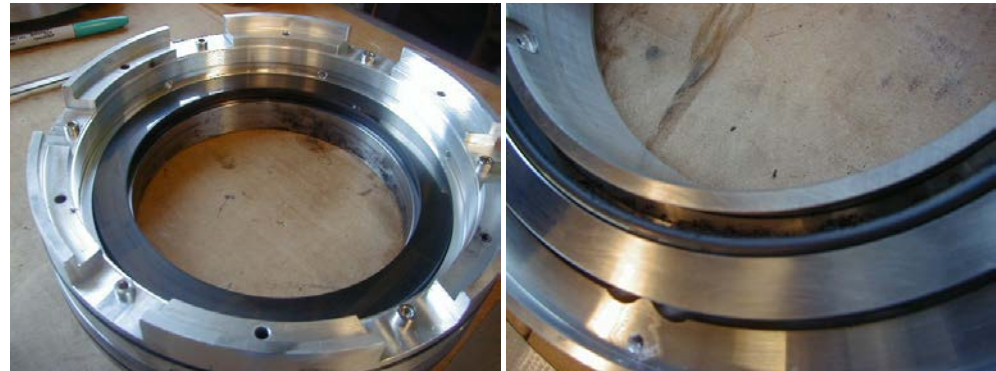
- > Suction End DGS O-ring show's signs of heavy nibbling, a white substance and small amount of oil in the compressor ports is found.
- > Barrier seal shows signs of damage to carbon ring and face springs.

Secondary Seal – As removed from Compressor

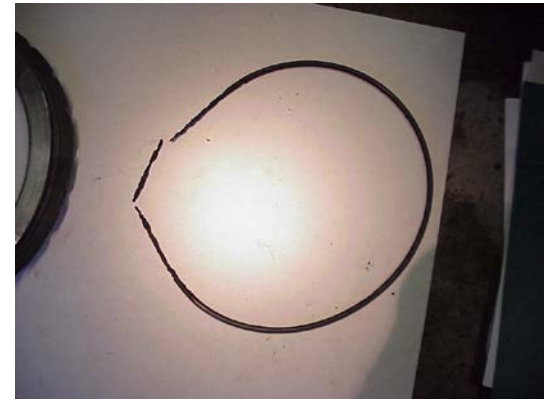
- > First DGS failure (1500 hours)
 - Slight nibbling and heavy “cracking” of the primary O-Ring
 - DGS Shim Ring run out – axial oscillation of seal
 - Explosive Decompression – blow down rate several times faster than recommended
 - Oil Flooding of Seals caused initial shut down – fault of GT auxiliaries – symptom
- > Second DGS failure (~450 hours)
 - Heavy nibbling of DGS primary O-Ring
 - Sever misalignment of compressor to GT
 - » Root cause of misalignment not discovered
 - » Check of alignment records and piping strain made

- > Changed Shim Rings
- > Changed blow down orifice size
- > Aligned machinery – monitored alignment
Changes through first 500 hours of operation
- > Changed buffer supply regulation system
- > Stopped use of Detergent cleaning of DGS

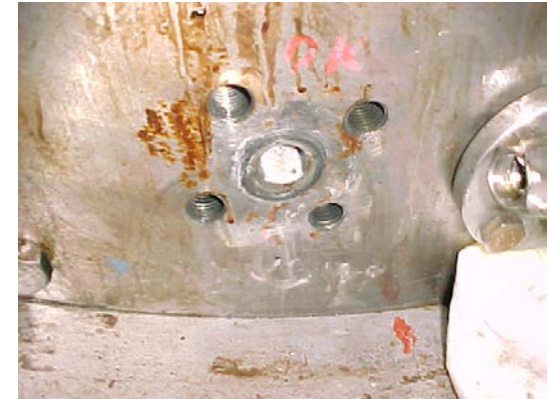
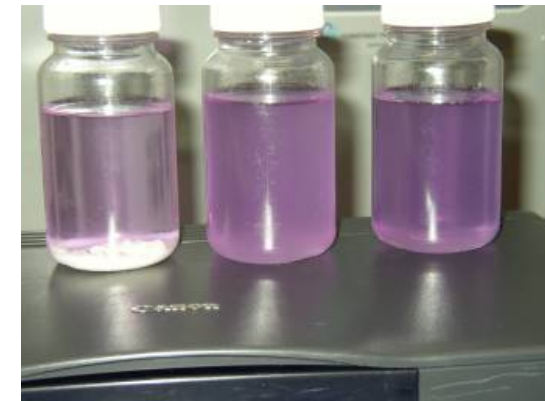
- > Third DGS failure (~450 run hours)
 - Heavy nibbling of DGS primary O-Ring
 - Sever misalignment of compressor to GT
 - » Root cause of misalignment not discovered
 - » Check of alignment records and piping strain made
- > Other Factors found and addressed
 - Barrier Seal Failures – buffer gas supply regulation
 - Oil getting to secondary vent port but not found at primary seal face
 - » Not a root cause but would lead to failure
 - Detergent cleaning of DGS
 - White residue found in DGS port cavities
 - Testing determined that detergent used to “wash” the seals was reacting with Methanol Alcohol that was also used to wash the seals
 - » Not found on seal faces, could lead to a failure – practice stopped
