ANALYSIS OF HOT SECTION FAILURES ON GAS TURBINES IN PROCESS PLANT SERVICE

BWD Turbines Limited

ABSTRACT

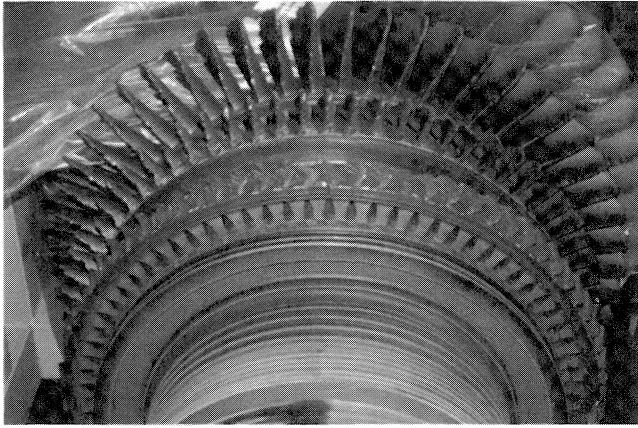
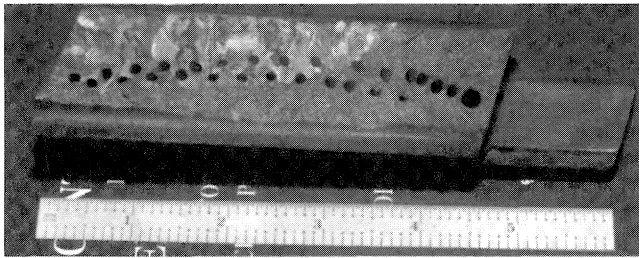
Figures 1 and 2 contrast the impact damage environment in a large, utility-type gas turbine and a smaller, mechanical drive turbine, respectively, resulting from the failure of a rotating blade. Despite the catastrophic airfoil damage on all four rows of blades shown in Figure 1, it was evident that the failure originated in the first row and, moreover, the particular blade involved was readily identifiable due to its different fracture surface location (in the root section), pattern, and coloration. The mechanism of the primary failure was subsequently identified as being high cycle fatigue related. In the mechanical drive turbine, Figure 2, all the hollow-cored bucket airfoils on the single-stage compressor turbine were fractured very similarly as a result of the impact cascade. Despite careful examination of all the buckets in the set, the one on which the initial failure and breaking out of a piece of airfoil occurred could not be positively identified. Nevertheless, a probable mechanism and cause for the primary failure was successfully determined (as will be seen later in the case history for this incident).

Figure 1. Damage to All Four Rows of Blades in Large, Generator Drive Gas Turbine. (The fracture surface (in the root section) of this particular blade is shown in the lower photograph.)

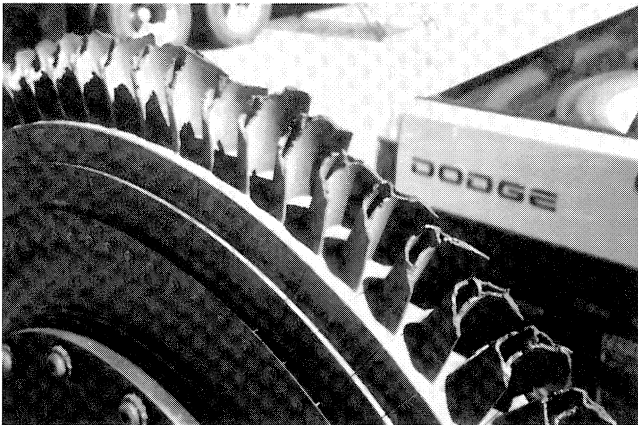
Figure 2. Damage to Hollow-Cored First Stage Turbine Buckets in a Mechanical Drive Gas Turbine.

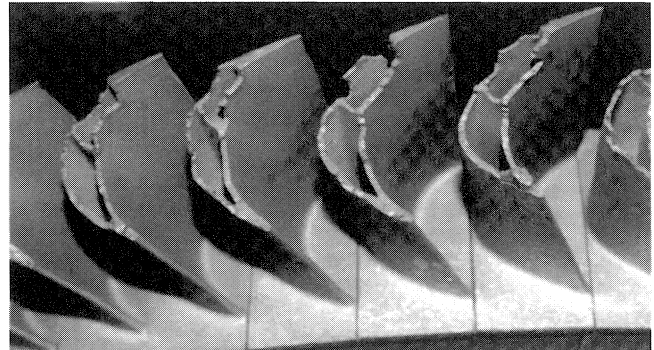
The failure was characterized by loss of airfoil material on all the first stage buckets down to 60 percent to 70 percent height (Figure 5). The last inch of the trailing edge tip was still intact in most cases.

Figure 5. Failed First Stage Buckets. (The volume and shape of airfoil material loss was very similar on all the buckets in the row.)

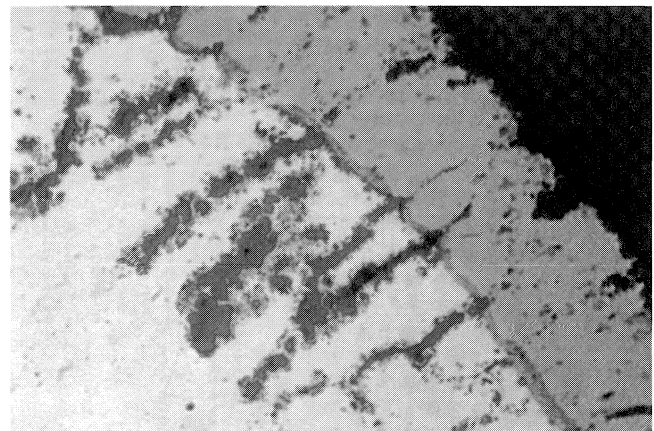
The metallurgical analysis revealed extensive, pre-existing oxidation/corrosion damage remained beneath the refurbished aluminide coating on the external side of the airfoil (Figure 6), while the original platinum modified aluminide coating was never actually removed from the inside surface. Heat treating the buckets in this condition had resulted in localized melting and excessive diffusion of the coating into the IN-738LC base metal. In thin-walled components, this not only locally destabilizes the alloy microstructure, but also results in a thick, brittle layer on the internal surface. While acceptable creep rupture properties were obtained, the regenerative heat treatment cycles used did not fully restore the IN-738LC microstructure (Figure 7).

Figure 6. Photomicrograph illustrating the Damage to the Base Metal Below the External Coating on One of the First Stage Buckets.

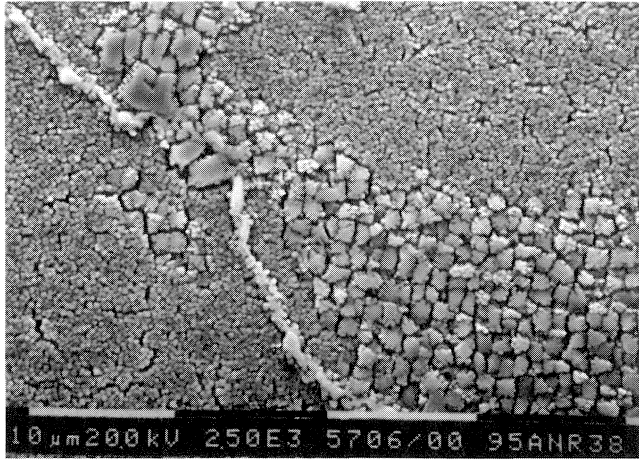
Figure 7. Scanning Electron Micrograph of First Stage Bucket Alloy Illustrating That the Component Had Not Been Properly Heat Treated. (The microstructure consisted primarily of a single size gamma prime distribution with small isolated islands of the normal duplex gamma prime precipitate structure.)

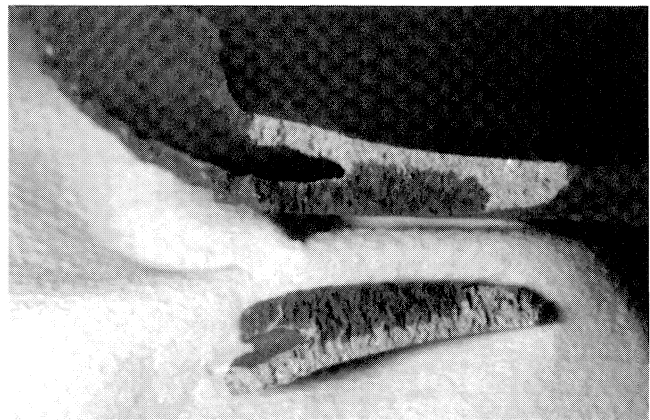
Metallurgical analysis revealed that on around 10 out of the set of 80 buckets, extensive oxidation of the IN-738LC alloy grain boundaries and axial cracking existed on the suction side surfaces behind the leading edge, just below the main fracture surface. The cracks extended almost completely across the airfoil section (Figure 8). These did not show up during a borescope inspection of the turbine just five days prior to the failure, though based on the oxide coverage of the fractured surfaces, the cracks had indeed been present and growing for some time. The material immediately below the cracks contained numerous secondary cracks running in parallel. Some of these were surface connected and oxidized, while others appeared unoxidized.

Figure 8. Oxide-Covered Surface of Mechanically-Opened Creep Crack in the Suction Side of a First Stage Bucket Around from Leading Edge.

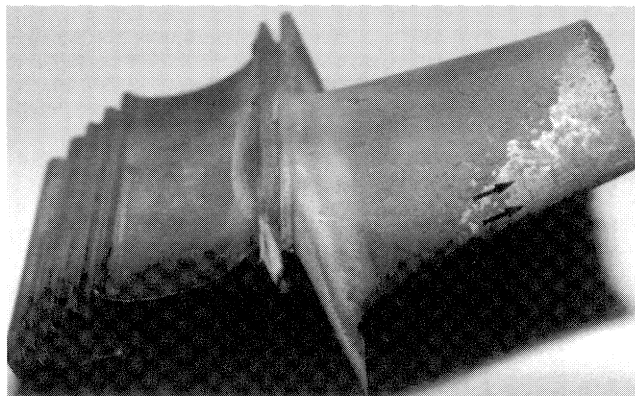
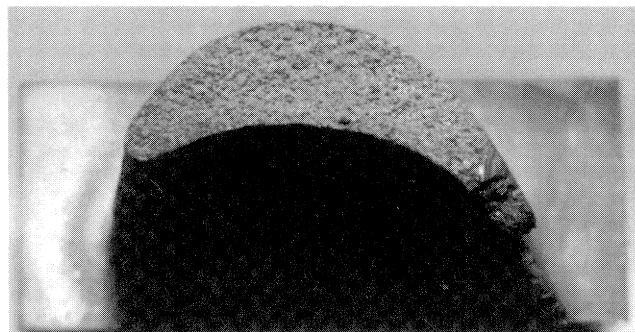
A catastrophic failure of the first stage turbine buckets occurred. All the bucket airfoils (which were of solid design) fractured at approximately mid-height (Figure 9), and impact damage was sustained by the downstream gas path components.

The primary fracture on the buckets had propagated in an intergranular mode across the entire airfoil section. The fracture surfaces at the leading edges appeared typical of high temperature creep or thermal-mechanical fatigue (Figure 10), while the remainder was more characteristic of intermediate temperature creep rupture crack growth and brittle impact overload. Evidently, one bucket airfoil had failed, initiating an impact cascade that resulted in the fracture of the other buckets in the row.

Figure 9. Failed First Stage Bucket. (The upper photograph shows that the aluminide coating was missing below the fracture surface and a secondary crack was present (highlighted by arrows). The mode of fracture was intergranular across the airfoil section (lower photograph).)

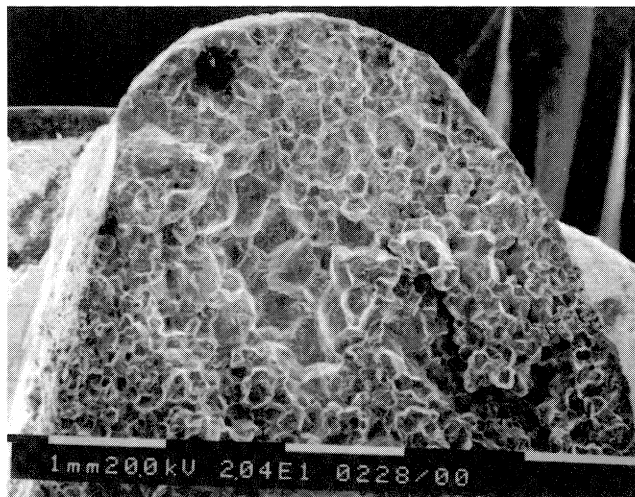
Figure 10. Scanning Electron Fractograph of Failed First Stage Bucket Leading Edge. (The fracture had propagated in an intergranular mode.)

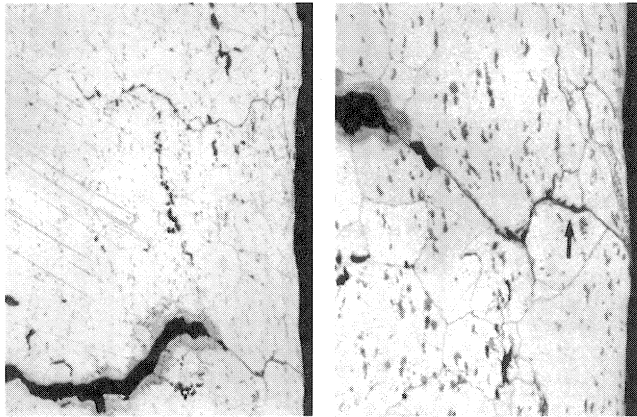
The coating on the buckets had been lost in the leading edge region adjacent to the fracture surface, but the base metal was not oxidized. Microstructural damage and axially oriented cracks were observed at the leading edges on all buckets (Figure 11). No damage was present in the trailing edge regions, however.

The estimated temperature of the bucket metal was only 1380°F at the nominal firing temperature of 1450°F. However, it was apparent that the buckets had experienced much higher temperatures at some point in their operating history. The over

Figure 11. Photomicrograph Showing Microstructural Damage and Cracking in the First Stage Bucket Leading Edge Region. (Left photograph, $\times 40$; right photograph, $\times 100$)

temperature was evidently hot enough to cause the observed metallurgical damage (greater than 2150°F) and melting of the coating/base metal diffusion zone (greater than 2175°F to 2300°F). It was of insufficient duration to cause oxidation of the base metal, after the coating was lost, as well as bring about any similar changes in the airfoil further away from the leading edge region. The latter aspect was investigated via a simplified heat conduction/convective model of the bucket, demonstrating that the duration of the high temperature transient was likely no more than 30 seconds.

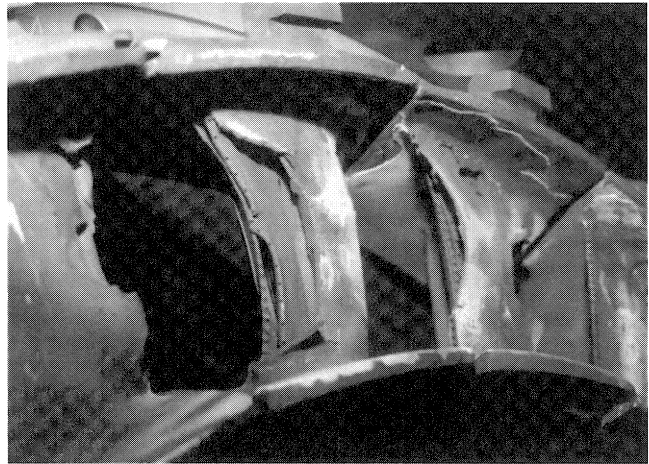
Figure 12. Row of First Stage Vanes Showing Burning Damage as Viewed from Trailing Edge Side.

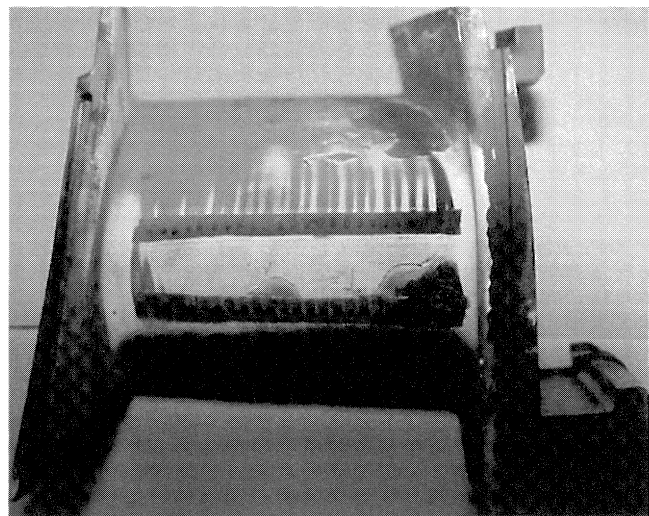
Figure 13. First Stage Vane Showing That Localized Oxidation Attack Had Commenced at Outer Shroud End of the First Row of Suction Side Film Cooling Holes.

Based on the location of the damage, the observed cooling air flow patterns and results from simulations on a finite element based heat transfer model of the vane, it was concluded that aggressive oxidation attack had occurred. This was due to locally excessive metal surface temperatures that had been caused by the failure of the cooling air ejected from the S1 row of holes to form a sufficiently persistent and protecting film over the airfoil surface immediately downstream. It appeared that this feature of the vane cooling design exhibited only marginal effectiveness under the uprated operating conditions. Among the contributing factors was that the S1 holes were located in a high curvature part of the airfoil, resulting in the angle of the ejection holes being unusually steep.

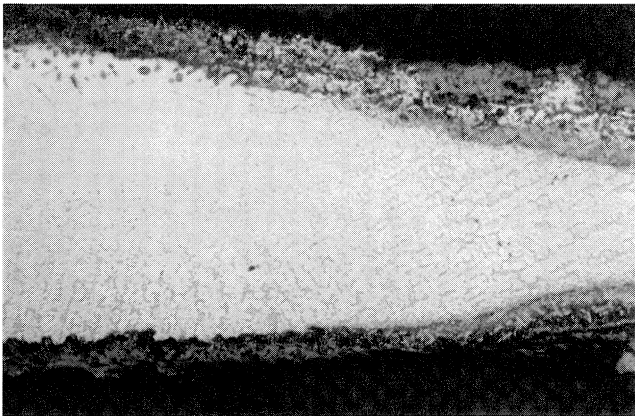
Figure 14. Photomicrograph Showing Level of Pre-existing Oxidation Damage on Internal and External Surfaces of First Stage Vane Wall Section in the Vicinity of the First Row of Suction Side Film Cooling Holes. (Photograph, $\times 60$)

Essentially, the weakened line of cooling holes acted as “perforations” along which the failure readily progressed. The inclusion in the vane set of components that had already accumulated 50,000 hours of service and been through four repair cycles was, in hindsight, probably not an appropriate strategy for a turbine about to be operated under even more demanding temperature conditions.

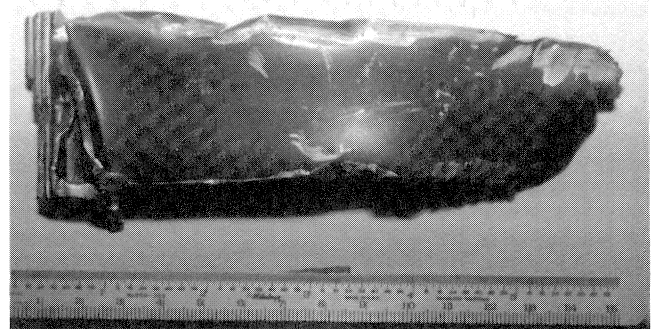
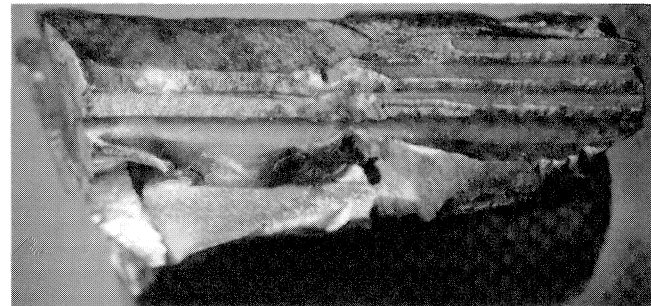
A last stage power turbine blade manufactured from Nimonic 90 failed after about 24,000 hours of operation. The fracture occurred in the root section of the blade (Figure 15) and a number of other blades were identified as having cracks at the same location. Changing process requirements at the site had dictated that the driven equipment run at lower power and speed levels. The failure of the blade occurred after operation of the gas turbine under these new conditions.

Figure 15. Failed Last Stage Power Turbine Blade. (The top fir tree serration crack and failure path along the second serration are seen.)

The blade root exhibited multiple fracture initiations on both first and second root serrations. The blade had failed across the second fir tree serration. Metallurgical examination of fracture surfaces and cracks revealed features consistent with high cycle fatigue. Fatigue striations were clearly visible and exhibited a repeating pattern at approximately eight-cycle intervals (Figure 16). No material defects or other forms of degradation were found.

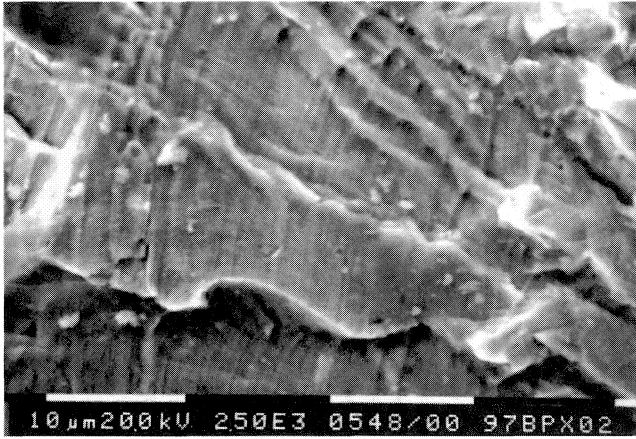
Figure 16. Scanning Electron Fractograph of Cracked Last Stage Power Turbine Blade.

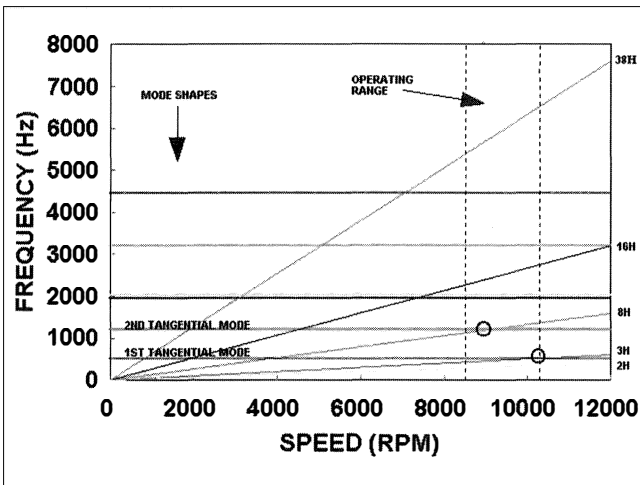
the failed blade during short term operation transients to 10,300 rpm, followed by propagation to failure under resonance conditions for much longer times at 9100 rpm. The cracked blades probably initiated cracks due to the excitation during operation at the lower speed. The location of the calculated highest dynamic stresses correlated with the observed crack initiation points.

Figure 17. Campbell Diagram for Last Stage Power Turbine Blade. (The interferences of interest are highlighted.)

The freestanding design of the last row of power turbine blades was somewhat unusual for a variable speed machine in which it is often impossible to avoid some resonant conditions in the operating range. Lashing wires or interlocking tip shrouds are typically utilized to control blade vibrations. Prompted by the failure analysis described here and further occurrences on turbines at the same site and elsewhere, the turbine manufacturer acknowledged that a problem existed and undertook a complete redesign of the blade.
