# GAS TURBINE BLADE FAILURES—CAUSES, AVOIDANCE, AND TROUBLESHOOTING

by  
**Cyrus B. Meher-Homji**  
Engineering Specialist  
Bechtel Corporation  
Houston, Texas  
and  
**George Gabriles**  
Consultant  
G&B Consultants  
Lake Jackson, Texas

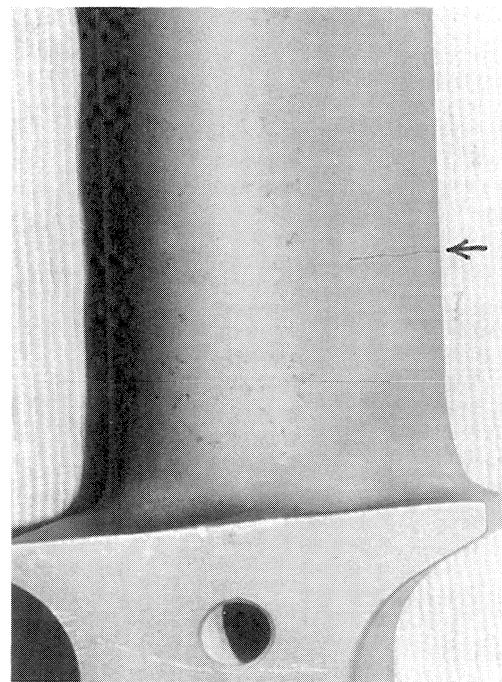
Figure 5. Blade Showing a Mid-Span Fatigue Crack.

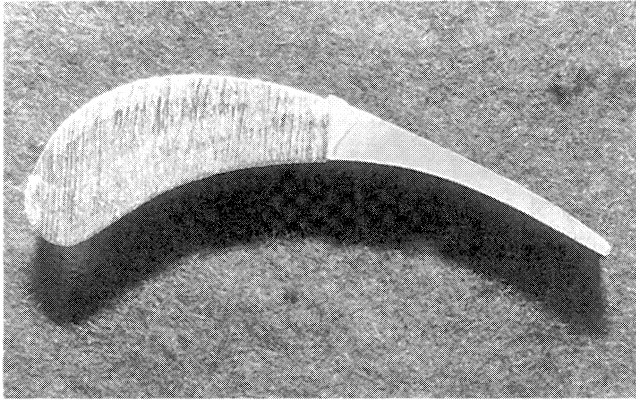
Figure 6. Sectioned View of Blade Shown in Figure 5. (The progression of the fatigue crack can be seen.)

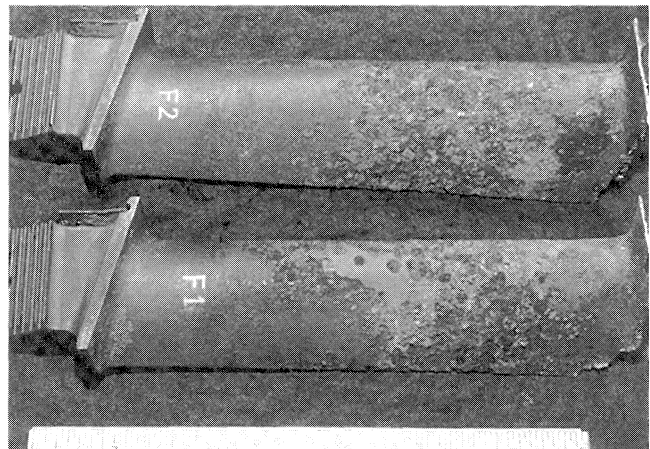
Figure 7. Turbine Blades with Hot Corrosion.

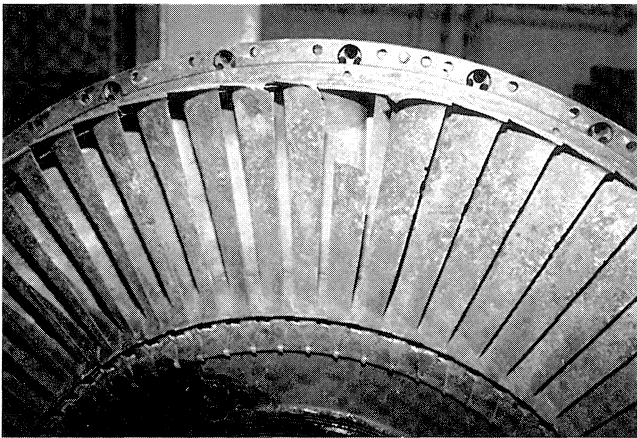
Blade failures are commonly caused by multiple failure mechanisms. Corrosion, for example, can reduce blade section size and drop the fatigue strength. Fretting wear in the blade attachment regions can reduce damping, causing increased vibration amplitudes and alternating stresses. Foreign object damage can cause nicks and cracks that can then be propagated by low or high cycle fatigue. Consequently, failure analysis must investigate all engineering causes including design issues, environmental factors, cleanliness of the fuel, air quality, material, and gas turbine operating and maintenance history. Problems such as these are quite common and often create significant disputes between the OEMs and the user as to how the damage is to be resolved commercially. A turbine rotor from an aeroderivative gas turbine that experienced a fatigue failure combined with hot corrosion is shown in Figure 11. In this case, severe tip rubs accentuated the problem.

Figure 11. A Typical Combined Failure Mode Showing Both Tip Rub, Hot Corrosion, and a Fatigue Failure.

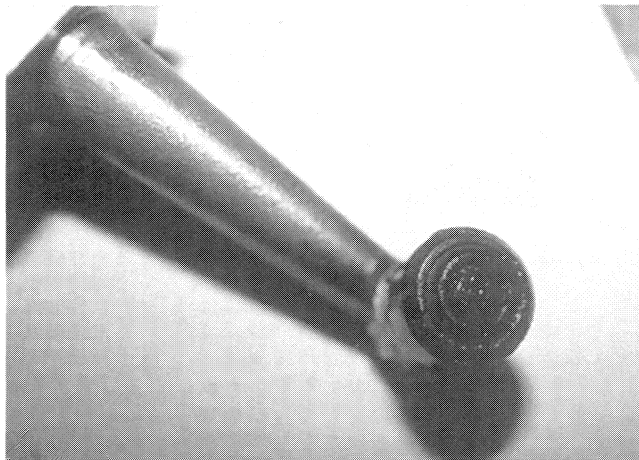
Figure 17. Coking of Fuel Nozzle.

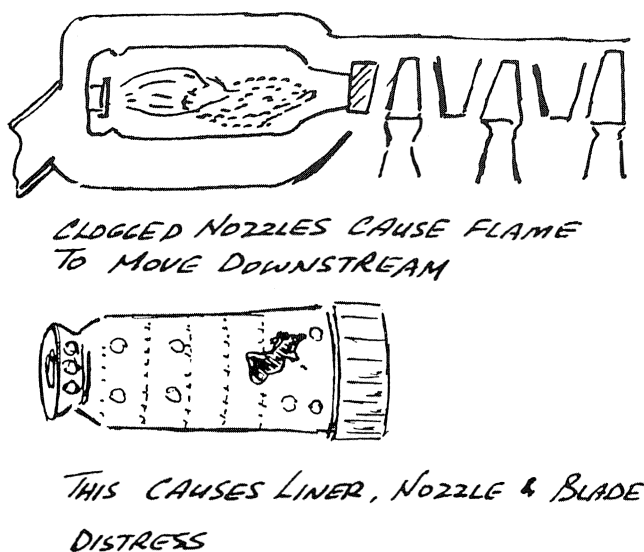
Figure 18. Coked Fuel Nozzles Can Cause Flame to Move Downstream Causing Undesirable Temperature Spreads, Overheating, Liner, and Blade Damage.

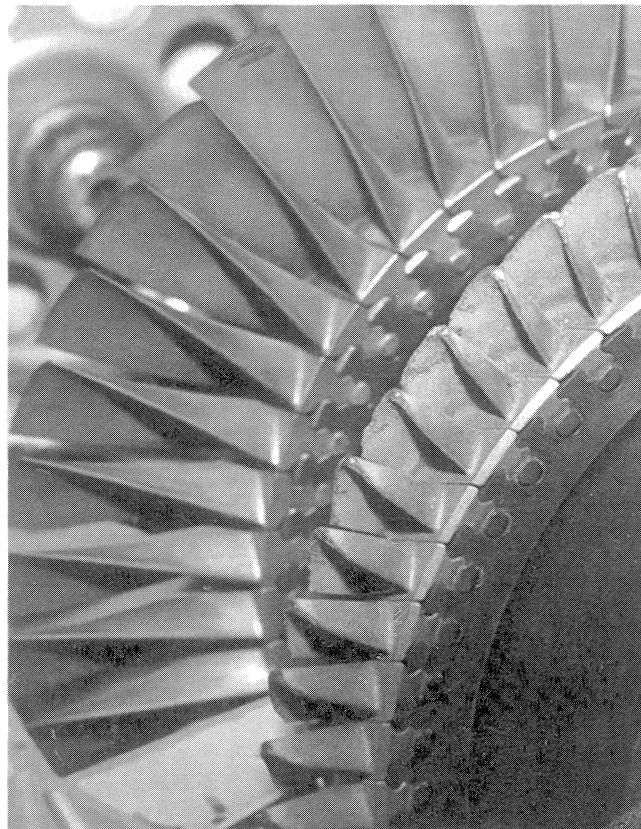
Figure 19. Burnt Blading Due to Fire in Turbine Section (Fuel Accumulation in Combustors).

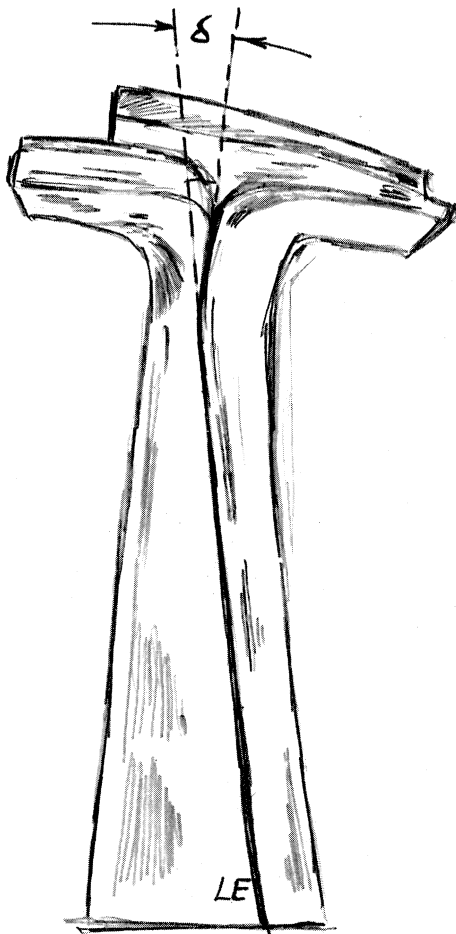
blades tipped forward (as depicted in Figure 21) due to the rapid temperature change. The strength of the blading was severely reduced, due to the elevated temperature. Because the tip shrouds were displaced, the natural frequency of the blades were modified to a much lower value. This change in natural frequencies caused a blade fatigue failure. The solution of this problem addressed the modification of fuel purging procedures to ensure that no fuel accumulation could occur.

Figure 21. Tipping Forward of Blade Shrouds Due to Fire in Turbine Section.

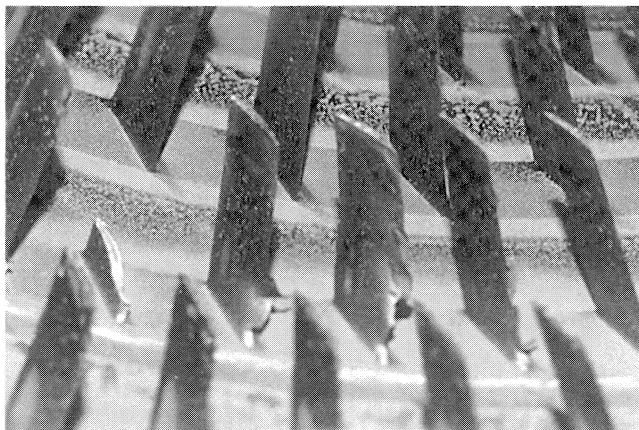
Figure 24. Damage Caused Due to Clash Failure. (Stator fatigue failure can also be seen.)

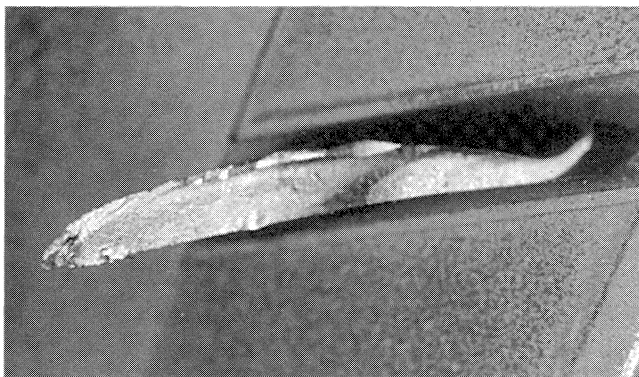
Figure 25. Fatigue Failure of Airfoil.

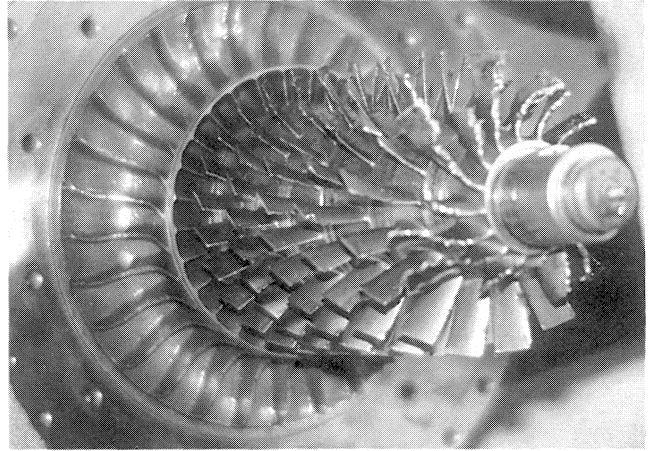
Figure 29. Massive Destruction on a Compressor Rotor Due to FOD.

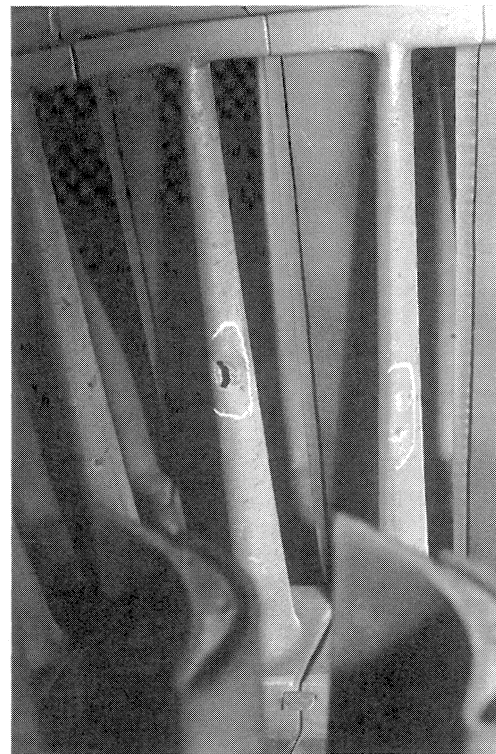
Figure 31. Hole in a Stator Vane of a Large Gas Turbine Caused Due to FOD (failure of a single first stage blade).

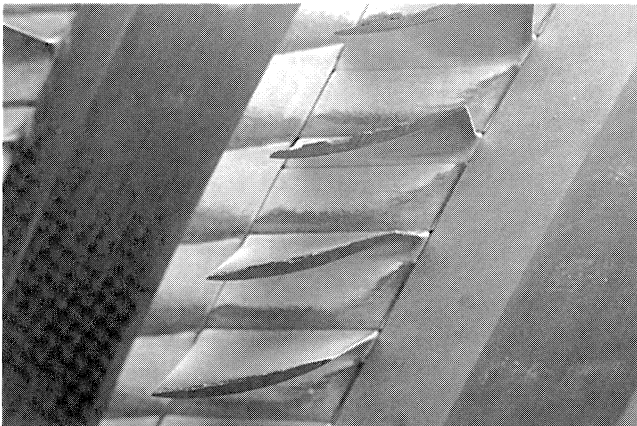
A rub on the tip of an axial flow compressor is shown in Figure 32. A severe radial blade tip rub is shown in Figure 33. The blade tip shroud has been severely rubbed in this case.

Figure 32. Blade Tip Rub on a Gas Turbine Axial Flow Compressor.

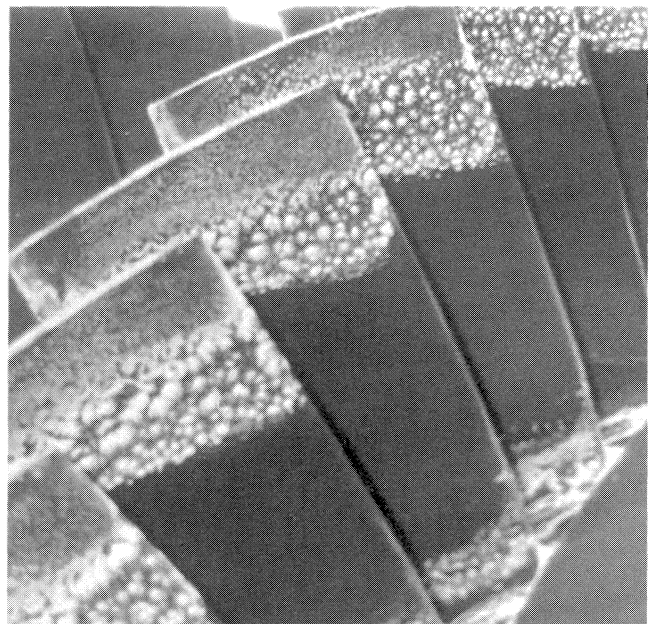
Experience has shown that deposits on compressor blades often contain sodium and potassium chlorides. These combine with water to form an aggressive acid, causing pitting corrosion of the blades (typically a 12 percent chrome steel such as type 403 or 410). Water often condenses due to the acceleration of the air prior to the IGV, and the salt particles get dissolved and pass through the compressor. The water evaporates as it moves through the compressor and, at times, salt is found deposited on compressor blading as shown in Figure 34. In a salty environment, the fatigue strength of steel can drop 50 percent to 60 percent, and this situation is worsened when notches due to corrosion pitting are present. Even with good air filtration, the right conditions of fog, humidity, or rain can cause migration of the salt through the inlet filter (leeching) and into the compressor. Donle, et al. (1993), have described an inlet air treatment approach that limits ingress of salt.

Figure 34. Salt Deposits on Compressor Blading.

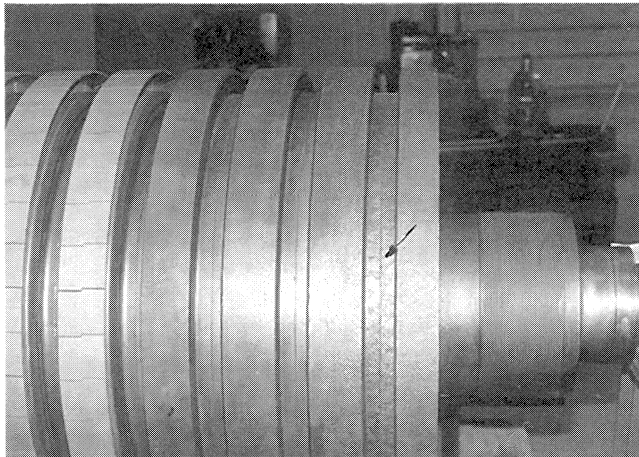
Figure 35. Standby Corrosion on Rotor of a Peaking Gas Turbine.

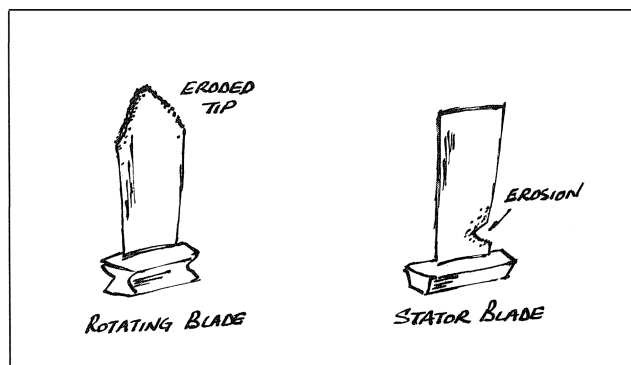
Figure 36. Erosion Patterns.

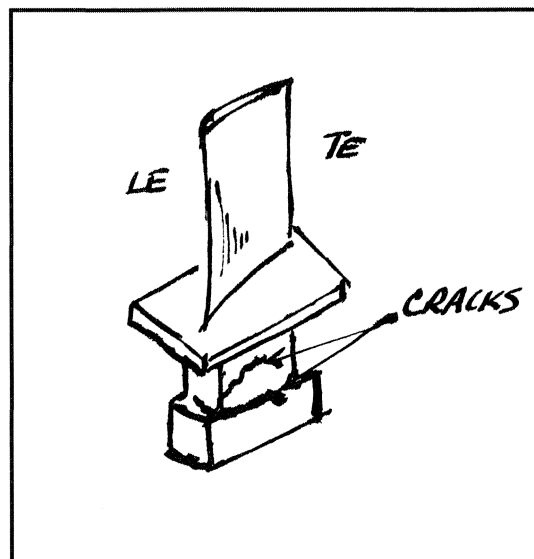
Figure 37. Crack Locations in Turbine Blade.

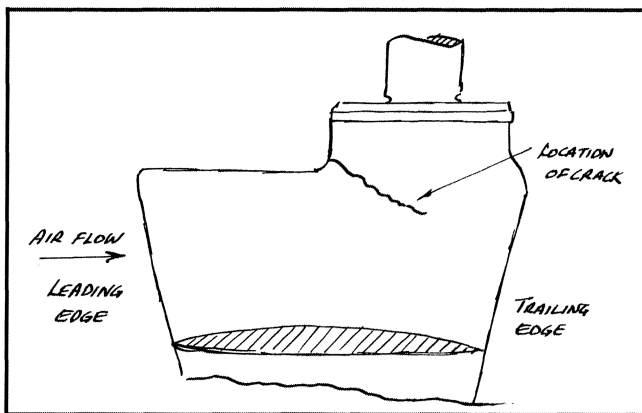
Figure 38. Crack Locations in IGV.

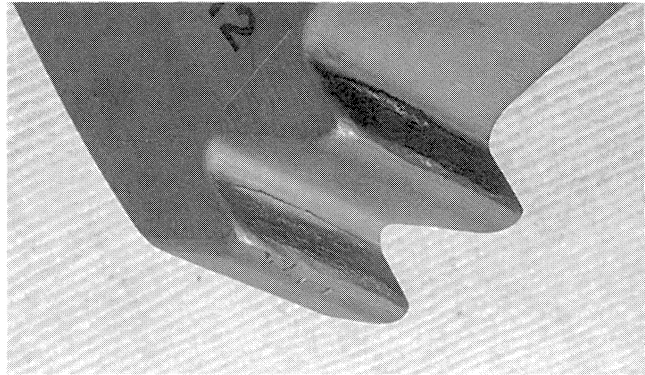
Figure 40. Fretting Damage on Turbine Attachment Lands.

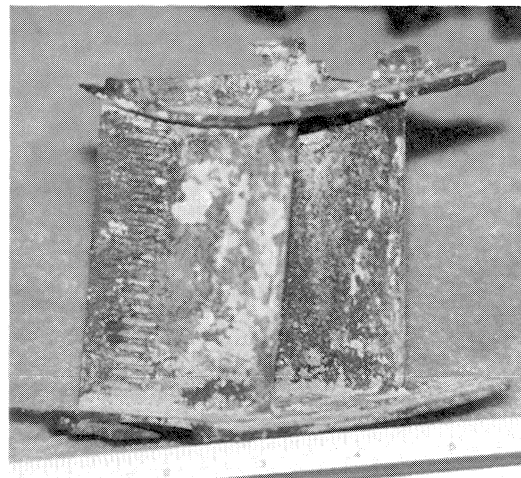
Figure 41. Massive Amount of Salts Found in Turbine Nozzle.

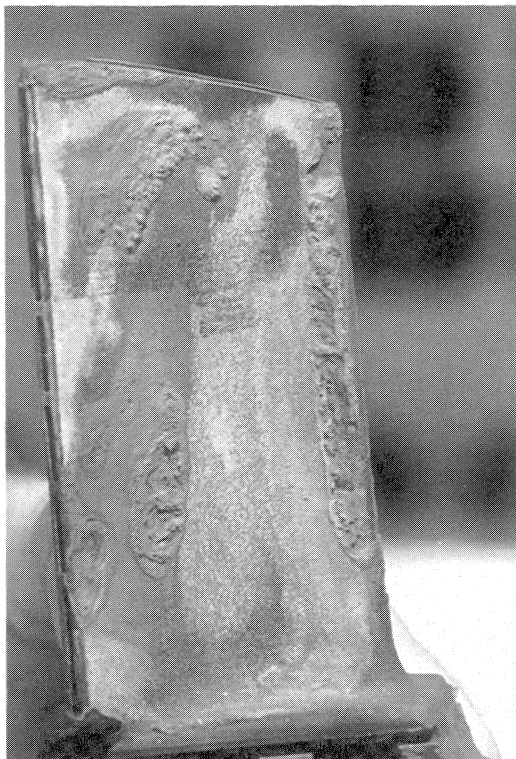
Figure 42. Hot Corrosion Damage.

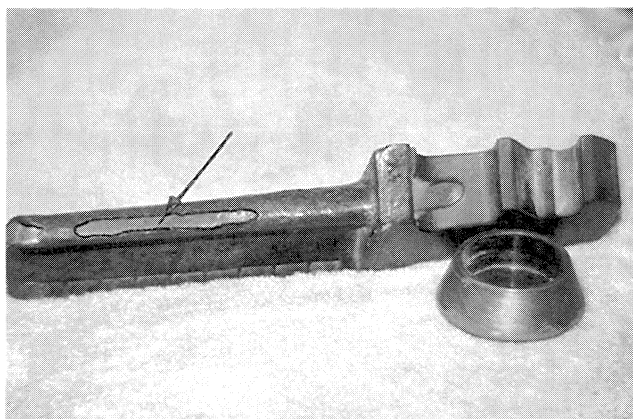
Figure 43. Hot Corrosion Damage Showing Total Defeat of the LE Cooling Hole.

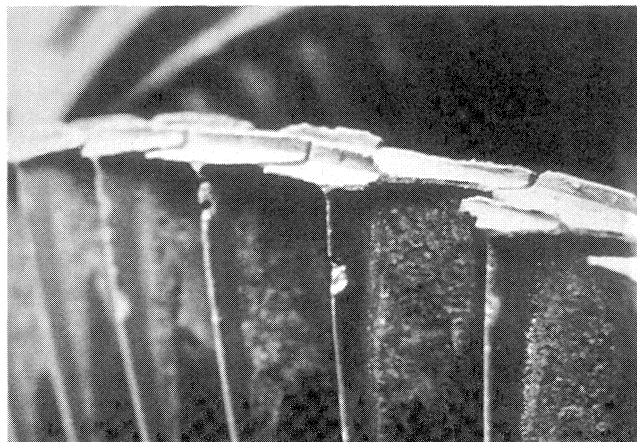
Figure 44. Material Loss at Shrouds Due to Hot Corrosion on Second Stage IN 738 Blades.

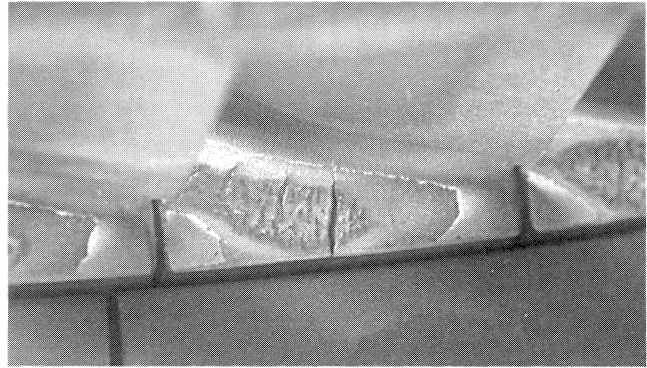
Figure 45. Hot Gas Erosion Phenomenon on Nozzle Outboard Platform. (This can result from localized heating (or poor heat removal).)

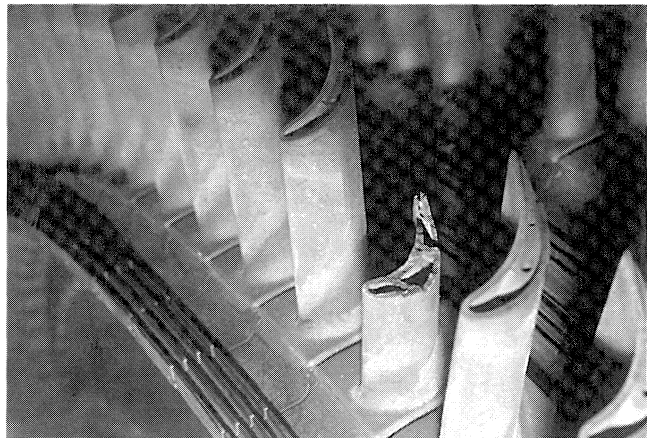
Figure 46. Creep Rupture Failure of a First Stage Blade Caused Due to Blockage of the Cooling Passages.

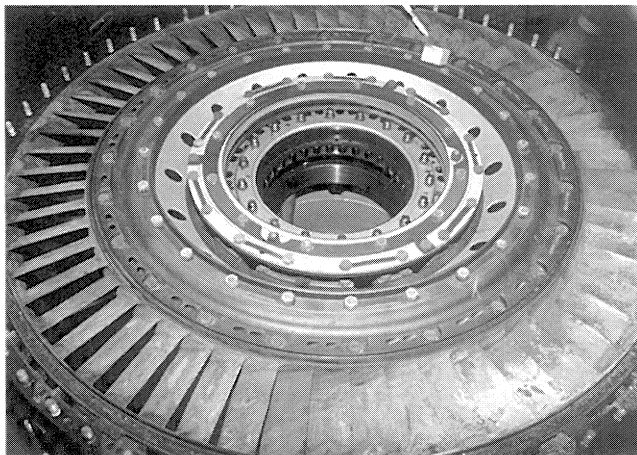
Figure 47. Gas Generator Turbine Section with Foulants.

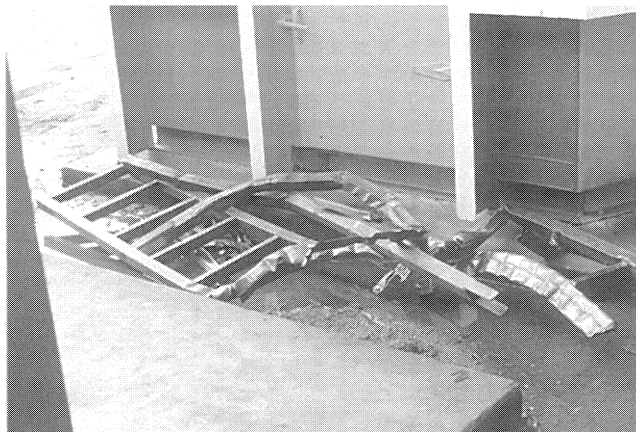
Figure 49. Mangled Remains of an Inspection Ladder That Was Left Within a Silo Combustor During Startup.

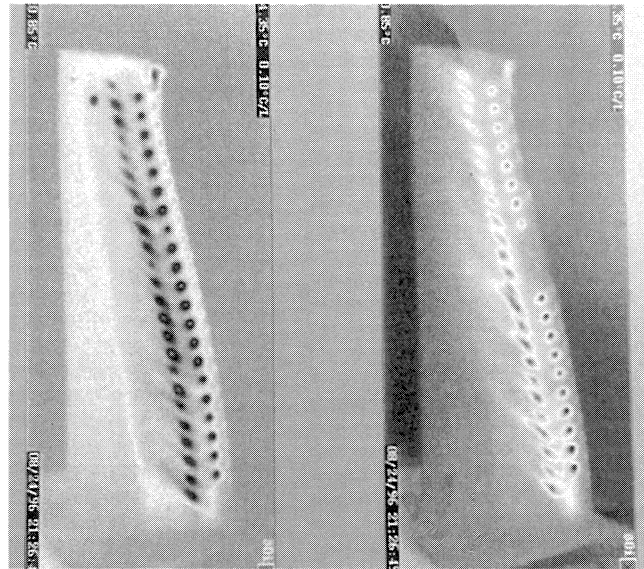
Figure 52. Infrared Photograph of a Turbine Blade Showing Blocked Cooling Holes On Right, Compared to Reference Blade on Left. (Courtesy of Bales Scientific Inc.)

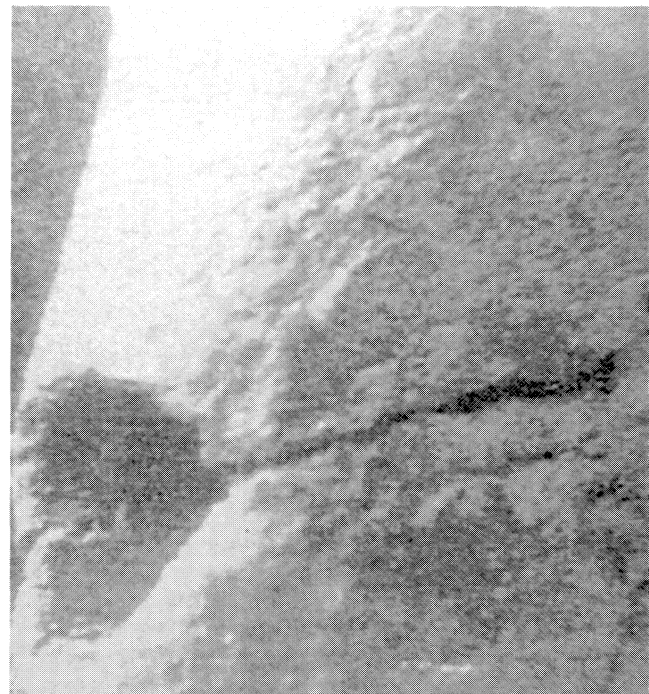
Figure 55. Cooling Hole Crack on Another Blade at 10x Magnification.

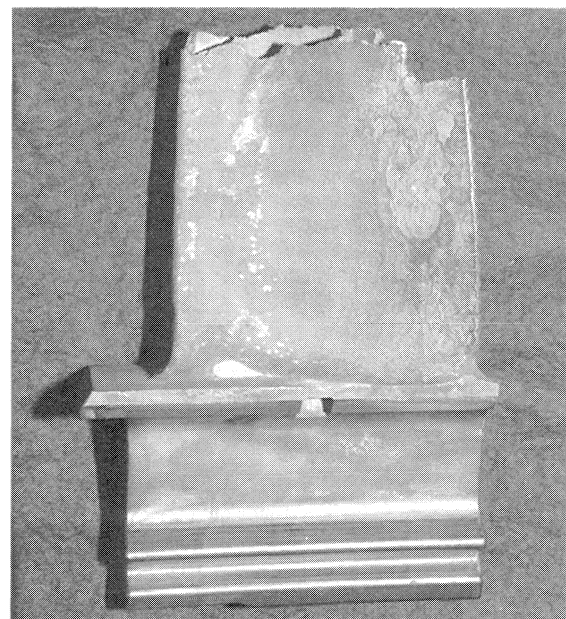
Figure 59. Pressure Side of Blading Showing Hot Corrosion and Partial Defeat of Some Cooling Holes.

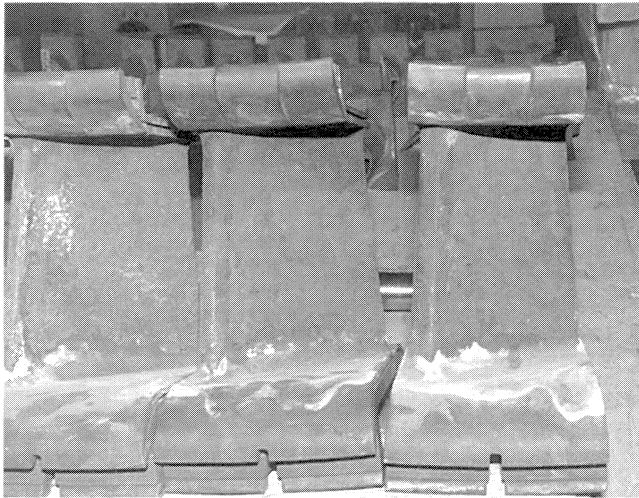
Figure 60. Photo of Nozzles Showing Presence of Salt Deposits.

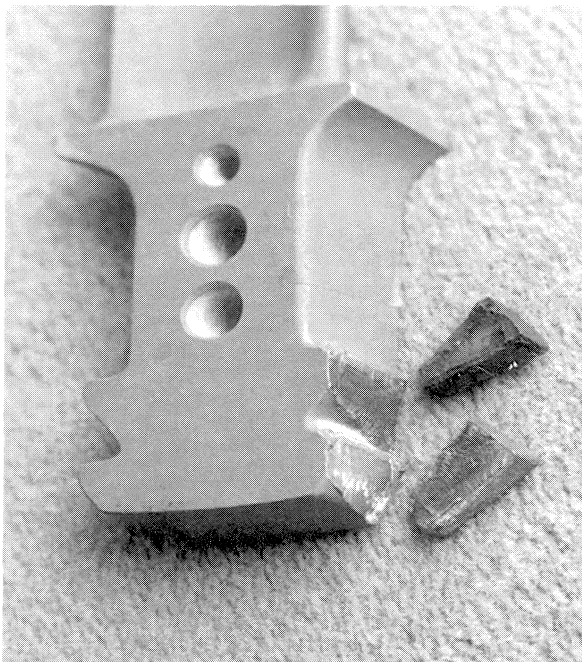
Figure 64. Land Failure on Fourth Stage Turbine Blade.

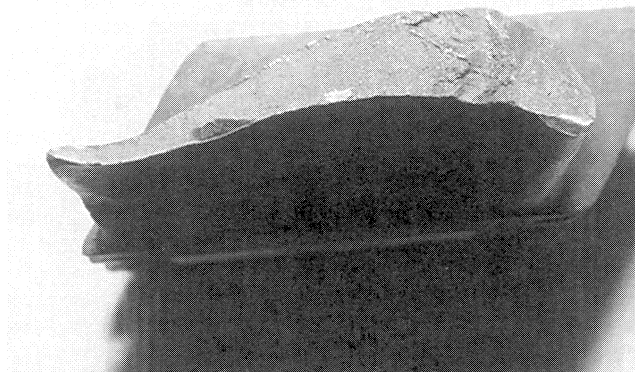
Figure 65. Fracture Surface of Sixth Stage Blade Showing Fatigue.

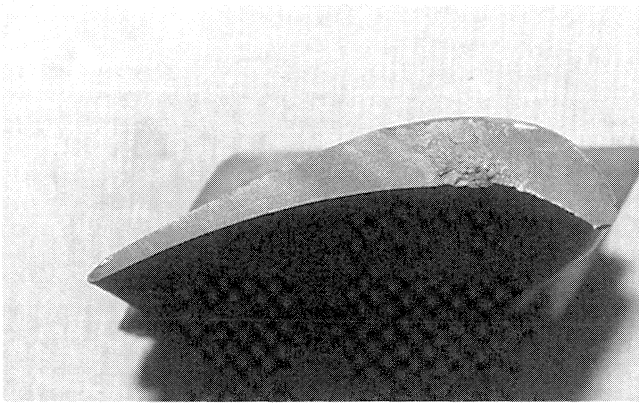
Figure 67. Classic Sixth Stage Fatigue Fracture Surface. (An oxide progressive coloration was observed.)

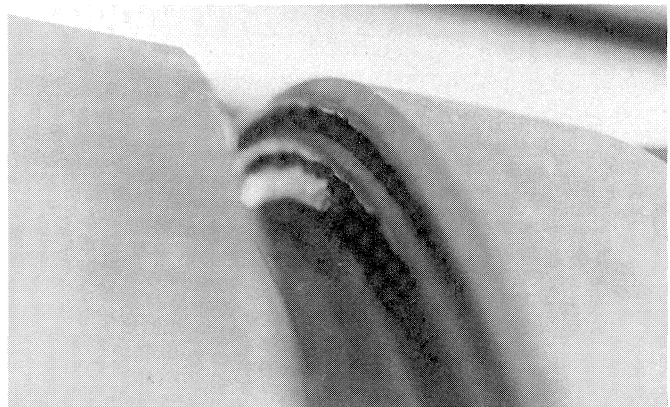
Figure 69. Standby Corrosion Damage to Rotor Drum in the Blade Attachment Region.

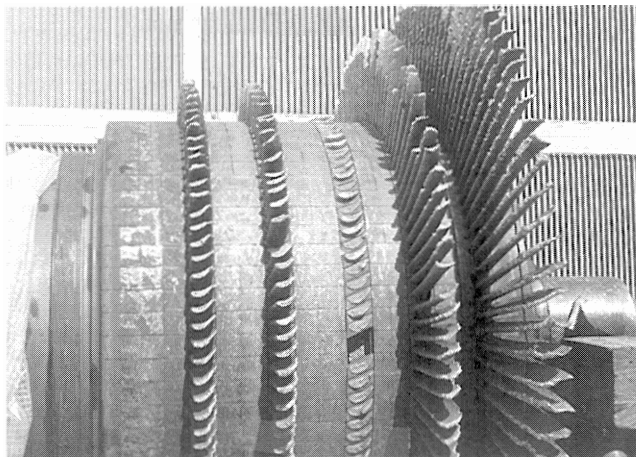
Figure 71. Destruction of Turbine Section.

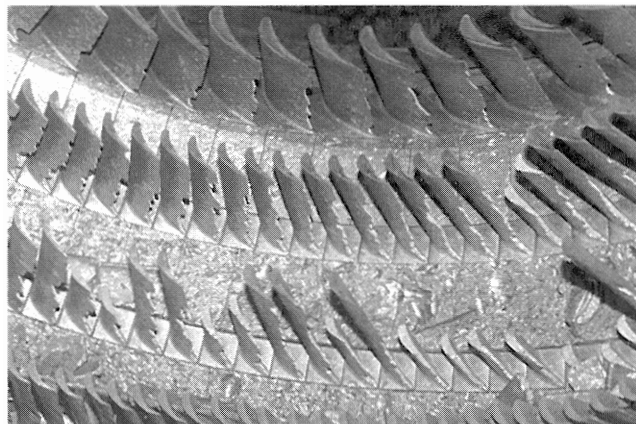
Figure 72. Lower Casing Stator Section Damage.

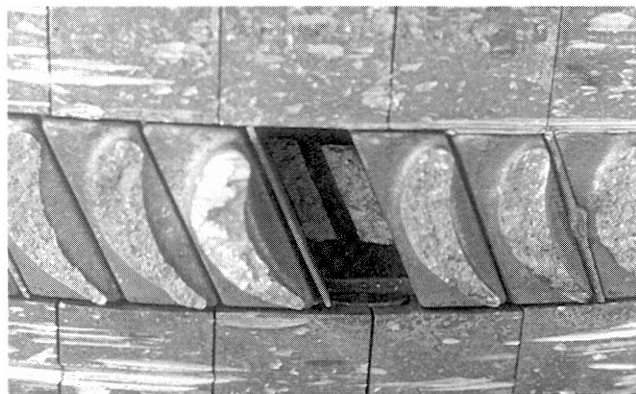
Figure 74. Blade Breakage at Root through Cooling Hole.

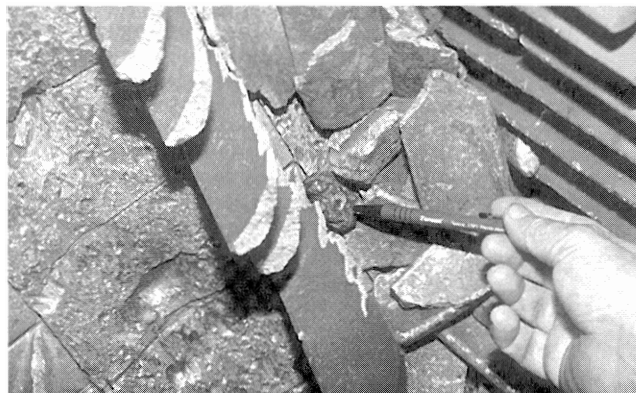
Figure 75. Battered Pin Found in Turbine Debris (Lower Turbine Casing). (This indicates the importance of a careful search of the debris. Missing this evidence on a similar failure in the past, resulted in this "repeat" failure.)

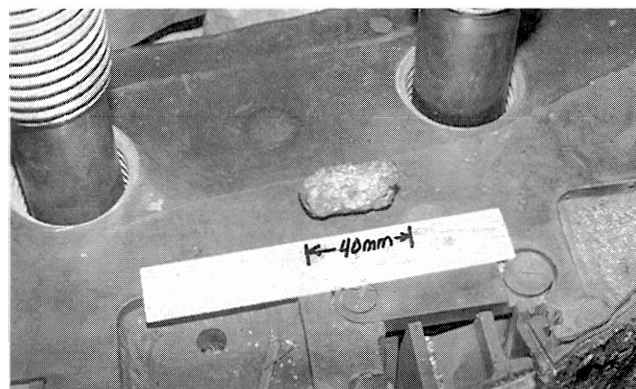
Figure 76. View of Pin Found in Debris. (Length approximately 40 mm, diameter 15 to 20 mm.)

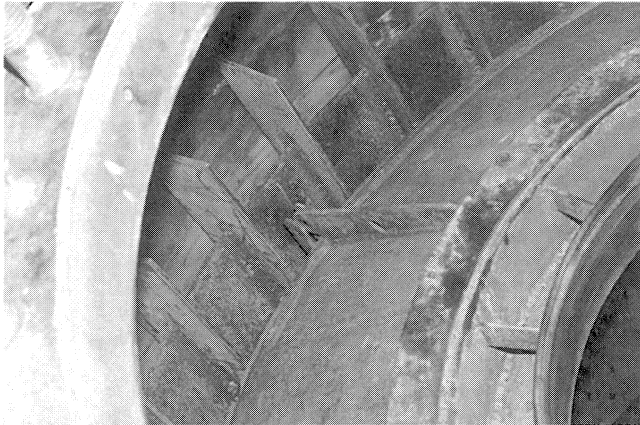
Figure 78. Photograph of Struts with Missing Clevis Pins.

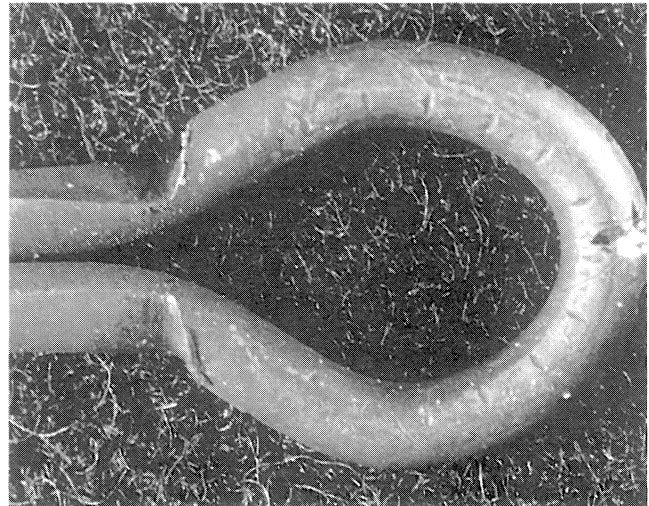
Figure 80. 10× Photomicrograph of Cotter Pin. (Fretting damage and wear can be seen.)

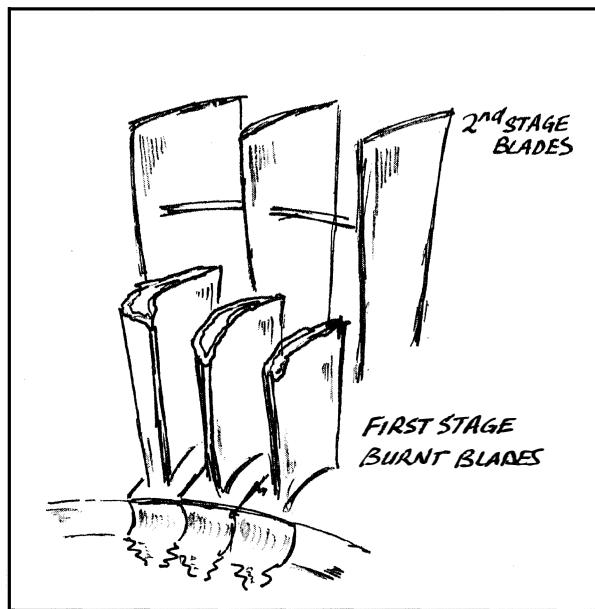
Figure 81. Blade Damage Caused Due to Combustor Fire (Liquid Hydrocarbons in the Fuel).
