# DISCOVERING, THE HARD WAY, HOW A HIGH PERFORMANCE COUPLING INFLUENCED THE CRITICAL SPEEDS AND BEARING LOADING OF AN OVERHUNG RADIAL COMPRESSOR—A CASE HISTORY

## ABSTRACT

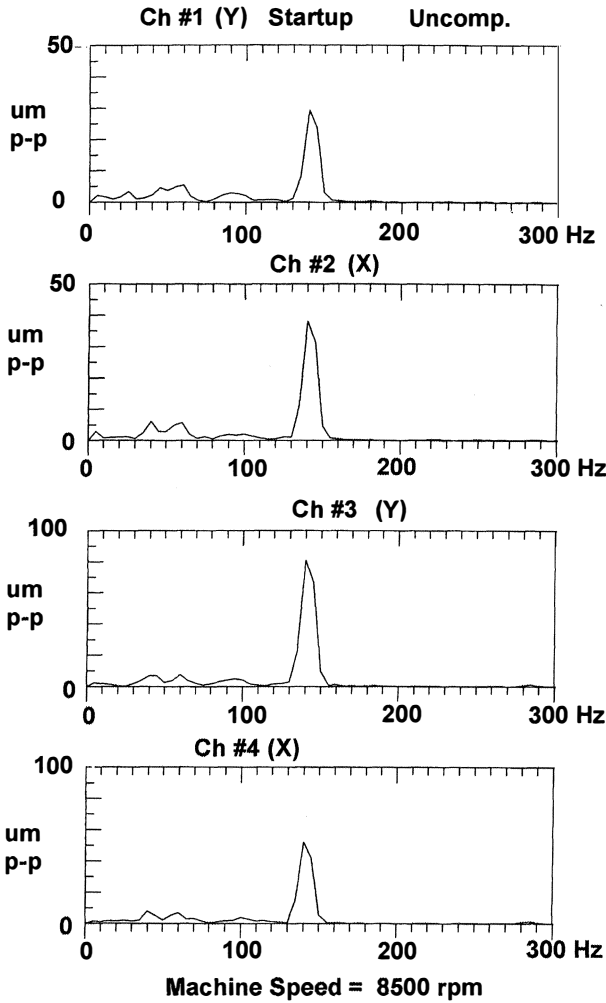
Figure 7. Original "Unbalance" Spectrum.

this 8500 rpm limit. The 1× filtered vs direct amplitude was comparable with little or no phase shift. FFT analysis indicated a clear 1× response that was initially interpreted as simply an unbalance condition. A typical set of system responses for these initial observations is shown in Figures 7, 8, and 9.

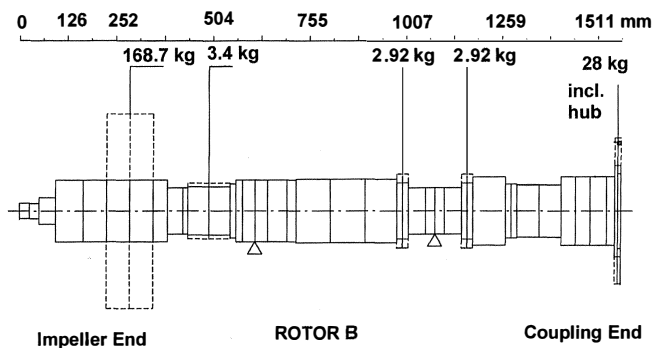
Figure 12. Rotor Model B—With Actual Contract Coupling Weight.

The contract coupling as delivered, however, was a standard design weighing 28 kg at the shaft end. The actual weight was somehow missed in the communication between the compressor and turbine manufacturer, as mentioned previously. The rotor model (rotor B) and forced damped unbalance (using the same unbalance of 1.06 kg-mm at the coupling end) response model and mode shape is shown in Figures 12 and 13, respectively. Calculated critical speeds and the amplification factor are shown in Table 1, column B. The first critical speed was at 3800 rpm and the second was at 9100 rpm, very near the problem speed on the test stand!

But, even though the observed test resonance was very likely related to the new rotor (rotor B) model second critical, the rotor had been calculated to be critically damped, with an amplification factor of 1.2 (Table 1). Damped Eigen value stability analysis showed no problems. Log decrement values were well in the stable range. The high amplification was completely unexpected and more investigation was necessary.

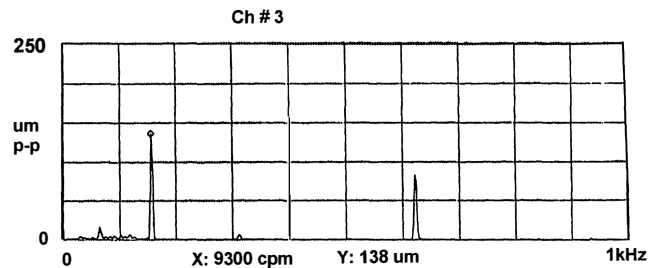
Figure 14. "Resonance" Spectrum.

through the resonance. The observed vibration magnitude was up to 250  $\mu\text{m}$  with a corresponding phase shift. This result appeared to be only the initial onset of the resonance. The machine could be run up to 9300 rpm, with stable amplitudes at 40  $\mu\text{m}$  to 60  $\mu\text{m}$  with no phase shifting. But once the speed was increased above 9400 rpm, the amplitude would increase dramatically. Depicted in Figures 14, 15, and 16, are the nature and magnitude of the vibration.

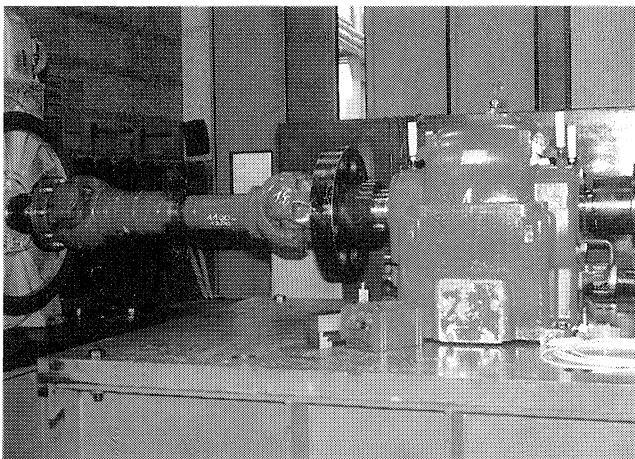
Figure 17. Original Gearbox and Cardan Shaft.

- *Cardan shaft*—The Cardan shaft (Figure 17) was also theorized as providing a source of the vibration. Following checks of the original unit balance records that showed an acceptable residual unbalance, another unit of approximately double the mass and physical size was substituted, with no significant influence. Therefore, this component was eliminated from the discussion.

- *Test gearbox*—The test gearbox was suspected as inducing the vibration. The original unit, also depicted in Figure 17, was a double helical unit of 1:3.11 ratio used to increase the available output speed of the DC motor. The gearbox generated some relatively high vibration readings. However, attempts to isolate this source of the resonance were inconclusive following disassembly and inspection of gearing and bearings, mechanical runout measurements and rebalancing of both input and output shafts, and gearing. Analytical methods incorporating the characteristics of the output pinion into the lateral/torsional model also showed no significant influence. A high level subsynchronous vibration ( $0.45\times$  to  $0.49\times$ ) was eventually isolated within the output shaft

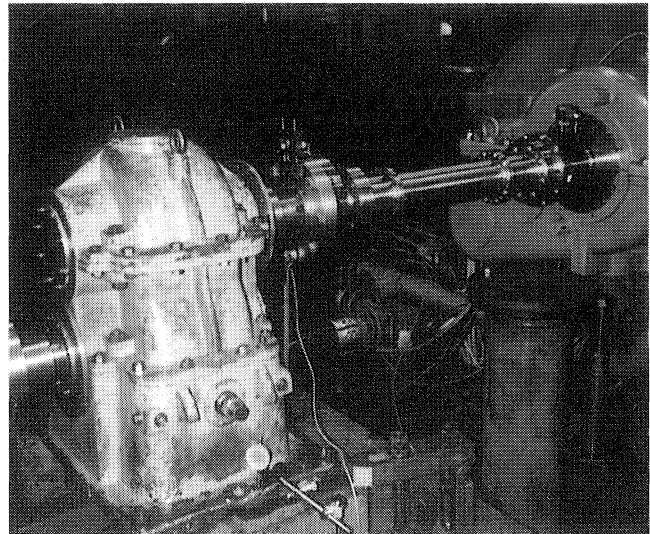
Figure 18. Replacement Gearbox.

bearing system. This gearbox was replaced with a larger capacity unit of 1:5 ratio that would allow operation at the full operating speed of 10,500 rpm and is shown in Figure 18. There was no measurable change to the vibration characteristics. Measurements of radial and axial vibrations, thermal growth, and mechanical runouts on input shafts, output shafts, bearing systems, and casing provided no relevant information. Due to the lack of system response following the gearbox replacement, this component was eliminated from the investigation.

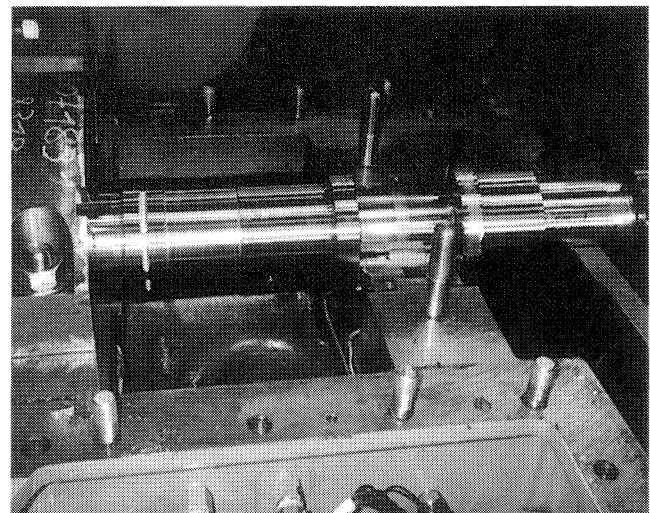
Figure 19. Bearing Pedestal.

- *Overhung bearing pedestal design*—A possible structural resonance was theorized within the overhung bearing pedestal design. The housing is a horizontally split design that allowed for impact testing of the unit in various stages of assembly and disassembly. However, the webs carrying the bearing systems are quite massive; therefore, the resultant Campbell diagrams showed no significant resonant frequencies. The fasteners mounting the bearing caps were eventually modified to provide a stiffer bearing assembly, but the effect was not quantifiable. This assembly is shown in Figure 19.

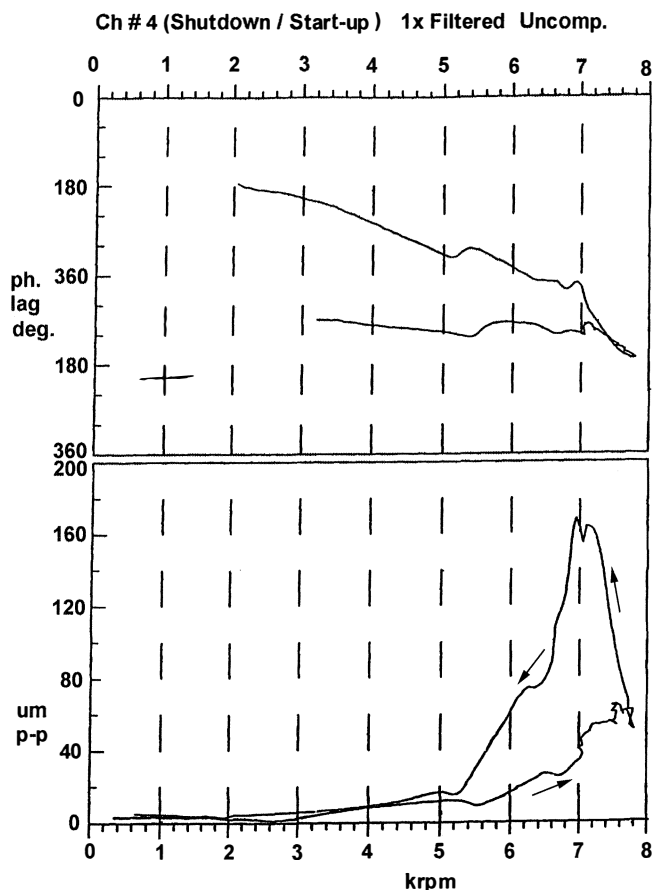
Figure 21. Bode Plot of Original Test Coupling with First Trial Weight.

It should also be noted here that there appears to be jump phenomena depicted on Figure 21, which indicates a highly nonlinear condition. However, it was assumed at the time, possibly incorrectly, that the odd vibration behavior was related to the unbalance in the weight ring assembly.

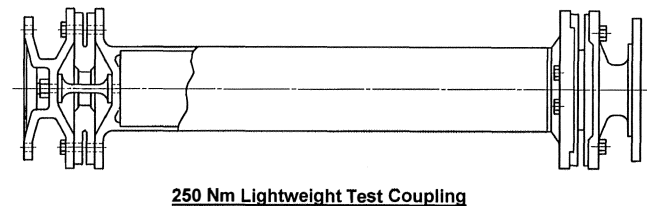
Figure 23. Shop Test Coupling.

- *Shop coupling test*—A different, shop test coupling (Figure 23) was balanced, then connected to the compressor rotor and spun. Again, the reasoning was that if the newer coupling worked and the contract one did not, there must likely be something wrong with the contract coupling.

This arrangement was able to run successfully. The overall vibration was within API levels, there were no phase changing effects at speeds up to 10,900 rpm, and there was no significant amplification factor during shutdown (Figure 24). But, as before, there were questions about the validity of using these test results to deduce that the contract coupling was the problem. First of all, the couplings were completely different designs with different physical characteristics.

The biggest distinction was the weight. The new test coupling weighed 2.7 kg and the contract coupling weighed 28 kg on the compressor end. In addition, the differences in flexible element bending, axial, and radial stiffnesses were significant. In other words, since there were all these dissimilarities that could affect the forces on, and therefore the vibration of, the end of the rotor shaft, the fact that the new coupling ran successfully could not prove that contract coupling was defective.

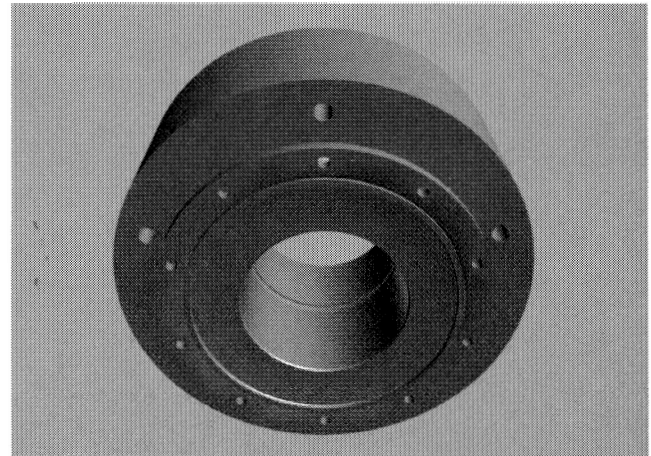
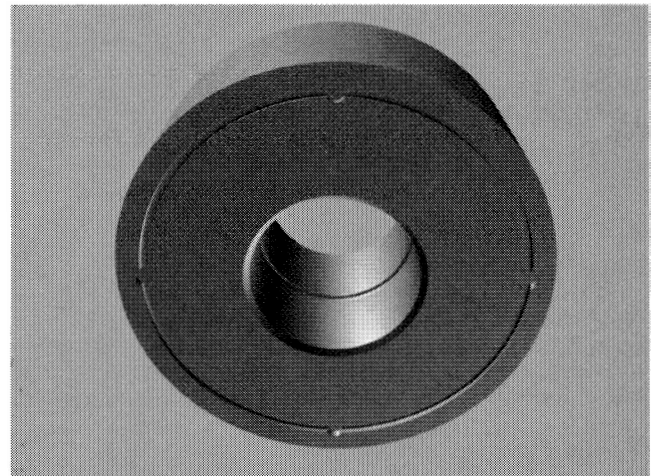
Figure 25. Heavy Hub. (Front view showing mating flange and threaded field balance holes.)

Figure 26. Heavy Hub. (Back view showing field balance groove.)

The entire coupling system was returned to the manufacturer where it was inspected, measured, and reassembled with a new half coupling with a mass of 75 kg to match the original specification shown in Table 1. The extra weight (47 kg) was incorporated in a new rigid hub design (Figures 25 and 26). This new hub was termed “the pregnant rigid hub.”

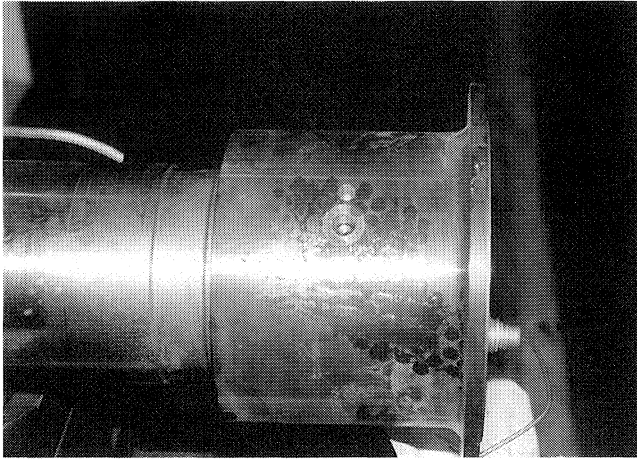
Figure 27. Unbalance in Original Contract Rigid Hub.

The contract coupling, which had been returned to the factory for inspection, had significant unbalance (230 g-mm) in the rigid hub; unbalance that was not reflected on the original balance report. Apparently, permanent field corrections (drilled holes in the hub body) had been made to the rigid, to account for the unbalance introduced in the hub when a threaded plug was inserted into a hydraulic port hole for dust/contaminant protection (Figure 27).

Rotor response to unbalance calculations were done to see if this rigid hub unbalance could have caused the severe vibration levels. The results were marginal; the unbalance in the rigid could have contributed to the problem, but it was probably not the only cause.

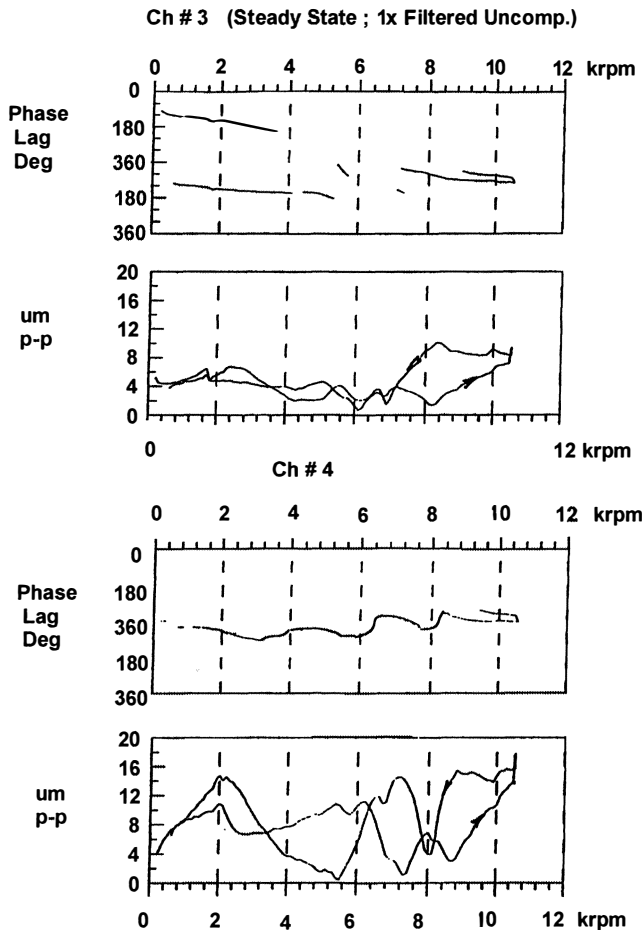
Figure 29. Final Successful Run Bode Plot.

After the mechanical test run with the heavy coupling arrangement (rotor E), it was reported “ ... the maximum direct (vibration amplitude) values (were)  $< 25 \mu\text{m}$ . Therefore, the sun is shining today!!!” The final run values are shown in Figure 29. The compressor was shipped shortly thereafter for mechanical linkup with the gas turbine.
