## A SYSTEMATIC APPROACH TO CASE RECERTIFICATION

Dresser-Rand Turbo Products Division

### Case History

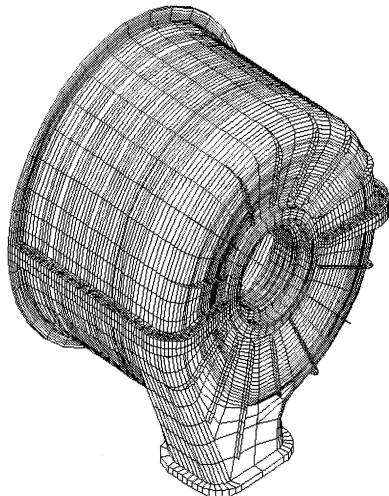
Figure 1. FEA Model of Discharge End of MTA 5124 Casing.

Only the discharge end was modelled. This model, illustrated in Figure 1, contains over 26,000 nodes and over 18,000 brick type (eight noded) elements. Beam elements, each with a 60,000 psi simulated preload, were used to represent the bolts connecting the upper and lower halves at the horizontal flanges.

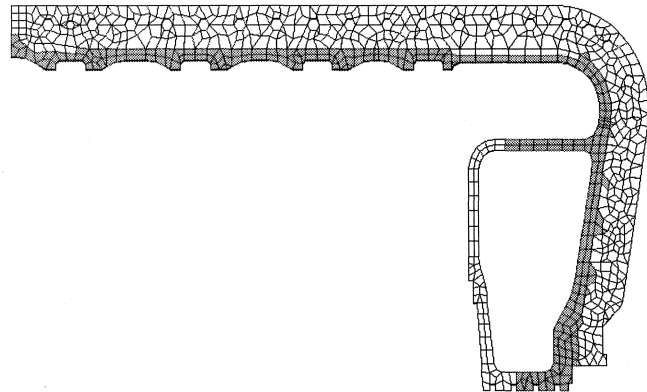
In general, the highest stresses occurred on the discharge end on the inside near the transition from the cylindrical to the end section. The calculated separation at the horizontal split resulting from the 72 psig pressure is shown in Figures 2 and 3. The darker shading shows areas of expected separation. These Figures show that small areas of leakage are possible at the casing discharge end.

Figure 2. Separation of Casing at Horizontal Split Line—Right Side as Viewed From Discharge End. Darker shading show areas of separation.

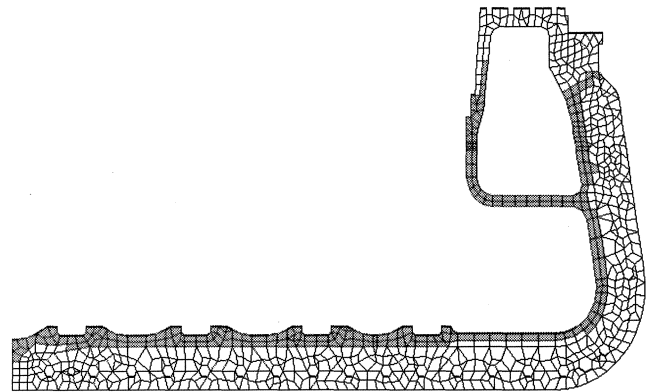
Figure 3. Separation of Casing at Split Line—Left Side as Viewed From Discharge End. Darker shading show areas of separation.

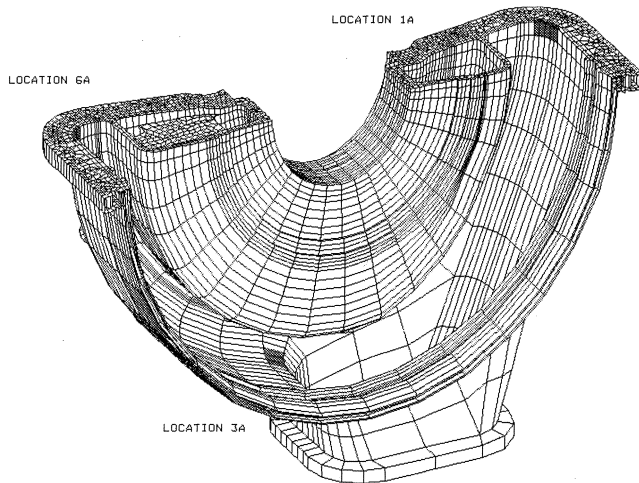
Figure 4. Strain Gauge Locations 1a, 3a, and 6a on Lower Discharge Case.

The seven locations at which strain gauges were placed are shown in Figures 4, 5, 6, and 7. Five of the seven locations were on the inside of the discharge case. Strain rosettes were placed at these five locations to provide 2-D Von Mises stresses in the plane of the surfaces that they were bonded to. Locations 1a and 6a, shown in Figure 4, are on opposite sides of the lower case, at the transition from the cylindrical to the end section (i.e., the most highly stressed portions of the lower case), at the horizontal split plane flange. Location 3a, also shown in Figure 4, is inside of the lower discharge case, at the nozzle to casing body transition. This is the most severely stressed corner of the nozzle. Locations 11a and 16a, shown in Figure 5, are in analogous positions to Locations 1a and 6a inside of the upper casing, again at the horizontal split plane flange.

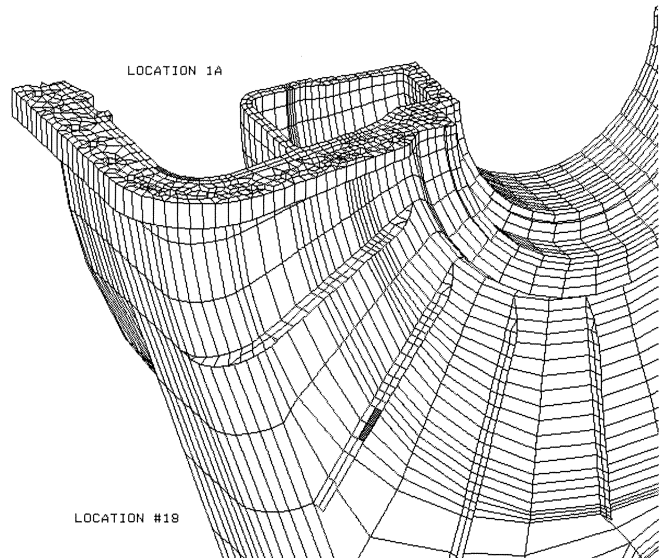
Figure 6. Strain Gauge Location 18: Stiffening, Rib Lower Discharge Case.

The sixth location, shown in Figure 6, is a stiffening rib location (identified as Location 18), which extends alongside the outside of

the nozzle. The finite element analysis identified this rib as the most severely stressed rib due to its dual role in a) stiffening the end of the case from outward expansion and b) acting as a load path for nozzle loads. A uniaxial strain gauge was bonded there oriented to measure "length direction" strains.

The large difference in results for gauge 18, which was on a casing rib, were suspected to be caused by the weight of the liquid which had not been included in the analysis. Considering the possible contributors to stress differences mentioned previously, and the general difficulties in comparing analysis to test results, the above correlation was considered to be good.

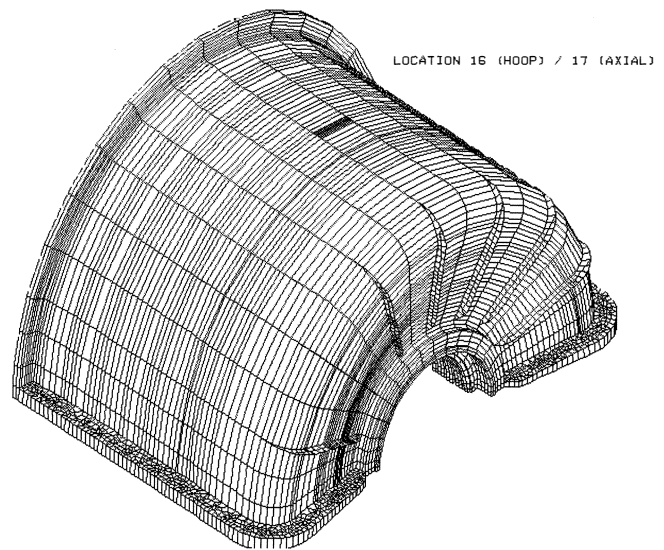
Figure 7. Strain Gauge Location 16/17: Calibration Point, Upper Discharge Case.

A seventh, non-stress critical, calibration point was also selected. Location 16/17 was selected for this purpose and is shown in Figure 7. At this location, two uniaxial strain gauges were placed and oriented to measure handbook predictable hoop/axial direction (cylindrical shell type) case stresses. Location 16/17 is 44.5 in from the vertical split at the top of the casing.

This comparison is shown in Table 1. Gauge 17 had failed, explaining the poor correlation of results at this gauge.
