# FATIGUE DAMAGE OF STEAM TURBINE BLADE CAUSED BY FREQUENCY SHIFT DUE TO SOLID BUILDUP—A CASE STUDY

## ABSTRACT

The case history is presented of a large steam turbine that experienced blade damage after about eight years of service. The probable cause and subsequent solution to the problem are addressed. A discussion of the metallurgical analysis of the damage, Campbell diagram, SAFE diagram and modal test results is provided. The damage is believed to have been caused by a solid build up at the blade root that shifted a natural frequency into an interference region, and changed the response characteristic of the bladed disk assembly.

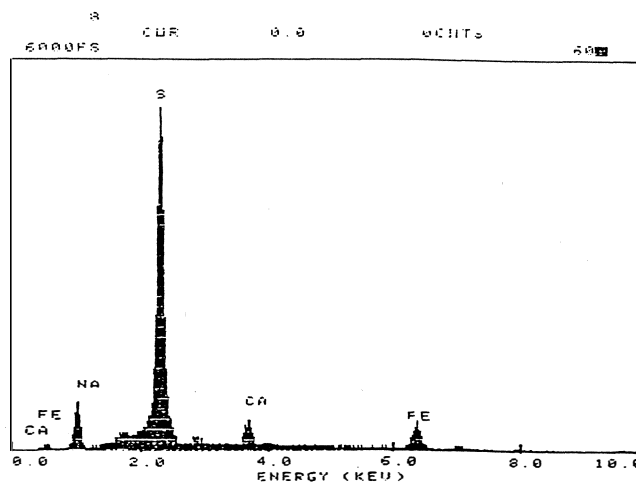
Figure 1. Low Atomic Number Material Decorating Airfoil/Wheel Rim Sample.

X-ray electron dispersive spectroscopy (EDS) analysis was performed on the deposit samples collected. The sample from the midspan of blade to shroud area indicated the presence of iron and noncorrosive metallic elements. The EDS analysis of the second sample from the base of the blade and wheel-rim area revealed the presence of sulphur, calcium and sodium. These elements produced medium to large peaks on the EDS spectrum. The deposit was also viewed as a back scatter image and the material showed patches of low average atomic number. A spectrum of low atomic numbers showed a significant quantity of sodium, as shown in Figure 1. Sodium is considered to be an aggressive corrodant causing stress corrosion cracking. Chlorine was not discovered, even though pitting was observed on the fracture surface. However, a similar analysis done at an earlier time revealed the presence of chlorine but not sodium. A chemical analysis of the material taken from blade 123 is shown in Table 1. Hardness testing and microstructure analyses confirmed that the blade material met the required specification.

was investigated. The solid buildup at the blade roots and wheel juncture could have resulted from an approximate one week period when the turbine was being operated on steam that was being desuperheated by a secondary makeup water source which contained some chemicals. This occurred one year before the blade damage.

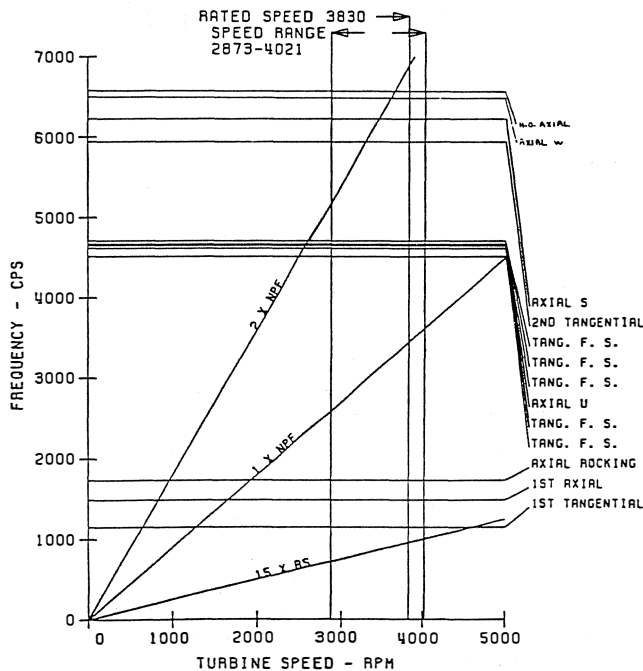
Figure 2. Campbell Diagram of Original Design Using NASTRAN.

During an uprate of this machine in 1983, Campbell, SAFE and Goodman diagrams were generated. These are provided in Figures 2, 3, and 4. Review of these diagrams shows that there are no interferences between low harmonics of the running speed (up to 15 times running speed) and any of the blade natural frequencies. These diagrams also show no interference between the one times nozzle passing ( $1 \times$  NPF) excitation and the blade frequencies. The Campbell diagram shows many interferences between  $2 \times$  NPF excitation and the higher order modes of the

blade. However, the SAFE diagram shows only one interference. This interference is between a higher order axial mode. Since higher order NPF excitations are weak, the calculated stress levels are low. The calculated factor of safety was higher than that required by the applicable design guideline.

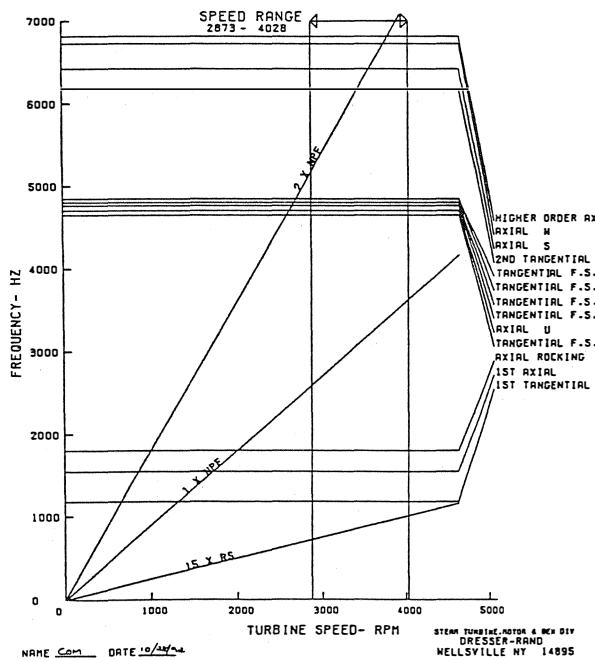
Figure 5. Campbell Diagram of Original Design Using ANSYS.

The finite element program "NASTRAN" was used to calculate the natural frequencies at the time of the uprate in 1983. The analyses conducted during this investigation were performed by a general purpose finite element program "ANSYS" [3] and a finite element program "TBDYNE" [4] purposely developed for analyzing blades and bladed disk systems. A packet containing six blades was modelled in "TBDYNE" and the Campbell and SAFE diagrams generated based on the results are shown in Figure 5 and 6, respectively.

with those of Figures 5 and 6 show insignificant differences in the natural frequencies. The SAFE diagram of Figure 7 shows basically the same results except at the low order modes where the disk's flexibility plays a major role. Therefore, the analytical

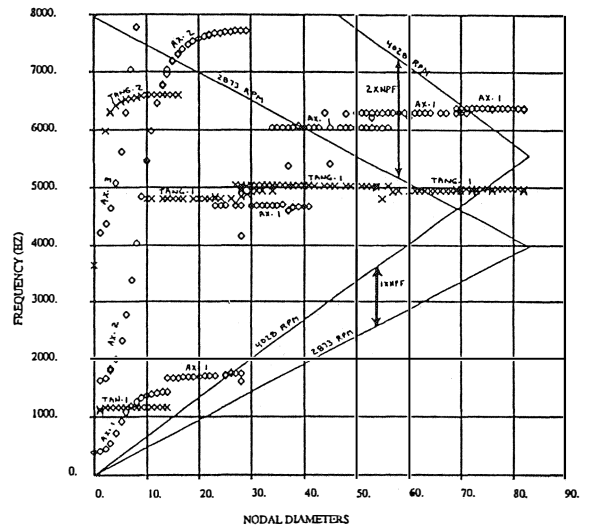
Figure 7. SAFE Diagram of Original Design Using ANSYS for Complete Bladed Disk.

generated, based on the results of this analysis, is shown in Figure 7. A typical axial vibration mode of the bladed disk system is shown in Figure 8. This mode is identified as a three nodal diameter mode (3ND). This nomenclature of identifying mode shapes of a bladed disk system is described by Dello [5].

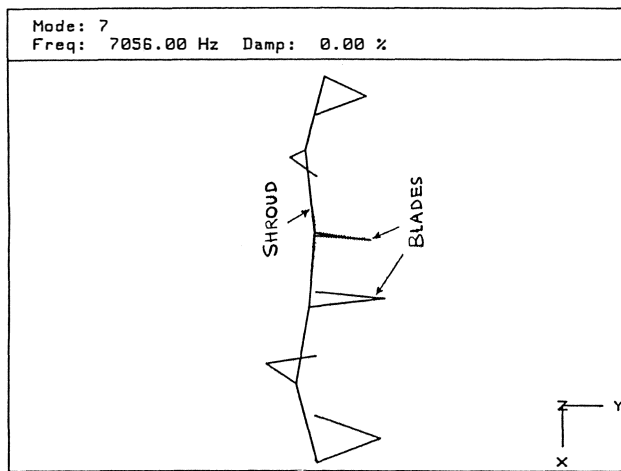
Figure 15. Axial "W" Mode Shape of a Packet.

nodal diameters and nodal circles content of a mode shape. Some representative frequency response functions (FRF) from the modal test are provided in Figures 11, 12, and 13. Two mode shapes of a single blade packet are shown in Figures 14 and 15. In Figure 14, the displacement is in the tangential direction with the displacements of all blades in phase. This mode is called the first tangential mode. The mode shown in Figure 15 is an axial "W" mode. In this mode, the displacement is in the axial direction and the shape of the displaced shroud band is in the form of a "W." The mode shape shown in Figure 16 is that of the rim of the disk. The displacement shows the characteristic of a  $\sin 2\theta$ . This mode is known as a two nodal diameter (2ND) mode. Experience with modal test results and their correlation with analytical predictions have been good, particularly for a single blade and a blade packet. In the case of packeted bladed disks, the correlation for well spaced modes has, in general, been good. However, for high density modes, although the natural frequency correlation has been acceptable, the precise definition of mode shapes poses some difficulty. The shape has been identified qualitatively which matches with analytical prediction.

- There is a possible shift in the blade resonant frequency due to solid buildup.
- No resonance is predicted at operating speed without this shift.
- The location and direction of cracks match with the axial "W" mode shape.
- Failure was due to high cycle fatigue.

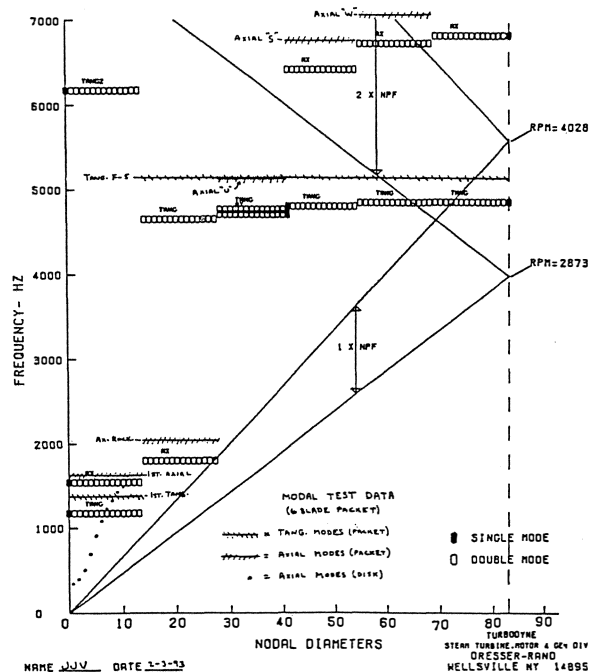
Figure 17. SAFE Diagram of the Original Design with Test Data.

results overlaid on the analytically predicted results for a six blade packet (as shown in Figure 6). The experimental results are consistently higher than the analytical results. All the analytically predicted and experimental results are listed in Table 2. Past experience of the correlation between analytical predictions and experimental results has been very good. However, such difference has occasionally been observed. This difference is due to a change in the root attachment boundary conditions with time. The clearance between the blade root and the disk groove is small, and steam deposit build up or a material corrosion/oxidation build up can fill these clearances. This can stiffen the support of the root in the groove, and hence raise the blade frequency. To investigate this possibility, a dynamic analysis was performed to see how sensitive the blade frequency is to changing root conditions. The results are listed in Table 3 for different root support conditions together with the results of the modal test. This comparison shows that the modal test results fall somewhere between the blade root being considered at the standard location (upper root lock) and the wheel outside diameter. It seems plausible that the solid deposit build up in the root could have contributed to this condition and raised the blade frequency.

The turbine at the time of damage was reported to be running at 3930 rpm. Examination of the SAFE diagram (Figure 17) indicates an interference of the blade frequency of the axial "W" mode with  $2 \times$  NPF at 3930 rpm. In summary, the following conclusions can be drawn

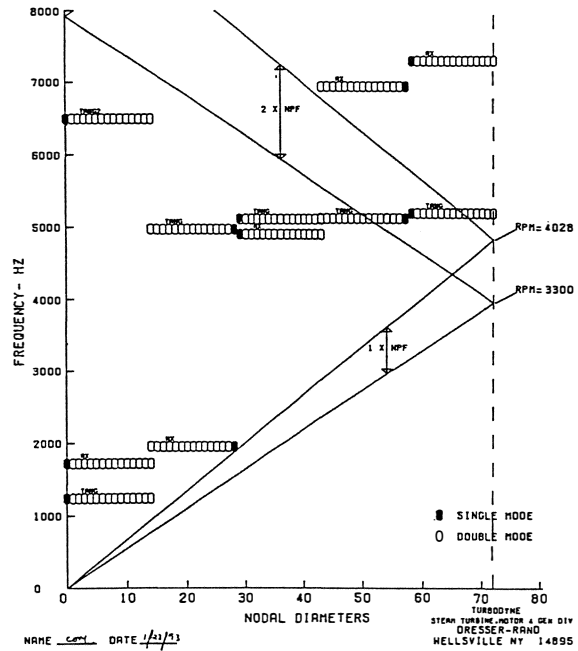
Figure 18. SAFE Diagram of the Replacement Blade.

To make the stage more reliable for future operation, it was decided to design a blade without this sensitivity to change in resonance condition. This was achievable either by changing the number of nozzles or by redesigning the blade to change the natural frequency. A decision was made to change the airfoil to offer more reliability and provide better stage efficiency. The SAFE diagram of this design is given in Figure 18 with a minimum operating speed of 3300 rpm rather than 2870 rpm as originally specified. This is due to the fact that a change in the minimum operating speed was anticipated for future operation.

Finally, for the replacement blade, the same analytical tool was used to evaluate its reliability. The SAFE diagram shows no resonance with  $2 \times$  NPF excitation.
