RETROFIT OF A STEAM TURBINE WITH DRY GAS SEALS

The solution to a chronic utility problem, with a critical natural gas compression unit, at the Ammonia plant at Du Pont's Beaumont, Texas facility, is described. The most critical problem, chronic steam leakage from the turbine and subsequent oil system contamination, was corrected by the installation of noncontacting spiral groove seals. In addition, vibration problems caused by coupling lockup and subsequent premature coupling failure were solved by replacing the grease lubricated gear type coupling with a nonlubricated flexible coupling. A feature of the coupling is a keyed hub, designed for hydraulic removal.

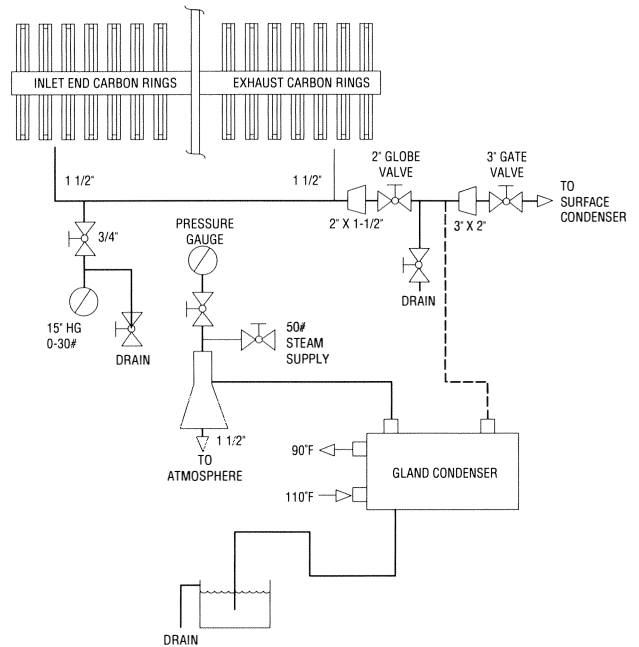
Figure 3. Schematic of Leakage System to Gland Condenser.

ring seals with a leak off line to a gland condenser, as shown in Figure 3. Typically, carbon ring life is short in high back pressure service. It was not uncommon for the leakage rate to be excessive after running only one week. Every time the plant came down, there was a standing repair order to change the carbon seal rings. These costs are detailed later.

- Safety hazard from steam leakage causing potential personal injury.
- Steam seal leakage that produced water that contaminated the oil system.
- Shaft damage from carbon rings rubbing on the shaft.
- Vibration problems from poorly fitted carbon rings.

- Reduced life for the gland seal condenser from excessive moisture impingement.
- Lockup and wear of the coupling, due to centrifuging of the lubrication causing premature failure.
- Damage to the compressor seals on account of water contamination of the lube/seal oil console.

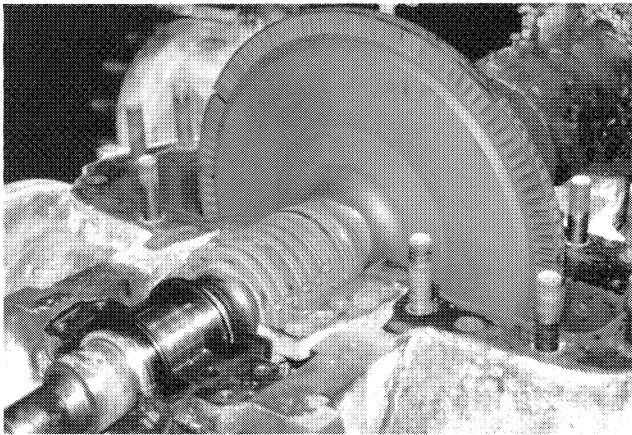
Figure 6. Turbine with Original Carbon Rings.

- Several oil passages in the case were about 50 percent blocked by buildup of debris.
- Varnish deposits were found on parts caused by oil breakdown.
- Numerous carbon rings in the original gland seal packing boxes were broken. (Figure 6.)
- The carbon ring boxes were eroded on the down stream side of the sealing area.
- Bluing of the horizontal split casing showed little contact in the gland face area.
- The trailing edges of the nozzle block vanes were very thin from erosion with some sections missing.

These deficiencies came as no great surprise, since this was the first time this machine had been removed and case inspected since installation in 1963.

In order to return the turbine to original design specifications the following work was performed, although no special machining was required to adapt these seals for this installation.

- Majority of sealing faces were refinished.
- Case horizontal split was ground.
- Inlet and discharge faces were machined.
- Trip and throttle valve faces and valve seats were machined.
- Eroded nozzle block was corrected by weld overlay.
- Other deficiencies were corrected as needed.

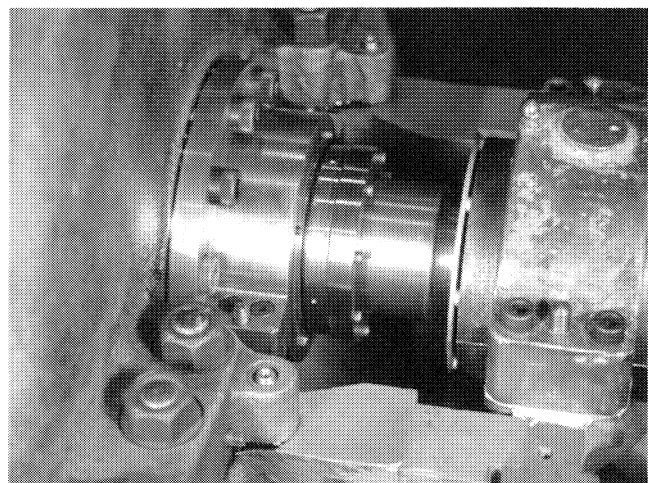
Figure 8. Completed Installation of Dry Steam Seal.

The machine was returned to the plant after the new dry coupling was installed. The machine was reinstalled on schedule, and the unit was started up. The seals have operated virtually trouble free since plant startup. There was no way to measuring seal leakage, except to place a flag (tubing with a rag attached to it) in the area

of the seal and detect no movement, collection of condensate, or other indications of leakage.

- The upper case was then removed. All accessories were removed from the rotor and the seals were installed on the rotor. The rotor was set in the case, the seals located and secured (Figure 8), and the turbine assembly was completed.
