TEMPORARY REPAIR OF A LARGE AXIAL BLAST FURNACE MOTOR-BLOWER AS A SOLUTION FOR A STEEL MILL OPERATIONAL CONTINUITY

Luiz Fernando Salgado Mendes

Promentec Ltd.

Ernesto Jose Meduna

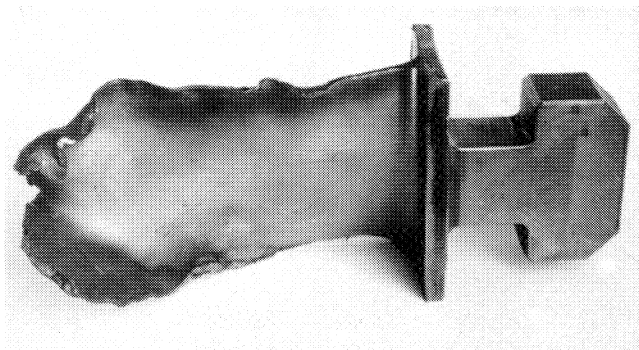
Figure 4. View of a Damaged Airfoil of a First Stage Blade.

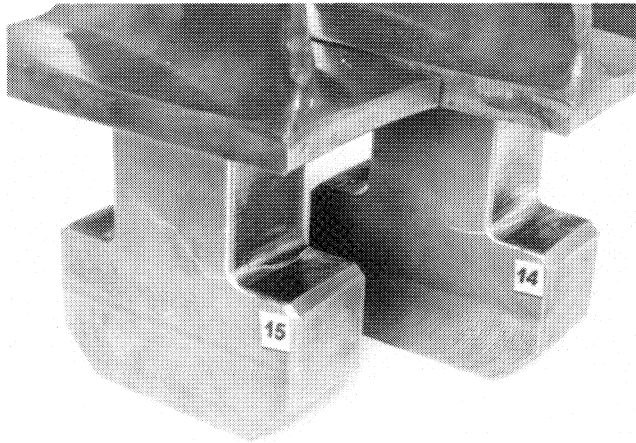
surfaces and propagated transversely across the root neck (see Figure 7). Micrographic analysis also indicated that several other microcracks existed on those surfaces.

Figure 7. View of Cracks in Blade 14 of First Stage and Blade 15 of Second Stage.

The fretting that resulted was most likely due to a process in which the initial blade close clearance was slowly increasing with time, allowing the increase in the relative movement. The crack propagation was then due to fatigue process caused by the combination of high static centrifugal load and the variable stresses due to blade vibration. The blade root surfaces were showing a poor finishing, as there were clear machining marks and irregular surface roughness in the original blades (Figure 8), and this problem certainly made conditions favorable for fretting to occur. The spare blades in stock had been recently ordered by the steel company, and the surface finish of the root surfaces was superior, when compared to the original blades.

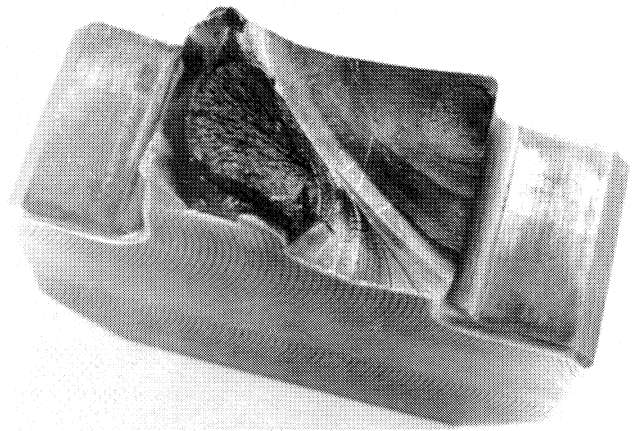
Figure 8. Machining Marks in a First Stage Blade Root and Typical Fractured Neck.

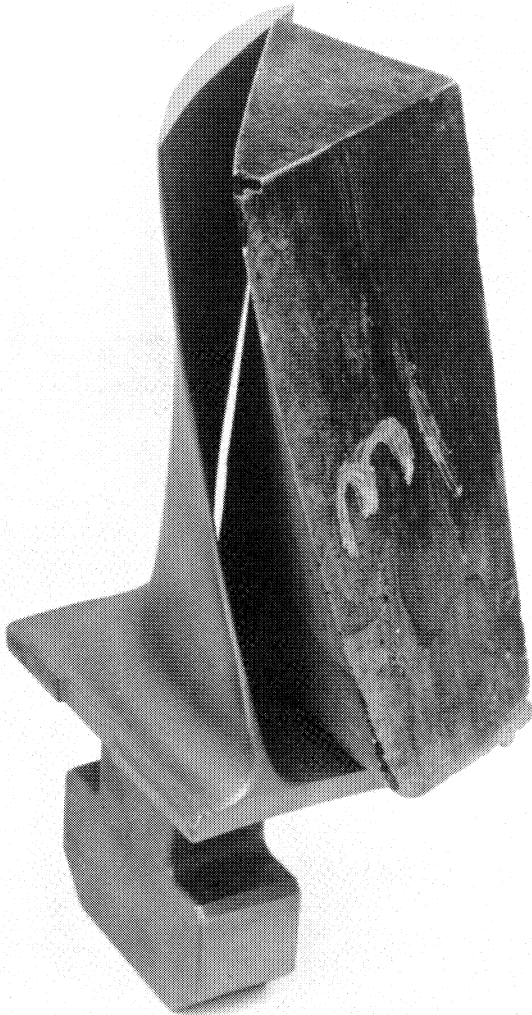
Figure 9. Template and Repaired Blade.

Damaged blades were first mechanically straightened and the original profiles were manually restored by trained personnel, using templates specially prepared, based on the shape of new blades (Figure 9). In particular, the smoothness of the curvatures and the angles of leading and trailing edges were carefully controlled to keep them as close as possible to their original values. To make this possible, a "production line" was prepared, and each individual blade was selected and repaired in accordance with the classification previously made to avoid working on excessively damaged ones.

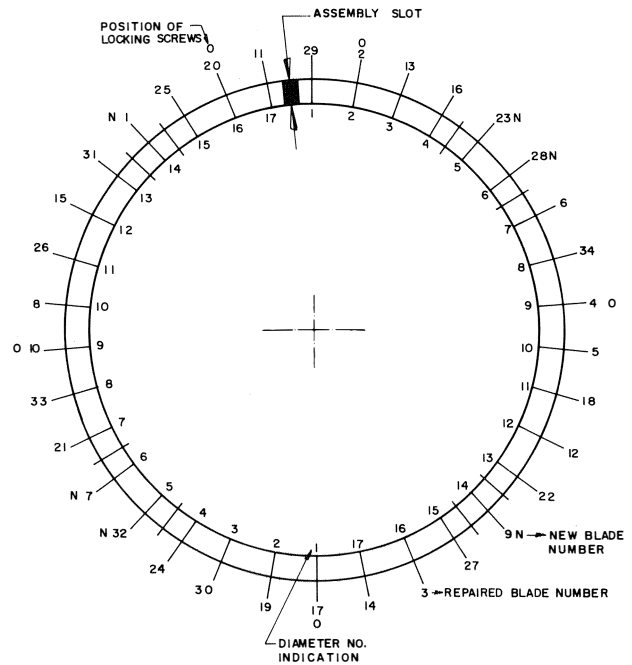
Figure 10. Example of a Weight Distribution Sheet for Rotor Blades.

The repaired and new spare blades prepared for each of the rotor stages were carefully weighed to a tolerance of one gram, and groups of blades were made to arrange equal weight blades in opposite sides on the mounting grooves in order to minimize final unbalance due to weight distribution around the rotor (Figure 10).
