EMERGENCY TURBINE REPAIR PROCEDURES

Emergency repairs of a cracked steam turbine disc can be accomplished effectively by using sound basic engineering principles. One such method used to expedite a repair is reported.

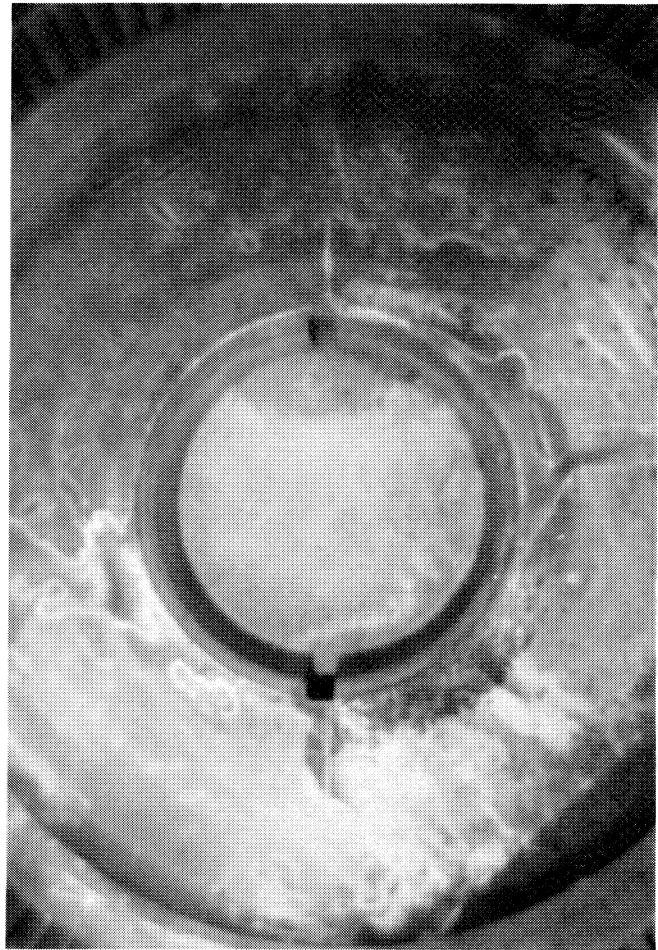
Two ratau wheels fully bladed and 21 in diameter, operating in a turbine at 600 psig, 680°F, 3500 hp, 150 psig exhaust, and 3000 rpm experienced singular cracks at each keyway (Figures 1 and 2). Availability of a spare rotor or spare discs was not expedient at the time, necessitating an expeditious solution for the problem.

Figure 1. Single Cracks at Both Keyways.

- drop affected wheels
- acquire test specimen of material and have analyzed
- use wet metal particle to examine and determine extent of cracking and crack lengths
- bore out cracked area to sound metal and recheck for cracks (wet mag particle)
- purchase and machine a “do-nut” of suitable material to replace the cracked portion that was bored out. (A “do-nut” is a cylindrical piece of metal slightly thicker than the wheel being repaired and having inner and outer radii close to dimensions required for final repair).
- determine hardness of wheels at different representative locations.
- heat treat rough machined “do-nut” to acceptable hardness and weld to disc
- recutting the keyway is not recommended...rather, install blanks in the shaft and shrink on repaired wheels.

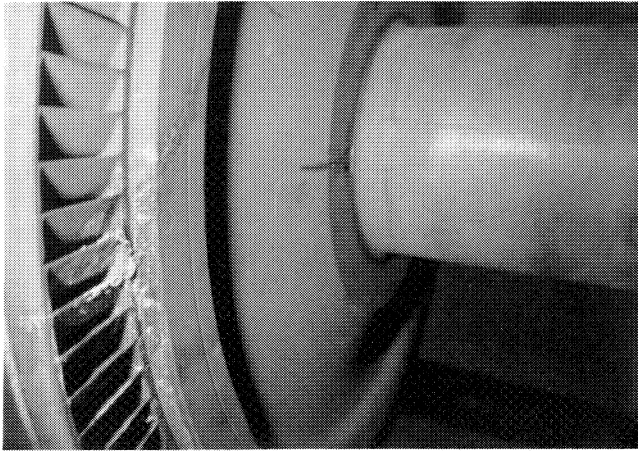
Figure 2. View of Crack.

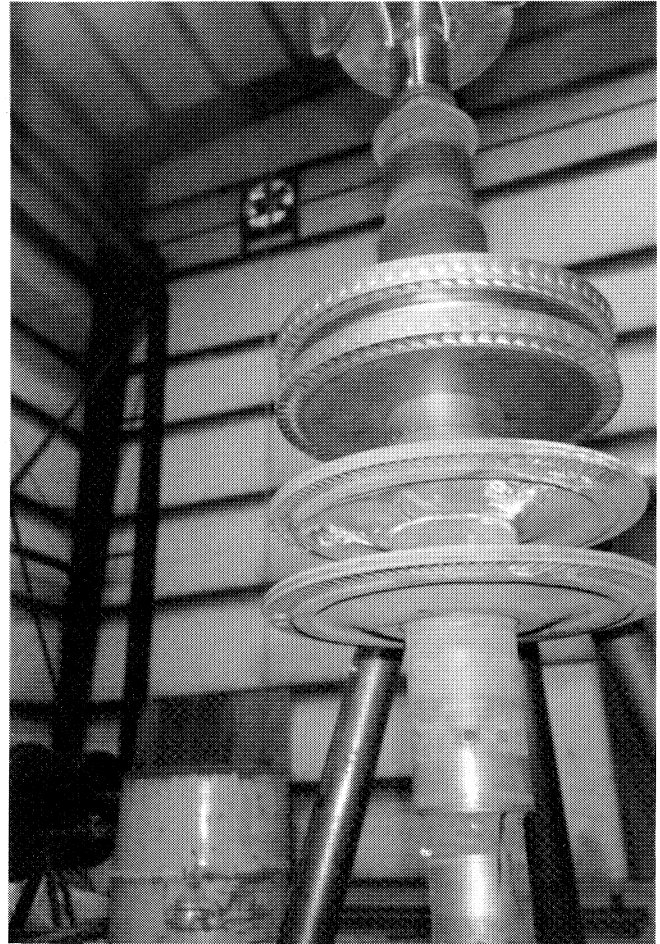
The rotor depicted in Figure 3 showed clearly visible damage. A closer view of this is portrayed in Figures 1 and 2.

Figure 3. Rotor Before Unstacking.

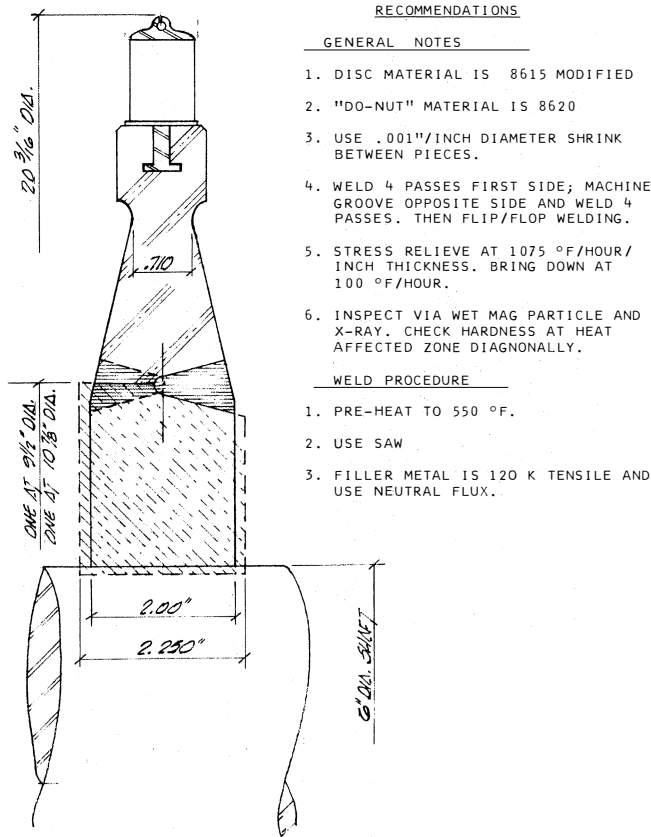
Figure 4. Cross Section of Turbine Disc.

Material of construction of the original discs was 8615 modified. The closest material available was 8620. Thorough review was made after purchasing this material and roughing out. It was sent to heat treating to match hardness of existing disc. The disc checked out at Rockwell C (Rc) 24/27 at the hub area. The “do-nut” came back at Rc 28/30, but losing some hardness was anticipated, because of oversizing for final machining. As shown in Figure 4, two different size “do-nuts” were required. They were shrunk and machined on one side only. After welding one side (procedures on Figure 4) with four passes, the discs were machined on the other side into the new weld to ensure full penetration. Welding was accomplished by four passes and then flip/flopping the disc to minimize distortion.

repair shop agreed to 0.0022 in to 0.0025 in/in of diameter shrink was sufficient to achieve the desired fix.
