## MAJOR REVAMP AND RETROFIT OF IDENTICAL PROCESS COMPRESSOR TRAINS

Standard Oil Chemical Company

Port Lavaca, Texas

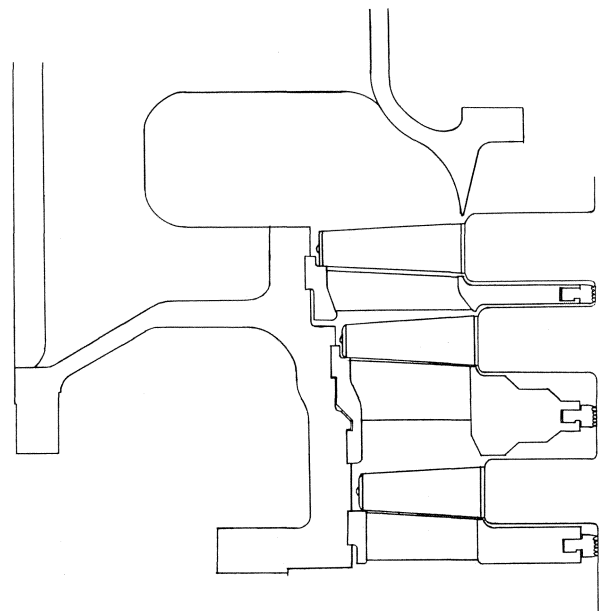
Figure 7. Expander Diaphragm Cross Section. (Note that the second stage diaphragm bridges two diaphragm slots).

Mechanically, only the rotors and diaphragms were changed (see Figure 6). The casing, bearings, and labyrinth seals remained the same. Three new integral three stage rotors were manufactured, two for the process trains and one common spare. Two new sets of diaphragms were also manufactured. Although the rotor and diaphragms fit into the same relative envelope, the changes were quite significant. The blades for the new rotors had a cross section roughly eight times larger, were longer, and considerably stronger than the originals. Blade material is 403 stainless steel. There were less blades on the new rotor, approximately 60 per stage. The blades were riveted into a shroud, five or six to a packet. The number of stationary blades also decreased while the flow area increased several times. Only one casing modification had to be made. One internal circumferential shoulder had to be manually ground off at a 45 degree angle to accommodate the middle diaphragm (Figure 7).

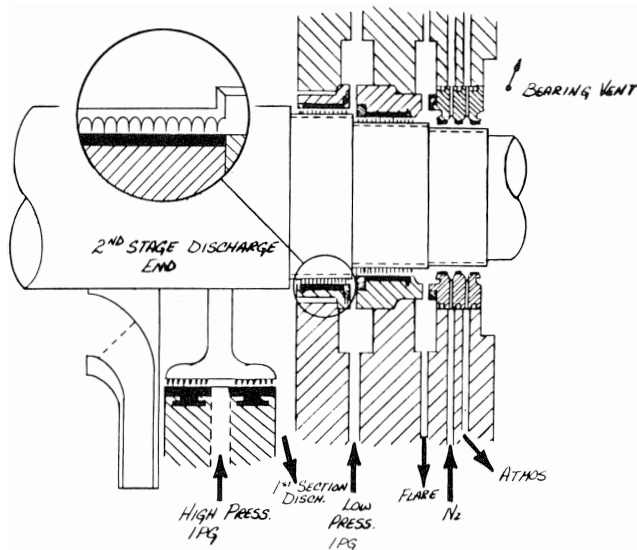
Figure 8. Process Compressor Discharge End Seal System Modification.

A number of problems were experienced with this seal system: erosion of the Fluorosint 500® labyrinth teeth; high nitrogen costs; higher than expected buffer gas flows; and, high maintenance replacement cost. In one case, loss of a seal resulted in the contamination of the lube oil system with solids from the process gas. Another problem was the buildup of solids between the stationary labyrinth teeth. Solids would harden and actually cut into the stainless steel shaft sleeve.

the inner bore lined with smooth, replaceable Fluorosint 500® inserts. Second, rotating labyrinth teeth were added to the shaft sleeve design. The rotating steel labyrinth teeth were more durable than the stationary Fluorosint 500® teeth. This design is less susceptible to erosion damage and accumulation of solids buildup. Third, all diametral clearances were reduced to the minimum required for assembly purposes. Since the Fluorosint 500® is an abrasible material, diametral clearances were reduced from 0.012 in to 0.004 in. The clearance under the aluminum labyrinth was also reduced from 0.016 in to 0.008 in (and was later opened back to 0.015 in. These new clearances were discussed with the manufacturer prior to manufacture and installation. Rubbing of the rotating teeth against the Fluorosint 500® inserts was evident on initial startup during slow roll, but quickly dissipated as the inserts abraded.

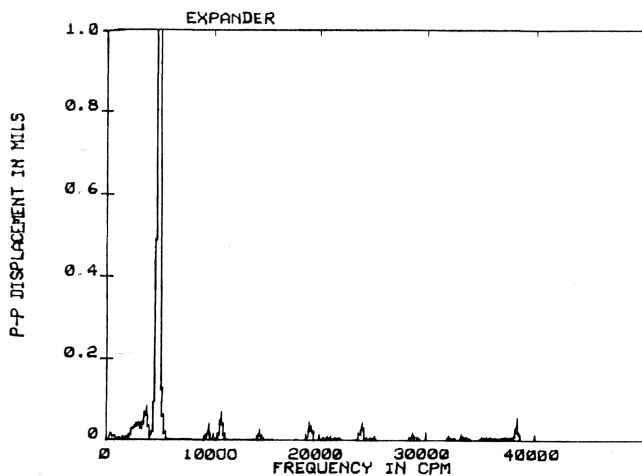
Figure 11. Expander Vibration Spectrum.

While still slow rolling, expander vibration began to increase. The increase was almost logarithmic with time, slowly increasing from 0.21 mils to over 5.0 mils in a few seconds to trip the train. Several attempts at startup were made, all with the same ramping vibration pattern. The FFT analyzer showed virtually all of the energy was concentrated in a long thin pulse at running speed (Figure 11). The speed of the compressor was changed, but the amplitude of vibration appeared independent of rotating speed. Audible noise and noise heard through an ultrasonic listening device indicated a hard rub. Inlet and outlet piping supports, spring hangers, and slide plates were checked for freedom of motion and found to be free. As a final measure, 50 lb cooling steam was injected into the inlet. This lowered the inlet temperature gradually to 500°F from 670°F. As the temperature of the inlet gas dropped, so did the vibration. With the expander running smoothly at 0.6 mils, speed was brought up to minimum governor, 4000 rpm. Inlet temperature was then slowly raised by about twenty degrees an hour until 750°F, the maximum allowable inlet temperature, was reached. Vibration stayed at below 0.6 mils throughout the temperature changes, finally settling out at 0.3 mils. Subsequent startups revealed that the expander vibration was sensitive to the rate of temperature increase. A teardown inspection of the internals in August revealed very hard shaft rubs along the bottom inlet end seals. A new operating procedure was drafted to bring inlet temperature up slowly.

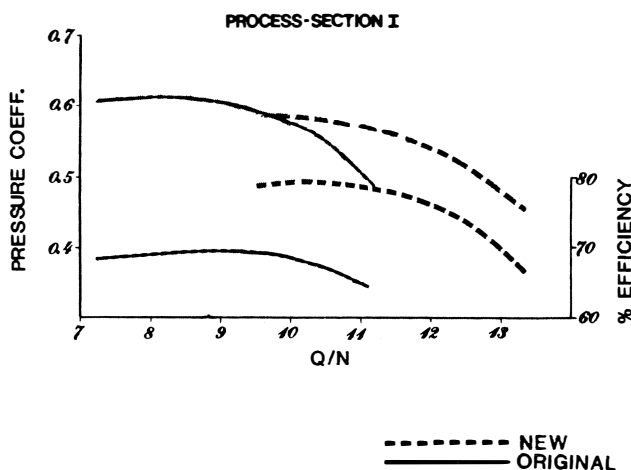
Figure 12. Process Compressor Expected Performance Curves.

The process gas compressor performance was also in question due to the actual data's relation to the expected performance on the pressure coefficient and efficiency curves (Figures 12 and 13). The most obvious problem was that inlet temperature was much higher than expected, boosting the actual cubic feet per minute ACFM significantly along with the corresponding horsepower required. Chemical cleaning of the suction coolers at the first opportunity solved that problem. The performance engineer also stated that the open impeller appeared to have a ten percent larger capacity than expected. This tended to lift actual data above the pressure coefficient curve. In addition, the higher calculated efficiency was due to liquid entrainment. Liquid entrainment has a positive effect in that evaporation of

liquid particles in the stream acts like an intercooler increasing calculated efficiency. However, film evaporation of liquid on the thermowell can distort discharge temperature readings to well below thermodynamically expected values. The performance engineer stated that although there was a net increase in performance, as supported by the net horsepower balance, the real efficiency and pressure increases were much lower than the calculations indicated. He also stated that he had no way of quantifying actual compressor performance for our two phase flow. The final conclusion was that the compressor was performing better than expected. Exactly how much better is not known. A strain gauge torque meter would give the best definition of actual horsepower, but was viewed as an unjustifiable cost.
