FAILURE OF TURBOMACHINERY COMPONENTS

by
Paul Lowden
 Metallurgist
 and
Joseph Liburdi

President
 Liburdi Engineering, Limited
 Burlington, Ontario, Canada

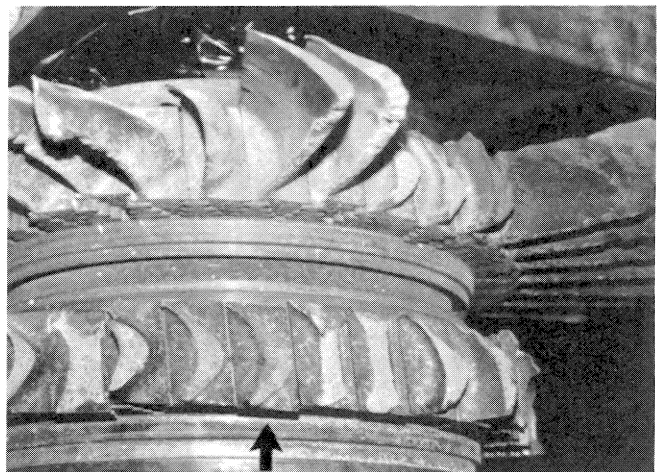
The first task of the metallurgist is to sift through the wrecked or cracked components looking for the piece that started the event, so that the laboratory analysis can be performed on the most significant (representative) fractures. This is often accomplished by visually reviewing both the overall appearance of the wreck as well as examining individual pieces for evidence of prior cracking (Figure 1).

Figure 1. Blade Root Section (Identified by the Arrow) Chosen for Analysis Due to Its Discoloration. This blade was found to have failed in creep, causing the remainder of the damage.

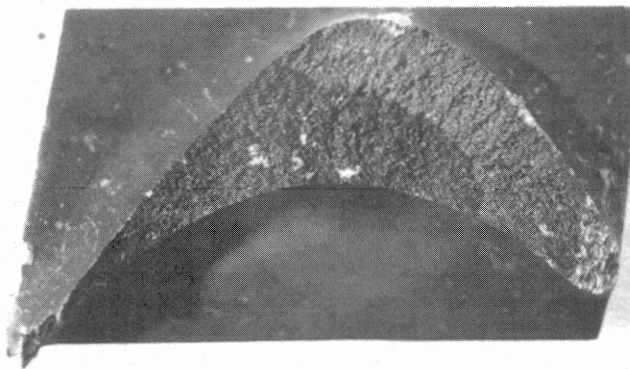
A creep crack which has grown to failure generally exhibits at least two distinct regions corresponding to the initial creep crack and the final overload zone. Optically, the creep region is characteristically discolored by oxidation, while the overload zone has a bright metallic appearance (Figure 2). More detailed examination by a scanning electron microscope (SEM) clearly reveals the intergranular nature of the cracks and, in many cases, grain boundary voids which have not linked to the crack are evident at the edge of the creep zone (Figures 3 and 4). The voids will grow and link to the crack.

Figure 2. Fractured Blade from the Wreck Shown in Figure 1 After Cleaning. The original creep crack area is clearly marked by discoloration caused by oxidation. The lighter region of the surface is the final fracture zone which failed by tensile overload.

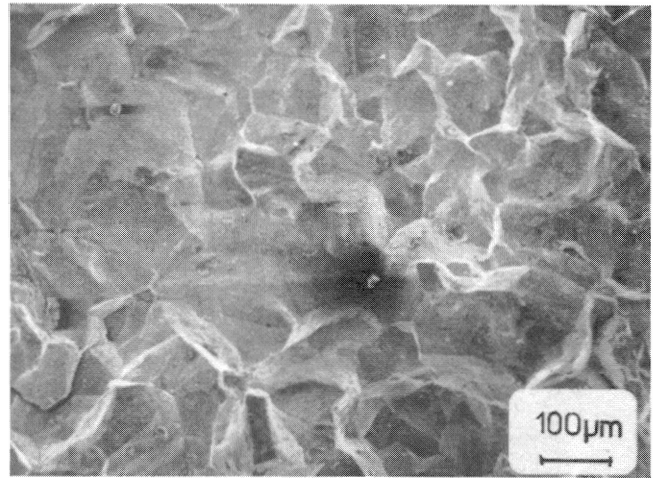
Figure 3. Creep Region of the Fracture Shown in Figure 2, Illustrating the Intergranular Nature of Creep Crack Growth.

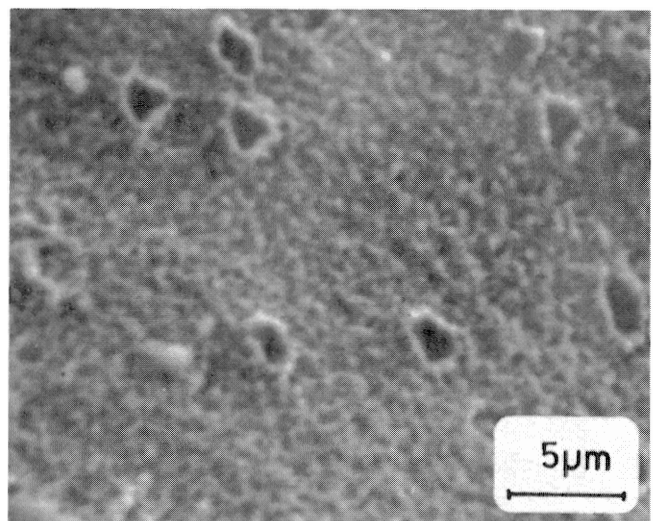
Figure 4. Voids Just Ahead of the Main Creep Crack in Figure 2.

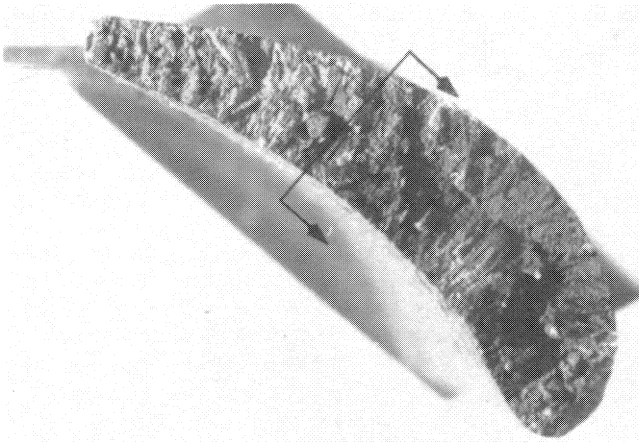
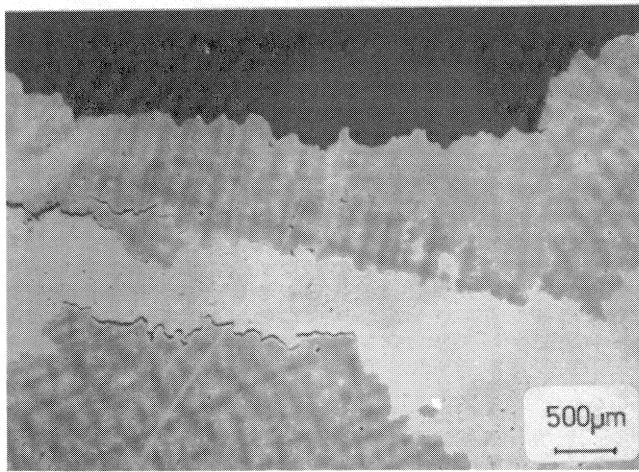
The formation and intergranular crack growth can also be identified in metallographic cross-sections removed through the crack or fracture (Figures 5 and 6). The cross-sections may also reveal the presence of multiple branching cracks running parallel to the main crack or fracture, which is another typical feature of creep cracking (Figure 5).

Figure 5. Photomicrograph of a Creep Fracture in a Cast IN738 Alloy Industrial Turbine Blade. The intergranular nature of the main fracture is clearly evident. The small secondary cracks running parallel to the main fracture are also intergranular creep cracks.

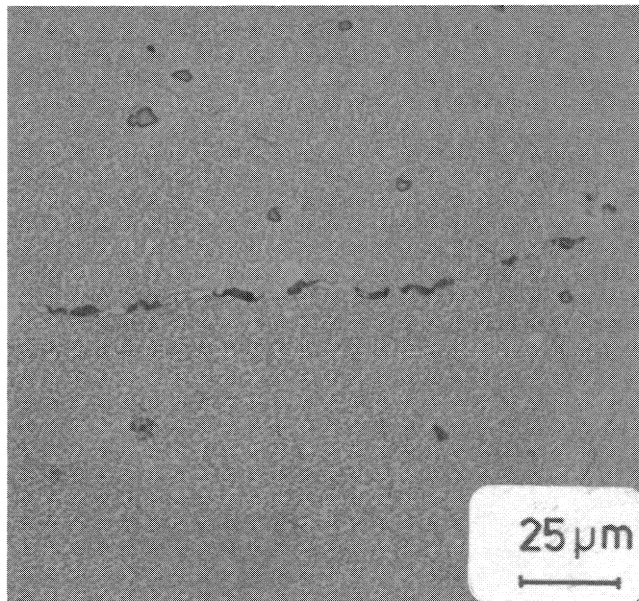
Figure 6. Photomicrograph of Intergranular Creep Cavitation Which Was Found on Grain Boundaries in the Cast Turbine Blade Failure Shown in Figure 5.

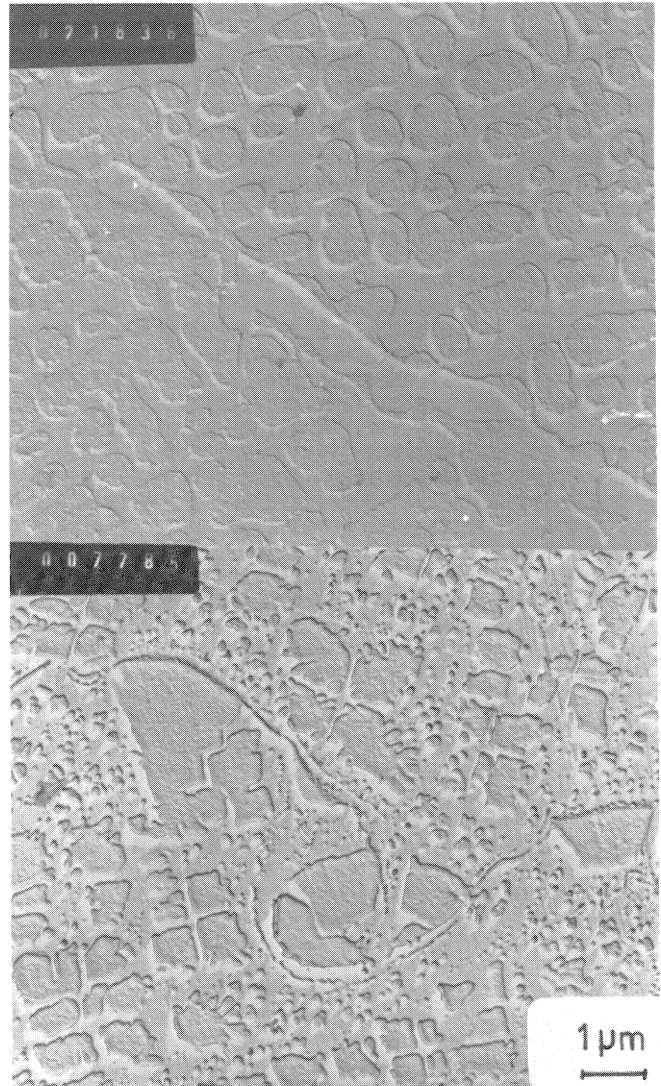
Creep failures are often accelerated by, or in extreme cases, even caused by overaging of the alloy microstructure. The precipitation hardened alloys used for the highly stressed hot section components are strengthened by second phase gamma prime particles. At the high operating temperatures of these components, the gamma prime particles can grow well beyond the optimal size present in the new components (Figure 7). The strengthening gamma prime particles in the service exposed material can change considerably with exposure. The large particles may become rounded and grow at the expense of the smaller particles, resulting in a measured decrease in the creep rupture life to as low as five percent of the normal test requirement. This can result in dramatic decreases in the creep resistance of the alloy and thus accelerate the accumulation of creep damage. Due to the extremely fine size of the gamma prime particles, such effects can only be detected through use of the transmission electron microscope (TEM).

Figure 7. TEM Photomicrographs Showing the Effect of Extended High Temperature Exposure. The top microstructure is from the failed blade shown in Figures 5 and 6 which had been in service for 30,000 hours. The bottom microstructure is from a new IN738 turbine blade.

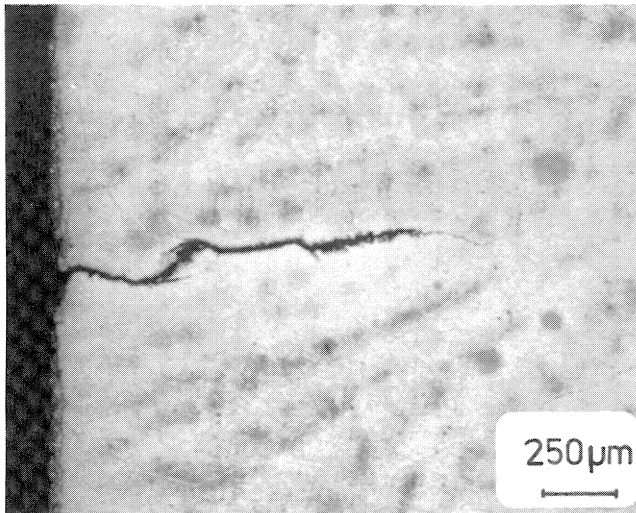
Figure 8. Photomicrograph of a High Temperature, Low Cycle Fatigue Crack Which Has Propagated in a Stationary Turbine Vane. The intergranular crack path is due to the strong creep component of the cyclic deformation at high temperature resulting in a creep-like crack.

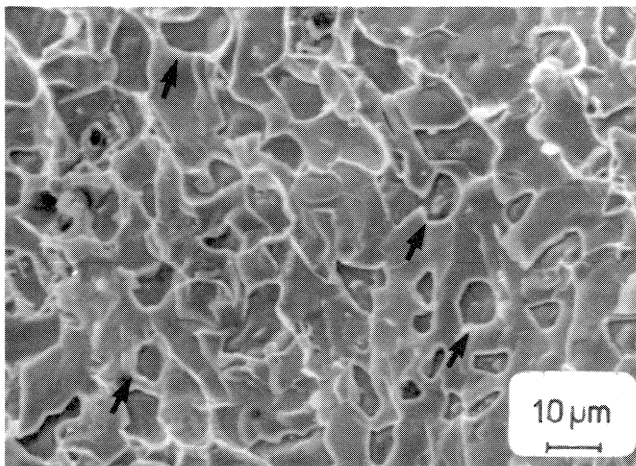
Figure 9. SEM Fractograph of Voids Formed by High Temperature, Low Cycle Fatigue in the Cracked Vanes Shown in Figure 8. The cavities are generally larger and more numerous than those formed by pure creep mechanisms, allowing the two modes of failure to be distinguished.

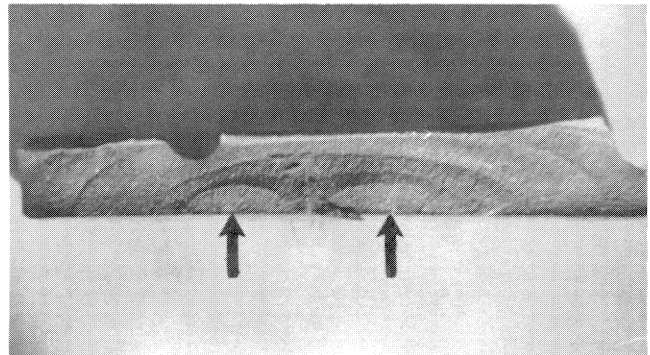
Figure 10. Typical Clam Shaped "Beach Marks" on the Fracture Surface of a Fatigue Crack through an Industrial Turbine Disc. Two cracks appear to have initiated (arrows) and grown together.

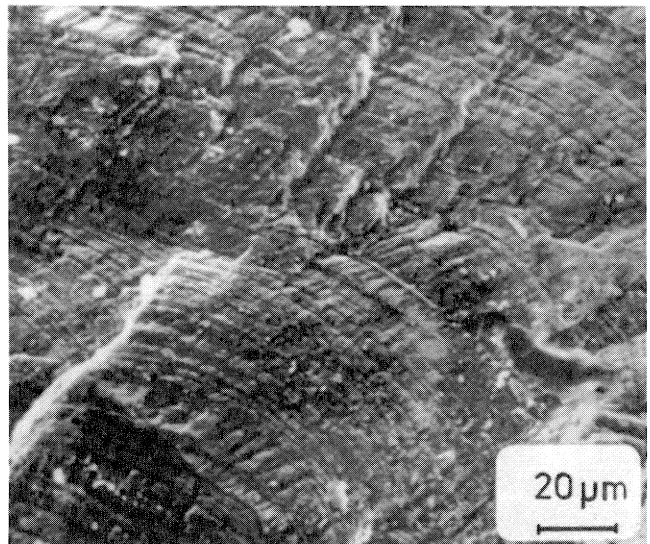
Figure 11. SEM Fractograph of Fatigue Striations on the Fracture Surface of a Failed Turbine Blade. The striations are formed perpendicular to the direction of propagation, marking the movement of the fracture front in each stress cycle.

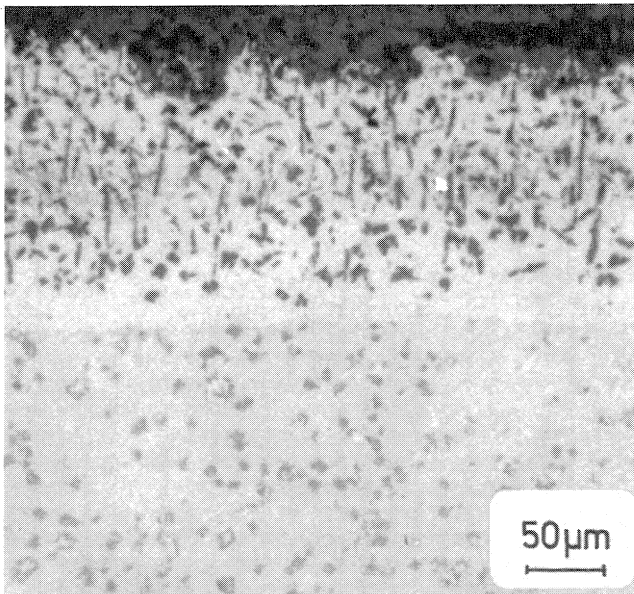
Figure 12. Photomicrograph Demonstrating the Oxidation Attack of a Turbine Blade.

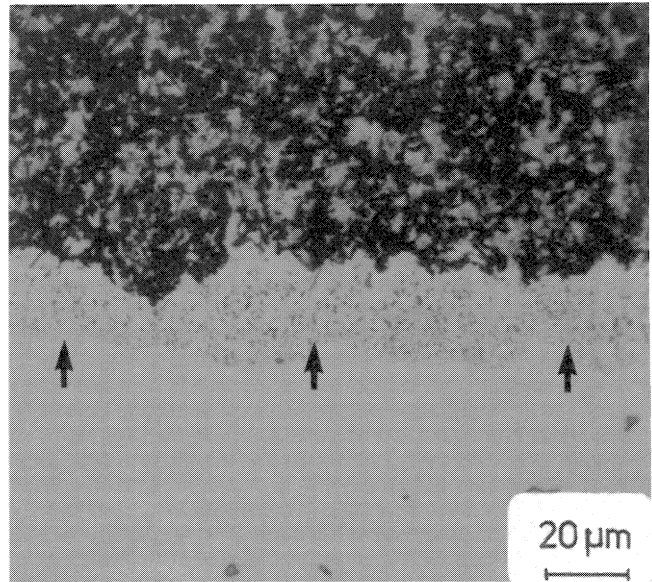
Figure 13. Photomicrograph Indicating the Sulphidation Attack of a Turbine Blade. Sulphur in the fuel reacted with the base metal to form the small globular sulphide particles evident in a band just below the scale. The reaction depletes the alloy of the elements required to form a protective oxide layer, thereby allowing oxidation to advance into the component as evidenced by the thick band of dark crystalline oxide which has formed.

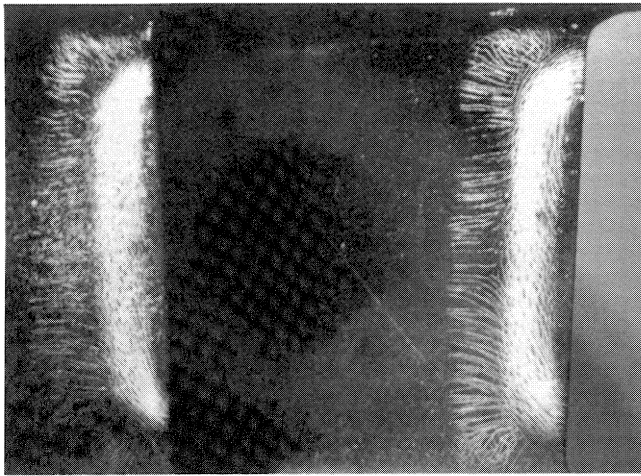
Figure 14. Pattern of Fine Cracks Found in the Coating of a Turbine Vane Segment as Revealed by Fluorescent Penetrant Inspection. The crack pattern is typical of thermal restraint cracking arising from rapid cycling and the difference of expansion coefficients between the coating and the base material.

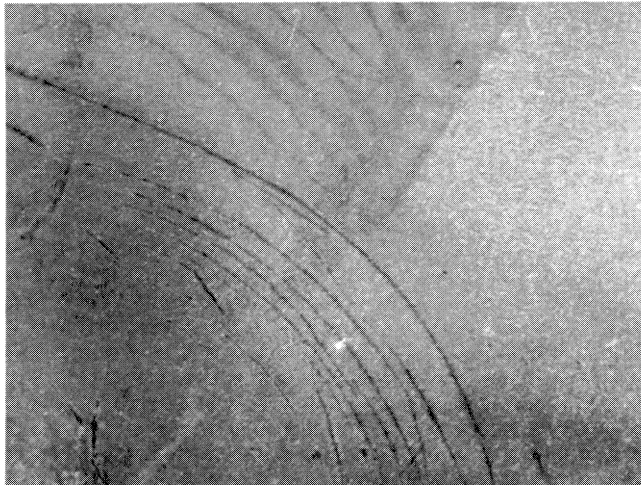
Figure 15. Typical Impact Damage Cracks in a Turbine Blade. The cracks form due to the poor ductility of the coatings.

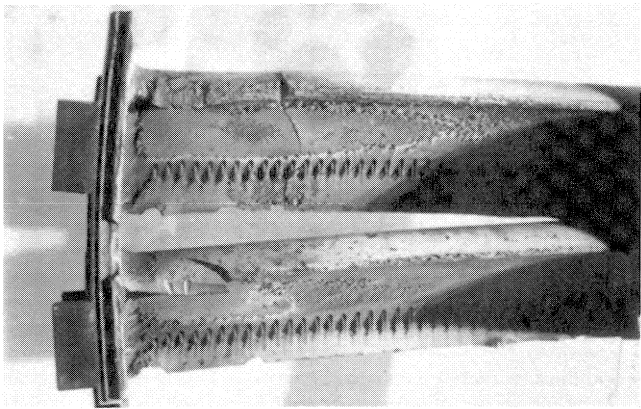
Figure 16. Severe Sulphidation Attack Which Resulted in Turbine Vane Segment Fracture After the Failure of a Protective Aluminide Coating in a Sour Gas Environment. Due to the severe loss of metal thickness from the environmental attack, some thermal fatigue cracks have also formed.

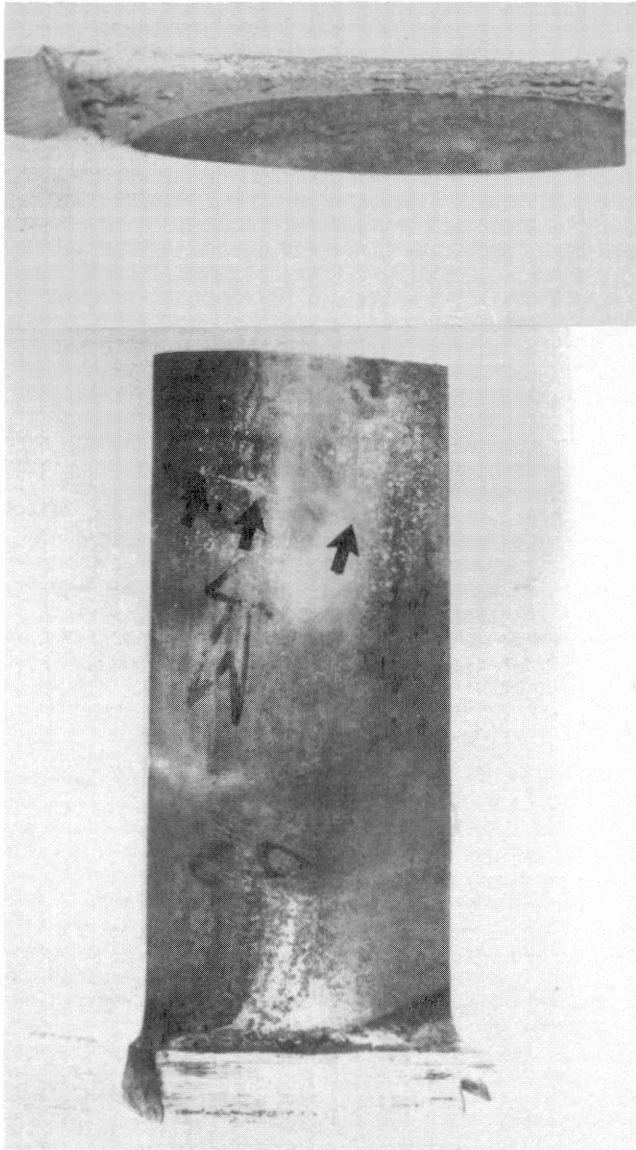
A third stage compressor blade from a large industrial gas turbine had failed catastrophically after 15,000 hours of service. The fracture occurred approximately three-fourths of the way up the airfoil. A second blade was identified as having a large crack at approximately the same location in the middle of the airfoil.

Metallurgical examination of both the crack and the fracture revealed many of the features of a high cycle fatigue failure. The crack had propagated transgranularly, giving the fracture a smooth appearance. SEM examination revealed the presence of fatigue striations on the surface (Figures 17 and 18). A large number of beach marks were evident surrounding the apparent initiation of a small corrosion pit on the convex side of the airfoil. Similar pits were observed on the rest of the

Figure 17. Crack in a Compressor Turbine Blade Which Was Identified as Having Failed by High Cycle Fatigue. The surface has the typical smooth appearance of a fatigue crack.

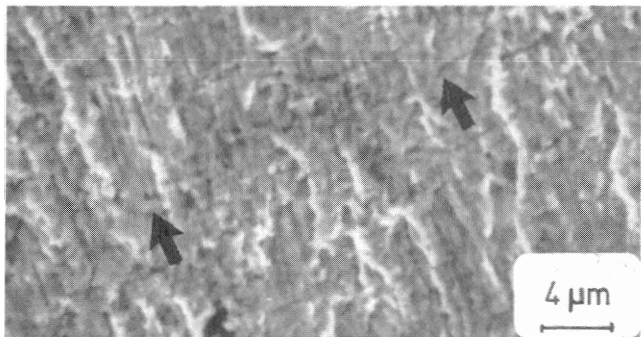
Figure 18. SEM Fractograph Showing Fatigue Striations Typical of a High Cycle Fatigue Mechanism.

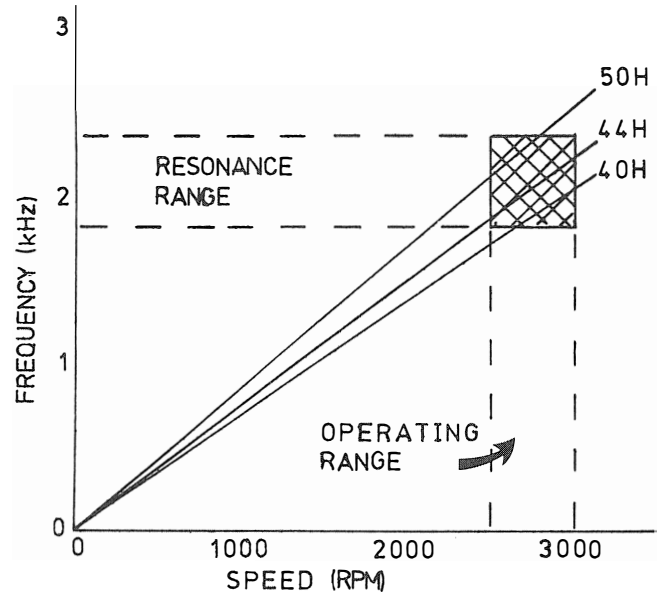
A mechanical analysis was performed to determine whether some feature of the design may have predisposed the blade to fail in fatigue. It was discovered that the natural vibration frequency of the blade in the third transverse bending mode was potentially in resonance with the excitations caused by the inlet guide vanes and first and second rows of stator vanes at normal operating speeds (Figure 19). Cracks occurring by this mode would be expected to initiate at approximately 75 percent of the airfoil height, at the point of highest bending stress which, for this particular airfoil geometry, is on the convex side. This exactly corresponded to the observed initiation point of both the crack and the fracture of the failed blade. Thus, the major mechanical factor contributing to the failure was the resonance of the blades with the preceding stator stages.

Figure 19. Campbell Diagram Showing Fatigue Excitation Resulting from Harmonics of the Running Speed. The excitation resulting from the inlet guide vanes and row 1 and row 2 stator vanes is resonant with the blades' natural vibration frequency in the third transverse bending mode.

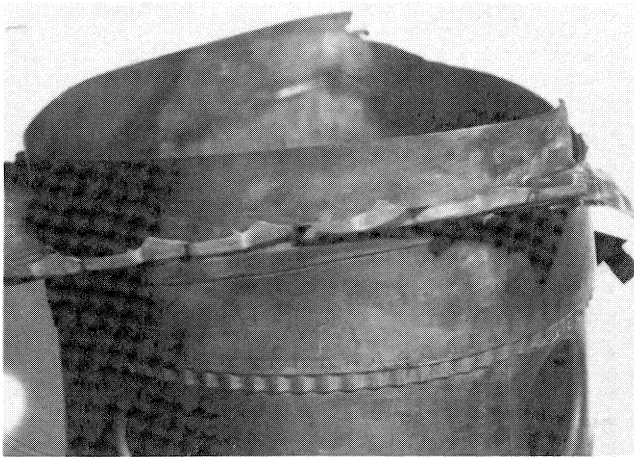
Figure 20. Failure of a Turbine Combustion System. Cracks have grown through the supporting flange baffle strip, the welded joint between combustors (arrow), and the combustor itself.

Based on this evidence, the following failure sequence was identified. The combustion system appears to have failed first. Cracks initiated at the improperly welded joints between combustion tubes, due to the excessive vibration, allowed by the poor fit up of the baffle strip support system and the lack of damping. As the cracks grew in length, the combustion system was free to vibrate more extensively, thus accelerating the crack growth rate. Eventually, pieces of sheet metal came loose and became lodged in the first stage vanes, resulting in a very strong, once per revolution, impulse on the first stage blades. This excitation was transmitted to the disc, allowing the formation of the observed fatigue crack and impact failure of the blade, by debris from the combustor.

The recommendations made in this instance were based on the observation that the combustor damage which led to the failure initiated in the assembly of the combustor. Modifications to the assembly that were suggested to improve its reliability and inspection were performed at the rebuild of the engine to ensure that the welds had been properly located and the fit up in the baffle strips was satisfactory.

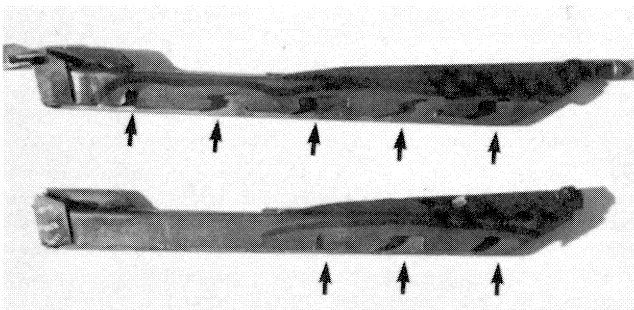
Figure 21. Heavy Fretting Wear of the Support Channels for the Combustor Shown in Figure 20. The channels have worn completely through in some areas (arrows).

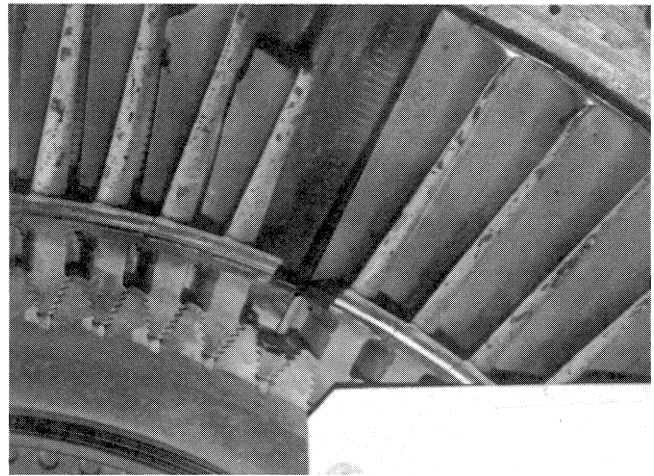
Metallurgical analysis of the fractured disc fir tree and the combustion cracks revealed that both had apparently occurred by fatigue mechanisms. The combustion failures appeared to have initiated at the welds joining the individual combustion tubes. It was noted that some of the welds had been improperly located and were, in fact, missing in one location. The presence of extensive oxidation and smearing due to rubbing of

Figure 22. Failure of a First Stage Blade and Disc Fir Tree Associated with the Combustor Failure Shown in Figures 20 and 21.

the mating surface indicated that the cracks in the combustion system had occurred over a long period of time. By contrast, the fatigue crack in the disc had relatively few beach marks, suggesting that it had grown continuously and, therefore, rapidly. The fracture of the blade root appeared to have occurred by an overload mechanism.

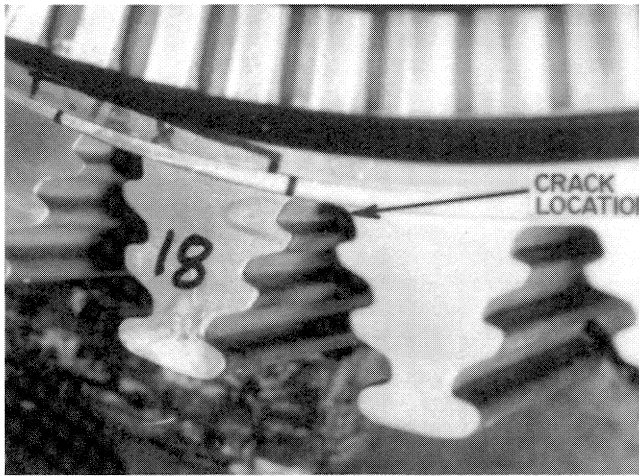
In this case, a chronic disc cracking problem was being experienced in several units. The cracks generally occurred at the bottom serration of the disc fir trees and propagated across the load bearing section (Figure 23). Although in most cases the cracks were detected during periodic inspection, in at least one instance a catastrophic wreck had occurred.

Figure 23. Location of Chronic Cracks Found in Turbine Discs.

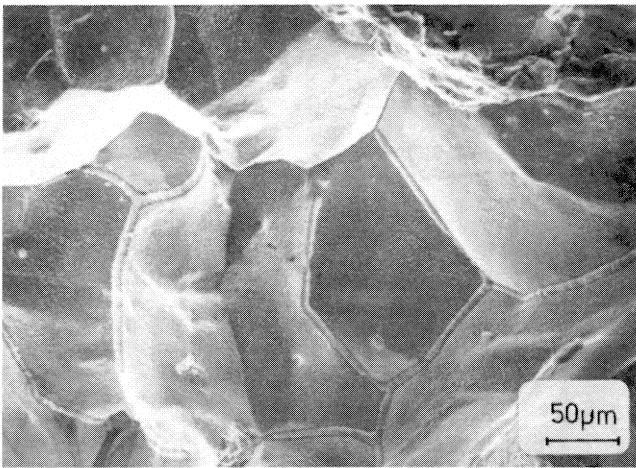
Metallurgical analysis revealed that in all cases the cracks had propagated along the grain boundaries (Figure 24). In some instances, cavities were found to be present at the tip of the crack, providing convincing evidence that the cracks were occurring by a creep mechanism (Figure 25). A large degree of

Figure 24. SEM Fractograph Indicating the Intergranular Nature of the Cracks Examined from the Disc Shown in Figure 22.

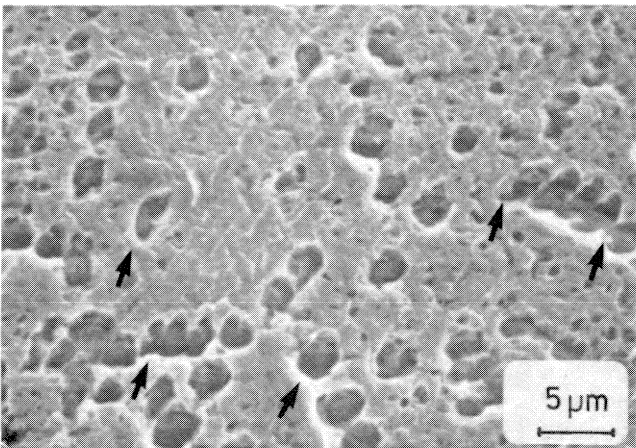
Figure 25. SEM Fractograph of Voids Found at the Edge of the Crack Shown in Figures 23 and 24. The intergranular nature of the crack and the presence of voids indicated that the crack was growing by a creep mechanism.

oxidation was observed in the cracks, indicating that high disc temperatures were providing the driving force for the

creep failures. This hypothesis was finally confirmed in an instrumented engine test which revealed abnormally high temperatures in the disc cavities.

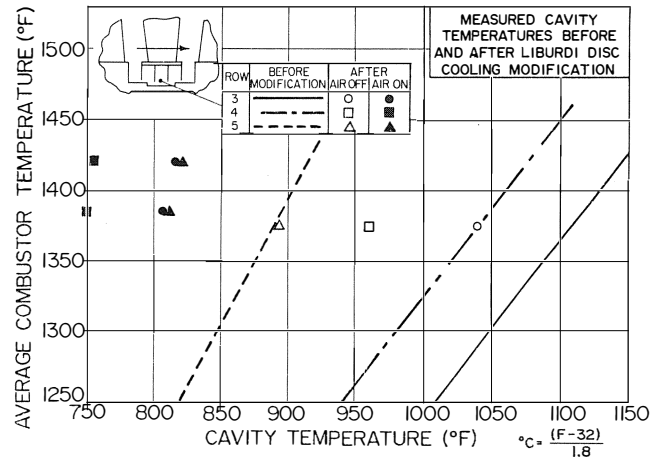
Figure 26. Decrease in Disc Temperature Cooling Modifications Implemented.

In order to provide an explanation for the high disc and cavity temperatures, an engineering study of the gas path and cooling networks was performed by computer modelling. It was discovered that excessive ingestion of hot gas into the disc cavities was occurring, resulting in the observed temperatures. The proposed solution to the problem was to provide supplemental cooling air in such a way as to minimize hot gas ingestion and thus lower the disc temperatures. These changes were implemented and resulted in a 100°F to 300°F decrease in the disc cavity temperature, which corresponds to a 20 to 300 times increase in the creep life for the disc (Figure 26). The details of the engineering analysis, the design modification and the implementation of the changes are available for further study [1].

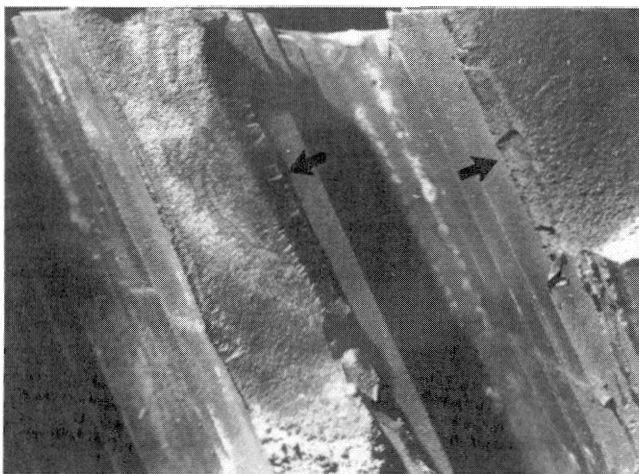
A catastrophic failure occurred in the first stage of an industrial turbine 1750 hours after the last overhaul. One blade was found to have failed in the third serration of the root and the two adjacent disc fir trees had large cracks running through them at the same location. Fluorescent penetrant inspection of the remainder of the blades and disc fir tree revealed the presence of a number of similar cracks in both the blades and the disc.

Figure 27. Cracks on Two Disc Fir Trees Adjacent to a Blade which Failed Catastrophically in the Root. Beach marks are evident and the cracks appear to have initiated at the arrows.

had been subjected to overspeed conditions for extended periods. The higher temperatures and stresses due to overspeed operation likely caused some creep, resulting in growth of the disc diameter. This would, in turn, loosen the fit between the disc fir trees and blade roots, resulting in a decrease in the fatigue damping efficiency.

It was recommended that the operator avoid operating the units with high combustion temperature spread, especially near the critical speed range, and that dimensional checks of long life discs be carried out at overhauls.

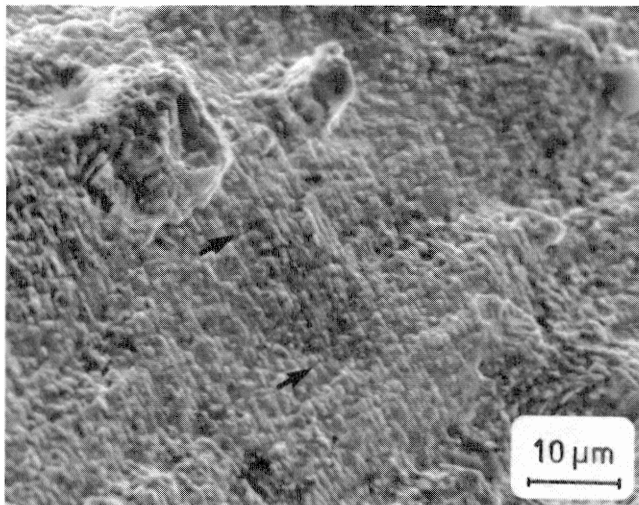
The examination of the cracks and fracture surfaces by metallography and SEM revealed the typical features of fatigue. The cracks were propagating in a transgranular fashion and fatigue striations and beach marks were evident on both blade and disc fractures (Figures 27 and 28). It was concluded that both the blades and the disc had formed fatigue cracks due to fatigue loading acting at the root of the blades. However, no apparent cause for the cracking could be identified in the mechanical design or materials.

Figure 28. SEM Fractograph of Fatigue Striations Found on the Surface of the Blade which Failed Between the Two Disc Fir Trees Shown in Figure 27.

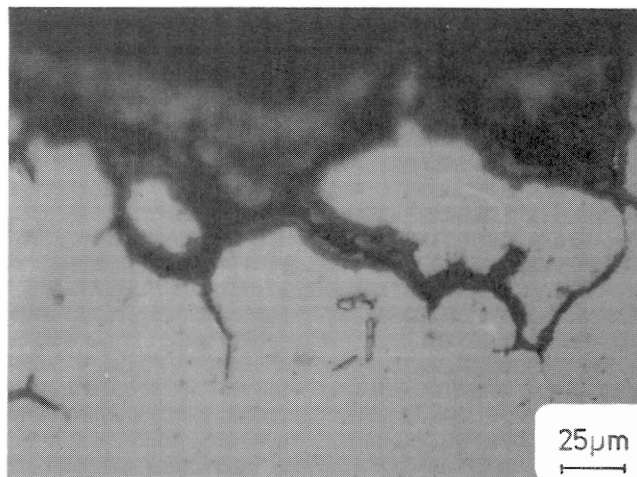
A re-examination of the failures led to different conclusions on the cause of the cracking. The fracture paths in the cracks examined were in fact intergranular, but a heavy oxide layer was also observed to be present on the crack surface (Figure 29), indicative of high temperature. Stress corrosion cracking was eliminated as a possible cause, since the operating temperature of the disc was expected to be well above the range for the proposed aqueous stress corrosion mechanism. Metallographic examination of the material also revealed extensive carbide precipitation, suggesting that it may have aged due to high temperature exposure during service.

Figure 29. Photomicrograph Showing the Heavy Oxide Layer on the Fracture Surface of the Cracked Gas Expander Disc.

It was hypothesized that the cracks had grown by a creep or thermal fatigue mechanism, due to high operating temperatures. This was confirmed by stress rupture tests performed on the service exposed material, which revealed that the disc creep life was approximately 20 percent of that expected for new material, suggesting that service aging had indeed occurred.

The conclusion reached was that the material used in the discs did not have an adequate operating margin at the temperatures at which it was being used and, therefore, was prone to creep deformation. Accordingly, it was recommended that operating conditions be moderated as much as possible, to reduce the gas inlet temperatures and thermal cycling.
