RESIDUAL OIL BURNING EXPERIENCE AT THE PUTNAM PLANT OF FLORIDA POWER & LIGHT COMPANY

William J. Hensler

Operations Superintendent

Florida Power and Light Company

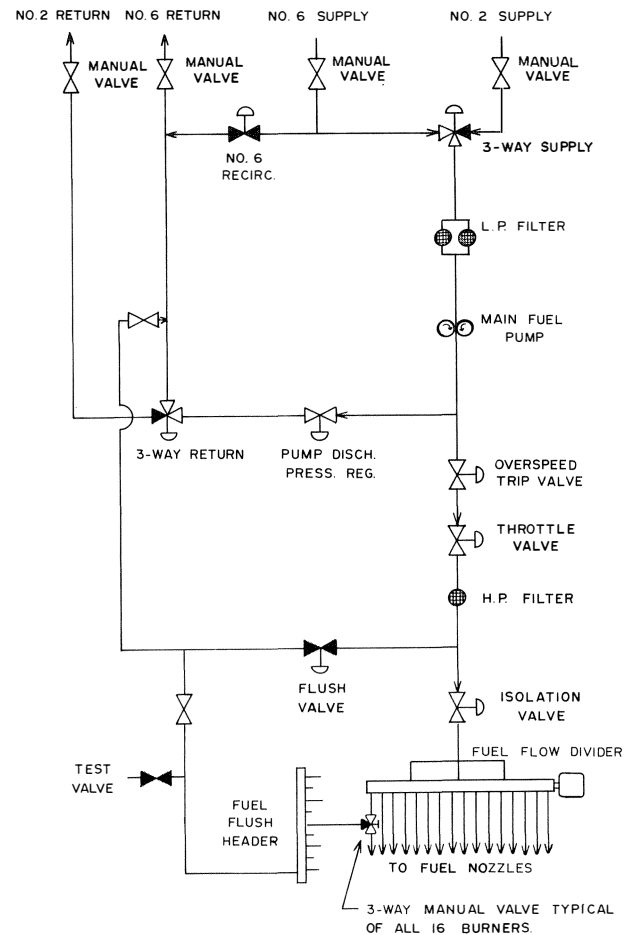
Figure 3. Gas Turbine Fuel Delivery System.

The main concern about using the larger particle size filters is the possible detrimental effect that the particles might have on the main fuel oil pump, flow divider and nozzles. Through May, 1982, approximately 25,000 hours of experience

burning residual oil, with the 75 micron excelsior filters, has indicated no abnormal wear on any of these components.

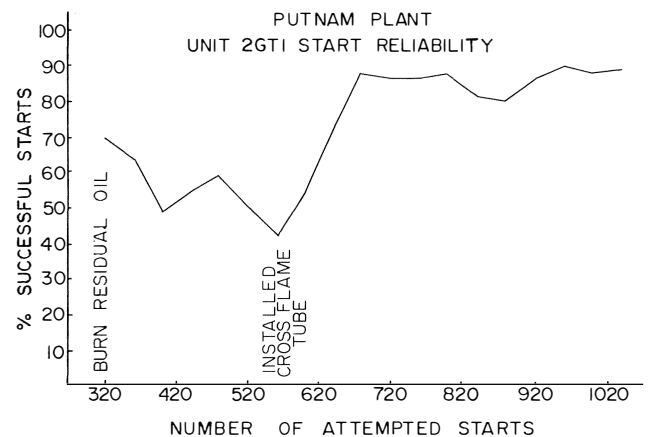
Figure 4. Gas Turbine Starting Reliability.

1. As shown in Figure 4, installation of the cross flame tube between burner 1 and burner 16 caused a noticeable increase in starting reliability.
2. The purge air system uses combustor shell air to purge the burners. Since flow through this system is caused only by the pressure drop across the combustor basket, any air leakage in the piping, flexible hoses or fittings will cause the air flow through the nozzle to stop or reverse. This reverse flow allows oil mist and products of combustion to enter the burner air passages and the atomizing air system. All of the changes which involve purging the atomizer air system address the symptoms of the inadequate purge system. The installation of the welded two-inch diameter atomizing air ring header reduces the pressure drop through this header and improves the quality of the purge system. This header has only been installed on 2GT2 and it has had a noticeable impact on starting reliability. Sixty-four of the last 65 attempts were successful and the one failure was not ignition related.

The starting reliability of all the four gas turbines at Putnam Plant has averaged 86% for the last four months and it is anticipated that the goal of 95% will be achieved in the near future.

7. The ignitors are removed from the engine before a water wash and they are "sparked" prior to installation following a water wash.
8. A cross flame tube was installed between burner 1 and burner 16.

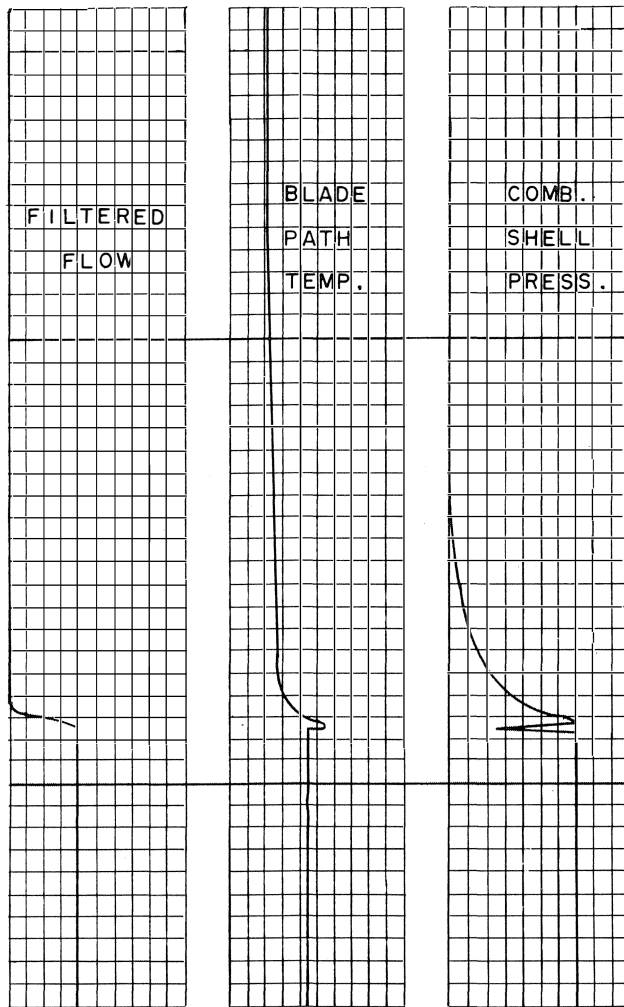
Figure 7. Brush Recording of Compressor Surge.

- a. A series of low pitch muffled booms occurring approximately every 1 to 2 seconds, increasing in amplitude to a loud final boom, audible at long distances (200 to 400 yards).
- b. The actual gas turbine trip is normally caused by high blade path temperature.
- c. Reverse current conditions also occur causing the generator breaker to open.
