# ELECTROMAGNETIC SHAFT CURRENTS AND DEMAGNETIZATION ON ROTORS OF TURBINES AND COMPRESSORS

**John S. Sohre**

**Paul I. Nippes**

## ABSTRACT

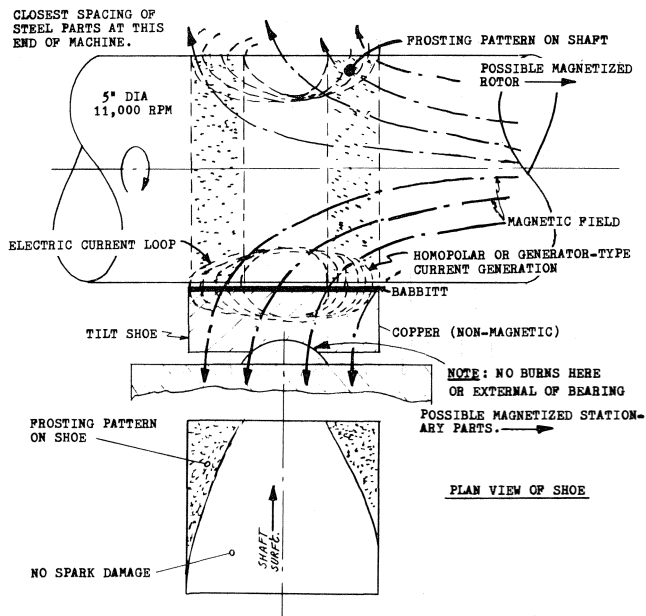
Figure 3c. Short-Circuited Current Loop Within One Journal Bearing.

A tilt-shoe bearing is shown (based on a specific case-history), but the same pattern occurs also with any other type of bearing. The shoe in this case was non-magnetic, damage would have been worse with a steel-backed shoe.

Note that this type of damage would not be prevented by isolating the bearing, nor is there any effective method of grounding. It is theoretically possible to reduce damage by grounding at both sides of the bearing. However, this would require 4 brushes, running at 240 ft/sec surface velocity. Heat generation would be considerable.

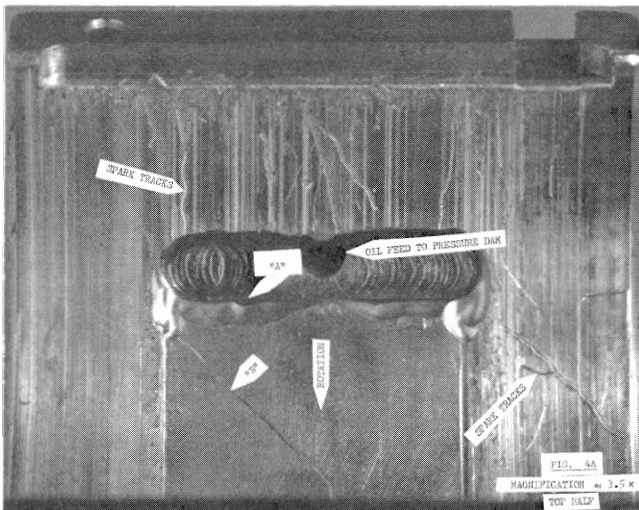
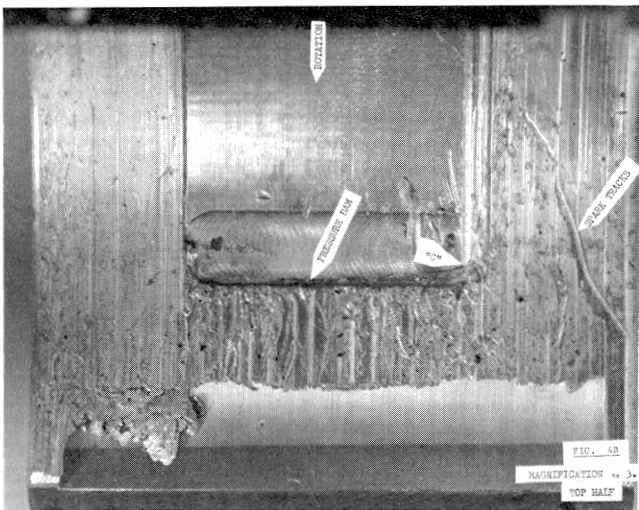
Figure 4 A & B. Dam-type bearing of turbine, steam end, refrigeration compressor damage caused by magnetic currents. ( $\approx 7,000$  HP/11,500 RPM).

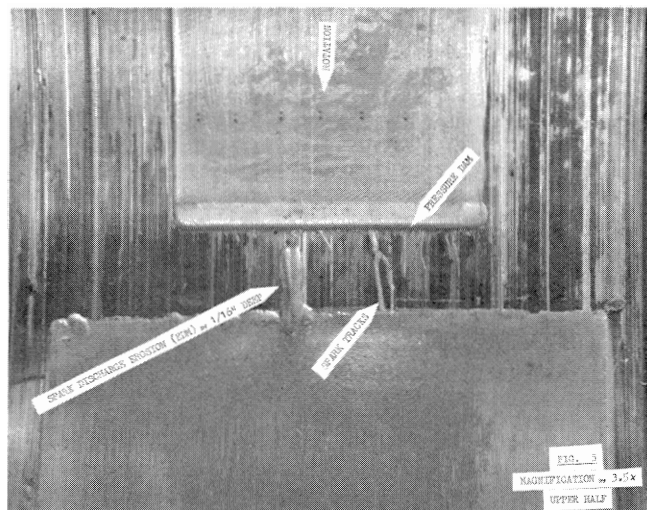
Figure 5. Details of exhaust-end bearing (same turbine as Figure 4).

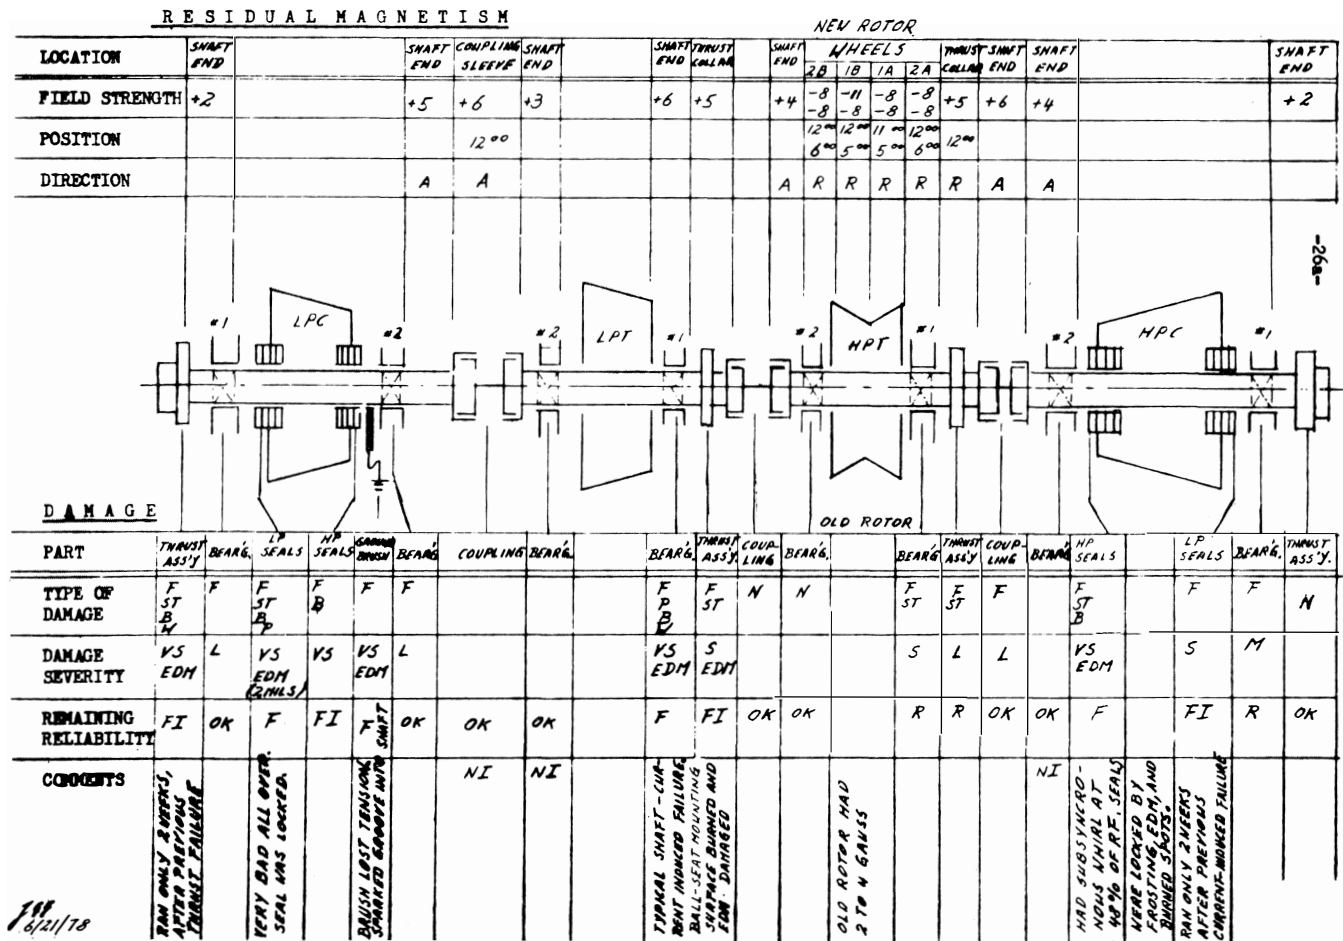
Figure 7. Map Showing Magnetism, Failure Location and Severity.

Finally, a thorough inspection was performed during a scheduled turnaround. Strong magnetic fields and extensive shaft current damage were found. Figure 7 shows a summary of the findings. Many vital components had either failed or failure was imminent, over-all damage level was extremely severe and very extensive. There was a pronounced orientation of the magnetic fields in the 6:00/12:00 plane throughout the train. Magnetic fields were found on most parts. There was bad frosting on the low pressure compressor thrust bearing at the 1:00 plane only. Components of the thrust bearing assembly had spot-welded together. The thrust collar was welded to the shaft shoulder and the retaining nut. Welding had also occurred between the shaft OD and the ID of the thrust compo-

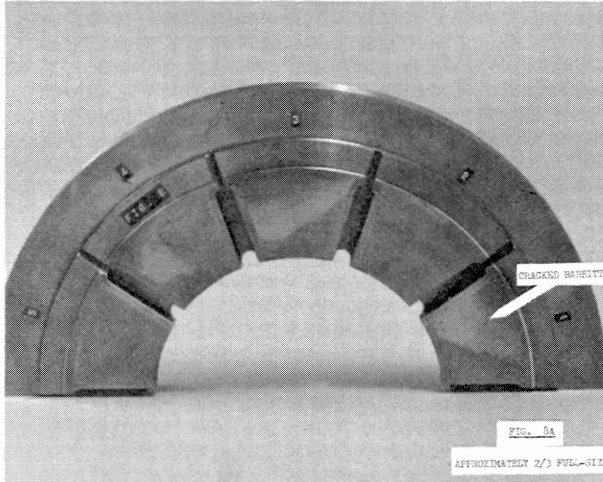
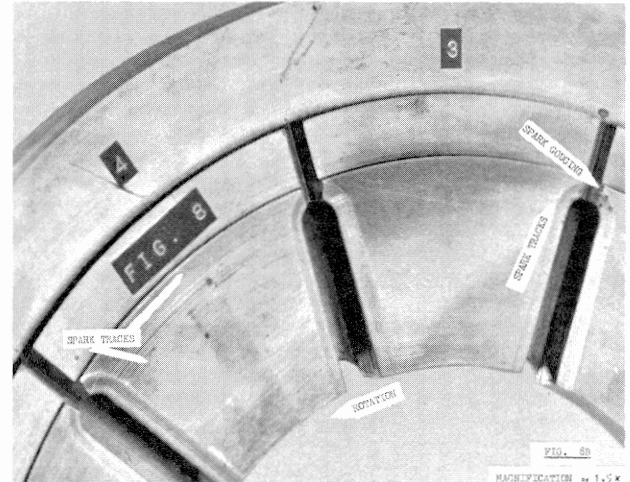
Figures 8 and 9 show the bearings that were affected greatly by the generated shaft currents. In Figure 8 frosting is medium to severe. The thrust capability was significantly reduced. The area near #3 land was overheated. Note the land discoloration, yellow blush ( $\approx 450^\circ\text{F}$ ) on steel next to land #3. Thrust failure was imminent.

*Land #1:* Severe spark frosting, most of the oil wedge is lost. Heat discoloration ( $\approx 375^{\circ}\text{F}$ ) and babbitt cracking from excessive load.

*Land #2:* A few isolated, light pits, over entire surface, heavy pitting at trailing OD. Note that this pad and #5 carried much less load than #1, #3, and #4. This is a result of manufacturing defects, these pads being slightly lower than 1, 3, and 4.

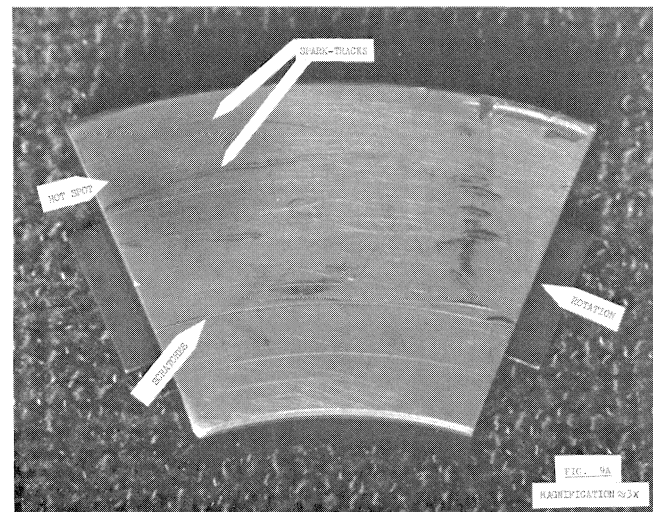
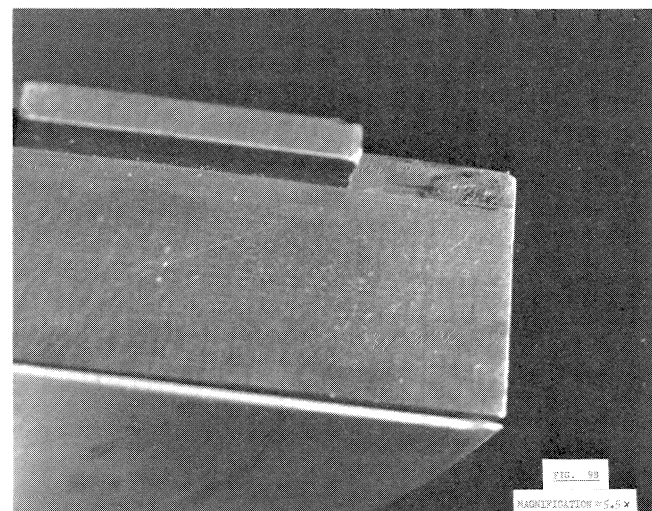
9A Shoe Surface

9B Burn at Shoe-to-Backup-Plate Contact Point

Figure 9A & B. Syngas compressor thrust shoe, damage caused by magnetic shaft currents (40,000 HP/11,000 RPM Train).
