# REPAIR AND REHABILITATION OF TURBOMACHINERY FOUNDATIONS

E. M. Renfro

Adhesive Services Company

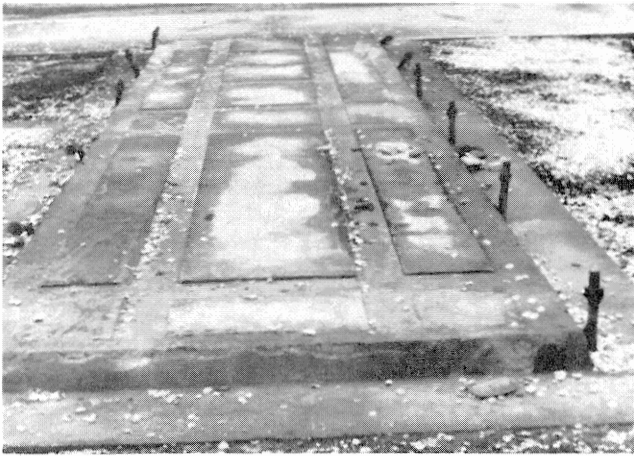
Figure 2 is a fine example of correct grout placement. This photograph, showing the grout intact after platform removal, would not have been possible if epoxy grout had been used in the original installation. Cement based grouts will not bond well to the platform load bearing surfaces. Note that portions of this grout are oil soaked. Over a period of time, lubricating oils will severely degrade both cement grouts and concrete. This problem is further aggravated by the fact that most platforms are not designed with oil drains. On several occasions the author has noted as much as 6 to 8 inches of oil trapped within the platform cavities. This condition not only provides head-pressure for an increased rate of oil penetration, but also creates a *severe* fire hazard.

Figure 2. A Properly Grouted Platform which Later was Removed from its Concrete Pad. Note that 100% Contact had been Obtained by the Grout on All Longitudinal and Transverse Supporting Beams.

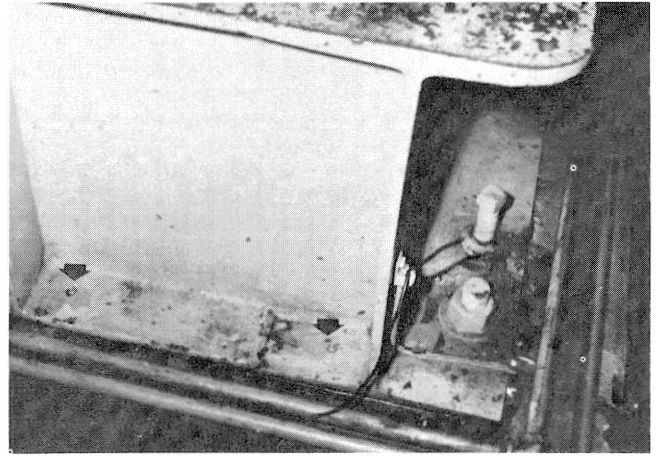
Figure 4. A View of a Corner of a Platform where the Lower "I" Beam Flange has been Pressure-Grouted with Epoxy to Bond the Platform to the Concrete Foundation. Arrows Indicate the Points of Injection Through Grease Fittings.

When differences in vibration amplitudes can be detected between the lower flange of the platform beams and the concrete structure, the decision to bond the entire lower surfaces of the platform to the concrete structure should be made. Bonding can be accomplished using a technique known as pressure-grouting. With this technique, holes are drilled through the lower flange at locations near the web on centers of approximately 18 inches. These holes are then tapped and ordinary grease fittings installed. The arrows in Figure 4 locate grease fittings and this configuration represents a typical injec-

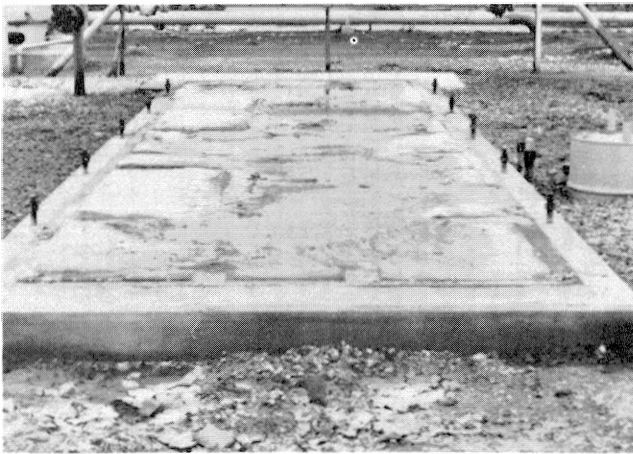
Figure 3 is a fine example of poor grout placement. Note the lack of support in the center where most of the machinery weight is concentrated. Long, unsupported spans are an invitation not only to resonance vibration problems but also to progressive sagging with age. Progressive sagging would cause continual misalignment problems. The obvious solution to this defect is simply to grout in the unsupported sections. Since cement grout will not bond well to itself or concrete, any re-grouting should be carried out with an epoxy grout because of the inherent bonding properties of epoxies. Some epoxies will even bond to oily surfaces [4].

Figure 3. An Improperly Grouted Platform which Later was Removed from its Concrete Pad. Note that Very Little Contact was Made in the Center with Supporting Beam Flanges. Proper Contact was Obtained Only on the Outer Periphery of the Platform.

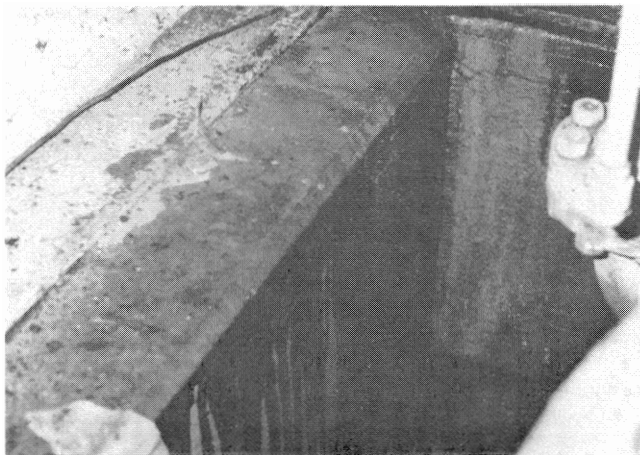
Figure 5. Bleed of Excess Epoxy from Beneath the Internal Edge of the Lower "T" Beam Flange.

tion site pattern. Pressure-grouting can then be carried out with either automatic injection equipment or with conventional grease guns. Figure 5 is a view from the inside of the platform after pressure-grouting, and this view shows the bleed of excess epoxy from beneath the flange. Almost 100% coverage has been obtained. In cases where the gap between the structural member and concrete is too wide for the epoxy liquid to maintain capillary contact, and at the same time, too narrow to be filled with epoxy mortar, the epoxy can be thickened to near grease consistency by adding a thixotrope to the mix. This thixotropic fluid can then be pressure injected between the two surfaces and will maintain capillary contact. This technique is illustrated in Figure 6.

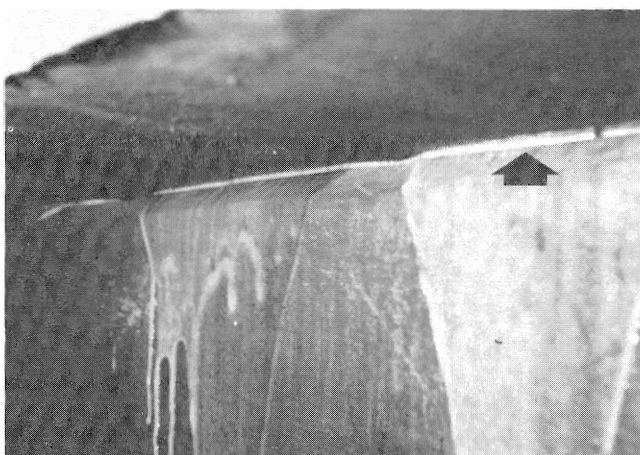
Figure 6. Bleed of Excess Epoxy from Beneath a Steel Plate Stiffener which was Field Installed. Because of the Large Gap, a "Thickened" Epoxy was used in Order to Maintain Capillary Contact Between the Two Surfaces.

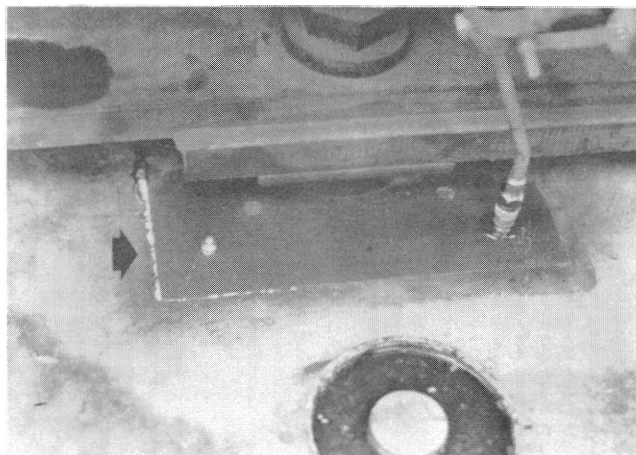
Figure 7. Pressure-Grouting of Voids Beneath a Sole Plate. Note the Water Being Flushed from the Crack Between the Edge of the Plate and the Cement Grout.

In Figure 7 small pilot holes were drilled in the exposed edges of the sole plate. These holes were then reamed out to accommodate a  $\frac{1}{8}$  inch pipe tap. Fittings were installed and epoxy liquid injected in the voids until excess epoxy escaped around the outer periphery of the sole plate. Usually, oil or, in this case, water is driven from beneath the sole plate with the epoxy flush. This flushing should continue until clear epoxy is emitted from the crack. If necessary, the position of the plate can be monitored while pressure-grouting with dial indicators. In any case, the grease fittings should be removed after injection is complete and before the epoxy has gelled in order to bleed off remaining pressure. If satisfactory results are not obtained during the first attempt, the holes can be redrilled, tapped and new grease fittings installed for a second pressure-grouting. Pressure grouting of sole plates seldom changes level or alignment because grease fittings are removed immediately after pressure-grouting to release pressure and because the weight of the equipment discourages lifting. When anchor bolts are tight, movement is further restricted.

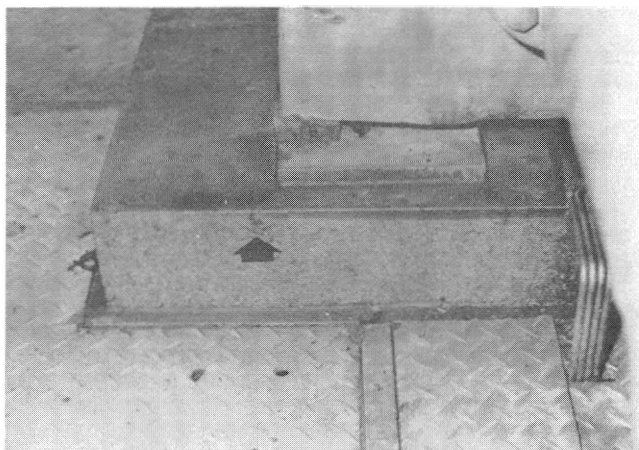
Figure 8 illustrates four problems on one installation. First, the chock block between the equipment base and the sole plate is inadequate to transmit the load evenly to the sole plate. Secondly, the corners on the edges of the sole plate should have been rounded to a 2 inch radius in order to prevent the creating of stress risers and subsequent cracking at the corners. The third problem is caused by an insufficient quantity of aggregate in the epoxy mortar. Note the distinct layer of unfilled epoxy on the surface of the mortar. The linear coefficient of thermal expansion of the unfilled epoxy can be expected to be on the order of magnitude of  $6-8 \times 10^{-5}$  inches per inch of thickness per degree F. The linear coefficient of thermal expansion for the epoxy mortar below can be expected to be on the order of magnitude of  $2 \times 10^{-5}$  inches per inch of thickness per degree F. This difference in thermal expansion rates will encourage crack propagation, particularly on cooling when the system is subjected to cyclic temperatures as between day and night. The fourth and most severe problem, though not obvious in the photograph, is the presence of a foam surface immediately below the sole plate. This problem is also caused by an insufficient quantity of aggregate in preparing the epoxy mortar.

Figure 8. A Poorly Designed and Grouted Sole Plate. Sharp Corners of the Plate Promote Corner Cracking.

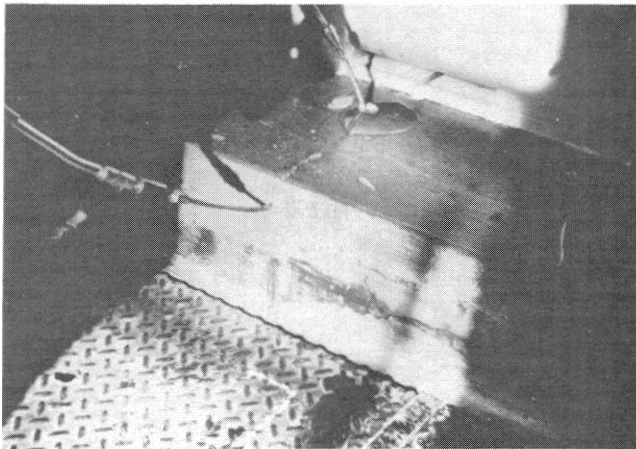
Figure 10. Pressure-Grouting a Crack Caused by Stress Risers around Sharp Sole Plate Corners. Pressure-Grouting Repairs the Grout in a Stress Relieved Condition.

Pressure-grouting of cracks caused by stress risers at the corners of rails or sole plates may be accomplished using the technique shown in the photograph of Figure 10. Here, holes have been drilled into the cracks, injection tubes installed and sealed in place with epoxy putty. After curing of the epoxy

putty seal, the crack is pressure-grouted. This repairs the epoxy mortar in a stress relieved condition.

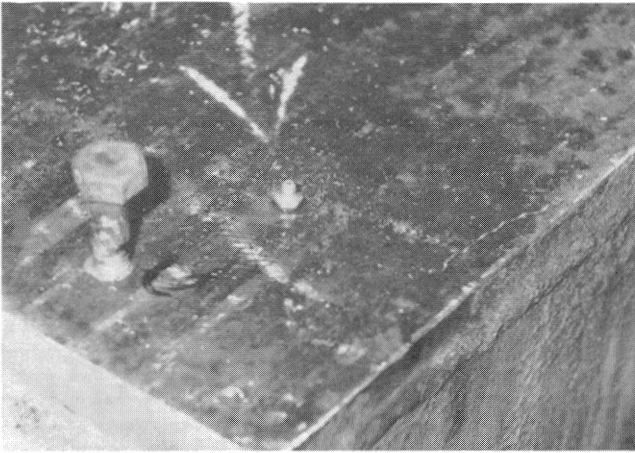
Figure 12. A Close-up View of One Injection Site. Injection Sites were Installed at Each Corner of the Gear Box Support Shown in Figure 7.

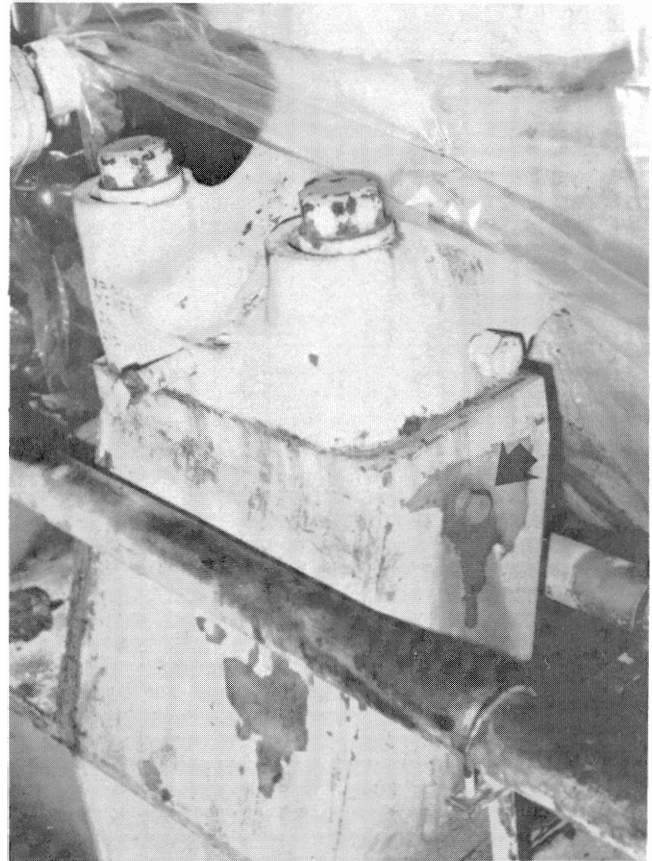
Figure 14. A View of a Pedestal Supporting the Low Pressure Stage of the Compressor Train. This Pedestal was Filled with a Special Mortar Comprised of Epoxy Liquid and Steel Shot in an Attempt to Increase Mass and Rigidity of the Support.

cavities with a special mortar prepared with epoxy and steel shot. The density of this special mortar was in excess of 300 lbs. per cubic foot. Figure 14 is a view of a typical compressor support pedestal. A pipe plug has been installed in the access

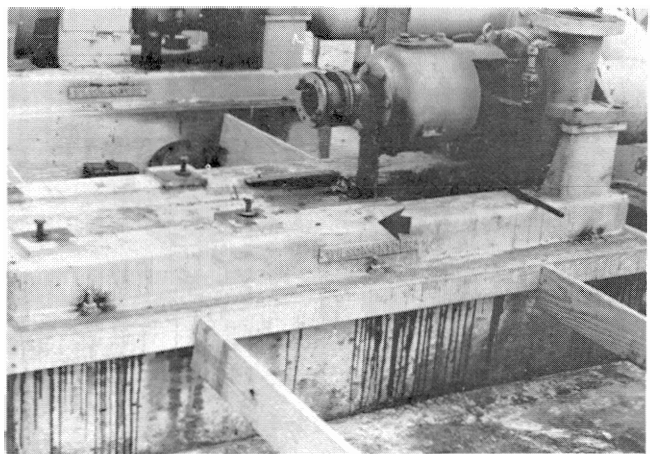
Figure 15. A Typical Stamped Metal Base Under a Centrifugal Pump which has been Grouted and is to be Pressure-Grouted thereby Filling All Remaining Voids.

These same techniques can be employed to stabilize the foundations under much smaller equipment. Figure 15 is a photograph of a stamped metal base under a centrifugal pump. Note the access holes, indicated by the arrow, which have been grouted with epoxy mortar. As soon as the epoxy mortar has cured, holes will be drilled into voids, detected by hammer tests, and these voids pressure-grouted using the same techniques outlined above.
