REJUVENATION OF USED TURBINE BLADES BY HOT ISOSTATIC PROCESSING

Turbine and Generator Division

Westinghouse Canada Limited

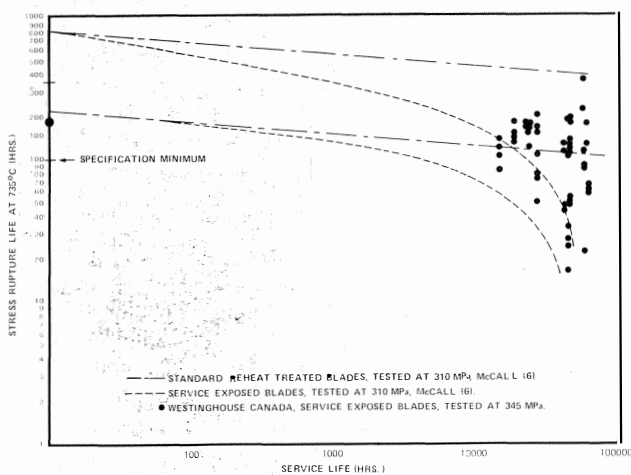
It is not known to what extent each of the above mechanisms contributes to turbine blade degradation during service. It is also probable that each alloy will respond differently to a particular temperature stress combination. Figure 1 shows the typical variation in stress rupture life determined at 735°C (1350°F) with service time for forged Inconel X-750 blades. The data for the machines was taken from McCall [6]. It should be noted that the tests conducted by us were conducted at 345 MPa (50 Ksi), while McCall's data resulted from tests at 310 MPa (45 Ksi). Both data sources display considerable scatter; some is undoubtedly due to variations in initial (new) material properties and differences in machine operating conditions. Additional reasons for large scatter are that the data includes values from both W62 row 3 blades and W92 rows 4 and 5 blades. Figure 1 indicates that, after 40,000 hours service, about half of the blades evaluated could not meet the new blade stress rupture specification value of 100 hours at 345 MPa/735°C. The blades which were selected for the HIP rejuvenation program had been in service for approximately 45,000 hours and exhibited the lowest life of all blades tested (Figure 1) (15 to 35 hours as received).

Figure 1. The Variation of Remaining Stress Rupture Life at 735°C with Service Time in Forged Inconel Alloy X-750 Turbine Blades.

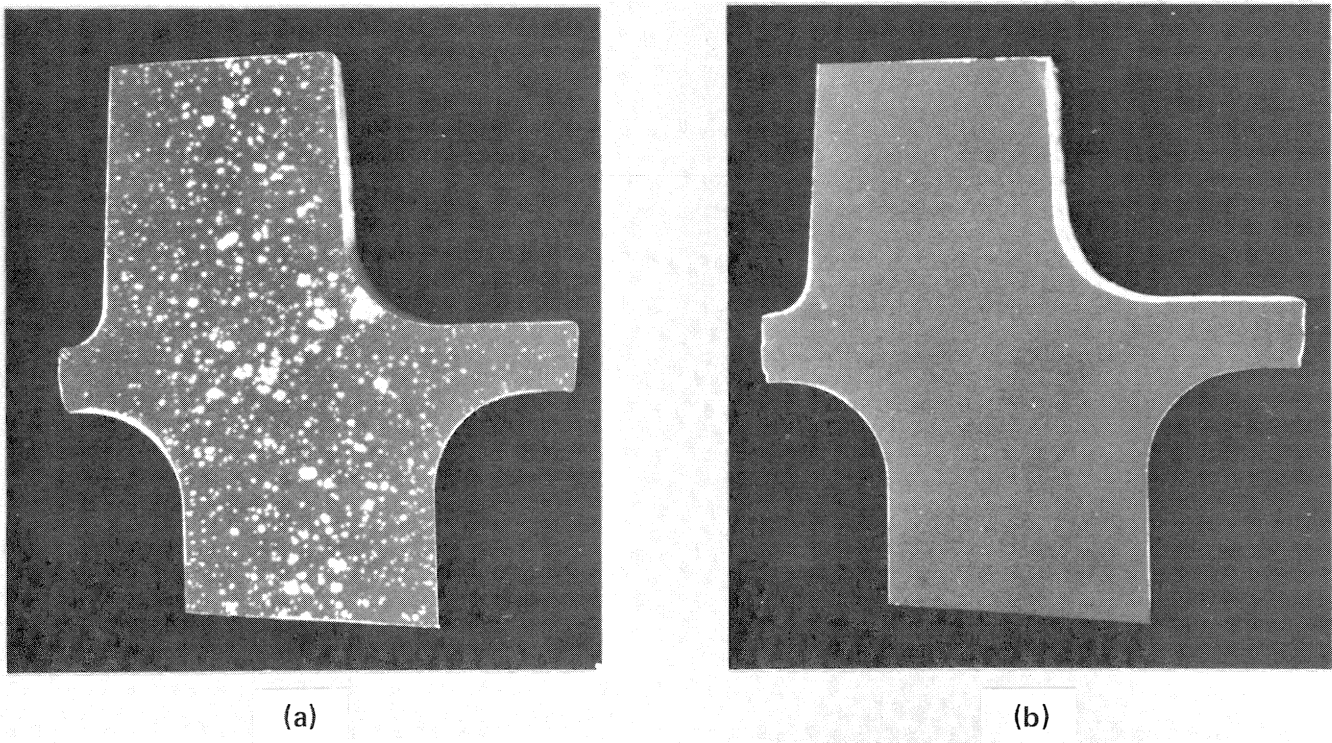
Figure 2. Fluorescent Penetrant Indications on Sections Cut from the Root-Airfoil Transition of Investment Cast Turbine Blades. (a) As Cast; (b) Cast Plus HIP Processed.

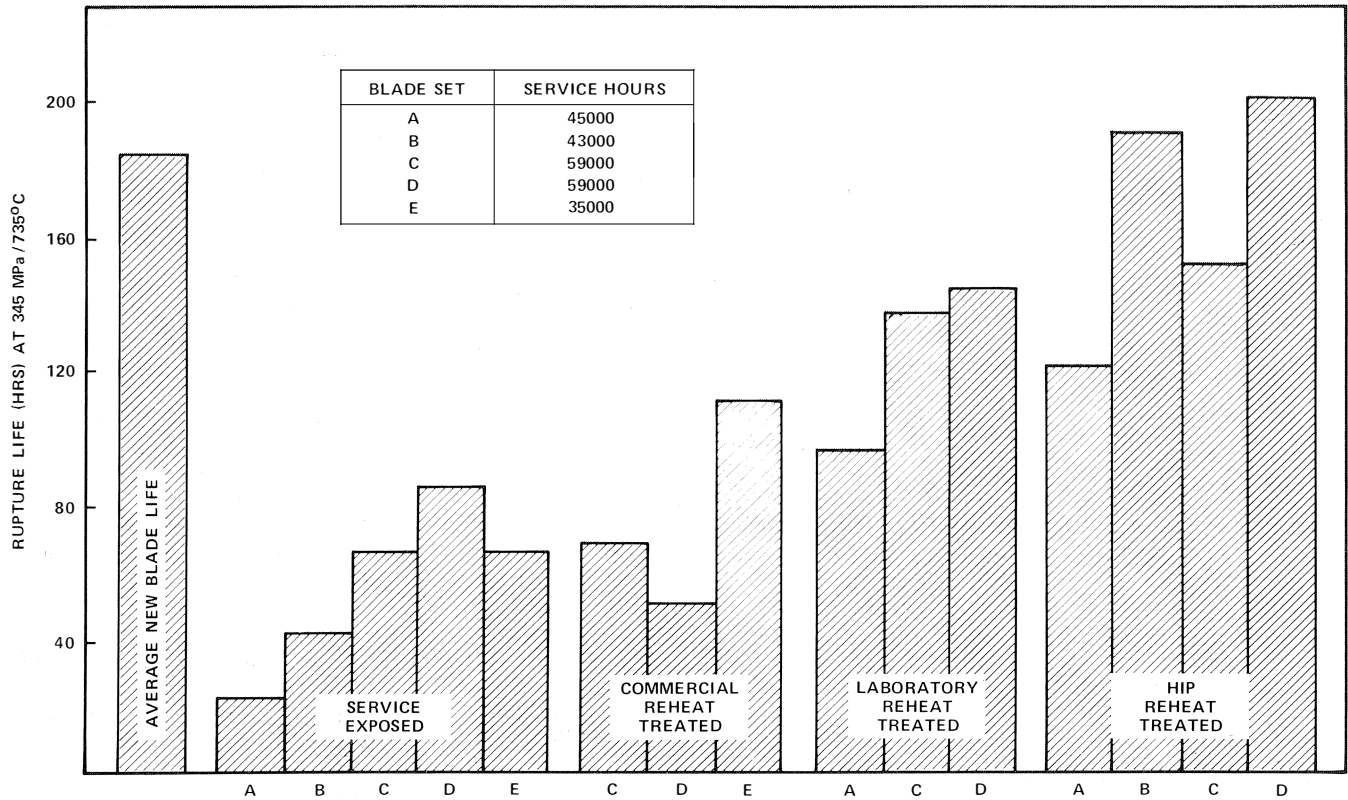
The results of this work, presented in Figure 3, clearly show that the HIP processed material is superior to both commercial and laboratory conventional reheat treated material. The laboratory treated blades should represent the maximum property improvement attainable by this approach, since ideal temperature control and cooling rates were employed and the microstructure was fully restored. Therefore, the improvement achieved using the HIP cycle must be due to complete removal of service damage.

Figure 3. Comparison of Stress Rupture Life at 345 MPa/735°C (50 KSI/1350°F) in Service Exposed, Commercially Reheat Treated, Laboratory Reheat Treated and HIP Reheat Treated Used Inconel X-750 Turbine Blades.

With the distinct advantage of HIP reheat treatment evident in Figure 3, a cooperative program was conducted with Trans Canada Pipe Lines to process a complete blade set and return them to service. The blades are forged Inconel X-750, with 45,000 hours of service and are identified as Set A in Figure 3.

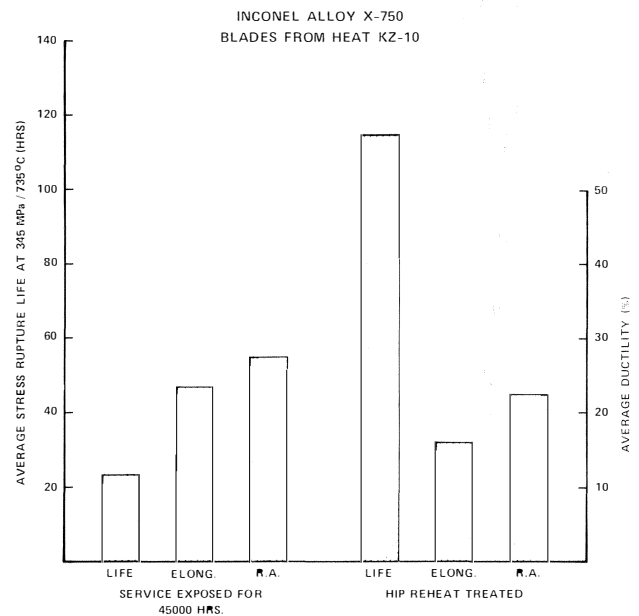
The service exposed and HIP processed conditions were initially established by testing ten specimens of each condition at 345 MPa/735°C/(50 Ksi/1350°F). The averaged results are presented in Figure 5. The results are nearly identical to the Set A results in Figure 3, which indicates that with due care, production scale HIP processing can duplicate preliminary laboratory results.

Figure 5. Bar Chart Comparison of Before and After Stress Rupture Properties at 345 MPa/735°C (50 KSI/1350°F) of the HIP Processed Blade Set.

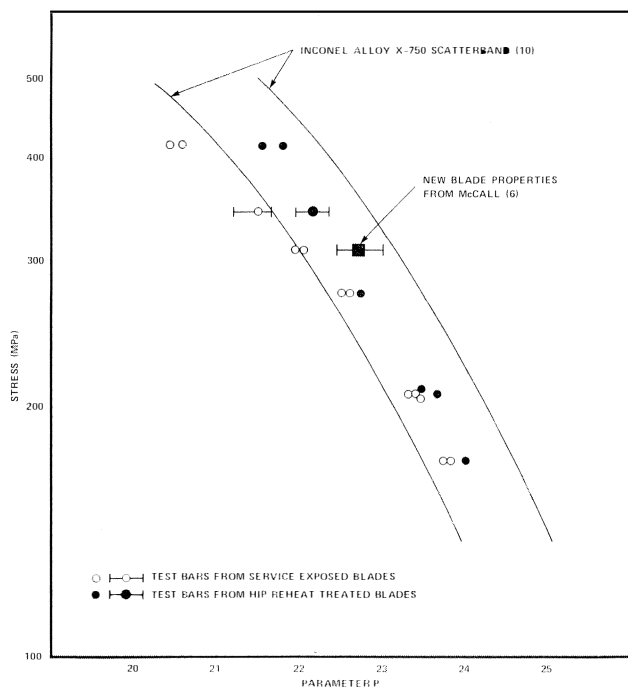
In addition to the above results, material in both the service exposed and HIP reheat treated condition was tested at various stress/temperature combinations. Test parameters were chosen so as to yield an average life of 100 hours for the HIP treated material. The results are presented in the Larson-Miller plot of Figure 6. The HIP processed results fall nearly in the centre of the Inconel X-750 scatterband [10] indicating that this condition is comparable to what one could expect for new blade properties.

It should be noted that service damage is only clearly apparent in the tests conducted at lower temperatures (up to 735°C), which is higher than the actual service temperature for Inconel X-750. In the higher temperature tests, the difference becomes less pronounced, apparently because the failure mechanism becomes insensitive to microstructural changes and cavities. This result indicates that testing of serviced blades should always be conducted at as low a temperature as possible to approximate the use temperature.

Figure 6. Larson-Miller Plot ($P = T \times 10^{-3} (20 + \log t)$, T in $^{\circ}\text{K}$, t in hours) Showing Service Exposed, New and HIP Processed Blade Stress Rupture Properties.

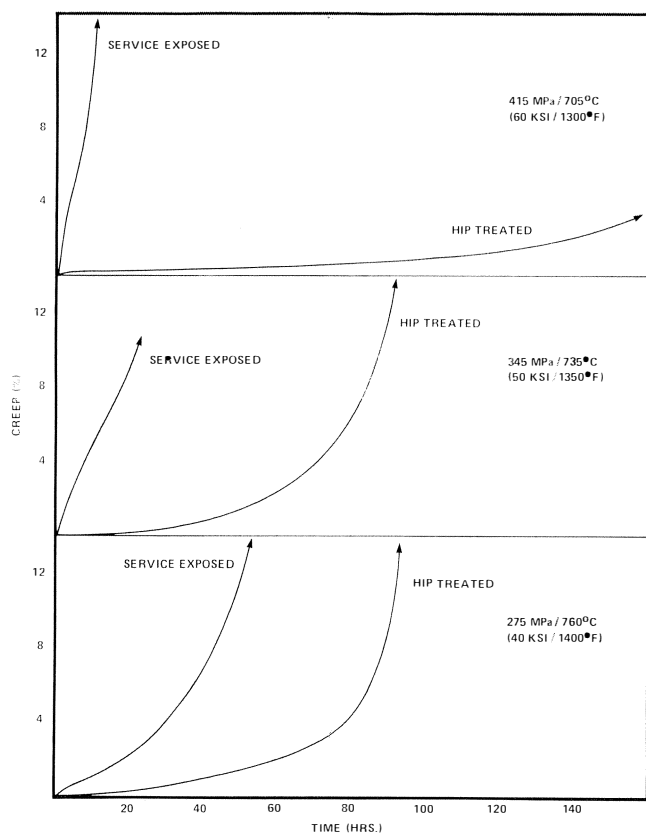
Short term creep rupture tests were conducted at three stress/temperature levels. Representative creep curves are presented in Figure 7. In all cases, the HIP reheat treated material clearly exhibits a secondary creep stage which is virtually absent in the service exposed material. Again, as previously noted in Figure 6, the differences between the service exposed and HIP processed material decrease as test temperature is increased.

Figure 7. Creep Rupture Curves Comparing the Service Exposed and HIP Reheat Treated Conditions at Three Stress/Temperature Combinations.

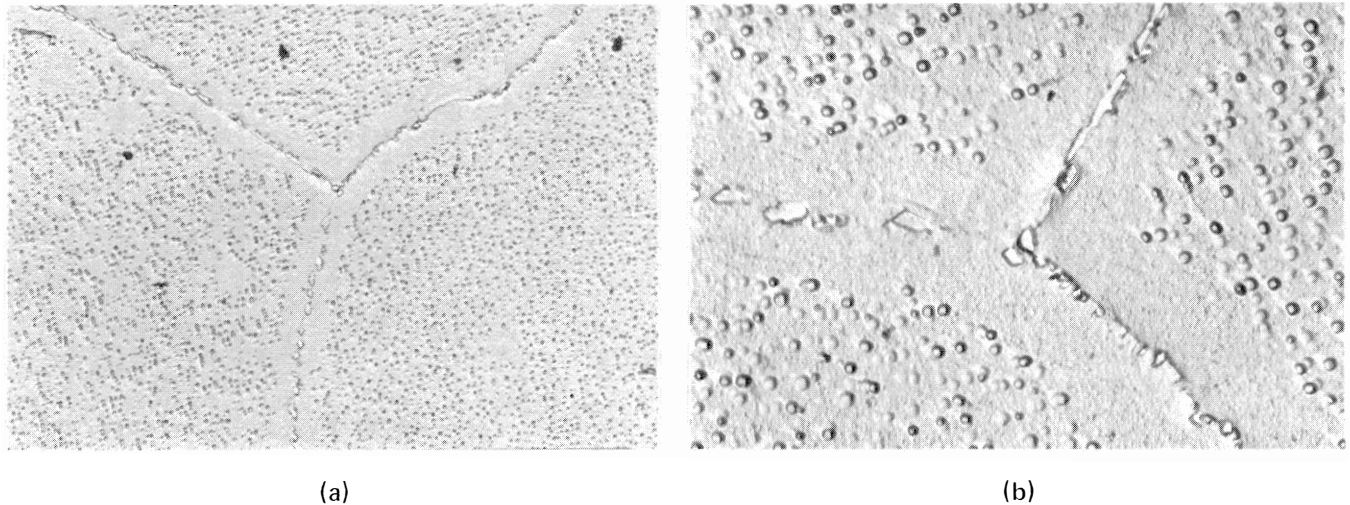
The only obvious microstructural differences between service exposed and HIP treated material were revealed in shadowed carbon replicas. The HIP treated microstructure, Figure 8, is comparable to that reported for new material by Raymond [9]. The intragranular γ' is spherical, 0.15 to 0.2 μm in diameter, while the grain boundaries have a well defined "denuded" zone containing nearly unresolved γ' particles approximately 0.01 μm in size. By comparison, the intragranular γ' in service exposed materials is cuboidal, 0.2 μm in size, indicating that some coarsening has occurred (Figure 9). Considerably more γ' coarsening is apparent near the grain boundaries. The original denuded zone has divided into three zones, Figure 9 (b); very little if any γ' is observed immediately adjacent to the grain boundary; in the central zone of γ' particles are cuboidal and range in size from 0.1 to 0.15 μm ; the zone furthest from the grain boundary contains coarsened spherical γ' 0.02 to 0.04 μm in diameter. The considerable γ' coarsening in the regions next to the grain boundaries is believed primarily responsible for the lower service exposed properties. The severely overaged condition would result in reduced strength leading to the localization of deformation to the grain boundary areas. Such inhomogeneous deformation will result in cavitation and eventual failure at the preferred failure sites; i.e., the grain boundaries.

Figure 8. Carbon Replicas Showing the Microstructure of an HIP Processed Blade. (1) 3500X; (b) 10500X.

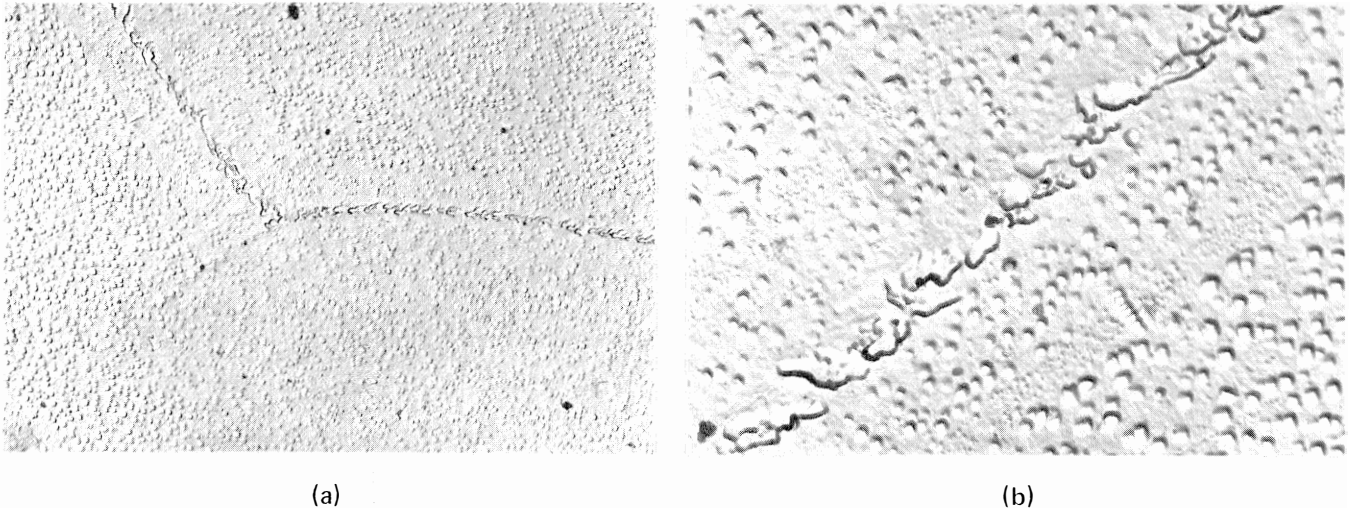
Although no clear cut evidence of cavitation or creep voids could be observed microscopically, their presence is inferred from the literature and mechanical test results. It would, in any event, be difficult to distinguish voids from other microstructural features such as pulled out grain boundary carbides.

With regard to grain boundary morphology, there appears to be a heavier carbide film in the service exposed material which was subsequently broken up during the HIP reheat treatment; however, a quantitative analysis of the relative amounts and effect was not carried out.

Figure 9. Carbon Replicas of the Microstructure of a Service Exposed Blade. (a) 3500X; (b) 10500X.
