DISTORTION OF SPEED CHANGER HOUSINGS AND RESULTING GEAR FAILURES

Fred L. VanLaningham

Union Carbide Corporation

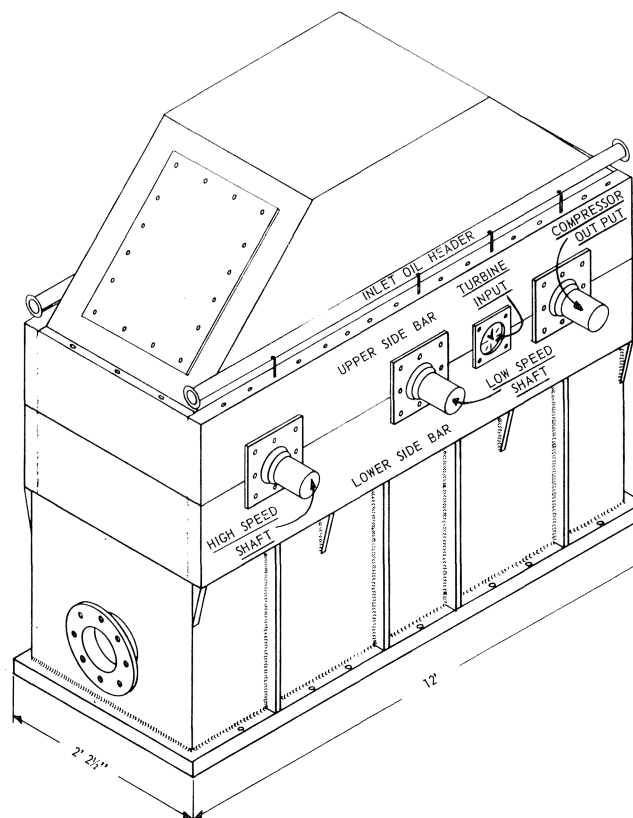
Figure 1. Triple pinion single helical gear speed increaser/reducer showing base plate at extreme bottom of enclosure.

The housing was disassembled and the babbitt thrust face of both low speed bearings were badly wiped. Wiping had also occurred on the inboard side or next to the thrust faces of both journal bearings. Prior to the failure, the system was operating normally and nothing unusual was noted. The most probable cause for such a failure is insufficient thrust or axial clearance. Clearance had been checked and recorded during the post-mechanical running test inspection at the builder's plant and again after installation at the job site. The only clue to the cause of failure was that during the time thrust bearing temperatures were rising, thunder showers were occurring. We concluded that this failure was caused by thermal bowing inward of the housing side bar sections thus decreasing the axial or thrust clearance. The higher temperature inside of the housing due to windage, hot oil mist, etc., relative to the outside of the housing had caused the housing side bars to bow resulting in a loss of clearance. The higher temperature inside of the housing due to windage, hot oil mist, etc., relative to the outside of the housing had caused the housing side bars to bow resulting in a loss of clearance. The higher than normal thrust bearing temperatures we had experienced resulted from the heavy Gulf Coast thunder shower cooling the exterior, increasing the temperature differential, and resulting bowing enough to totally wipe out both thrust faces. Figure No. 2 indicates the side bars bowing.

The unit was repaired temporarily with replacement bearings machined for increased axial clearance plus insulating the entire outside surface of the housing. The manufacturer then redesigned the low speed bearing arrangement changing from the plain journal bearings with taper land thrust faces to two double element type TDO tapered roller bearings. The unit on the main oil pump side was fixed, and the unit on the motor generator side floating. The calculated life of the roller bearings is about 125 years. After modification, the insulation on the exterior of the housing was removed.

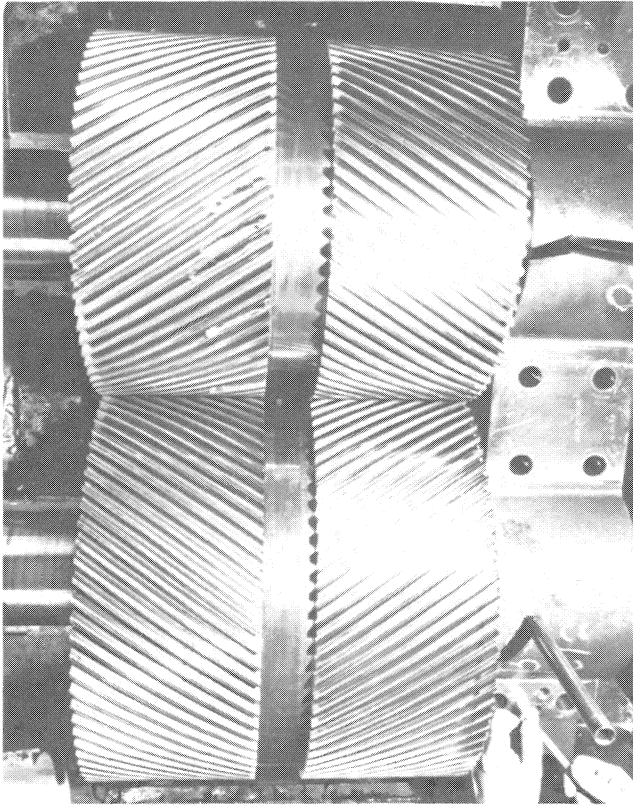
The number one unit failed after 23,500 hours of service and had teeth broken out of the pinion near the apex on the input or turbine helix as shown in Figure 3. In addition to the pitting, which was similar to the number two unit, near the apex on the loaded flanks of the gear, pitting was also evident near the edge on the output or compressor helix as can be seen in Figures 4 and 5.

The gears had no doubt failed due to an internal alignment difficulty that had concentrated the load resulting in localized fatigue failure. Distortion of the housing, its foundation, or barreling of the gear and/or pinion in the center due to nonuniform heat rejection from the gears were possible causes.

Figure 3. Photograph of failed double helical speed increaser gears as upper half of housing was removed. Fatigue breakage is evident on pinion.

door installation was shielding the gear housing from the heat radiated by the hot end of the gas turbine. The radiant heat was causing the horizontal center distance to increase on the side nearest the turbine; also the vertical thermal growth was greater at one shaft than the other resulting in the gear and pinion centerlines being out of parallel in two planes during operation. This altered the tooth contact and concentrated the load near the apex.

A shield was installed in addition to the previous lubrication and cooling spray modifications. The units have operated continuously except for planned preventive maintenance for the past six years with no reoccurrence of the failures. Routine inspections of the gears indicate excellent tooth contact and no further indications of distress.

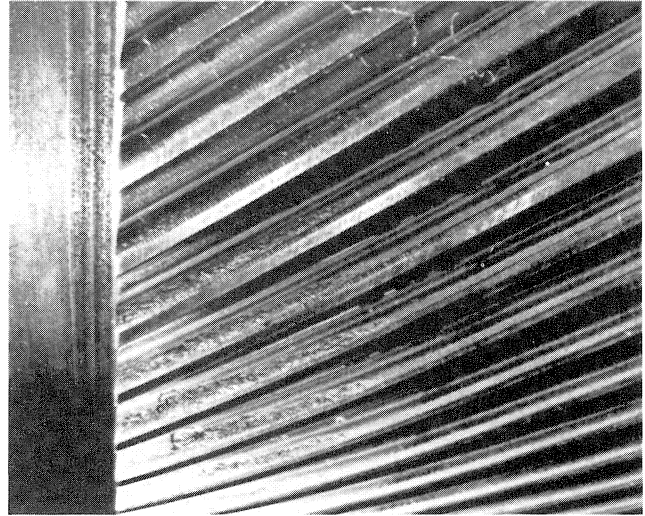
Figure 4. Photograph of low speed gear turbine side helix loaded flanks showing destructive pitting and spalling.

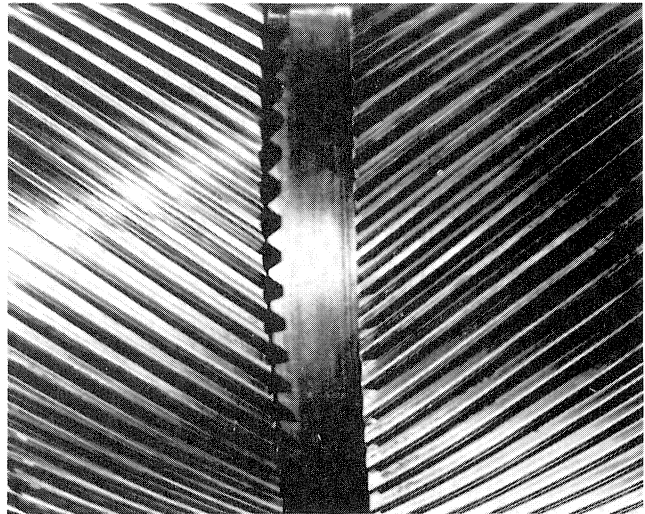
Figure 5. Photograph of low speed gear showing pitting on loaded flanks of both helices. Additional markings on compressor side helix can be seen in lower right hand corner.

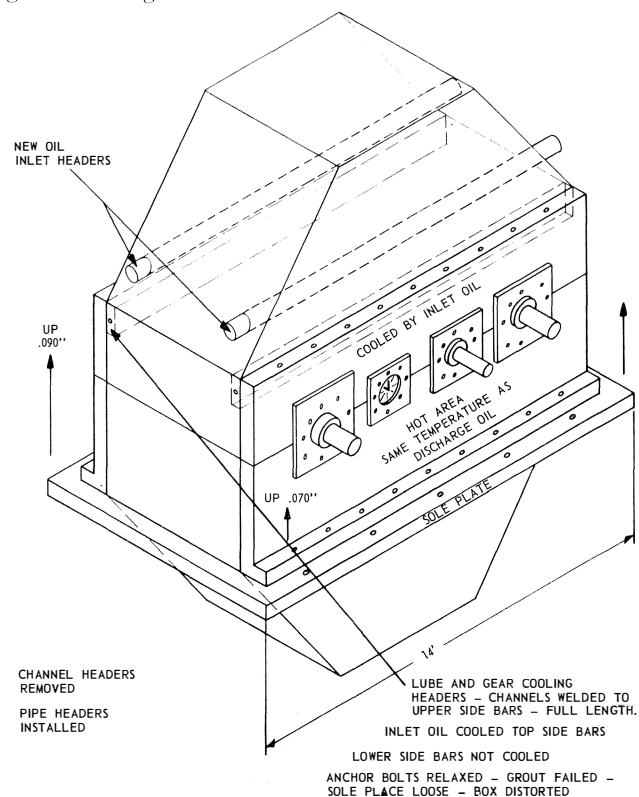
The bowing, we thought, most probably was the result of a temperature difference between top and bottom halves of the housing. How this condition could exist became clear when the lubricating oil header design was reviewed. The filtered and cooled oil entered at one end of the housing just above the horizontal centerline, i.e., the upper half. Once the oil entered the inlet nozzle and passed through the housing, the flow divided equally to each side into two identical oil headers. The headers were formed by two 1-1/2 in. by 5 in. channels welded to the inside of the two upper side bars or rails and ran the full

Figure 7. Triple pinion double helical unit indicating cut over sole plate mounting and location where distortion was greatest plus location of original and as modified oil inlet headers.

Redesign of the internal lubrication and cooling system was relatively simple. The channels welded to the rails were removed, and two full length pipe headers were welded into the end panels that were relatively thin compared to the heavy rails. Jacketed braided hoses were connected and tack welded to prevent loosening to threaded couplings welded into the pipe headers. Both faces of every mesh are sprayed. Sixty spray nozzles cool and lubricate the three meshes of the four gears. See Figure 7.

After modification of the housing, the grout was chipped out, the soleplates removed, optically leveled, and regouted with epoxy resin grout. The units also had bearing metal temperature detectors and noncontacting vibration probes installed while the modifications to the lube system was being done. Both units as reinstalled are monitored continuously.
