Mechanical Services Shops Department

Abu Ali Water Injection Shipper Pump Failures

By: Adeeb AL-Safrani

March 8, 2007

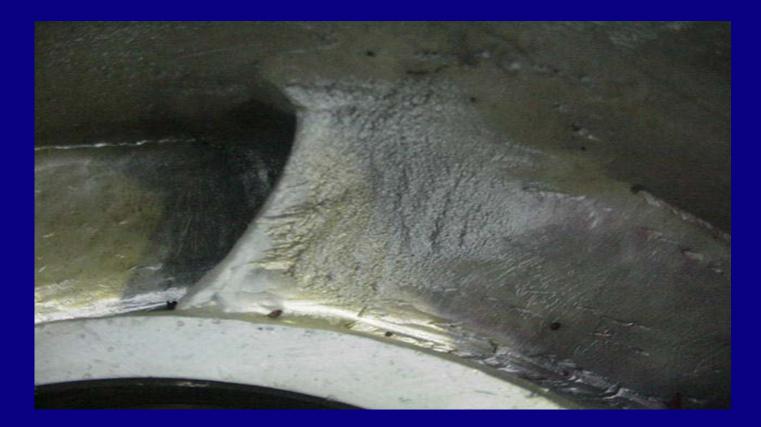
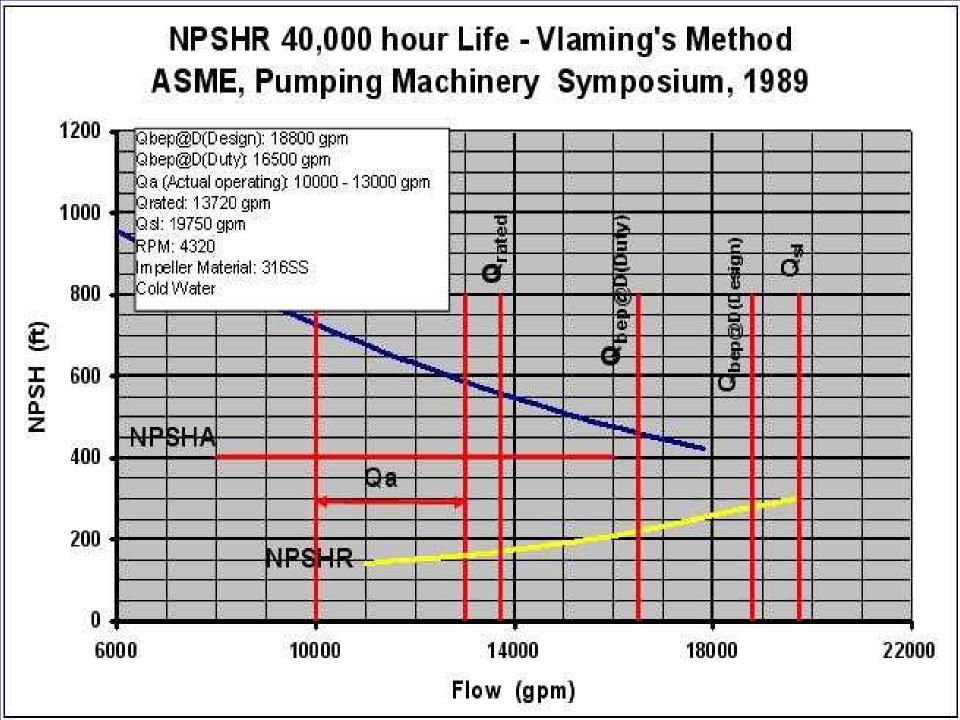
Pump Operational Problems : Impeller Damage

- Surface aspect in the damaged zone : typical cavitation pitting
- Location : blade suction side (visible side). No damage observed on the blade pressure side (backside)
- Cavitation mode : "Blade sheet cavitation " attached to the vane .

Cavitation damage on the vane suction side because :

- Qoper < Qshockless and
- NPSHA < NPSH 40000 < NPSHinc

Cavitation damage rate is too high because :

- Impeller design is oversized for the rated capacity
- Actual operating capacity is even below the rated flow
- Pump speed is too high giving high NPSH 40000
- Booster head is undersized giving insufficient NPSHA for achieving acceptable impeller life (40,000 hours = 5 years)
- High Oxygen content has been likely an aggravating factor

- Review / confirm the expected operating range
- New pump design (impeller with smaller shockless capacity)
- New pump speed and configuration
- Review pump booster head
- Reevaluate the oxygen scavenger system
- Reduce Oxygen content
- Upgrade impeller material (higher resistance to cavitation damage)

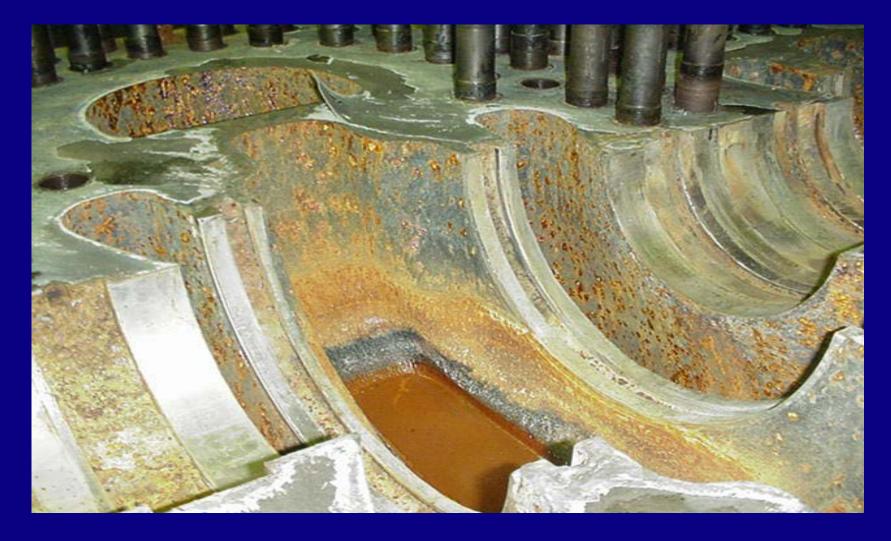
- Pitting Corrosion on the pump casing and pump shaft
- Cavitation and erosion on the 1st stage impeller
- Water boxes and shaft sleeves were completely damaged

- High oxygen content in the process fluid.
- Aggressive Working Fluid (Raw Water from Hanifa Zone)

Pitting Corrosion on Pump Casing

- Pump casing was coated by Inconel 625 coating
- > 1st stage impeller was replaced to 316 SS
- Pump shaft was fabricated out from CS 4340
- Water boxes and shaft sleeves were replaced

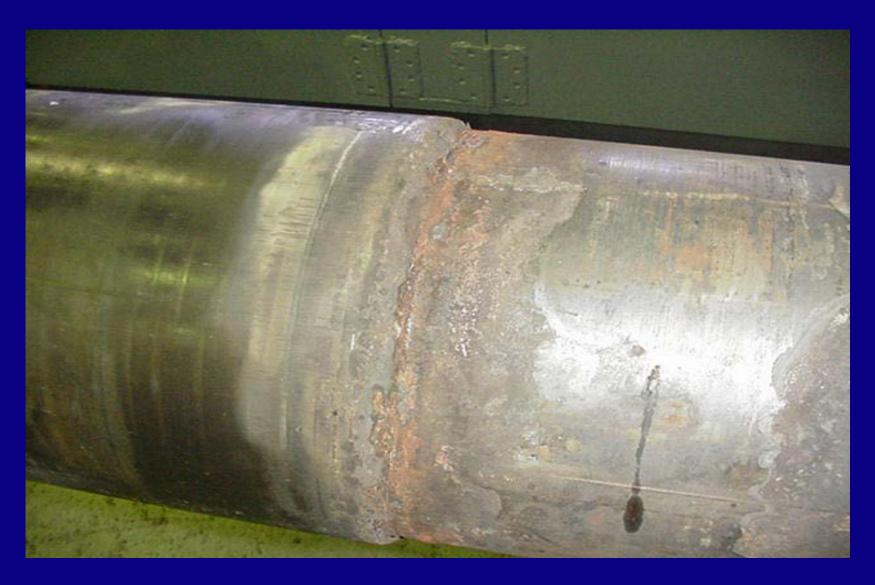
Corrosion on Pump Shaft

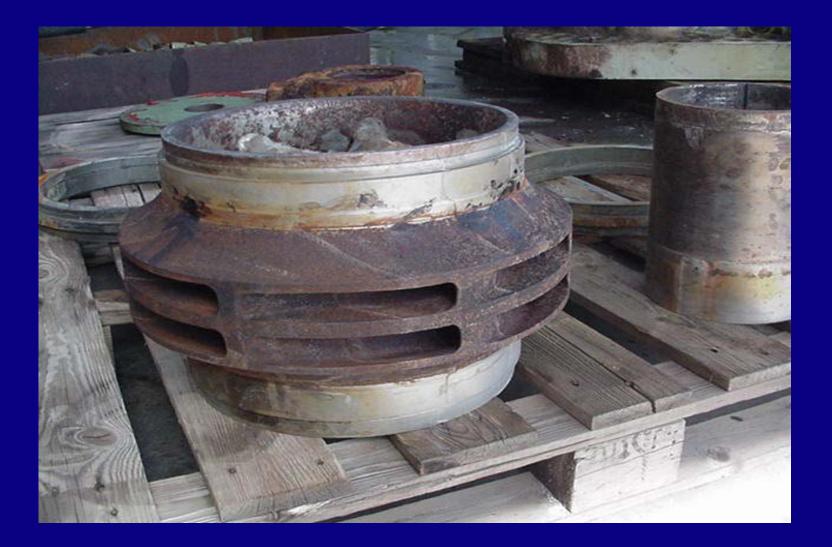
Pump Impeller as Received

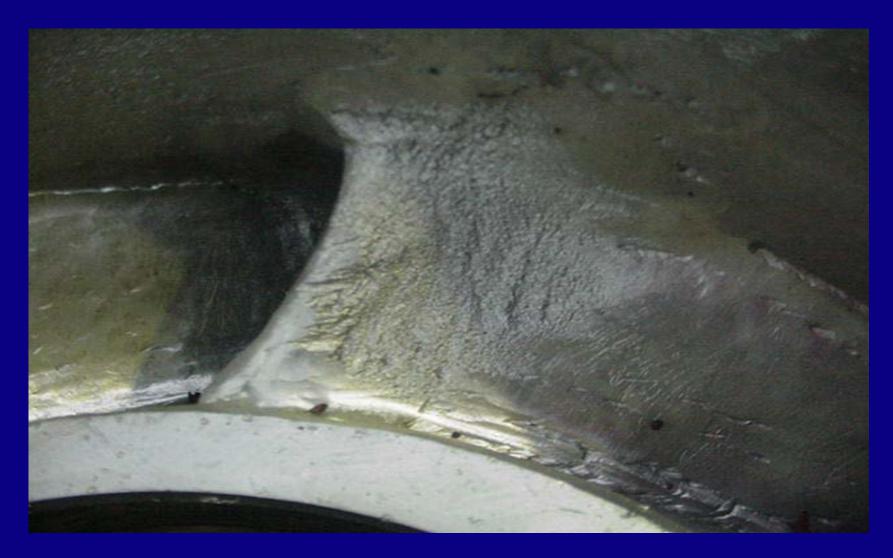
Cavitation On The First Stage Impeller Vanes

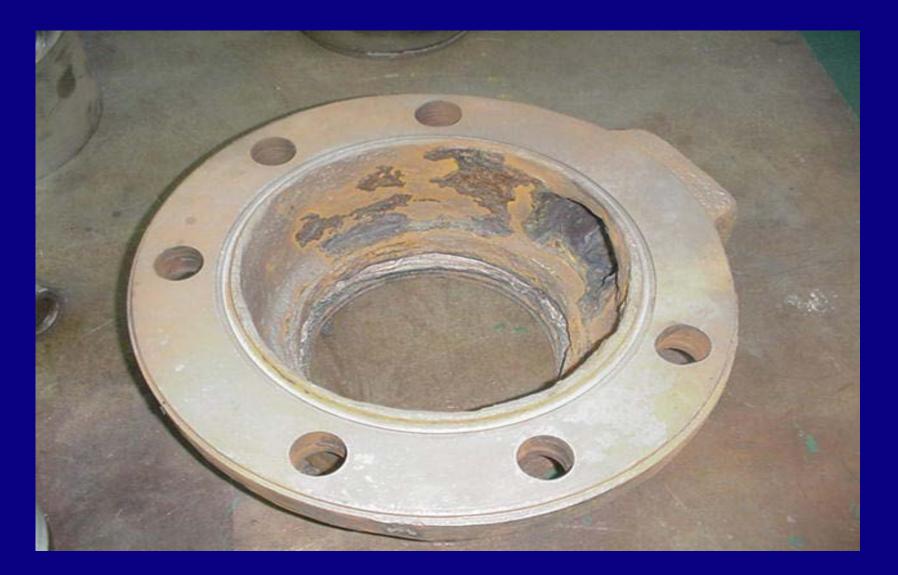
Water Box as Received
