**“SUCCESSFUL MODIFICATION OF VERTICAL-TURBINE PUMPS FOR CAPACITY AND RELIABILITY IMPROVEMENT”**

**César A. Morales Casanova**  
*Rotating Equipment Specialist*  
*PDVSA – Pequiven*  
*UNF Morón, Edo. Carabobo*  
*Venezuela*

*17<sup>th</sup> International Pump Users Symposium*  
*March 6-9, 2000. Houston, Texas*

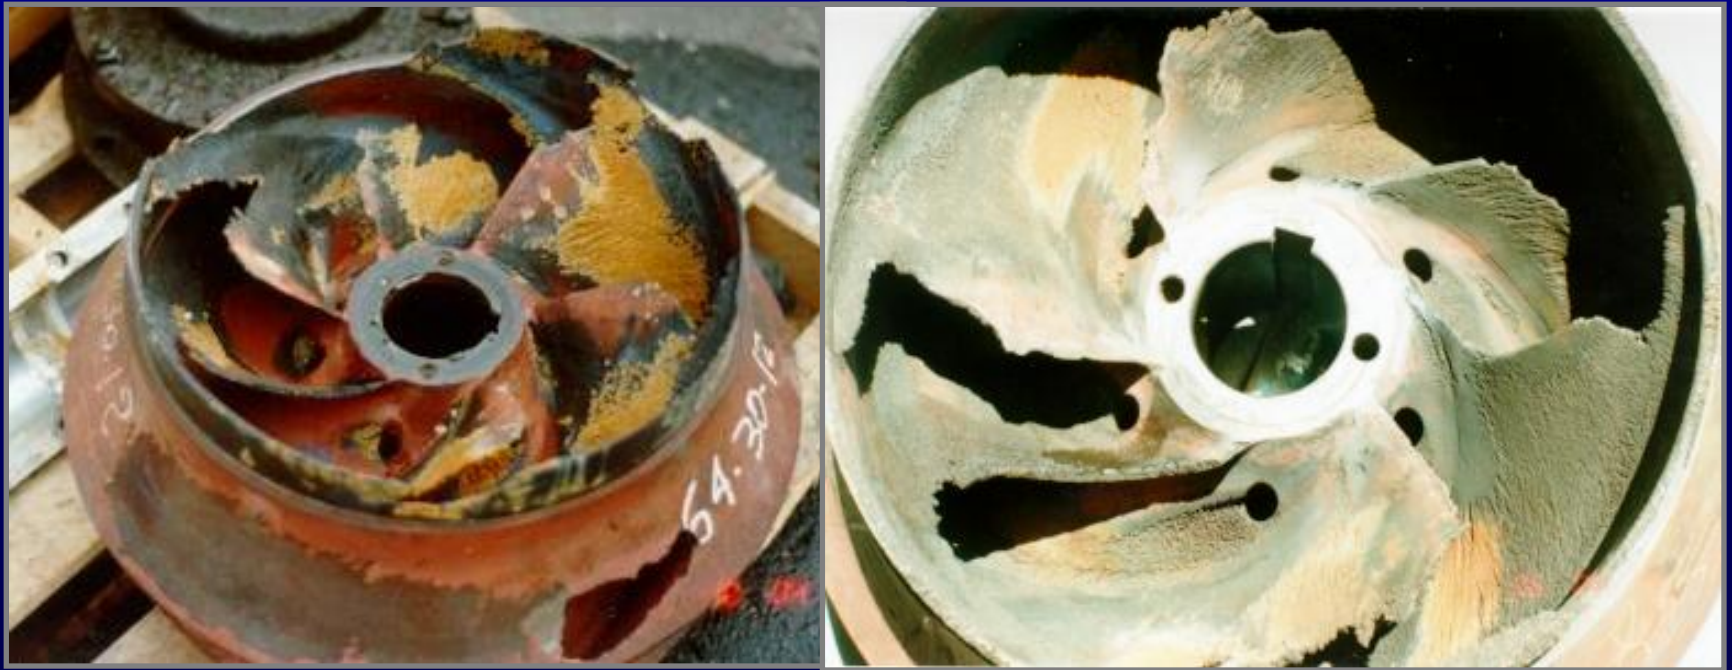
- ▶ **Pump efficiency was reduced due to severe cavitation damage of impellers, causing additional limitations to cooling water feed.**

***IMPELLER CONDITION AFTER 1 YR IN SERVICE***

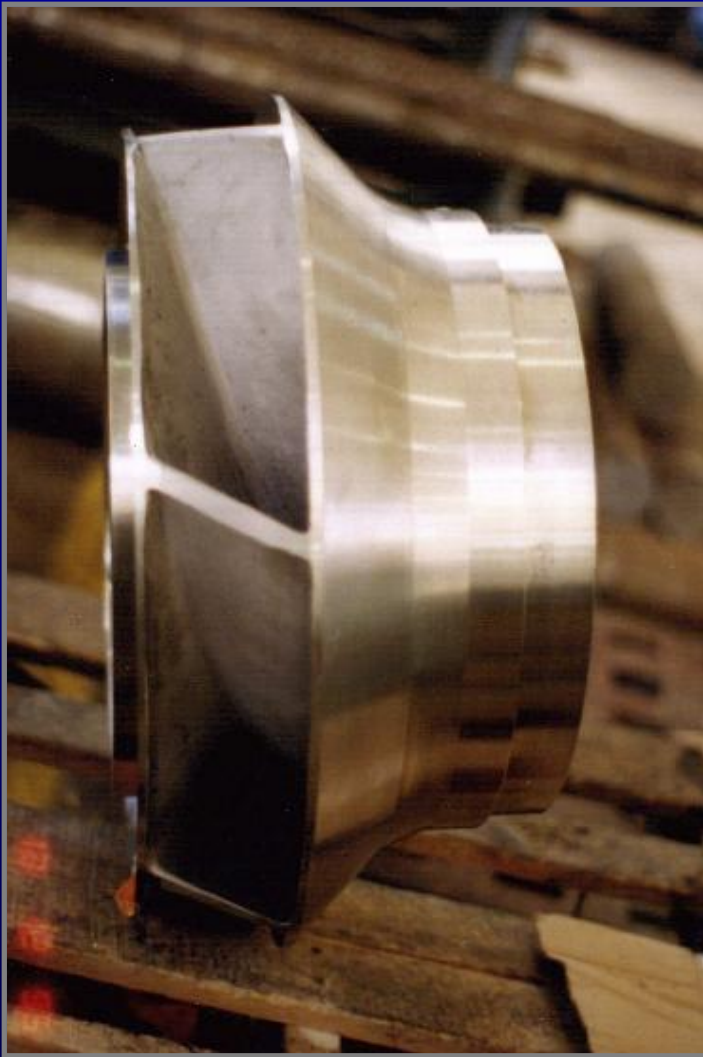
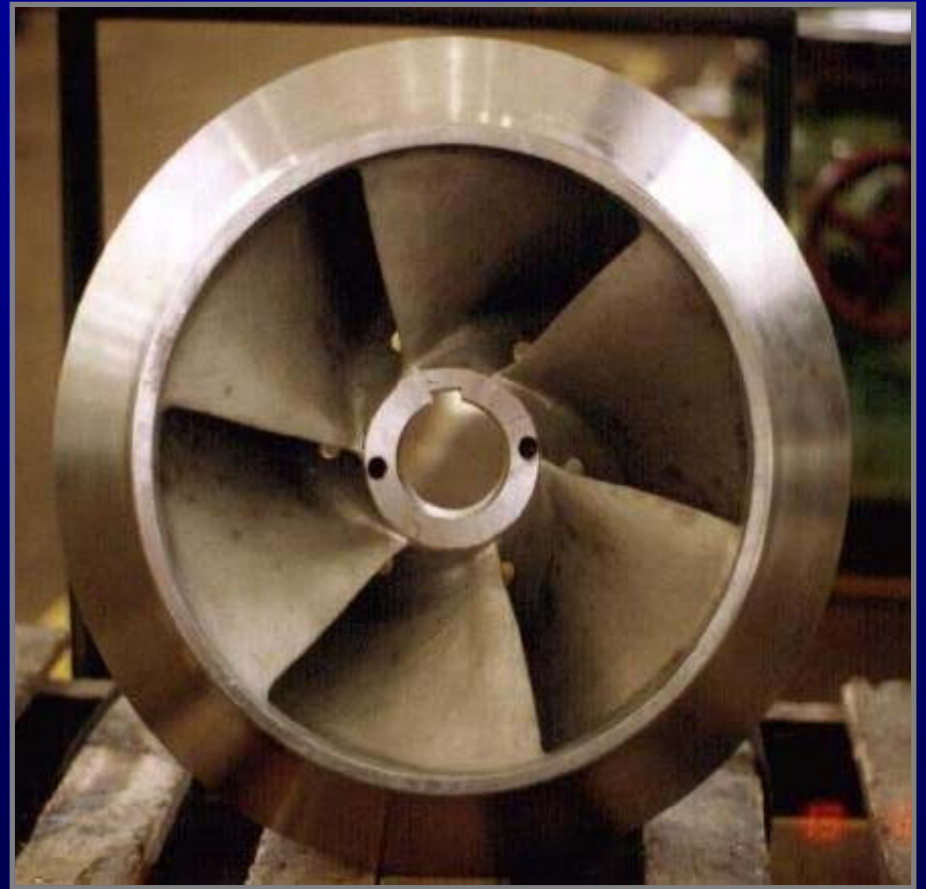
**FIRST IMPROVED IMPELLER "AS SUPPLIED"- DEC'96**

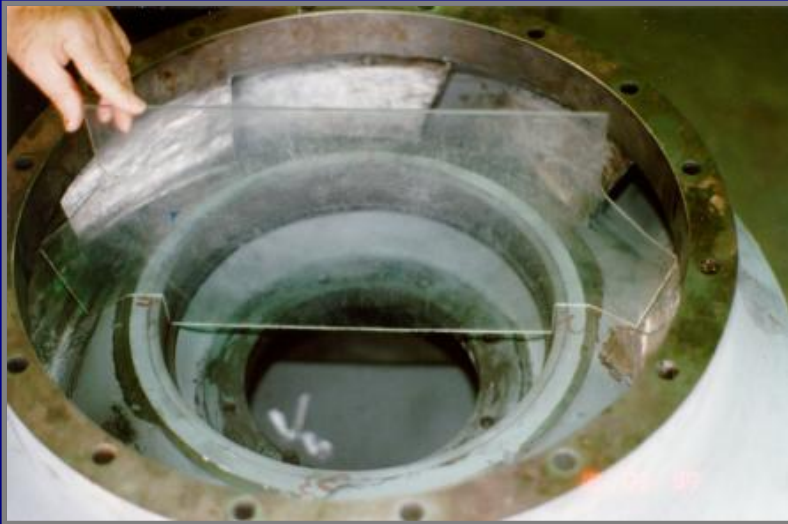
**IMPELLER TEMPLATE INSERTED**

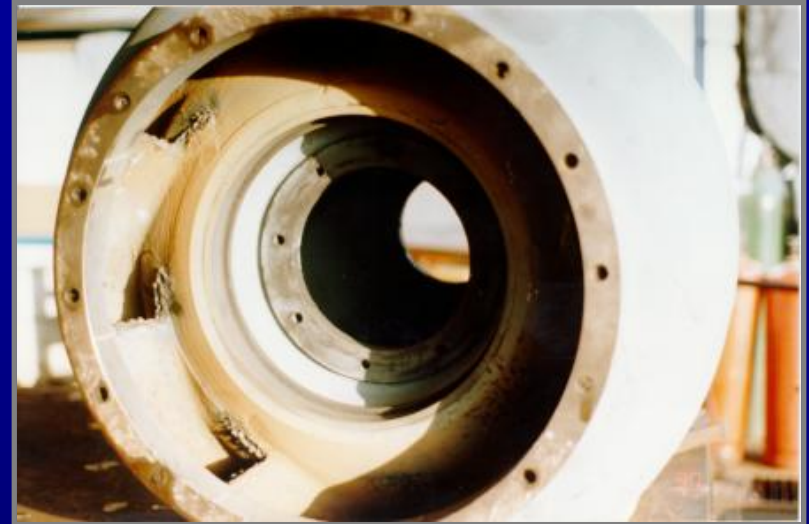
**VANE ROUGH CUT**

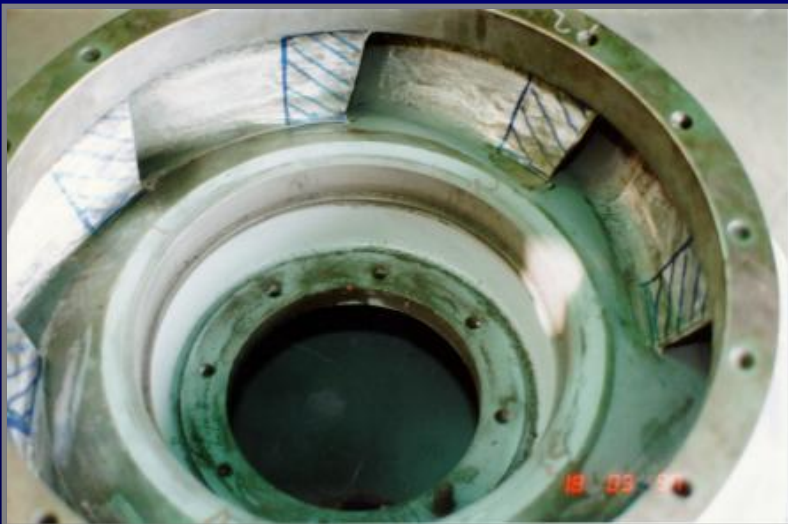
**VANE CUT MARKING**

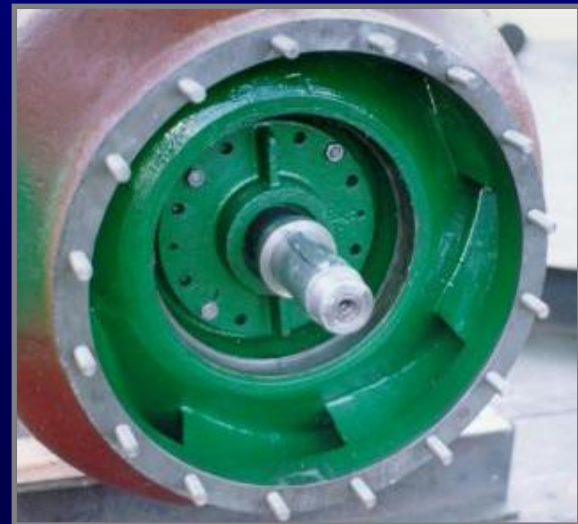
**FINISHED BOWL**

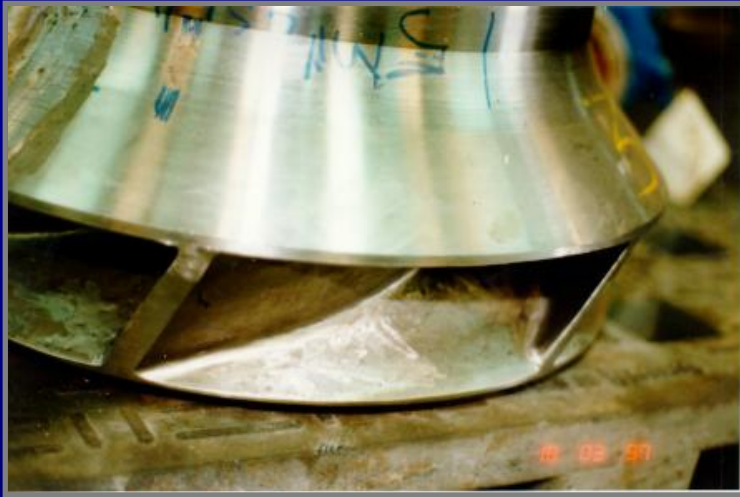
**“AS SUPPLIED” VANE EXIT**

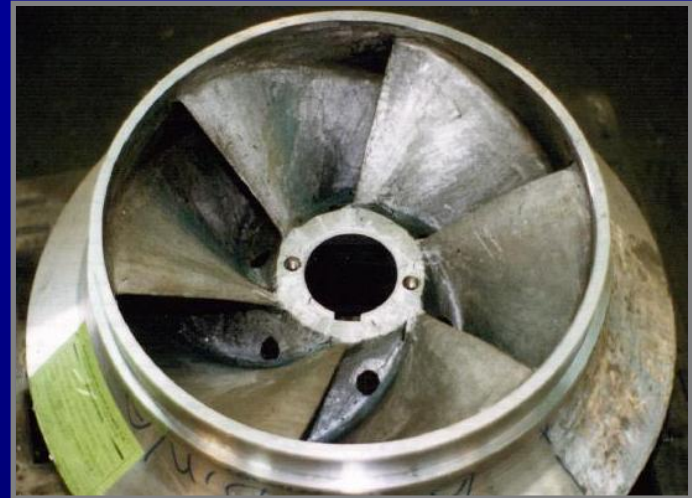
**“AS SUPPLIED” ROUGH VANE SURFACE**

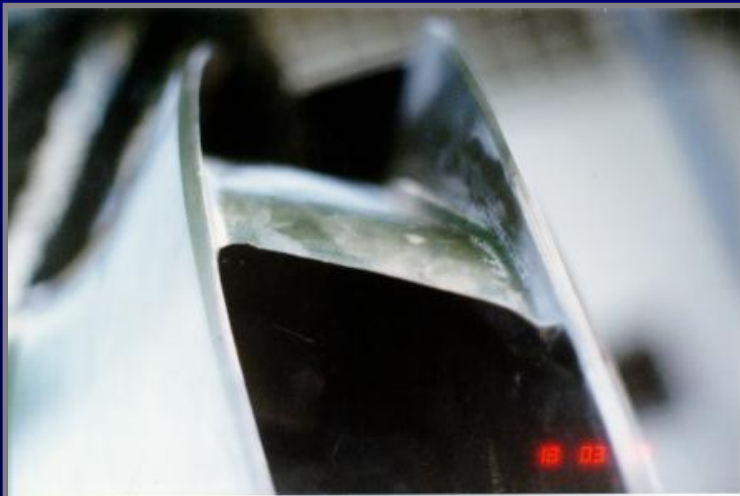
**ADJUSTED (UNDER/OVERFILLED)  
VANE EXIT**

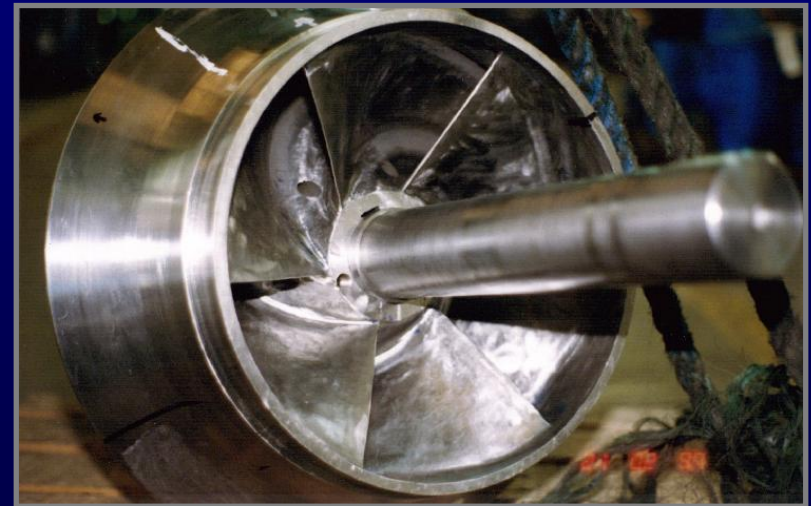
**VANES POLISHED  
LEAD EDGE ROUND & THIN**

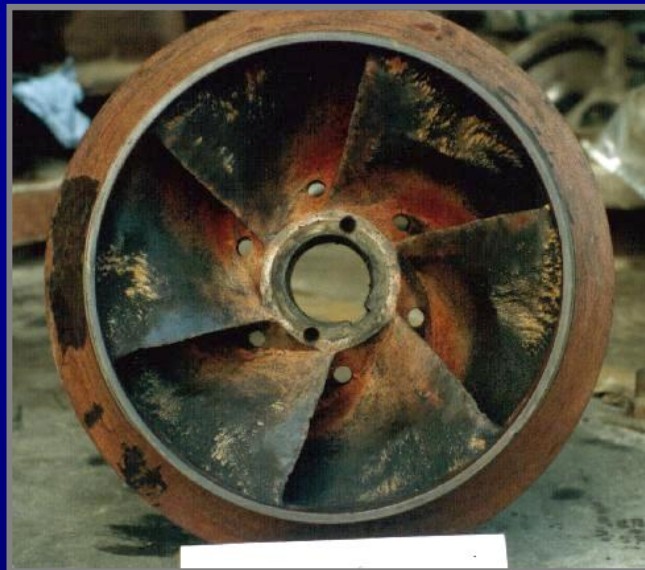
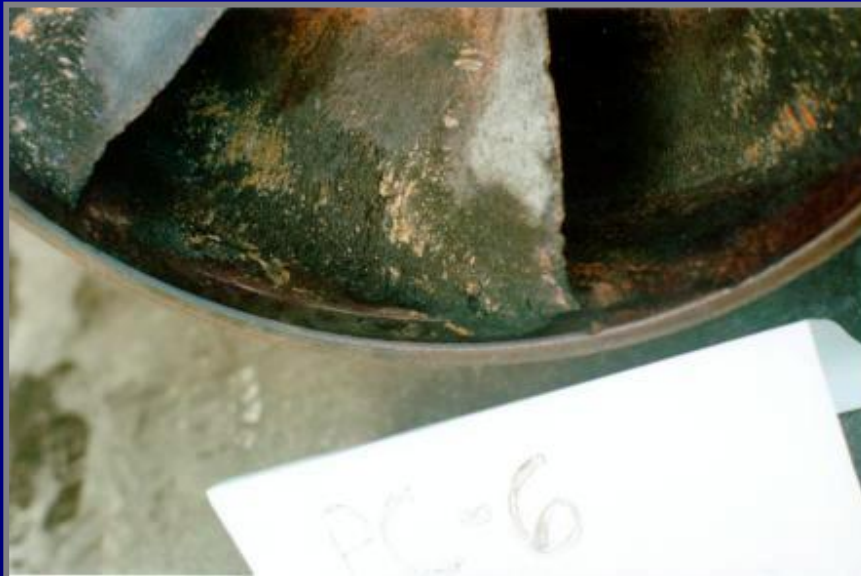
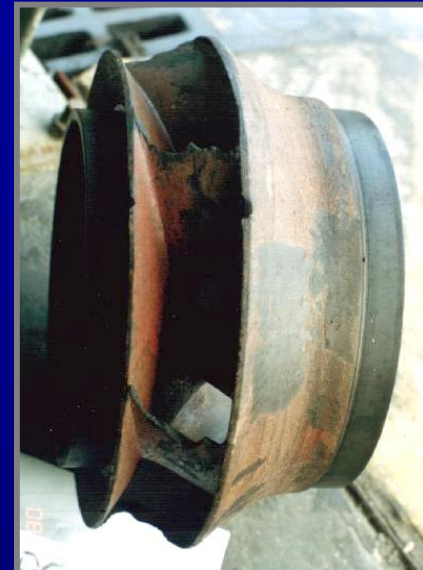
**AGOSTO 1996 – 1 YEAR IN SERVICE**

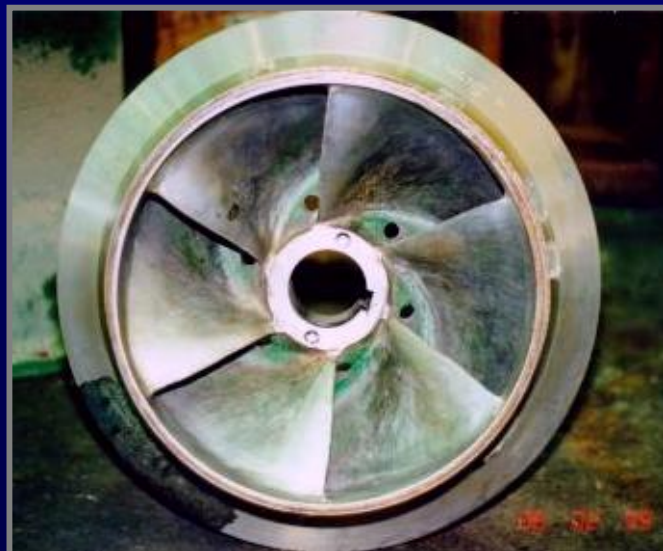
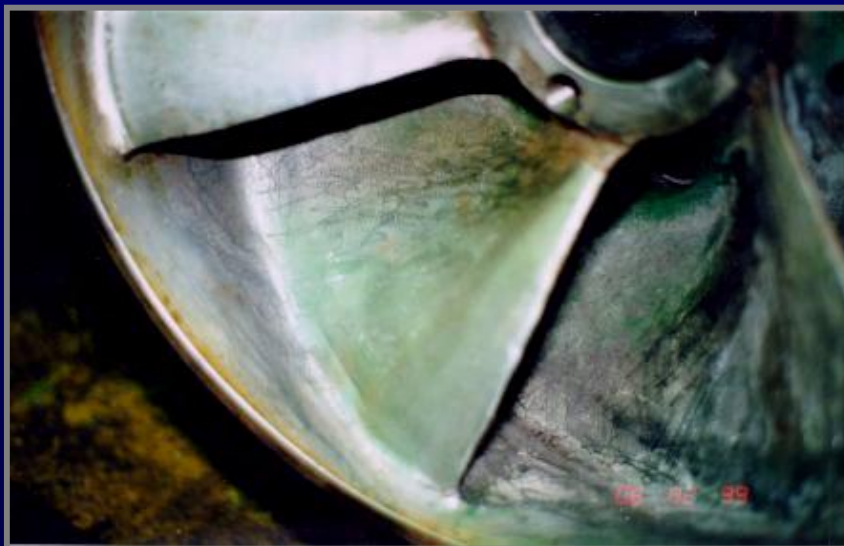
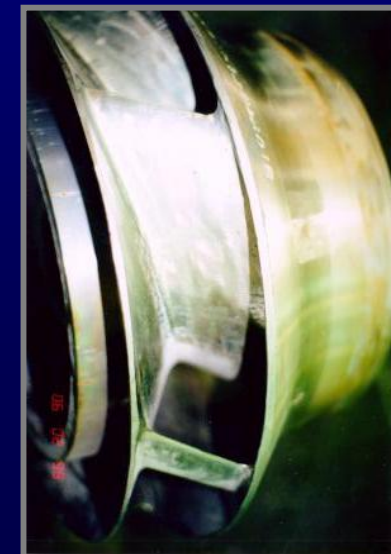
**MAY 1997 - FEB 2000 – 3 YEARS IN SERVICE**
