## **THUNDERSTORMS-RISK FACTORS IN AVIATION. CASE STUDY: AREA OF RESPONSABILITY OF THE BUCHAREST- OTOPENI AERODROME ON 30.06.2009**

### **ABSTRACT - Thunderstorms-risk factors in aviation. Case study: Area of Responsibility of the Bucharest-Otopeni Aerodrome on 30.06.2009**

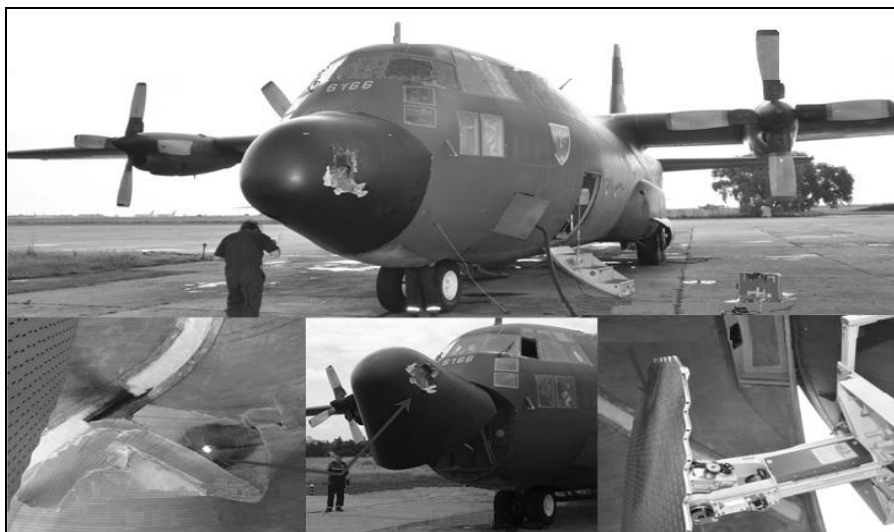
At about 40 km north-east of the aerodrome, the aircraft was struck by lightning (15:20 UTC) during the approaching procedure. The crew heard a loud noise but didn't realize the fact that their plane was struck by the thunderbolt, instead they noticed that the radar was malfunctioning. The crew contacted and informed the Bucharest-Otopeni Tower about the emergency and requested landing priority. Their request was immediately approved and the aircraft landed safely even if the radar system was totally out of order and the weather conditions were very poor.

After landing, when the aircraft was parked, the flight crew and the maintenance crew have noticed that the aircraft was struck by lightning in its forefront area, namely in the radom box accommodating the radar system, where the lightning encountered the lowest resistance. (Photo 1).

Photo 1. Damages caused by lightning on a military aircraft
