Sborník vědeckých prací Vysoké školy báňské - Technické univerzity Ostrava
číslo 1, rok 2008, ročník VIII, řada stavební
článek č. 38

Marian MARSCHALKO¹, Libuše HOFRICHTEROVÁ², Lubomír TŘESLÍN

**ENGINEERING-GEOLOGICAL CONDITIONS OF LANDSLIDE IN THE OSTRAVA-KARVINÁ
COALFIELD**

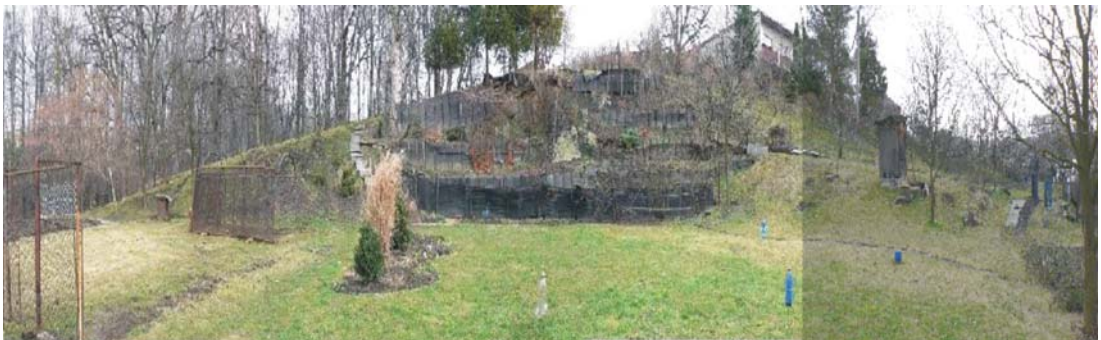
The tear edge of the slide is pronounced, it reaches as high as 7 m (Figure 4) and spreads in the direction NW-SE.

Fig. 4: Tear edge of the slide

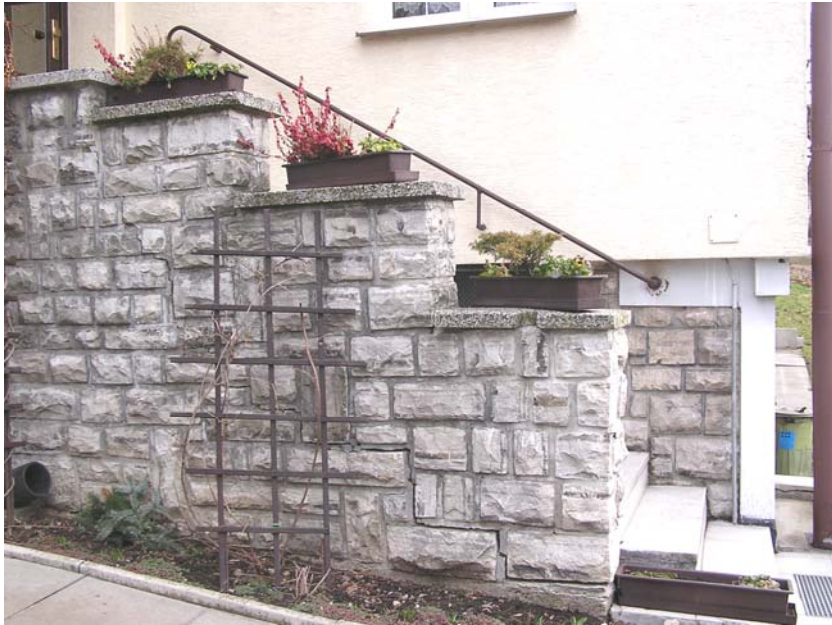
Since 1990 small cracks in the coat of the house have appeared, that have probably been caused by coal mining, and in 1995 they began to open distinctly. More serious manifestation of devastation showed in 1997. The initiator of the manifestation could have very probably been rainfall in the summer of 1995, in May and August 1996 and especially in June and July of 1997, when the rainfall exceeded the long-period average in the CR and caused a number of slides in Moravia. Currently, the slope movements are still active and a study was started to monitor the potential mining influences. In the first stage, we carried out study of archives, engineering-geological survey and geo-

In the subsoil of the house, complicated foundation conditions were identified due to changes in the quality and thickness of the foundation soil.

The surface of the pre-Quaternary bedrock forms an elevation under the south-east corner of the house which can cause retention of ground water and its lifting effect (bulging of floors in the cellars).

Fig. 5: Damage to the construction of the house

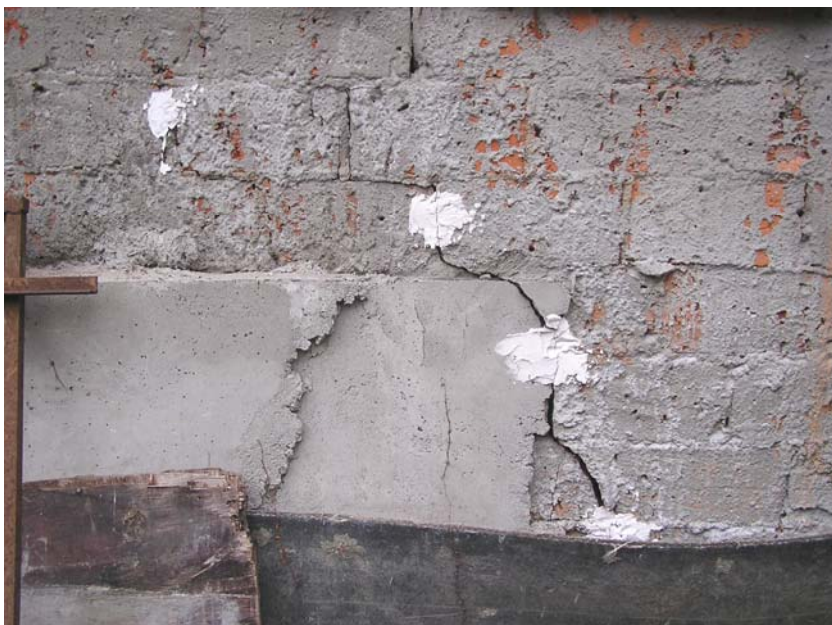
Fig. 6: Damage to the construction of the workshop

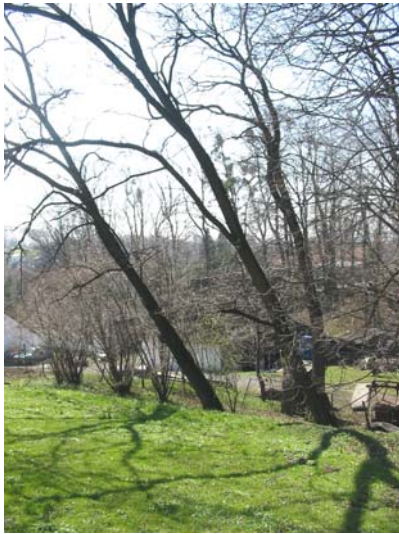
Fig. 7: Bending of trees

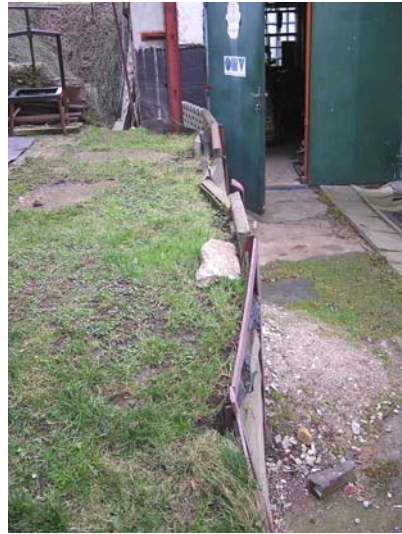
Fig. 8: Sliding and displacement of the top soil near the workshop

On the basis of the study results, the best recommendation in order to improve the stability situation would be building a draining system in connection with subhorizontal drainage wells, which would be able to drain anomalous hydrogeological states related to potential overlimit rainfall. In order to obtain the best effect, the depth of the draining system should go along the eluvium surface of the Frýdek Members. Next, construction of static measures by means of an anchored pile wall should be built in the level of the existing supporting wall behind the house. In addition, we can suggest demolishing of the inconveniently placed garage and possible placement of heavy gabions as a stabilizing fill.

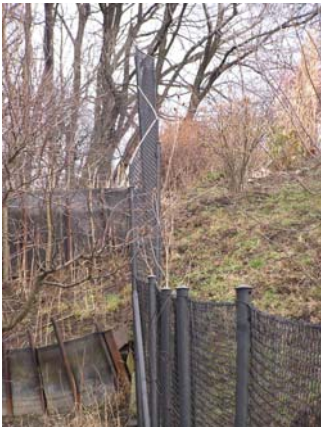
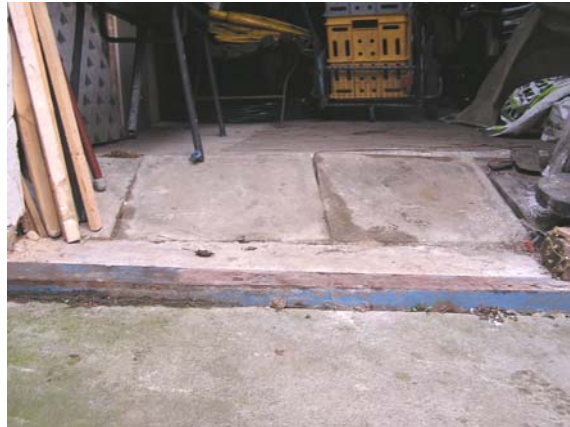
As for the circumstantial evidence of the slope deformation and its active manifestation, we identified damage to the construction of the house (Figure 5), to the workshop (Figure 6), bending of trees in its vicinity (Figure 7), sliding and displacement of the top soil near the workshop (Figure 8), bent fence in the top part of the slope deformation (Figure 9), and terrain deformation with the manifestation of floor bulging in the workshop up to 15 cm (Figure 10).

Fig. 9: Bent fence in the top part of the slope deformation (left) Figure 10 Terrain deformation with the manifestation of floor bulging in the workshop up to 15 cm (right)

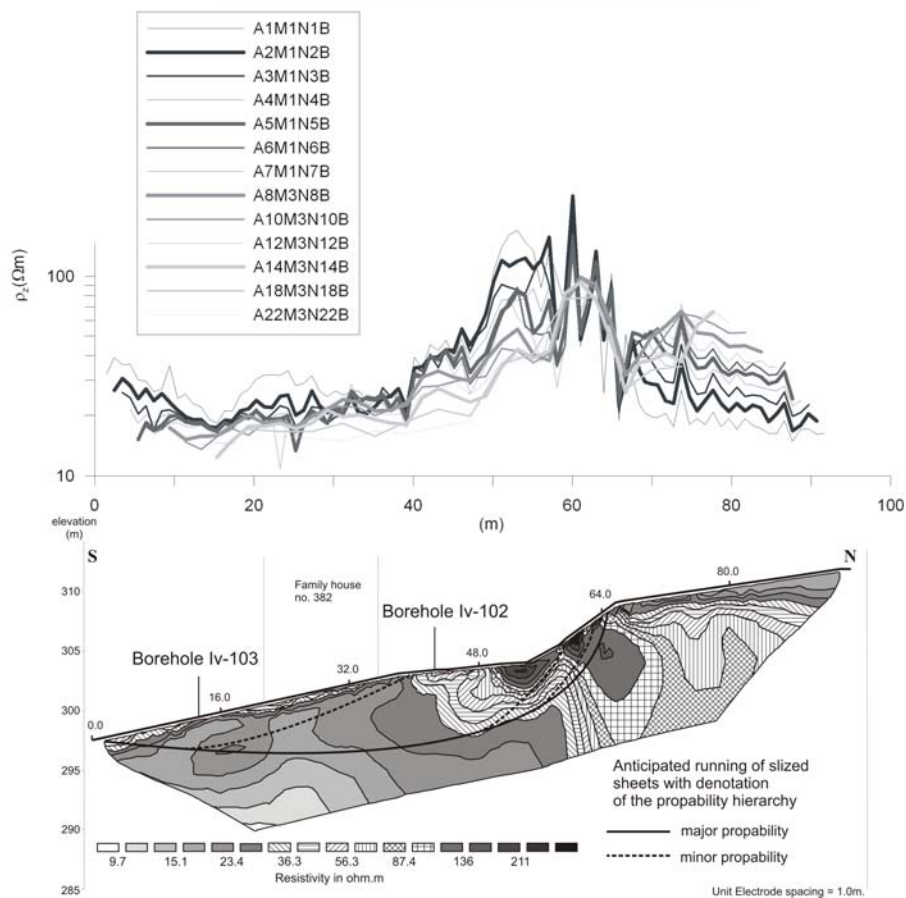
The interpretation of the slip surfaces of *S1 section* (Figure 11) was mainly conditioned by morphology, by means of top tear edge manifestation, and next by inclinometric measuring in the bores Iv-102 and Iv-103 (bore placement – Figure 3). According to the inclinometric measuring in the bore Iv-102 an occurrence of a slip surface was proved in the approximate depth of 6-7m under the collar of well and the slip surface depth identified in the bore Iv-103 was about 3 m p. t. (under the ground). Inclinometric measurements register both movements caused by undermining in the direction of the subsidence trough as well as movements related to a slide.

Fig. 11: Resistive model of S1 section

Resistively, the outcrop of teschenites is demonstrated by a considerable rise in resistance, 150 Ω m and more, and the course of the slip surface is situated between the maximum resistance values on the stationing 50 - 65 m and next, it runs in an inclinometrically identified depth in the bore Iv-102. Cracks were situated according to local resistive minimums both in the model as well as in the section curves.

As for lithology, the tear edge begins at the outcrop of teschenites on the stationing 65m and transits to silty claystone (it is identified in the place of bore Iv-102 2.5 m under its roof).

With the bore IV-103 in the slip surface depth there is a boundary between clayey-sandy loam and loamy-stony debris in the bedrock.

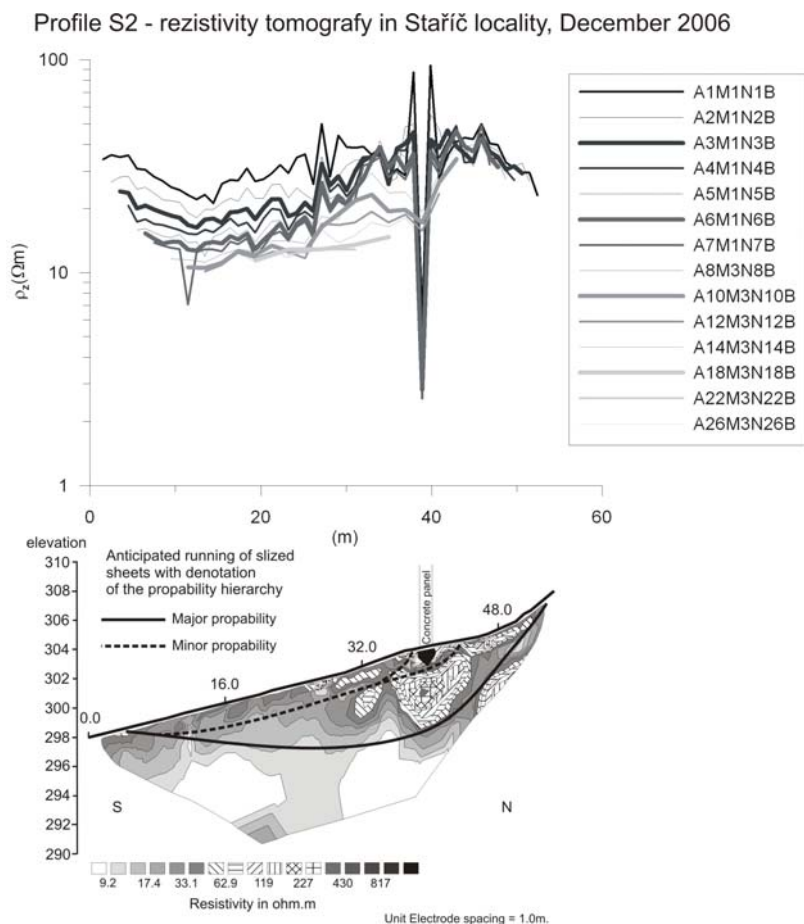
The determination of the course of the slip surface with *S2 section* (Figure 12) was only grounded in the areal continuity of the course of the slip surface as in the vicinity of the measured section there is no inclinometric bore. Similarly to the S1 section, this slip surface is affected by morphology and its course is situated between the local maximums of impedance. The maximum depth of the estimated slip surface 6 m p.t. is found on the stationing 37m.

Fig. 12: Resistive model of S2 section
